BEACH EROSION CONTROL REPORT  
ON COOPERATIVE STUDY  
OF CONNECTICUT

AREA 9

EAST RIVER  
TO  
NEW HAVEN HARBOR

AUGUST 12, 1955

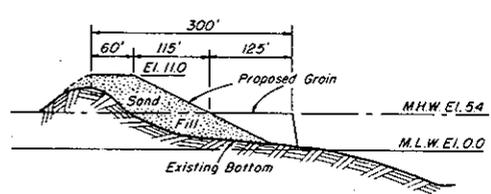
**PROPOSED GROIN AND SAND FILL (GUILFORD POINT)**

The spits and marsh on either side of the point have been subject to erosion which between 1933 and 1948 caused the shore line to recede 25 to 50 feet. This process is continuing. No harmful effects are known to have resulted from this erosion. Improvement of the public bathing beach is desired for recreational use. Since there are no sources supplying beach building materials by natural processes, improvement of the beach can only be effected by artificial nourishment. Probings in East River and opposite the river entrance in Guilford Harbor indicate that suitable material exists offshore within a practicable distance for hydraulic dredging and placement of fill on the bathing beach. A plan of improvement by direct placement of fill to widen the bathing beach and construction of an impermeable groin to retain the fill and reduce losses by eastward drifting has been considered and is shown on Plate 16. A Federal project, adopted in 1945, provides for improvement of Guilford Harbor by dredging a navigation channel into East River. No work has been done on the project. The Town of Guilford has reportedly appropriated and has had its required share of the cost of the improvement available for a number of years and it is attempting to obtain the necessary Federal appropriation for the work. There is an adequate quantity of suitable material required to be dredged for the navigation project within a practicable distance for pumping to the public bathing beach to supply the fill needed for the beach project. In the event the channel is dredged, consideration should therefore be given to disposal of suitable material to enlarge and improve the bathing beach.

**GROIN DETAILS**  
Top width 5'  
Side slopes, Outer 100' - 1 on 2  
Remainder - 1 on 1.5  
Top and slope stones, minimum size, 1 ton  
Sand tight core of quarry run stone up to 150 lbs. in weight

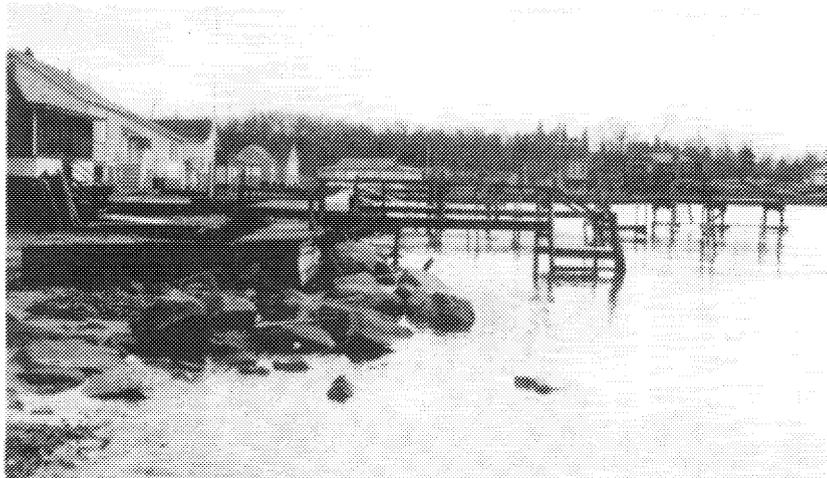
FIG. 1. ISLAND BAY, GUILFORD. November 20, 1952. Cottages on low barrier bar.

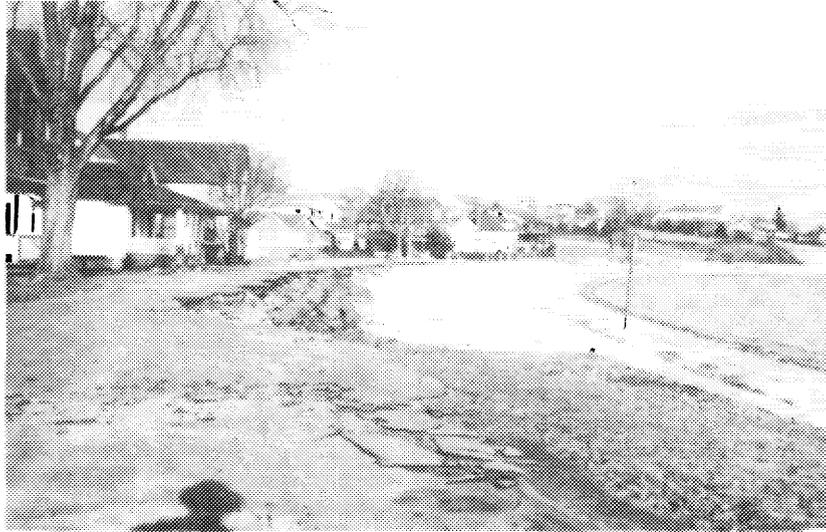
FIG. 1. HOTCHKISS GROVE BEACH, BRANFORD. December 1, 1950. Road washed out by storm of November 25, 1950.

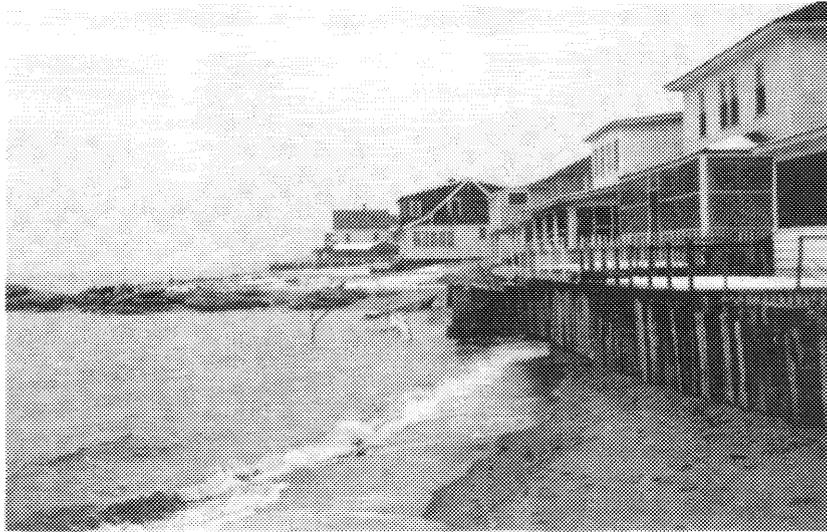
trailed eastward as a sandspit across the mouth of Bradford Cove almost connecting with the south tip of Mansfield Point. It was also noted that a deteriorated groin at the west side of the Bradford Cove entrance had been reconstructed with riprap since 1952 and extended southerly and then westerly as a continuous riprap mound in front of residences. Erosion and recession of the shore line has also been observed between 1948 and 1952 along the beach about 800 feet west of Bradford Cove. The beach area adjacent to Bradford Cove has reportedly been formed artificially by progressively extending a groin at Bradford Cove which impounded littoral drift on its west side. A practicable method of reducing the large fluctuations in the position of the shore line adjacent to Bradford Cove and providing protection for residences consists of additional extension of this groin to intercept and impound beach material which is now lost to the east. Momauguin Beach as a whole is low and the development on it is consequently subject to flooding and wave attack during storms accompanied by exceptionally high tides. Protection against wave attack can be provided by direct placement of a wider sand beach in front of buildings and structures. Reduction of losses of this fill, if excessive, can be effected by construction of impermeable groins. Groins will probably also intercept and impound some beach material but their effectiveness will decrease the farther west they are built since the length of sandy shore on the updrift side which can supply littoral drift will be progressively shorter and the supply of material therefore smaller. It is also likely that the supply of drifting material will decrease following construction of more structures for protection of developed areas to the west. A plan of protection involving beach widening by direct placement of sand fill from available sources offshore and construction of impermeable groins as discussed

FIG. 1. MOMAU GU IN BEACH, EAST HAVEN. February 1, 1952. Erosion of beach has endangered residences at Bradford Cove.

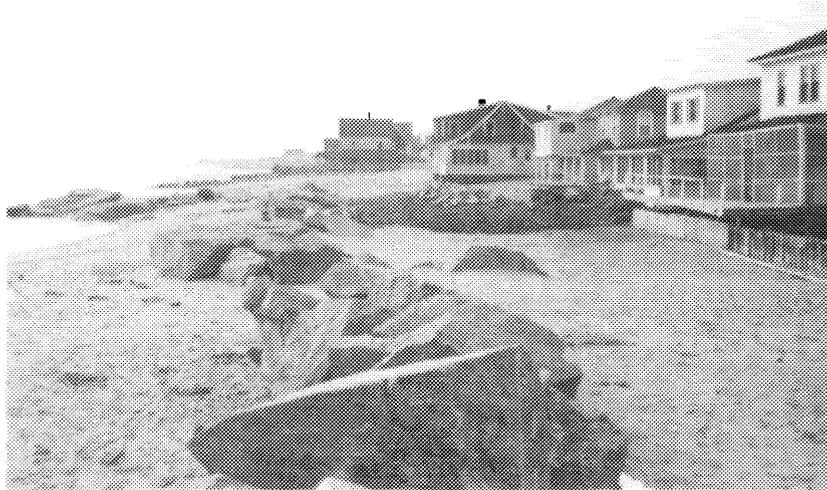
FIG. 2. MOMAU GU IN BEACH, EAST HAVEN. February 16, 1955. Compare with Fig. 1, above. Beach reformed in front of residences.

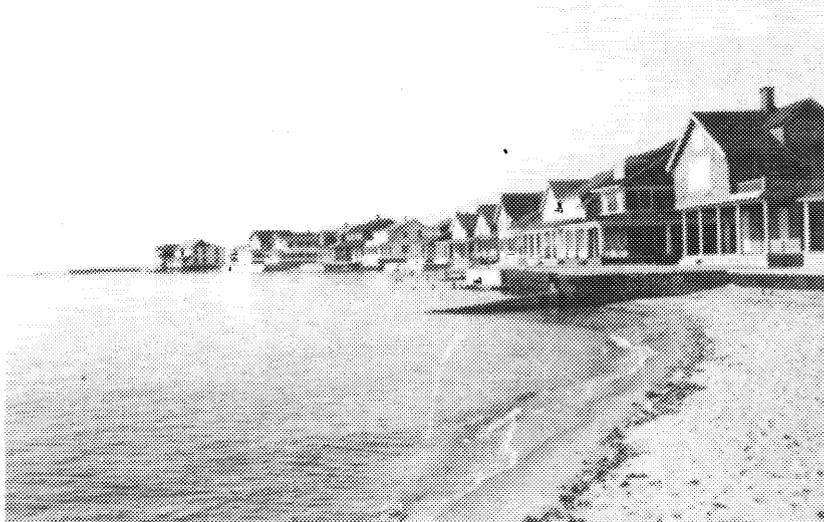
FIG. 1. SILVER SANDS BEACH, EAST HAVEN. November 18, 1952. Cottages located close to the shore.

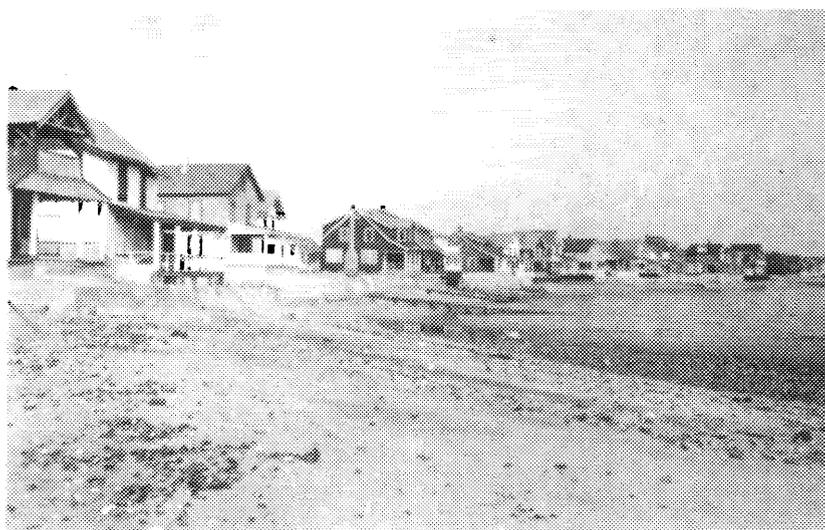
FIG. 2. SILVER SANDS BEACH, EAST HAVEN. February 16, 1955. Cottages near South End located close to the shore.

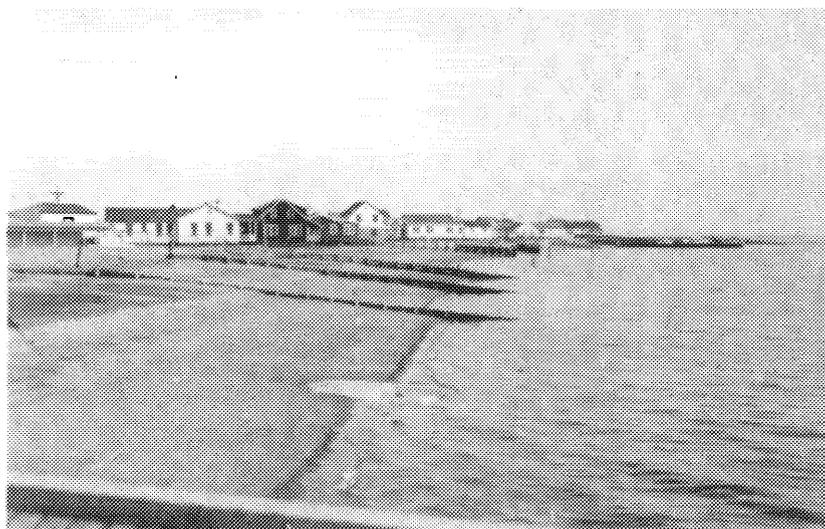
FIG. 3. WEST SILVER SANDS BEACH, EAST HAVEN. February 16, 1955. Groins and cottages on sandy barrier beach.

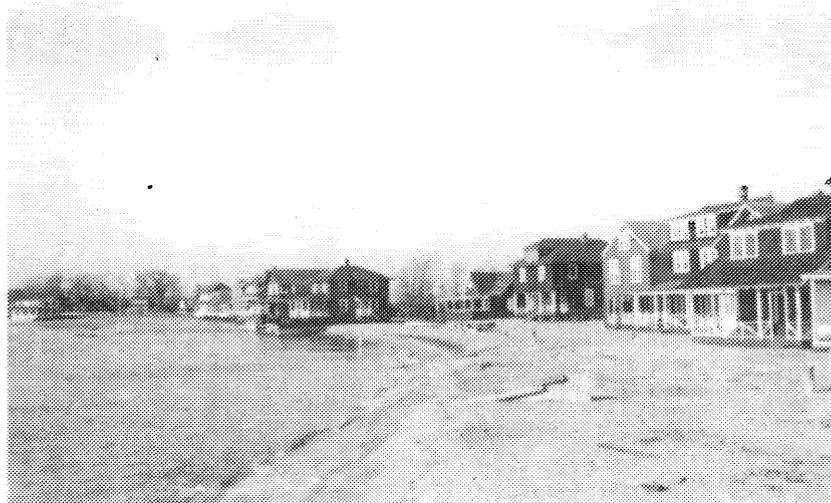
FIG. 1. WEST SILVER SANDS BEACH, EAST HAVEN. November 18, 1952.  
Cottages on low sandy barrier beach.

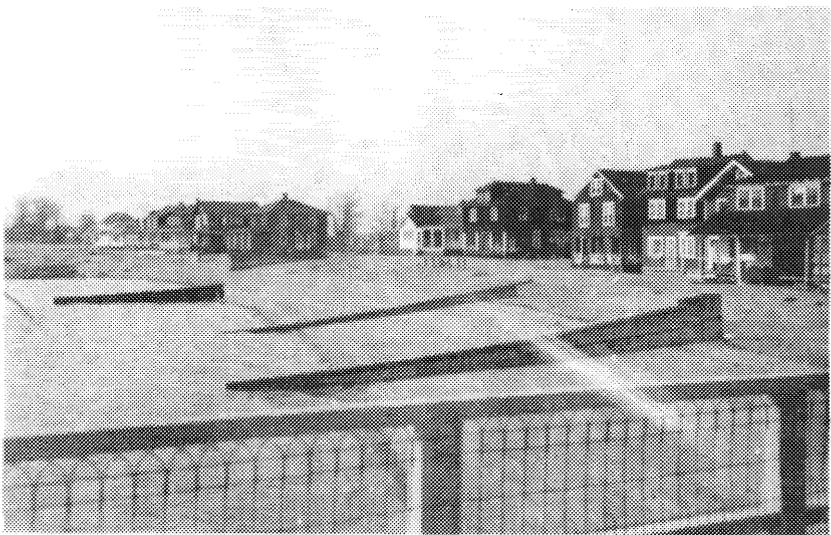
FIG. 2. WEST SILVER SANDS BEACH, EAST HAVEN. February 16, 1955.  
Compare with Fig. 1 above. Note lowering of beach at groins.

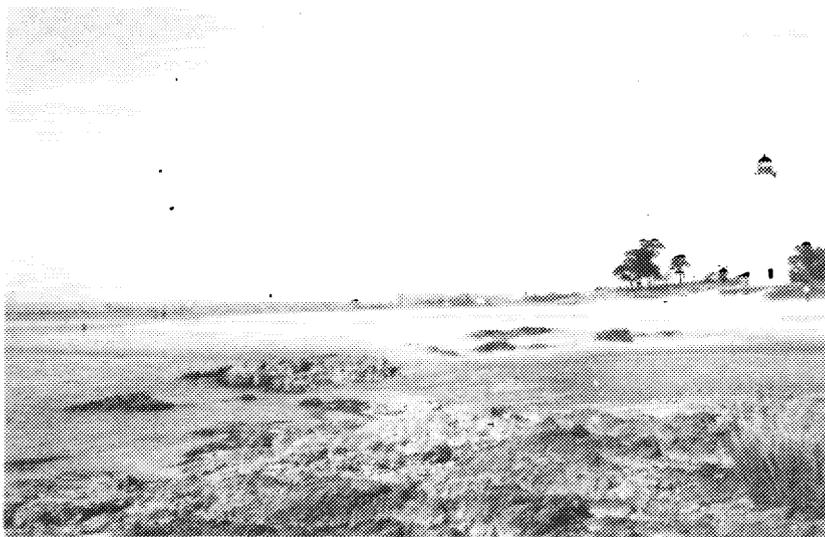
FIG. 2. LIGHTHOUSE POINT, NEW HAVEN. September 2, 1949. Six months after placement of sand fill.

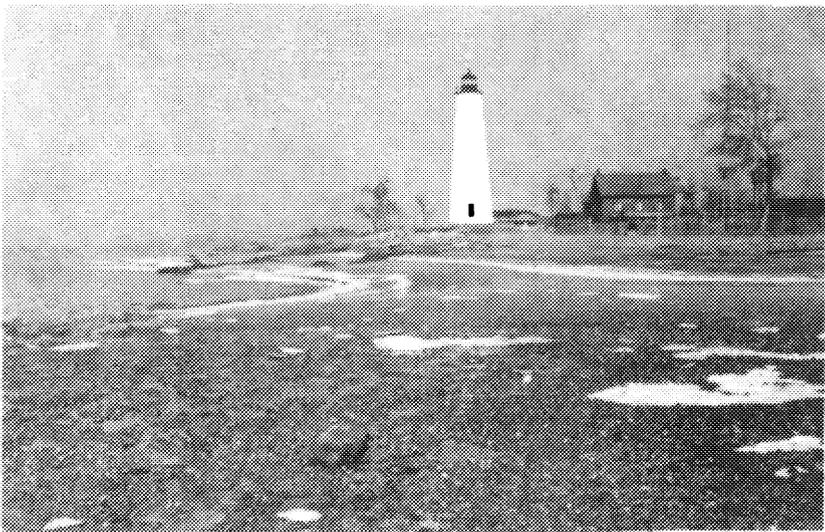
FIG. 3. LIGHTHOUSE POINT, NEW HAVEN. February 16, 1955. Compare with Fig. 2 above. Erosion of the fill has moved the shore back to bedrock at the light.

65. It is recommended that the United States adopt a project authorizing Federal participation by the contribution of Federal funds in an amount equal to one-third the first cost of construction of an

impermeable groin 380 feet long at Lighthouse Point Park generally as shown on Plate 16. The recommended Federal participation is subject to the conditions that local interest will:
