Smith-Curtiss House Complex
Osbornedale State Park
411 Hawthorne Avenue
Derby, CT 06418

Conditions Assessment **for the** **Smith-Curtiss House and Property**

September 2010

Prepared by:
Faesy-Smith Architects PC
523 Danbury Road
Wilton, CT 06897

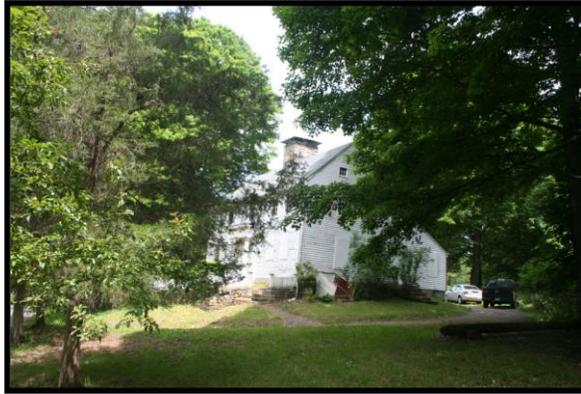
Figure 1: View of House from street.

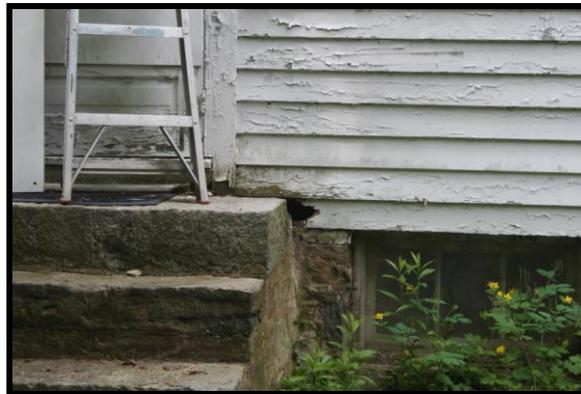
There are shrubs, small trees and vines along the south and west sides of the House. Some of the vines have attached themselves to the wood frame portion of the House and are visibly damaging it. The shrubs and small trees are constricting the movement of air around the building, inviting moisture and possibly damaging the foundation with their root systems. The minimal plantings around the Garage (pachysandra and weeds) do not appear to be damaging the building, though the grade on the east side of the garage is close to the wood sill of the building and could potentially bring moisture into the building.

Figure 2: Deteriorated siding on south side of House.

- **Exterior Landscape:**
 - Remove or prune shrubs, remove small trees and vines from perimeter of foundation.
 - Examine and prune large trees surrounding the House and Garage.
 - Pull up patio on the east side of the House and stockpile stones, excavate down, compact the soil and re-install patio stones over 4" layer of compacted crushed stone over compacted stone dust so that the top of the patio is minimum 6" below the bottom of the wood sill of the House.
 - Lower grade on east side of garage to allow minimum 6" below bottom of wood sill.

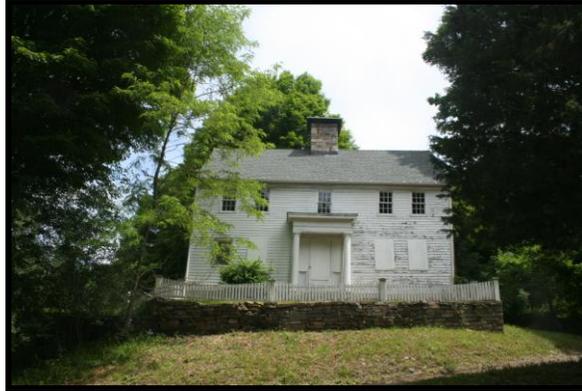
The dry stacked retaining wall that supports the terraced front yard on the west side of the House is collapsing in several areas. The low picket fence on top of the retaining wall appears to be relatively new, but is in need of some repair and paint.

Figure 3: Collapsing Retaining Wall.

- **Option C:** On some or all of the leader drain locations, install rain water collection barrels. The collected rain water could be used for irrigation of surrounding plantings.
- **Retaining wall:**
 - Repair or reconstruct the collapsed portions of the retaining wall. Reuse existing stone or install new stone to match existing.
- **Low picket fence:**
 - Any damaged or rotted portions of the low picket fence mounted to the retaining wall should be repaired as required and the entire fence should be repainted.

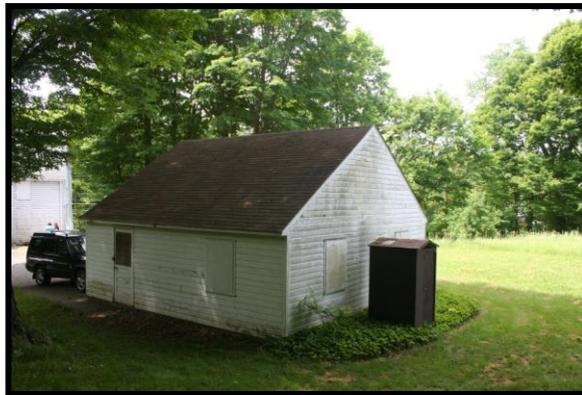
There is an unused outhouse on the east side of the garage that should be removed once the House becomes occupied.

Figure 4: View of outhouse and garage.

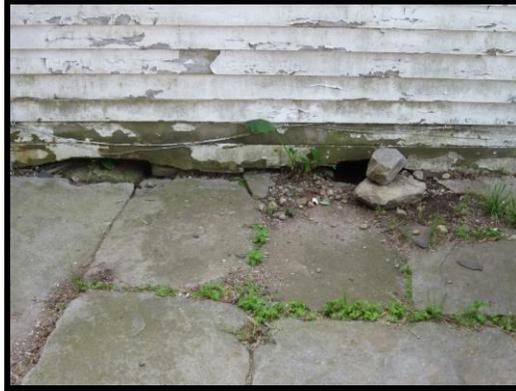
The stone patio off the east side of the House is uneven and is set very close to the wood sill of the House. It is visibly rotting the wood frame and cladding.

Figure 5: Patio on east side of House

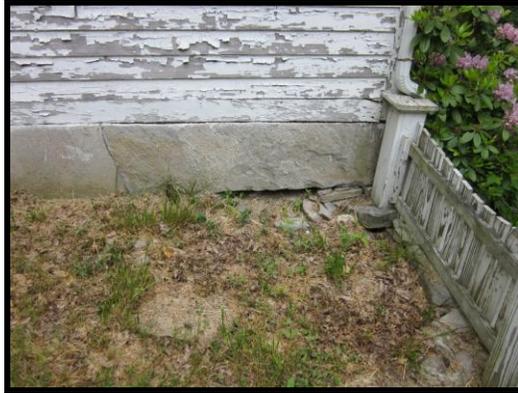
The front, west facing, facade of the House's foundation has an approximately 5" thick granite slab veneer. Some of the veneer has come free of the fieldstone foundation wall. This is likely due to moisture getting behind it and breaking the grout bond through the freeze-thaw cycle.

Figure 6: Granite veneer over foundation on west side.

- **Granite veneer:**
 - Carefully inspect the granite veneer along the west side of the foundation wall.
 - Document placement and remove any loose granite veneer, catalog and store for reuse.
 - Prepare fieldstone foundation wall and re-grout the granite veneer pieces back into their original locations.

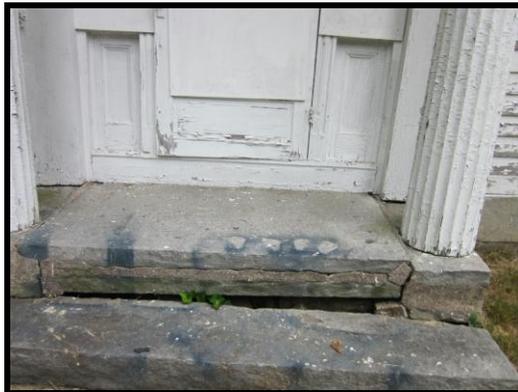
The landing and steps that are part of the front, west facing, portico have settled considerably and have been vandalized with spray paint.

Figure 7: Portico landing and steps.

- Take detailed photographs and careful measurements of existing granite landing and steps.
- Provide temporary shoring for the portico roof and columns. Remove the granite slabs that make up the landing and steps and store for reinstallation.
- Install proper footing and foundation (with footings a minimum of 42" below grade).
- Clean graffiti from the granite slabs and reinstall landing and steps.

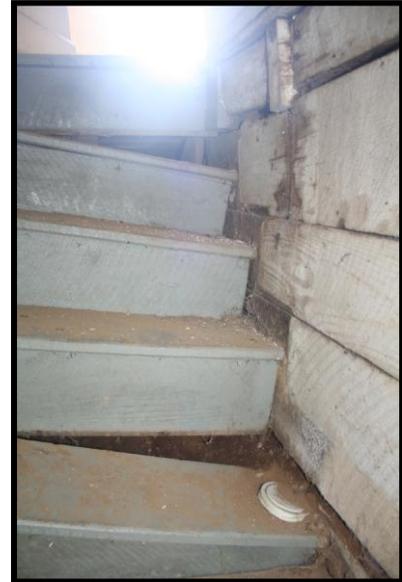
The interior wall of the cellar on the north side which separates the cellar from the crawl space consists only of deteriorated horizontal wooden planks. The planks have given way to the soil behind and are as a result, causing the deterioration and collapse of the wooden stair from kitchen to the cellar.

Figure 8: Collapsing interior cellar stair.

- **Interior Foundation Wall:**
 - On north side of cellar, shore up framing above as required to allow for the removal of the failing wood plank wall retaining the earth in the north crawl space.
 - Replace collapsed wooden stair.
 - Excavate as required to install new 8” concrete block foundation wall over poured concrete footing. Consult architect or engineer for details and specifications on the wall.

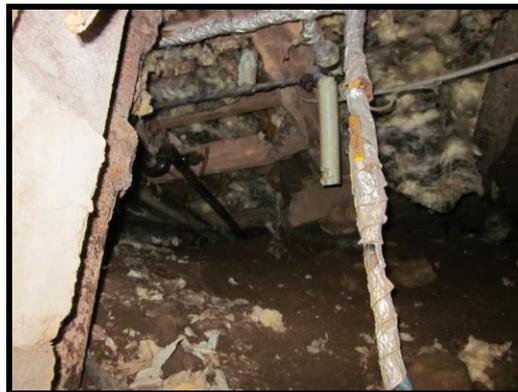
The north half of the House has crawl spaces beneath it. The crawl spaces have dirt floors and their heights from the bottom of the first floor framing vary from approximately 0" to +/-24". The only access to the crawl spaces is through a hatch covered exterior stair on the north side of the House. The access way is limited as it has filled in with dirt and debris. There are indications that the crawl spaces are inhabited by animals.

Figure 9: Photo of crawl space taken from access way.

- **Crawl Spaces:**
 - Excavate existing crawl spaces down to maintain a minimum 36” clear space from the underside of lowest beam.
 - Temporarily shore framing supported by stone piers. Remove stone piers and replace with concrete block or mortared fieldstone masonry piers over adequately sized concrete footings that extend below the proposed excavated depth. Consult architect or engineer for details on pier locations sizes, and specifications.
 - Install 2” thick concrete rat slab over 6 mil. polyethylene vapor barrier over 2” thick rigid polyisocyanurate foam insulation over 4” thick layer of crushed stone over well compacted soil.

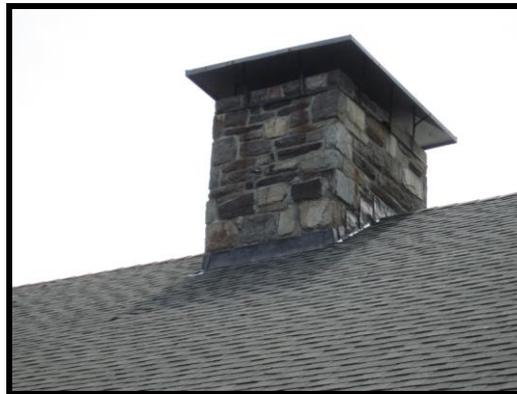
Figure 10: Large fieldstone chimney

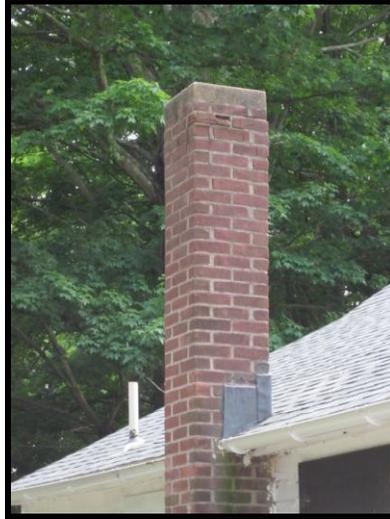
Small Brick Chimney: The smaller chimney is located on the eastern exterior wall of the House and like that side of the House, is a more recent addition, probably dating to the late 19th or early 20th century. It is not currently functional, but probably once served as a flue for a cast iron stove. The top of the chimney has deteriorated. Some of the bricks are cracked and spalling due to moisture infiltration. The brick chimney has no functional purpose at the present time. While it is not original to the House, it is still part of the history of the House and should be preserved.

Figure 11: Small brick chimney

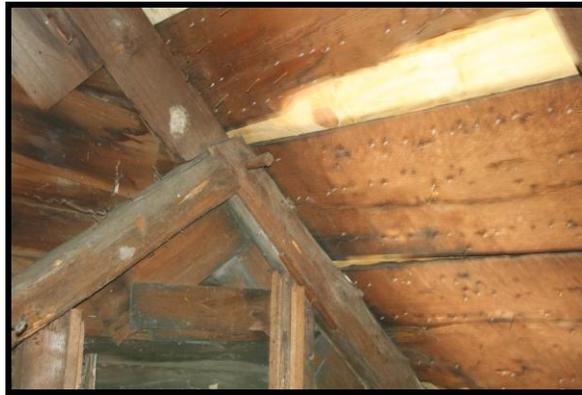
Figure 12: 2"x6" rafters sistered on to 5"x5" common rafters

The 2"x6" rafters that were sistered onto the original 5"x5" rafters have visibly deflected over time.

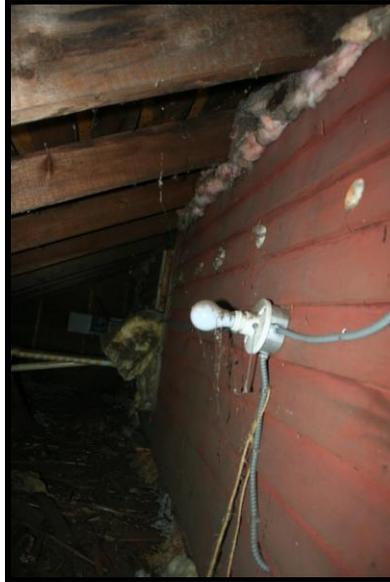
The second 'lean-to' addition extends further to the east and is also framed with 2"x6" rafters spaced approximately 18" on center. This addition likely was built in the late 19th century or very early 20th as the cut marks are vertical but are closer together and more regular which indicates that they were cut in a water mill, or by steam power rather than sawn by hand. The observed nails also appear to be late 19th or early 20th century style.

Figure 13: Rafters of second 'lean-to' addition

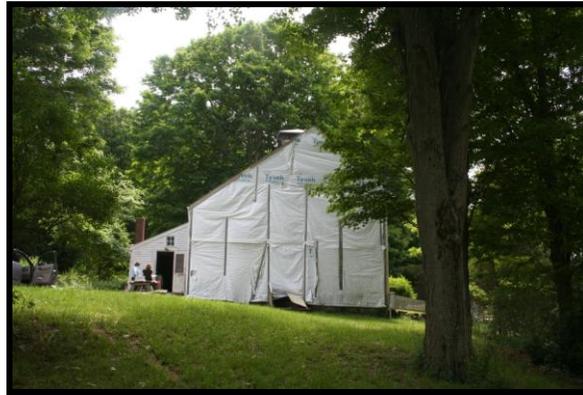
Figure 14: North side of House covered with 'tyvek'

The north side of the House is covered with tyvek house wrap, which was apparently an effort to temporarily control the infiltration of moisture on that side of the House. The tyvek was not removed for our inspection, but from what could be seen, it is clear that there is severe rot along the first floor sill. From the inside face of the north wall, there is rot evident at the floor perimeter of both the first and second floors. The fact that the north wall is extremely out of plumb is a large contributing factor to the deterioration found there.

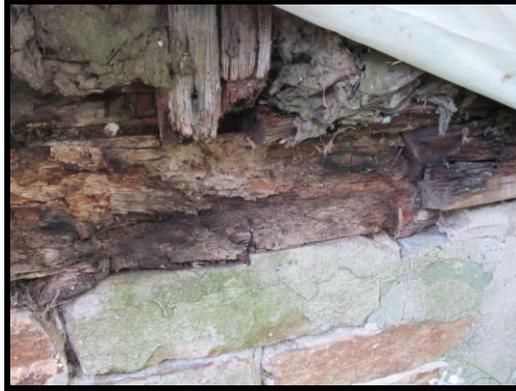
Rot along the first floor sill plate can be found in several locations all around the House.

Figure 15: Rotting sill on north side of House

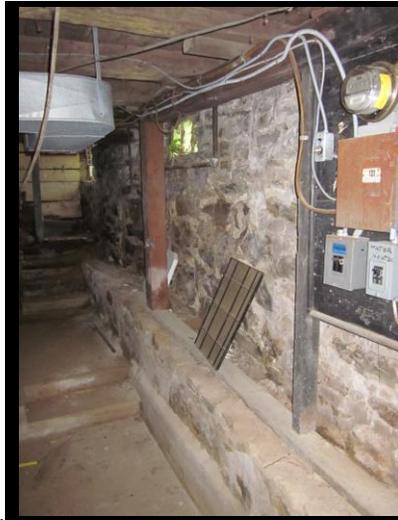
The first floor framing on the south side of the House has been internally shored up with a timber beam and posts. This is most likely due to settling that occurred as a result deterioration of the existing sill.

Figure 16: Shoring on the south side of cellar

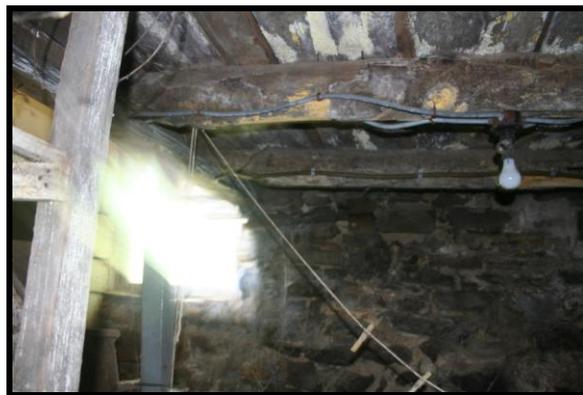
Figure 17: First floor framing with mold and powder post beetle damage

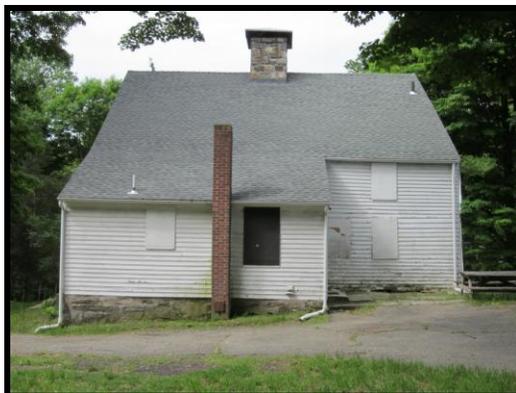
The leaders drain out at the grade around the House. The drains have been extended a few feet beyond the perimeter of the foundation with flexible tubing.

Figure 18: East side of House

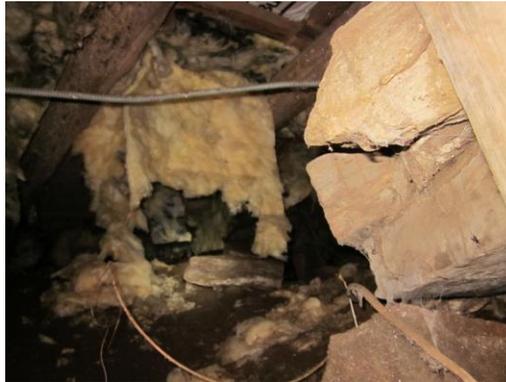
The insulation in the House that could be seen from the attic and the cellar is mainly fiberglass batt. Corncobs, a very early form of insulation, were also found. The batt insulation was sporadic and extremely deteriorated. There was loose fill insulation in the attic that should be tested to verify that it does not contain asbestos.

Figure 19: Deteriorating fiberglass batt insulation in the crawl space

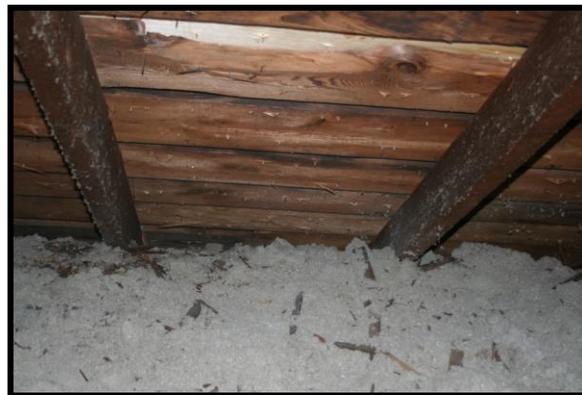
Figure 20: Loose fill insulation in attic of original portion of House

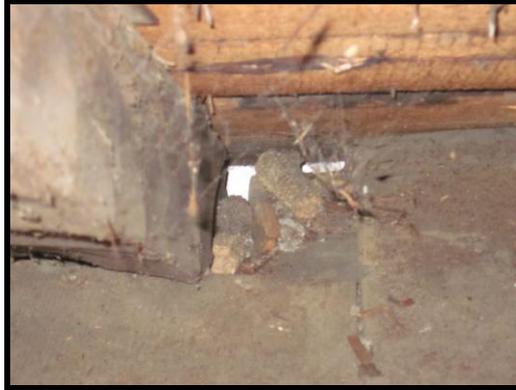
Figure 21: Original corn cob insulation

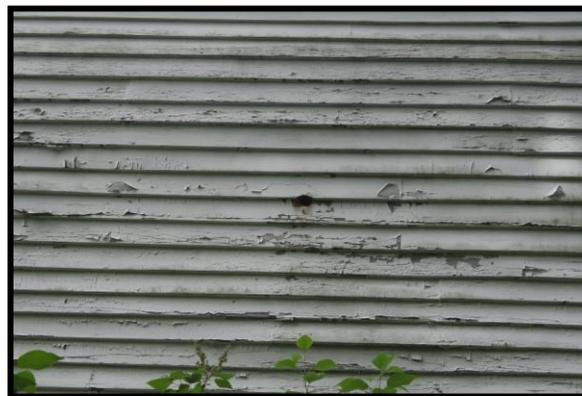
Figure 23: Hole in siding on south side of House

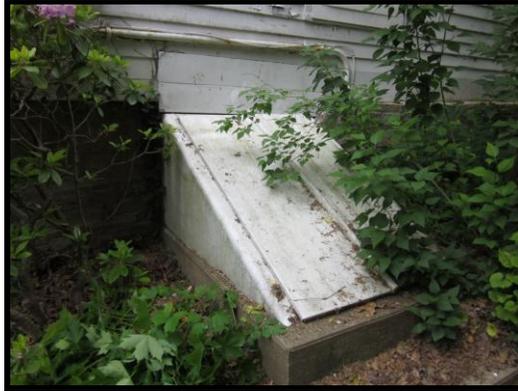
There are 'Bilco' hatch doors covering access ways to the cellar and crawl spaces. The hatches have rusted and are in need of repair or replacement.

Figure 32: 'Bilco' hatch on south side of House

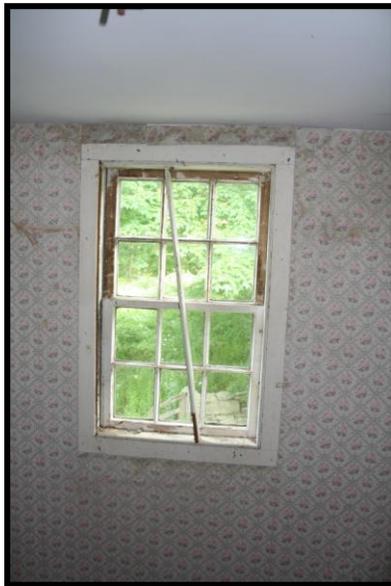
The majority of the trim work is in fair condition. Window trim in certain locations has been water damaged.

Figure 41: Double-hung window in bedroom #3

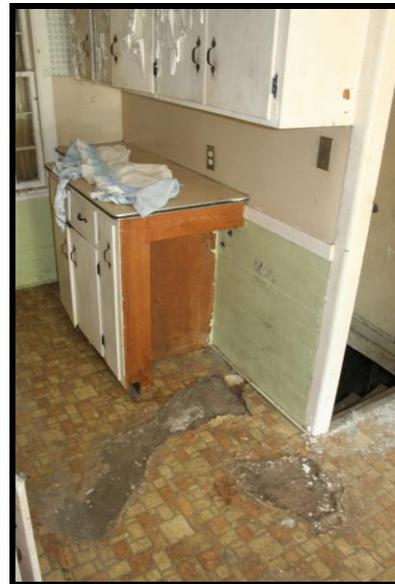
Kitchen: The kitchen floor has a layer of linoleum over plywood. The linoleum and plywood subfloor are in very poor condition. Portions of the floor have exposed plywood. There is visible rot in several locations.

Figure 44: Deteriorating floor in kitchen

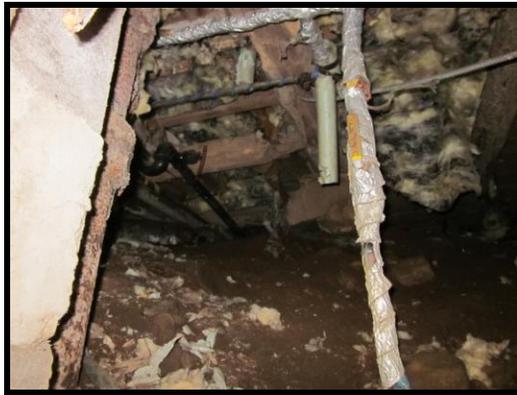
- The House is connected to the town water supply and sewer system. The water supply line appears to enter the House through the “Bilco” hatch on the north side. The water line was exposed and wrapped with an electric heat trace device and insulation to prevent freezing.
- The bathroom is plumbed with a wall mounted sink, 5-foot bathtub and a toilet. We were not able to get very far into the crawl space below the House to inspect the rough plumbing, as the dirt and debris had accumulated up to the bottom of the framing, so a more thorough inspection will be required to verify if it is working condition. This is also true for the plumbing for the sink and washing machine in the kitchen. There is rough plumbing for a sink on the east wall of bedroom #3. The kitchen and the bathroom appear to be properly vented.

Figure 46: Water line entering crawl space on north side of the House

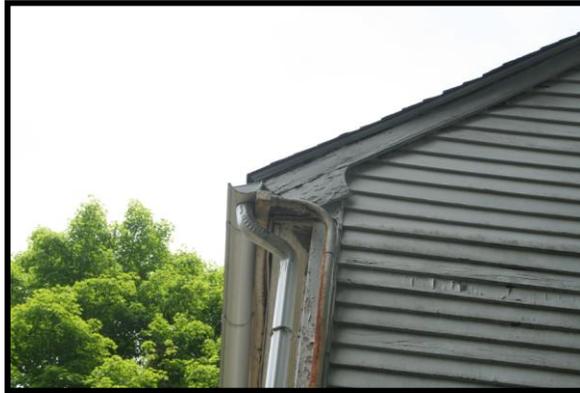
Figure 50: Electrical conduit running down corner board

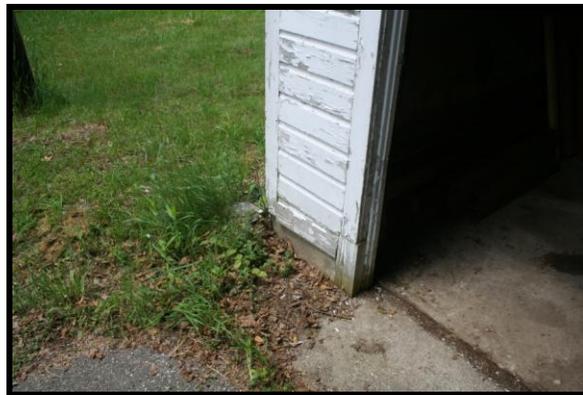
The head casing of the windows is deteriorated from moisture.

Figure 54: Detail of garage trim and novelty siding
