THERESA BISHOP RESIDENCE

Limited Hazardous Materials Inspection Report

41 Phillip Street
East Haven, CT

Connecticut Department of Housing Application No. 1022
Lothrop Associates Project No. 1524-03

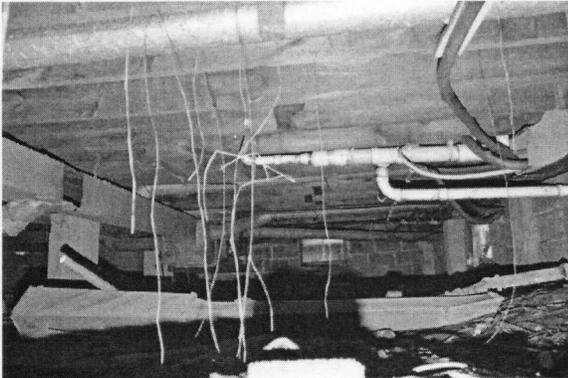
Figure 1

<p>Crawl space: Storm surge entered the crawl space saturating the floor insulation. The damaged insulation was removed by the owner.</p>	<p>There is no insulation under the floor in the crawl space. See figure 1</p> <p><i>Recommendation: Replace the insulation.</i> If the dwelling is to be raised above the flood zone: Provide new soffit panel material and new framed soffits around any plumbing to remain.</p>	<p>\$1,500</p>	<p>\$1,500</p>
<p>Windows to crawl space: owner states the storm surge damaged and broke the windows to the crawl space.</p>	<p>Some windows are broken and others have damaged frames. The windows are old. See figures 2 and 3</p> <p><i>Recommendation: Replace the windows with crawl space vents except for one which shall be an access hatch</i></p>	<p>\$1,000</p>	<p>NA</p>
<p>Heating system: Owner states the attic mounted heating system is malfunctioning ever since a power spike occurred when the power came back on. The power was turned off for neighborhood repairs to the local power distribution system. The owner had the unit serviced but all the issues where not resolved. Owner states the unit cannot maintain a living space temperature over about 60°F</p>	<p>It is cold in the house and the thermostat was set to approximately 10°F higher than the achieved temperature. The attic mounted gas fired boiler has the cover removed and a few removed parts where in the area indicating signs of recent service.</p> <p><i>Recommendation: Service and repair the boiler replacing any and all damaged and defective parts. Recalibrate the unit.</i></p>	<p>\$1,000</p>	<p>\$1,000</p>
