CAPOZZO RESIDENCE

Limited Hazardous Materials Building Inspection Report

60 Cosey Beach Avenue
East Haven, CT

Connecticut Department of Housing Application No. 1129
Lothrop Associates Project No. 1524-23

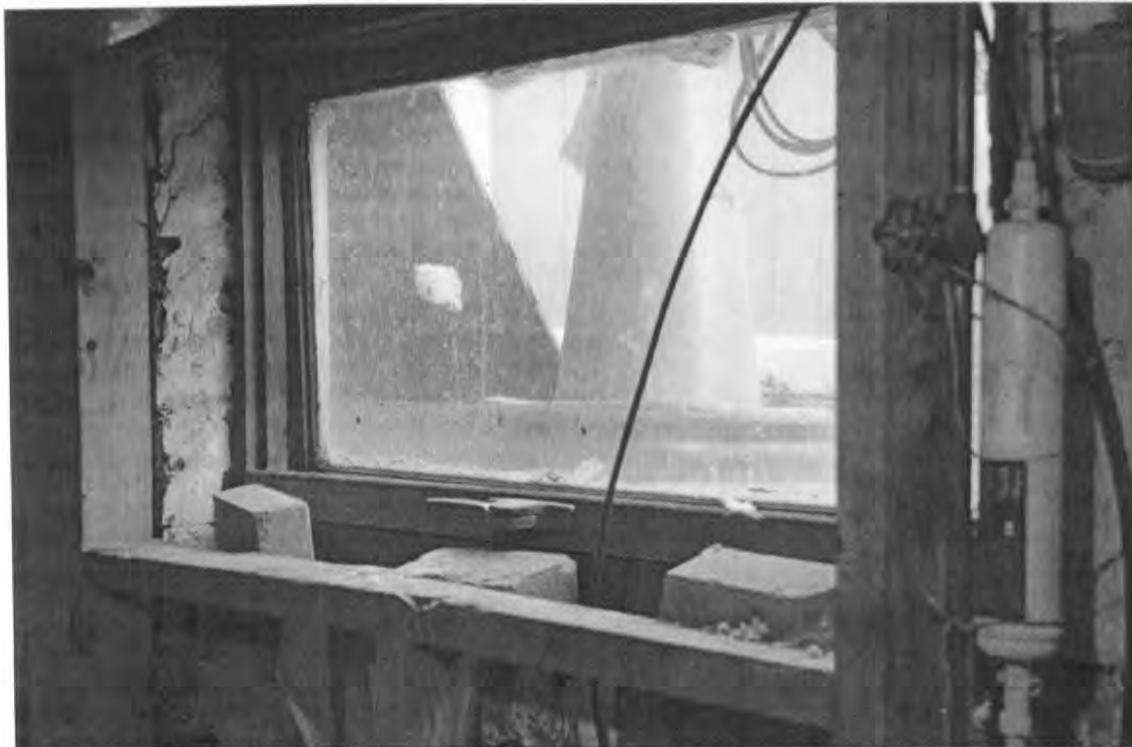
Figure 1 note the water line on the glass

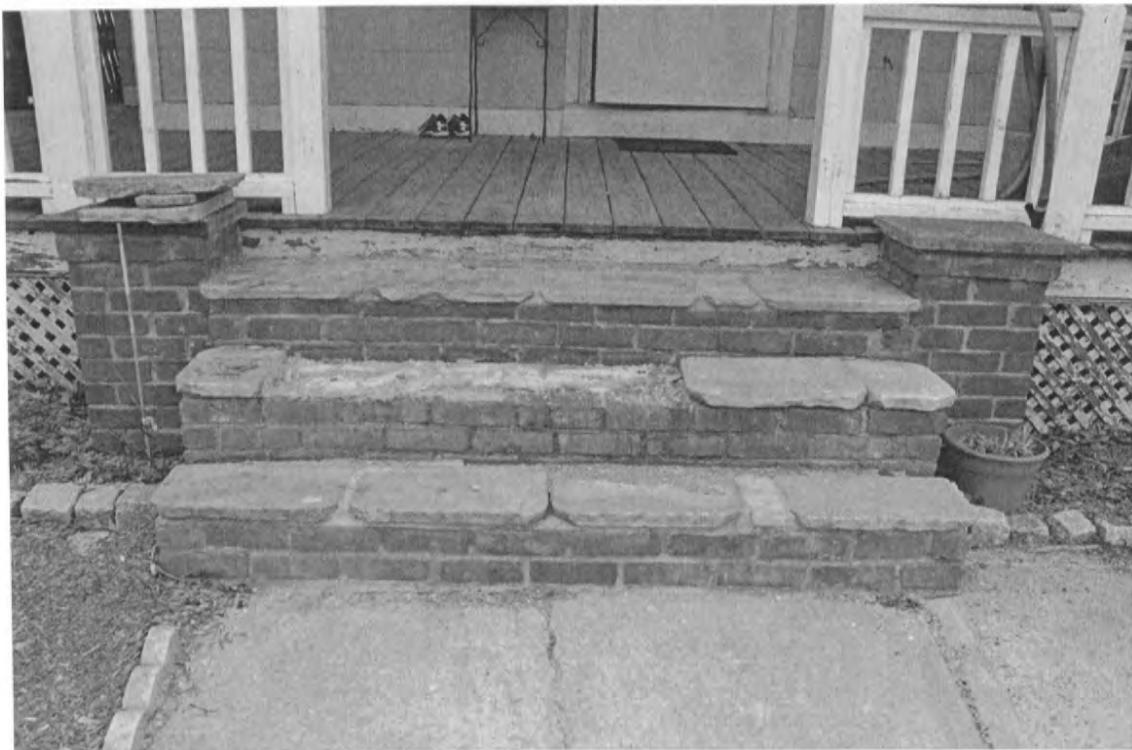
Figure 9

<p>Front porch entry steps: The owner states the storm surge displaced a few bricks and tread stones.</p>	<p>A few tread stones and bricks are loose & missing See figure 9</p> <p><i>Recommendation: remove loose and cracked mortar and grout and re-set, replace missing treads, if done as a rehabilitation</i></p>	\$500	NA
<p>Porch wood joint open: The owner states after the storm he noticed some porch trim loose with gaps in the joints.</p>	<p>The porch floor rim trim has an open outside corner joint and one piece is loose at the end. The wood is starting to dry rot. The open joint may be due one member popping out. Open joint looks older then the storm due to the inside being painted. See figure 10</p> <p><i>Recommendation: Not likely due to storm</i></p>	NA	NA

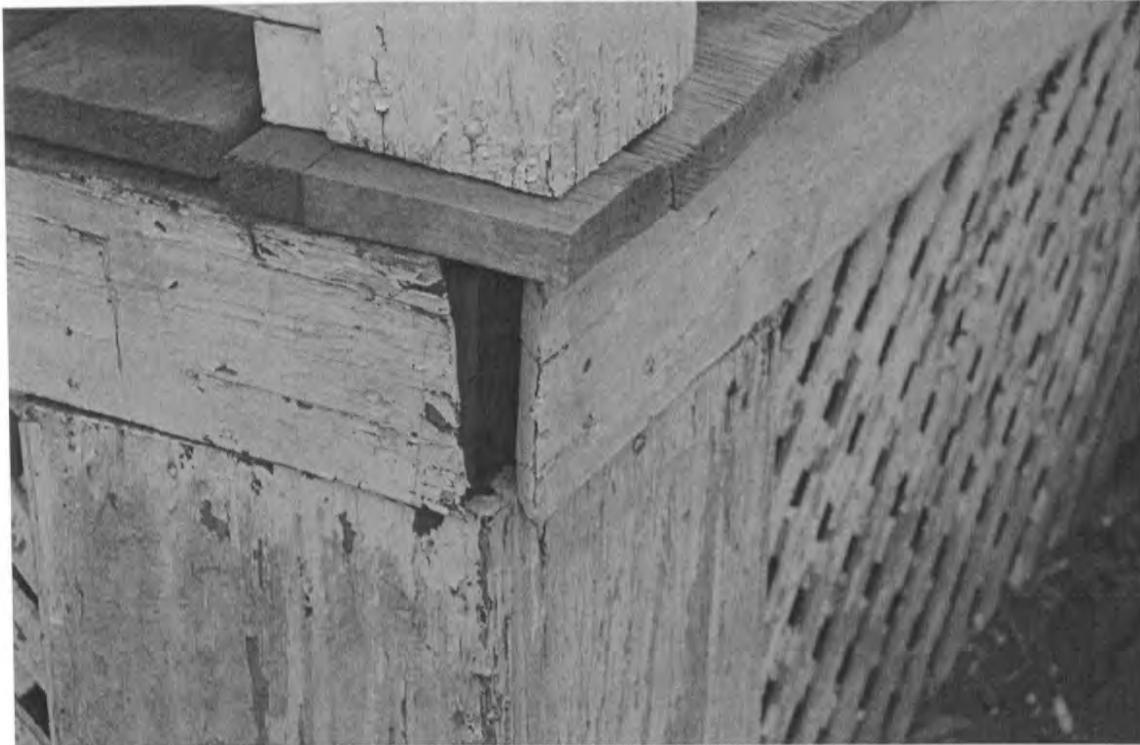
Figure 10 note old paint in open joint

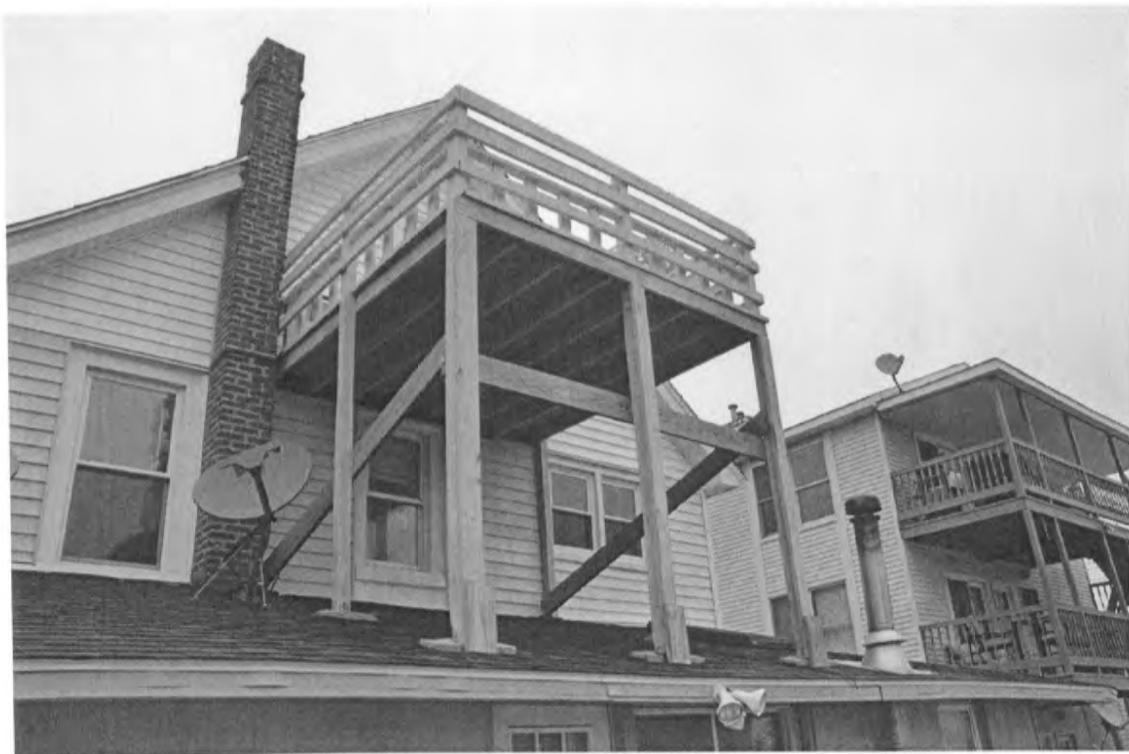
Figure 15

<i>damage, take no action.</i>		
Cracking driveway and curb: The owner states after the storm the concrete paved driveway and adjacent concrete curb cracked and sank. The owner expressed concern over sink holes and indicated a bituminous paved patch in the driveway was installed after the storm to fill a sink hole.	The cracks in the concrete appear to have weathering in the crack that is older than the storm. See figures 11, 12, 13 & 14 <i>Recommendation: Not likely due to storm damage, take no action.</i>	NA	NA
Third floor deck wobbly: The owner reports the third floor deck is wobbly. He reports he had his contractor add bracing to the deck but it is still wobbly.	The deck wobbles when one stands on it and shakes back and forth. The framing is exposed and it can be seen it does not have any framing elements that form structural triangulation. The newly added bracing also does not form any structural triangulation. See figure 15 <i>Recommendation: Not likely due to storm damage, take no action.</i>	NA	NA
