NEPA ENVIRONMENTAL REVIEW REPORT

**Community Development Block Grant – Disaster Recovery
Owner Occupied Rehabilitation and Rebuilding Program**

**Site ID No. 1168
12 Park Lane
Norwalk, Connecticut**

August 2014

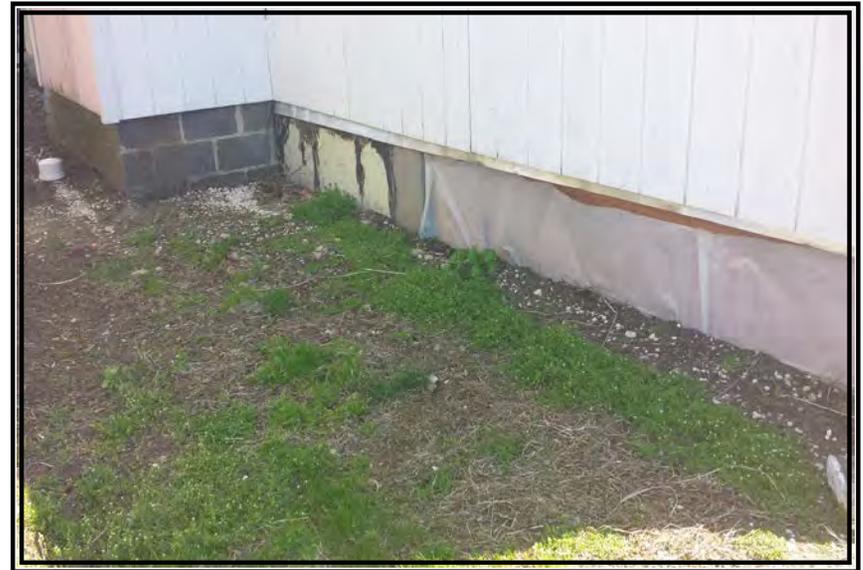
Material	Location	Approx. Quantity	Condition	% Chrysotile
Black tar sealant	Exterior foundation	25 SF	Good	10%

5. Asbestos Containing Materials (ACM) - Based on the results of the asbestos survey and testing, the black tar sealant on the exterior foundation of the dwelling was identified as an ACM. The tar sealant contains asbestos greater than 1%. Due to the nature of the project, it appears that the asbestos containing tar sealant will have to be removed by a qualified contractor. Additional suspect ACM may be encountered during renovations in spaces that were inaccessible or not apparent during the inspection such as within walls, beneath other layers of flooring, etc. As such, Triton recommends that a competent person be present during the renovation work who is capable of identifying additional suspect materials. Any such suspect materials encountered during the demolition must be sampled, tested, and if necessary, abated.

Photograph 2
Asbestos containing tar sealant on foundation

Approximately 25 square feet of asbestos containing tar sealant was identified the exterior foundation of the dwelling. Due to the intended demolition of the basement, this material will be required to be removed by a licensed asbestos abatement contractor. All abatement activities must be conducted in accordance with local, state, and federal regulations including, but not limited to, project design, containment structures, air monitoring, and clearance sampling by a licensed project monitor. Waste materials must also be properly disposed of at an appropriately permitted disposal facility. The abatement

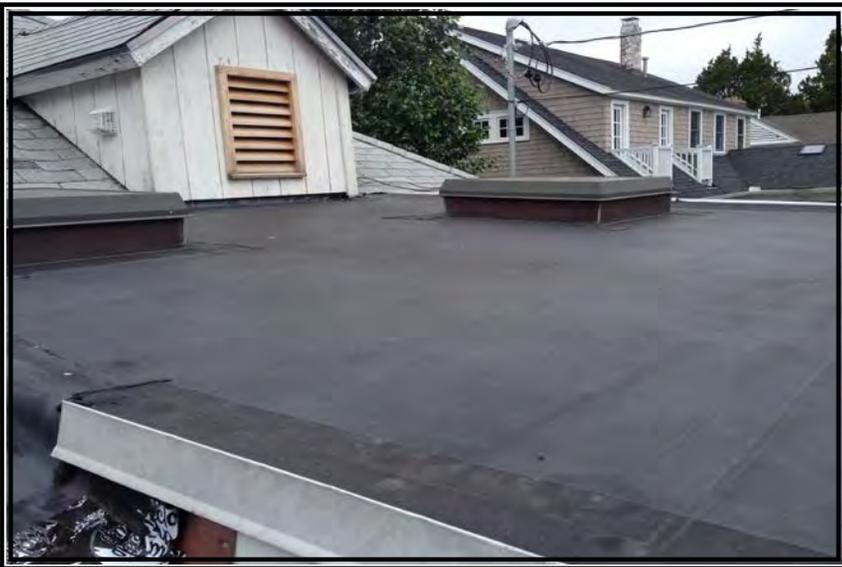
Photograph 3
Roof membrane

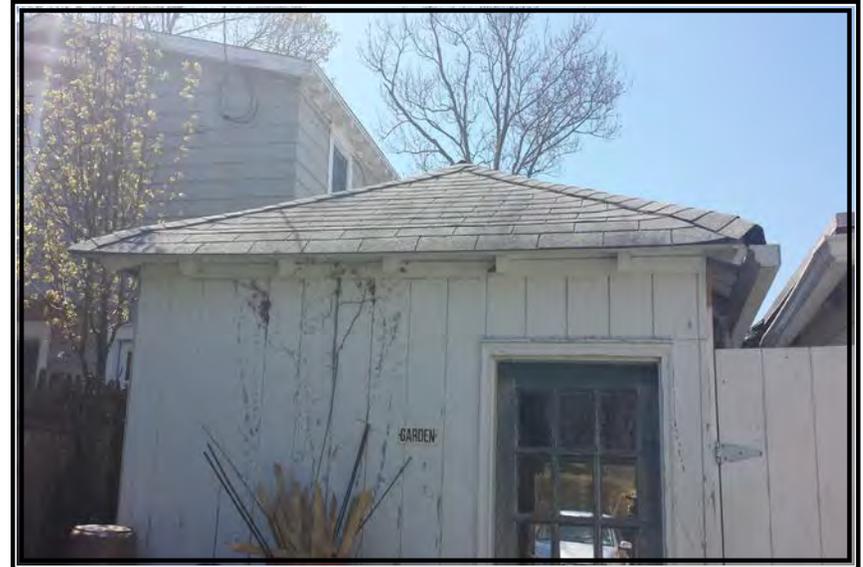
The results of the field XRF sampling (for deteriorated paint areas) are summarized on Form 5.3 “Field Sampling Form for Deteriorating Paint” provided in Appendix C. As indicated on Form 5.3, the following deteriorated paint surfaces were determined to contain lead paint above the HUD action level of 1 mg/cm²: exterior pink soffit of the dwelling and exterior white soffit on the garage.

- Hazard A - lead levels exceeding 1 mg/cm^2 in deteriorated paint on the pink soffit of the dwelling and the white soffit of the garage;
- Hazard B - elevated lead levels in dust on floor adjacent to the rear sliding door;
- Hazard C – elevated lead concentrations (above 5,000 mg/kg) in the on-site drip line for the abutting garage; and
- Hazard D - elevated lead concentrations (below 5,000 mg/kg) in soil in the back yard mulch area, house drip line, and garage drip.

Photograph 4
Deteriorated paint on garage

- Interim Control options for Hazard A include paint stabilization. Repair any physical defect in the substrate of a painted surface that is causing paint deterioration, remove loose paint and other material from the surface to be treated, and apply a new protective coating or paint;
- Abatement options for Hazard B include cleaning and vacuuming floors using HEPA vacuums or equivalent, combined with interim controls/abatement of lead containing soil (see below).
- Abatement options for Hazard C (the drip line soils exceeding 5,000 mg/kg) include soil removal and replacement or paving the area.
- Interim control options for Hazard D include temporary surface coverings (such as gravel, bark, and sod) or land use controls such as fencing, landscaping, and warning signs.
