November 19, 2014

**RE: Environmental Assessment Report
Department of Housing
CDBG-DR – Sandy Disaster Recovery Program
14 Waverly Park Road
Branford, Connecticut
Application #1180
Eagle Project No. 14-028.12T9**

LEAD-BASED PAINT INSPECTION AND RISK ASSESSMENT
14 WAVERLY PARK ROAD
BRANFORD, CONNECTICUT
FLOOR PLAN

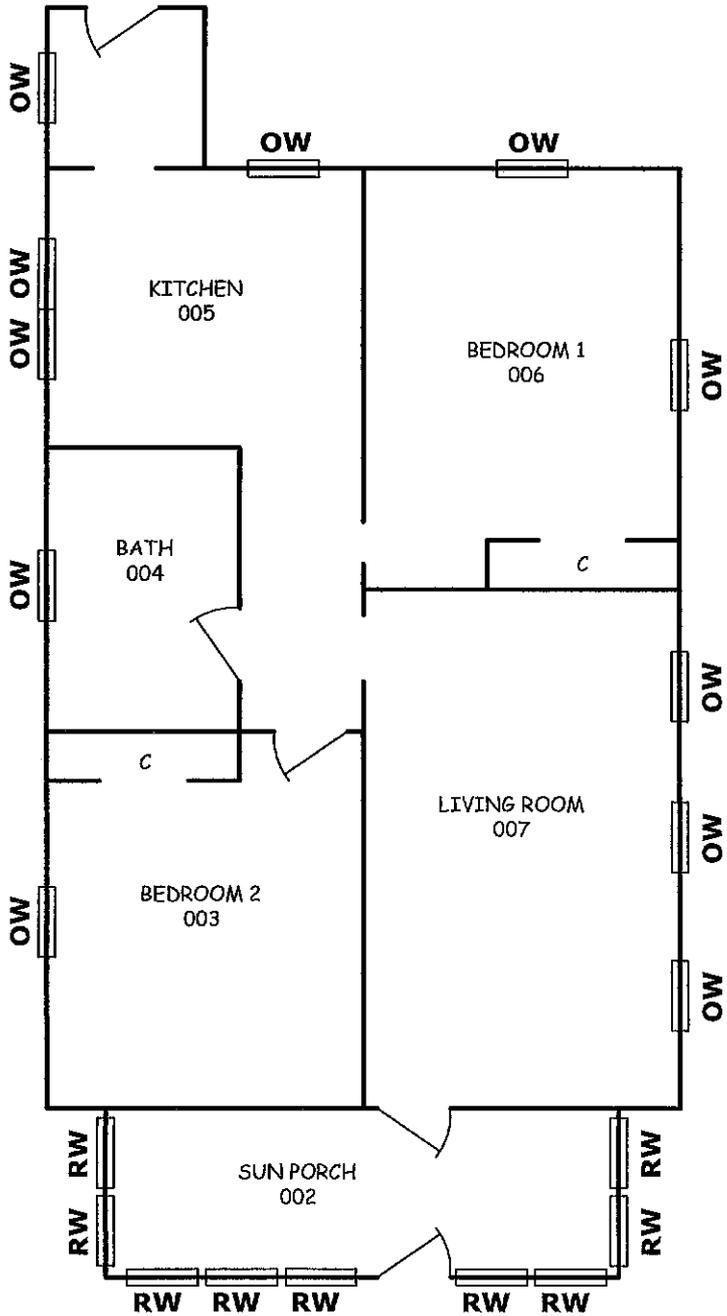
- Front Porch: Rafter Tails, Soffit, Fascia
- Exterior Facades: Cinderblock Foundation, Wood Trim, Exterior window components, Shiplap Siding*
