NEPA ENVIRONMENTAL REVIEW REPORT

**Community Development Block Grant – Disaster Recovery
Owner Occupied Rehabilitation and Rebuilding Program**

**Site ID No. 1195
5 Park Lane
Norwalk, Connecticut**

August 2014

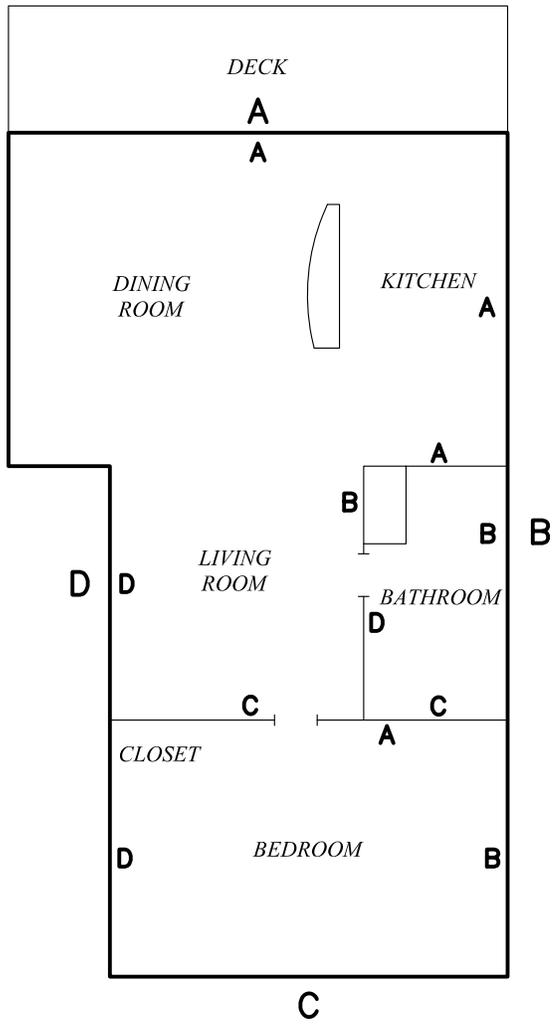
As indicated in Section 1.1, the work zone as described by Merritt is considered to be the entire dwelling. Triton conducted testing using X-Ray Fluorescence (XRF). The survey was completed by a Connecticut certified lead inspector. The surveys were completed using a Niton XL-300A XRF instrument. XRF readings were taken at a total of 81 locations of 56 distinct building materials in the work zone. Appendix C contains a spreadsheet summarizing the results. The results of the XRF testing indicate that several of the exterior painted building materials tested contained lead concentrations greater than the action level of 1 mg/cm² (0.5% by weight). The materials containing lead based paint above the action level are summarized in the table below. The approximate locations of these materials are shown on the Figure 2 diagram.

Triton completed a visual mold inspection of the work area on May 1, 2014. Mold was observed on the sheetrock inside the living room closet and on wall D of the bathroom (shown on Figure 2). Photographs of the apparent mold are provided in Appendix B. The entire structure was reportedly flooded with 18-inches of category 3 water and as such, it is assumed that mold is present behind all walls on the wooden framing and insulation throughout the entire work zone.

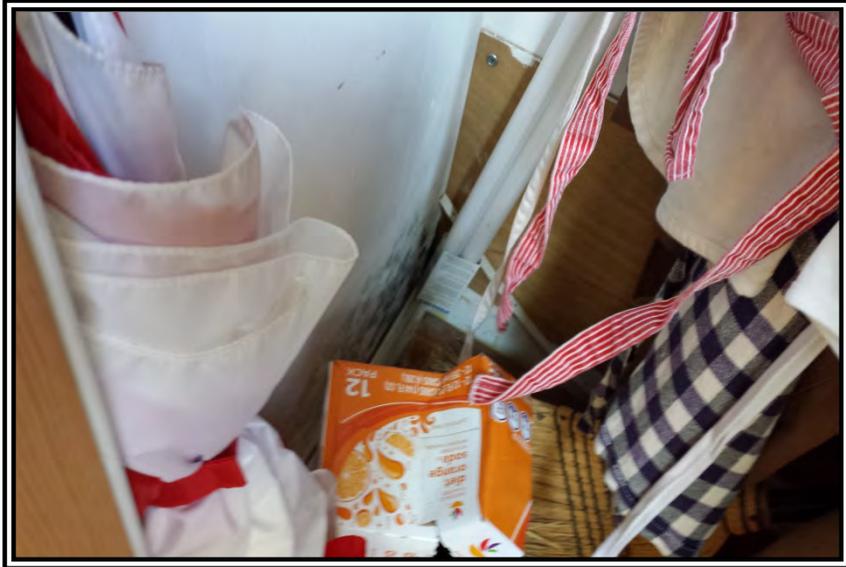
Photograph 4
Mold on sheetrock in closet

Mold was observed on the sheetrock inside the living room closet and on wall D of the bathroom. Mold may be present in other interior areas that could not be observed during the inspection (i.e. behind walls). Due to the intended demolition of the dwelling, abatement of the mold on (and possibly within) the walls will not be required.

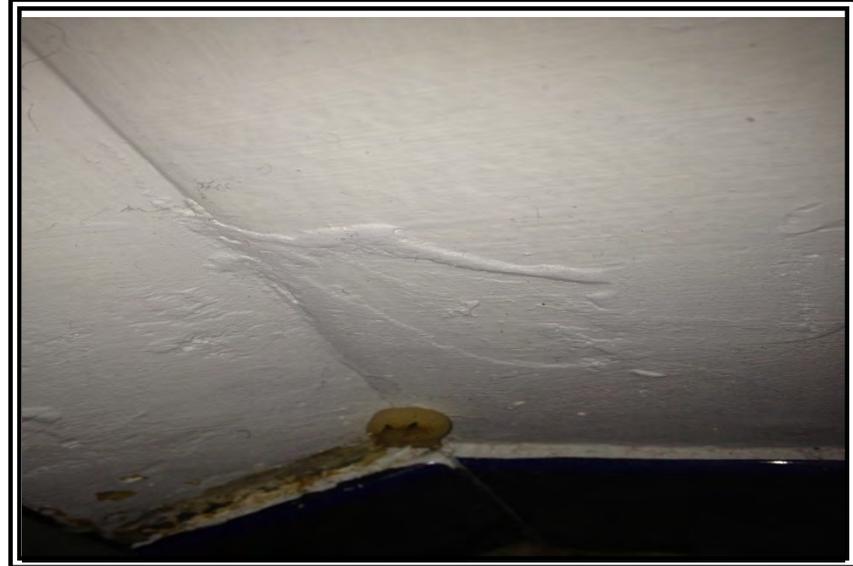
Photograph 5
Mold and mushroom on sheetrock in bathroom
