PROJECT 1228 - 28 MOUNTAINVILLE ROAD
DANBURY, CONNECTICUT 06810

SCHEMATIC LAYOUT

JOB NO.	DRAWING NUMBER	SHEET
33-262-1228	BASEMAP 33-262-1228.dwg	A-1.0

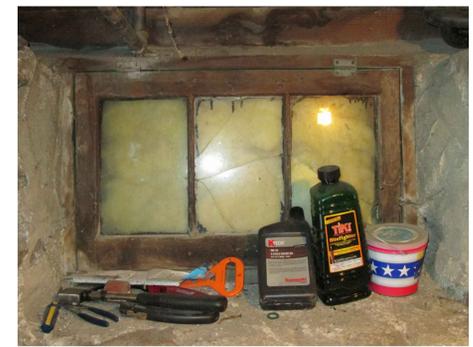
PHOTO 1
(BASEMENT WINDOW TO BE REPLACED)
(N.T.S.)

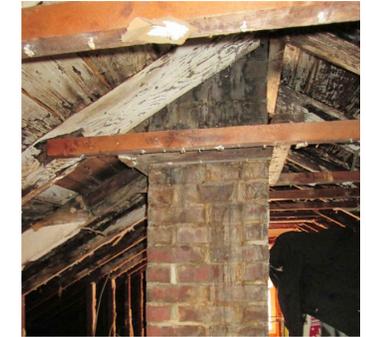
PHOTO 2
(CHIMNEY IN ATTIC)
(N.T.S.)

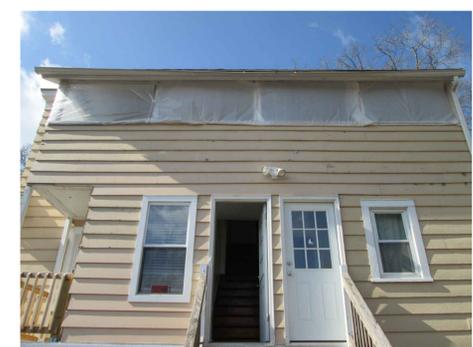
PHOTO 3
(REAR OF HOUSE FROM GROUND)
(N.T.S.)

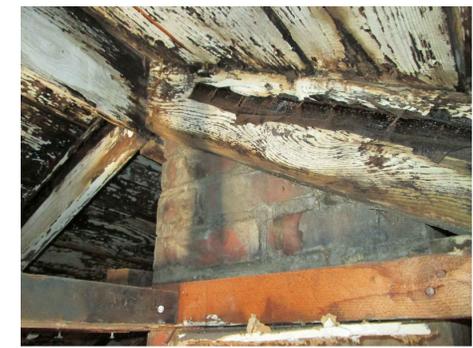
PHOTO 4
(BLOCKING AROUND CHIMNEY)
(N.T.S.)
