# **NEPA ENVIRONMENTAL REVIEW REPORT**

**Community Development Block Grant – Disaster Recovery  
Owner-Occupied Rehabilitation and Rebuilding Program**

**Site ID No. 1231  
154 Gregory Boulevard  
Norwalk, Connecticut**

**October 2014**

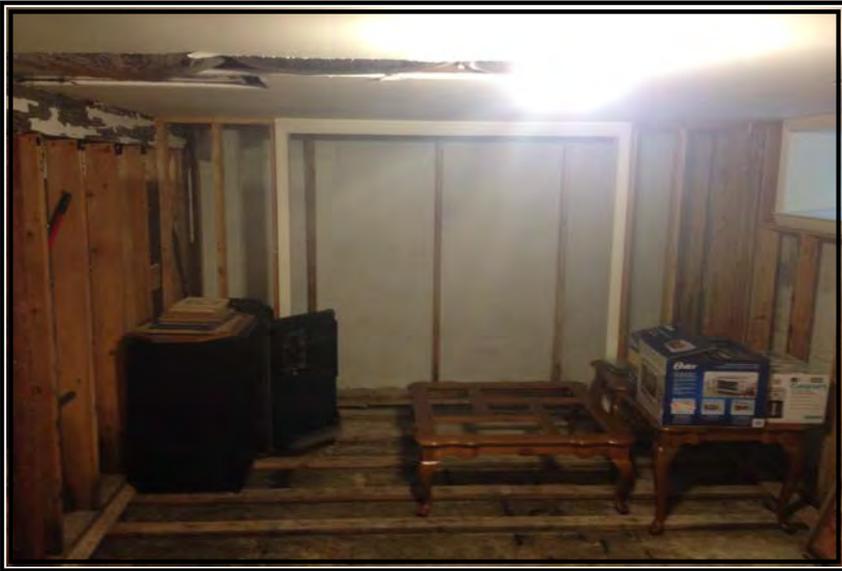
**Photograph 1**  
**Gutted basement**

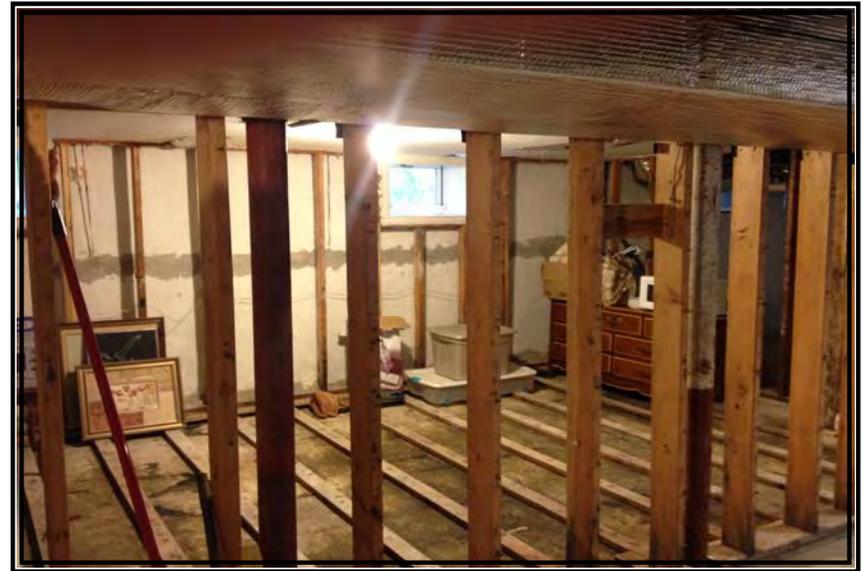
**Photograph 2**  
**Gutted basement**

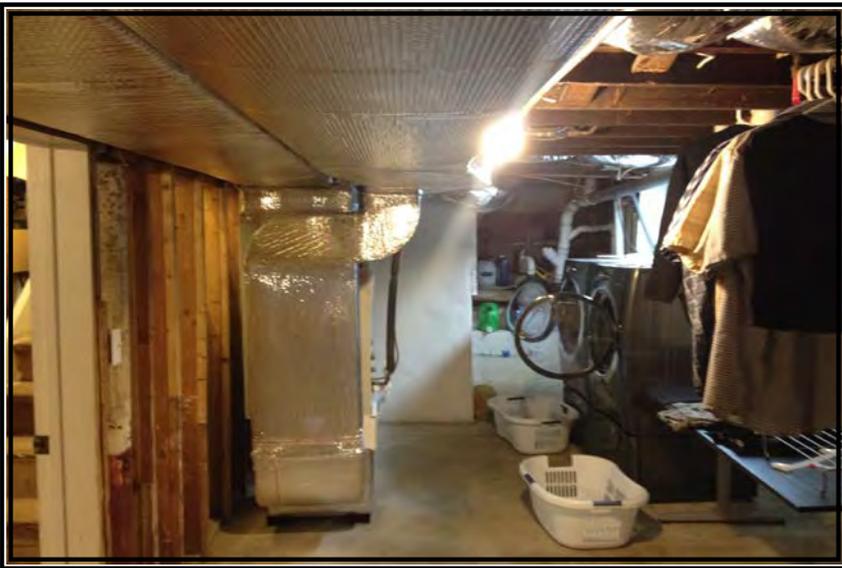
**Photograph 3**  
**Gutted basement**

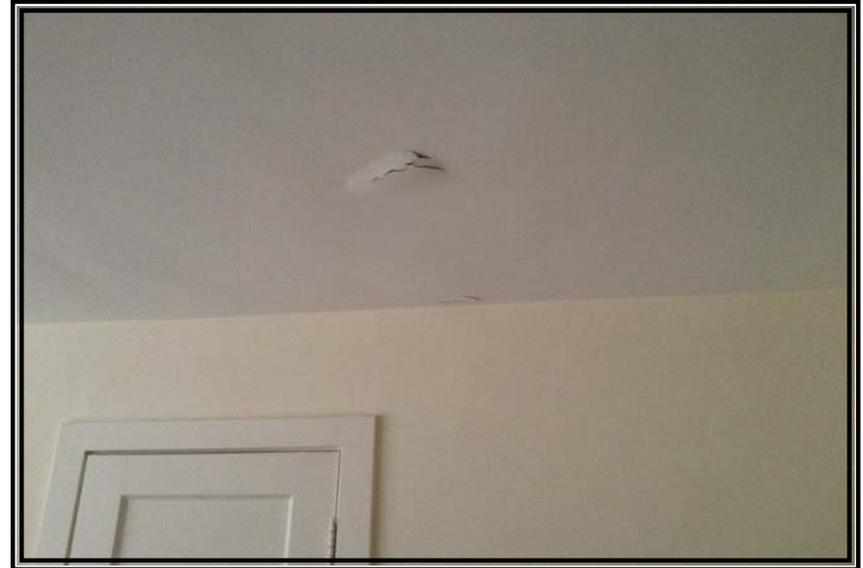
**Photograph 4**  
**Deteriorated paint on bedroom ceiling**

Aside 1<sup>st</sup> Floor Bedroom deteriorated Ceiling  
 C side (Rear) Enclosed Porch Deteriorated Paint on Windows &  
 Door Trim. Walls & Ceiling intact  
 Interior First Floor Trim is deteriorated  
 2<sup>nd</sup> Floor Paint in Good Shape  
 3<sup>rd</sup> Floor (Attic) Paint in Good Shape.

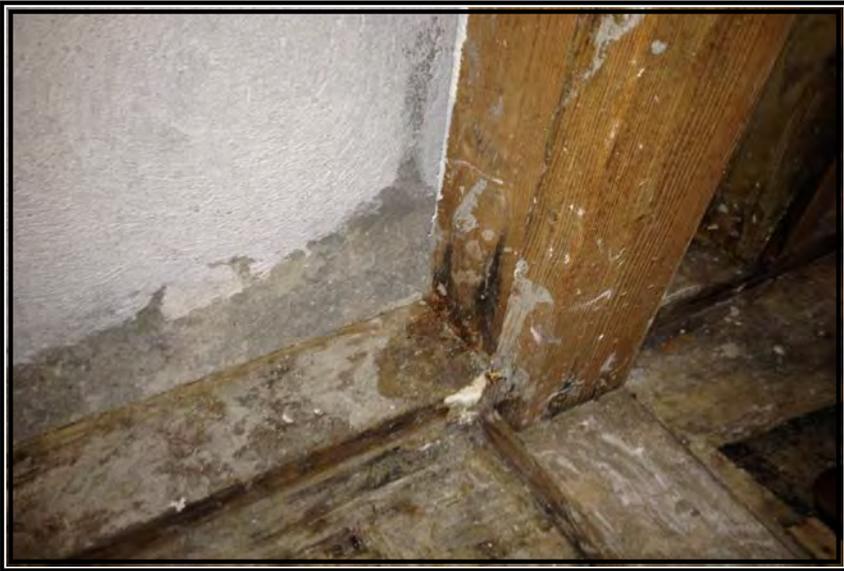
Triton completed a visual mold inspection of the work area on September 16, 2014. Mold was observed on wood risers of the basement stairs and in discrete areas of the exposed wooden framing in the basement. Photographs of the apparent mold are provided in Appendix B.

**Photograph 5**  
**Mold on wooden framing in basement**

Mold was observed on wood risers of the basement stairs and in discrete areas of the exposed wooden framing in the basement. Due to the intended finishing of the basement as livable space, abatement of the mold is needed to protect occupant health. Any porous materials containing visible mold that are encountered during the renovation should be removed in accordance with local, state, and federal regulations including, but not limited to, the guidelines put forward in the most recent version of the *Institute for Inspection, Cleaning,*

*and Restoration Certificate (IICRC) Standard and Reference Guide for Mold Remediation* as well as the *Connecticut Guidelines for Mold Abatement Contractors*. The abatement contractor must provide credentials/adequate qualification documentation and a work plan for abatement with their bid for review by Merritt and Triton. Pre-abatement and clearance air testing will be completed by Triton to evaluate pre- and post-abatement conditions.

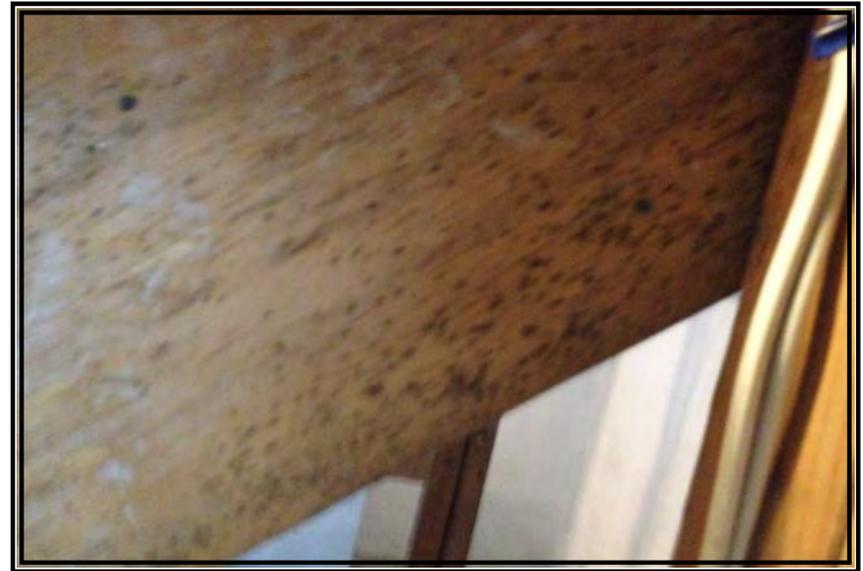
**Photograph 6**  
**Mold on stringer on stairs in basement**

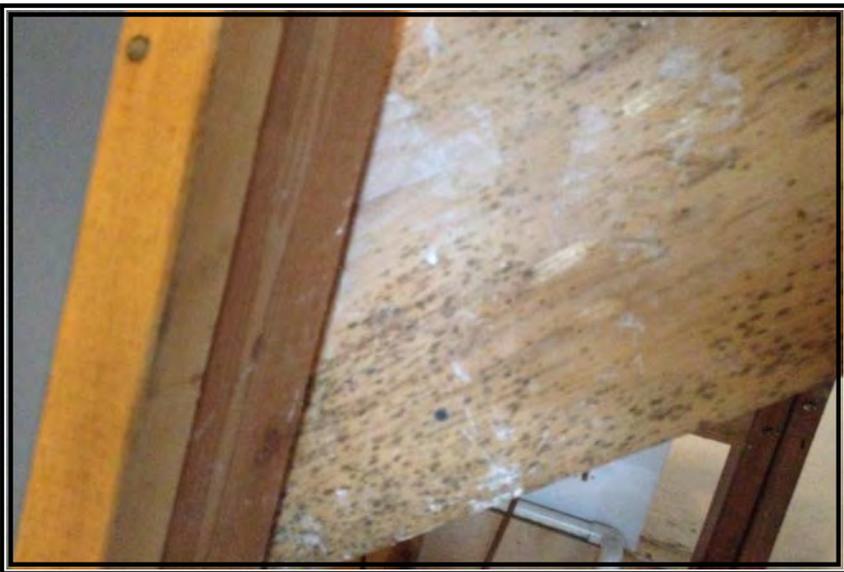
**Photograph 7**  
**Mold on stringer on stairs in basement**

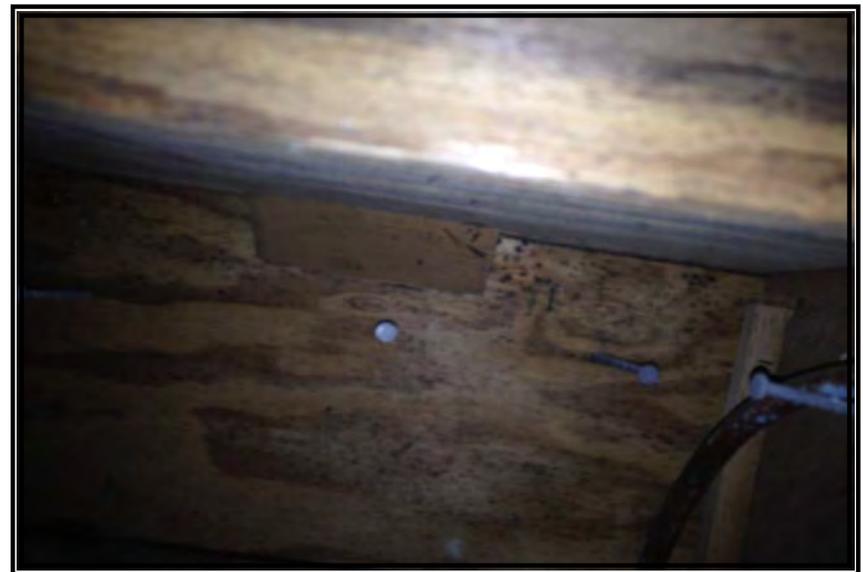
**Photograph 8**  
**Mold underneath stairs in basement**
