NEPA ENVIRONMENTAL REVIEW REPORT

**Community Development Block Grant – Disaster Recovery
Owner Occupied Rehabilitation and Rebuilding Program**

**Site ID No. 1390
19 Young Dixon Way
Stamford, Connecticut**

May 2014

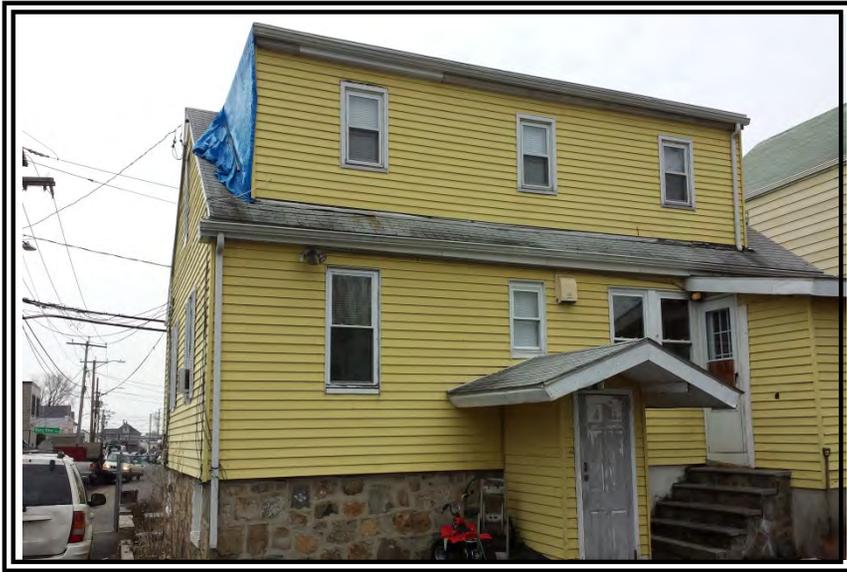
Photograph 1
Work area

The proposed work plan for the 19 Young Dixon Way property includes repairing siding on northeast corner of house, replacing roof shingles, and abating mold and water damage resulting from the leaking roof. As such, the work zone as described by Merritt consists of the roof and northeastern exterior side of the house, and the interior ceiling of a first floor bedroom.
