ENVIRONMENTAL REVIEW REPORT

**Community Development Block Grant – Disaster Recovery
Owner Occupied Rehabilitation and Rebuilding Program**

Applicant # 1437

**24 Elaine Road
Milford, Connecticut**

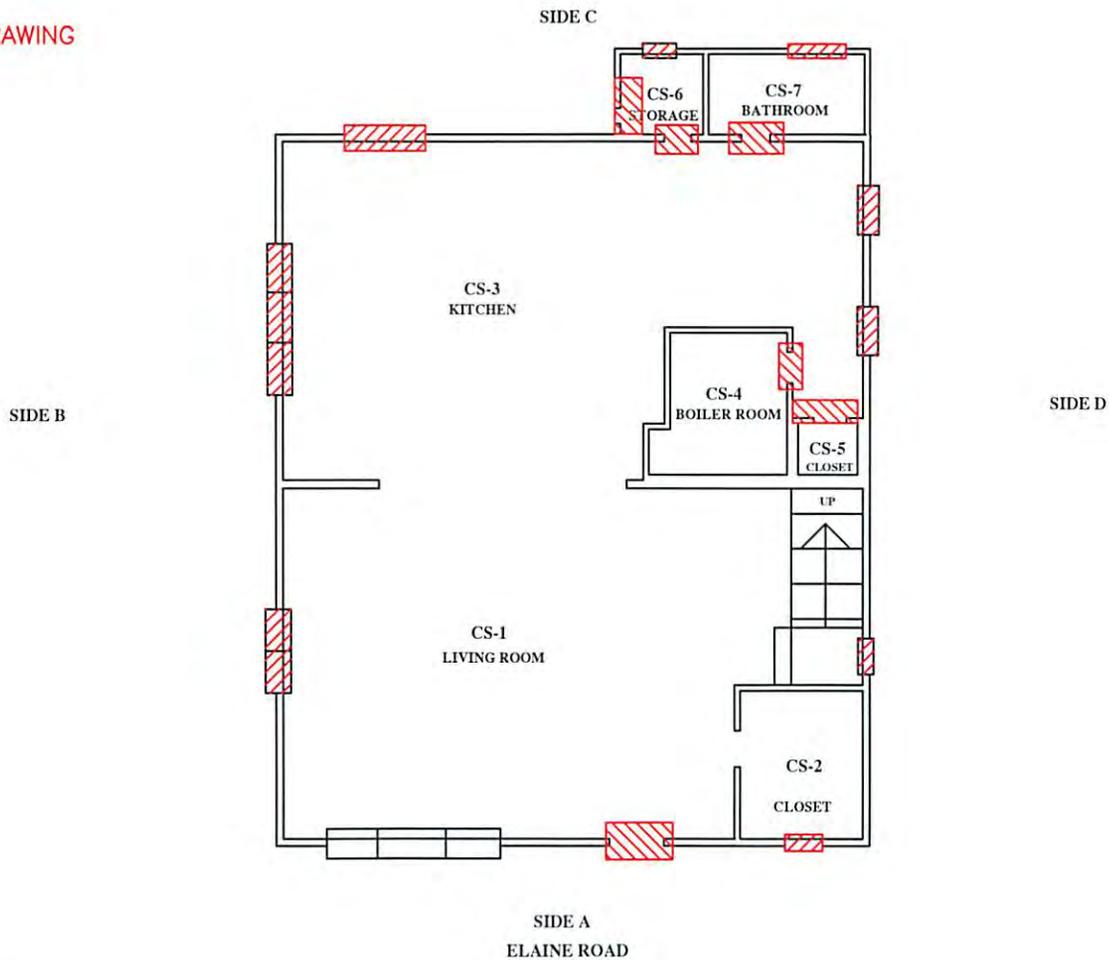
LEAD LOCATION DRAWING

Component/Description	Location	Defective	Friction Surface	Potential Remediation Methods
White/black painted wood window components such as casings, sills, *sashes, aprons, *frames, and wells	Interior – Throughout	Yes	*Yes	REM, REP, or LENCAP
White painted wood door casings,* frames and *stops	Interior – First Floor – CS-3 Kitchen, CS-6 Rear Storage and Second Floor – Throughout	Yes	*Yes	REM, REP, or LENCAP
White painted wood crown moulding	Interior – First Floor – CS-2 LivingRoom Closet and CS-6 Rear Storage	Yes	No	REM, REP, or LENCAP
White painted wood ceiling	Interior – First Floor – CS-6 Rear Storage	Yes	No	REM, REP, or LENCAP
Black painted wood door, *door frame, and door threshold	Exterior – First Floor – Rear Exit Door – Side B	Yes	*Yes	REM, REP, or LENCAP
White painted wood door stop	Interior – First Floor – CS-1 Living Room – Side A	Yes	Yes	REM or REP
White painted wood baseboard	Interior – First Floor – CS-1 Living Room	Yes	No	REM, REP, or LENCAP

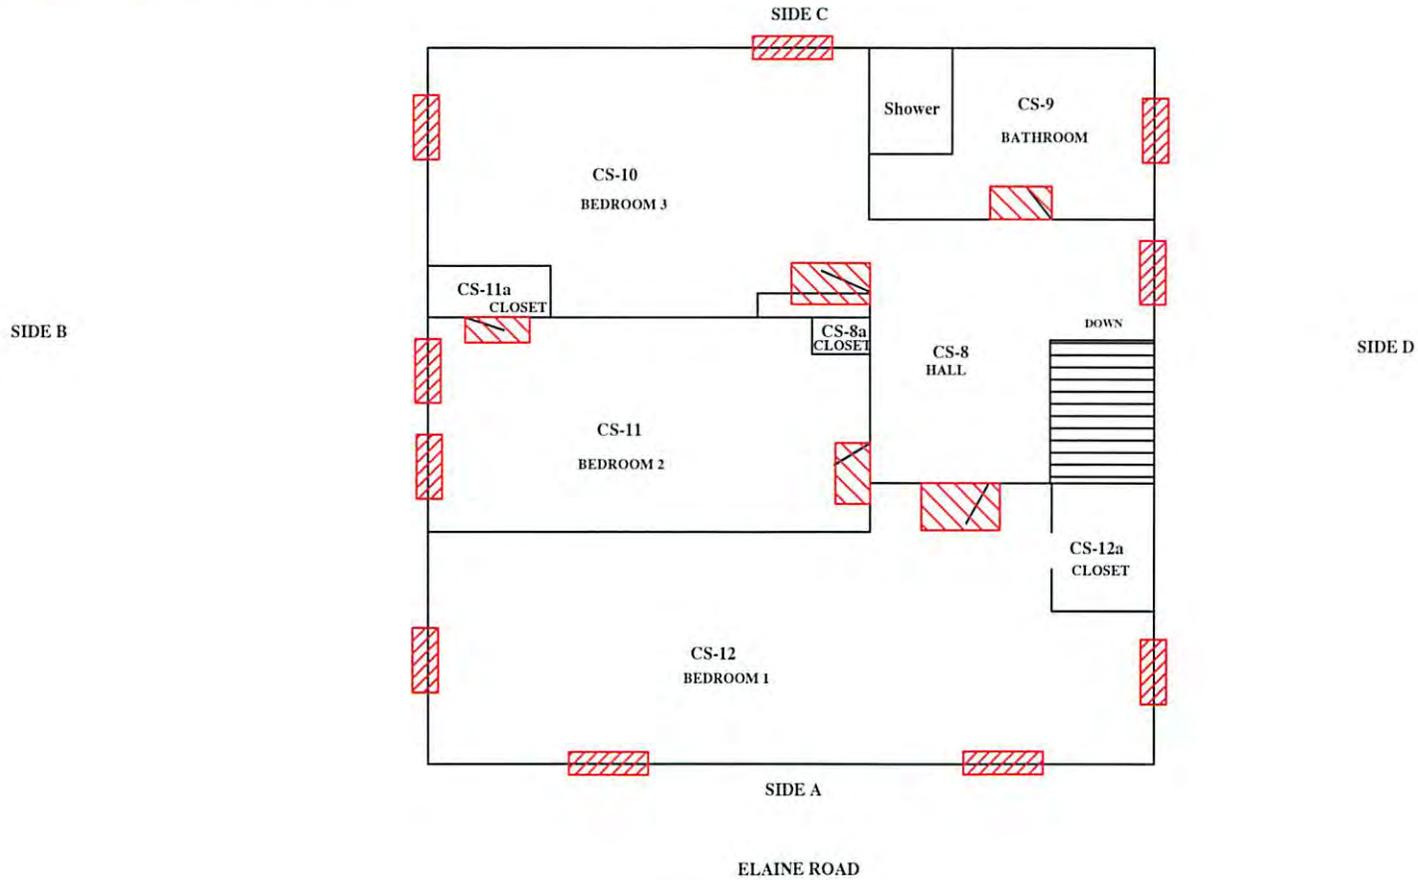
LEAD LOCATION DRAWING

Component/Description	Location	Defective	Friction Surface	Potential Remediation Methods
White painted wood ceiling	Interior – Second Floor – CS-11 Bedroom and CS-10 Bedroom	Yes	No	REM, REP, or LENCAP
Pink painted wood walls	Interior – Second Floor – CS-10 Bedroom	Yes	No	REM, REP, or LENCAP

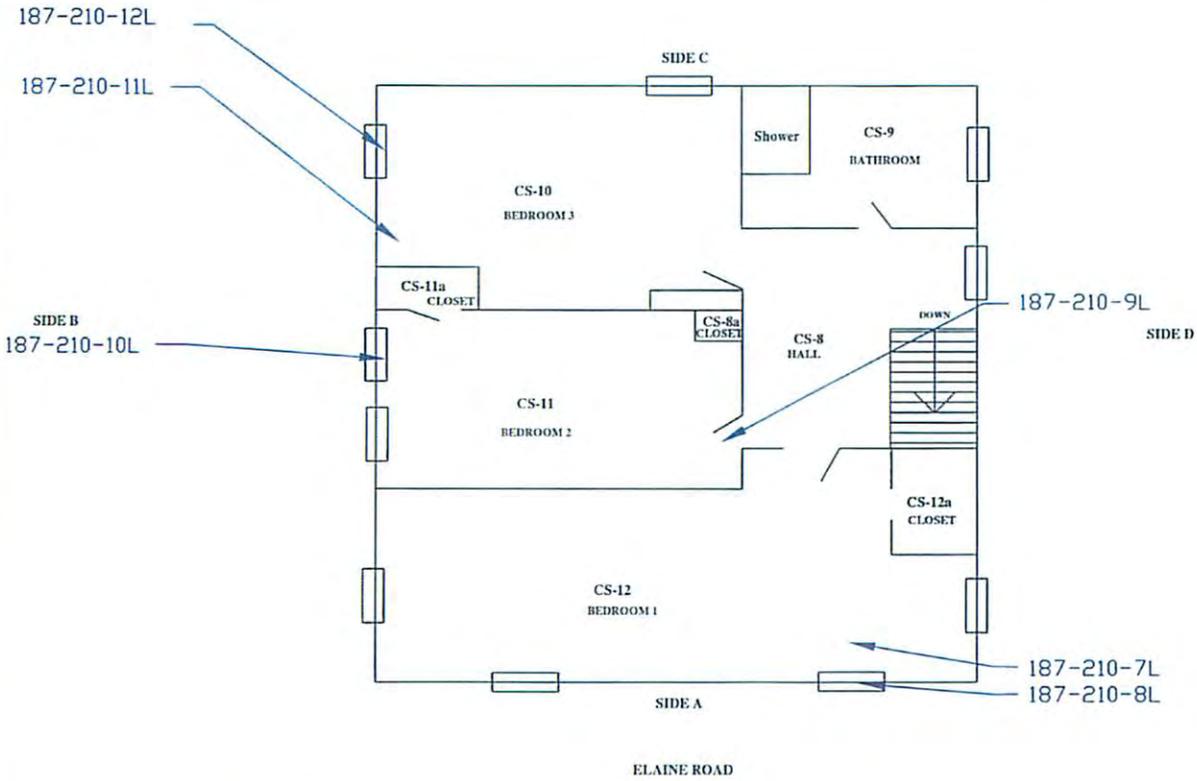
LEAD DUST SAMPLE LOCATION DRAWING

Six of the twelve dust samples collected were within acceptable levels. A summary list is given below, see attached analysis reports and drawings for details. **Samples noted in bold on the following page exceeded HUD and CT-DPH standards and represent dust-lead hazards. These samples constitute dust-lead hazards in those rooms.**
