October 2, 2014

**RE: Environmental Assessment Report**  
**Department of Housing**  
**CDBG-DR – Sandy Disaster Recovery Program**  
**595 James Street**  
**Bridgeport, Connecticut 06512**  
**Application 1791**  
**Eagle Project No. 14-028.12T20**

ENVIRONMENTAL REVIEW  
595 JAMES STREET  
BRIDGEPORT, CONNECTICUT

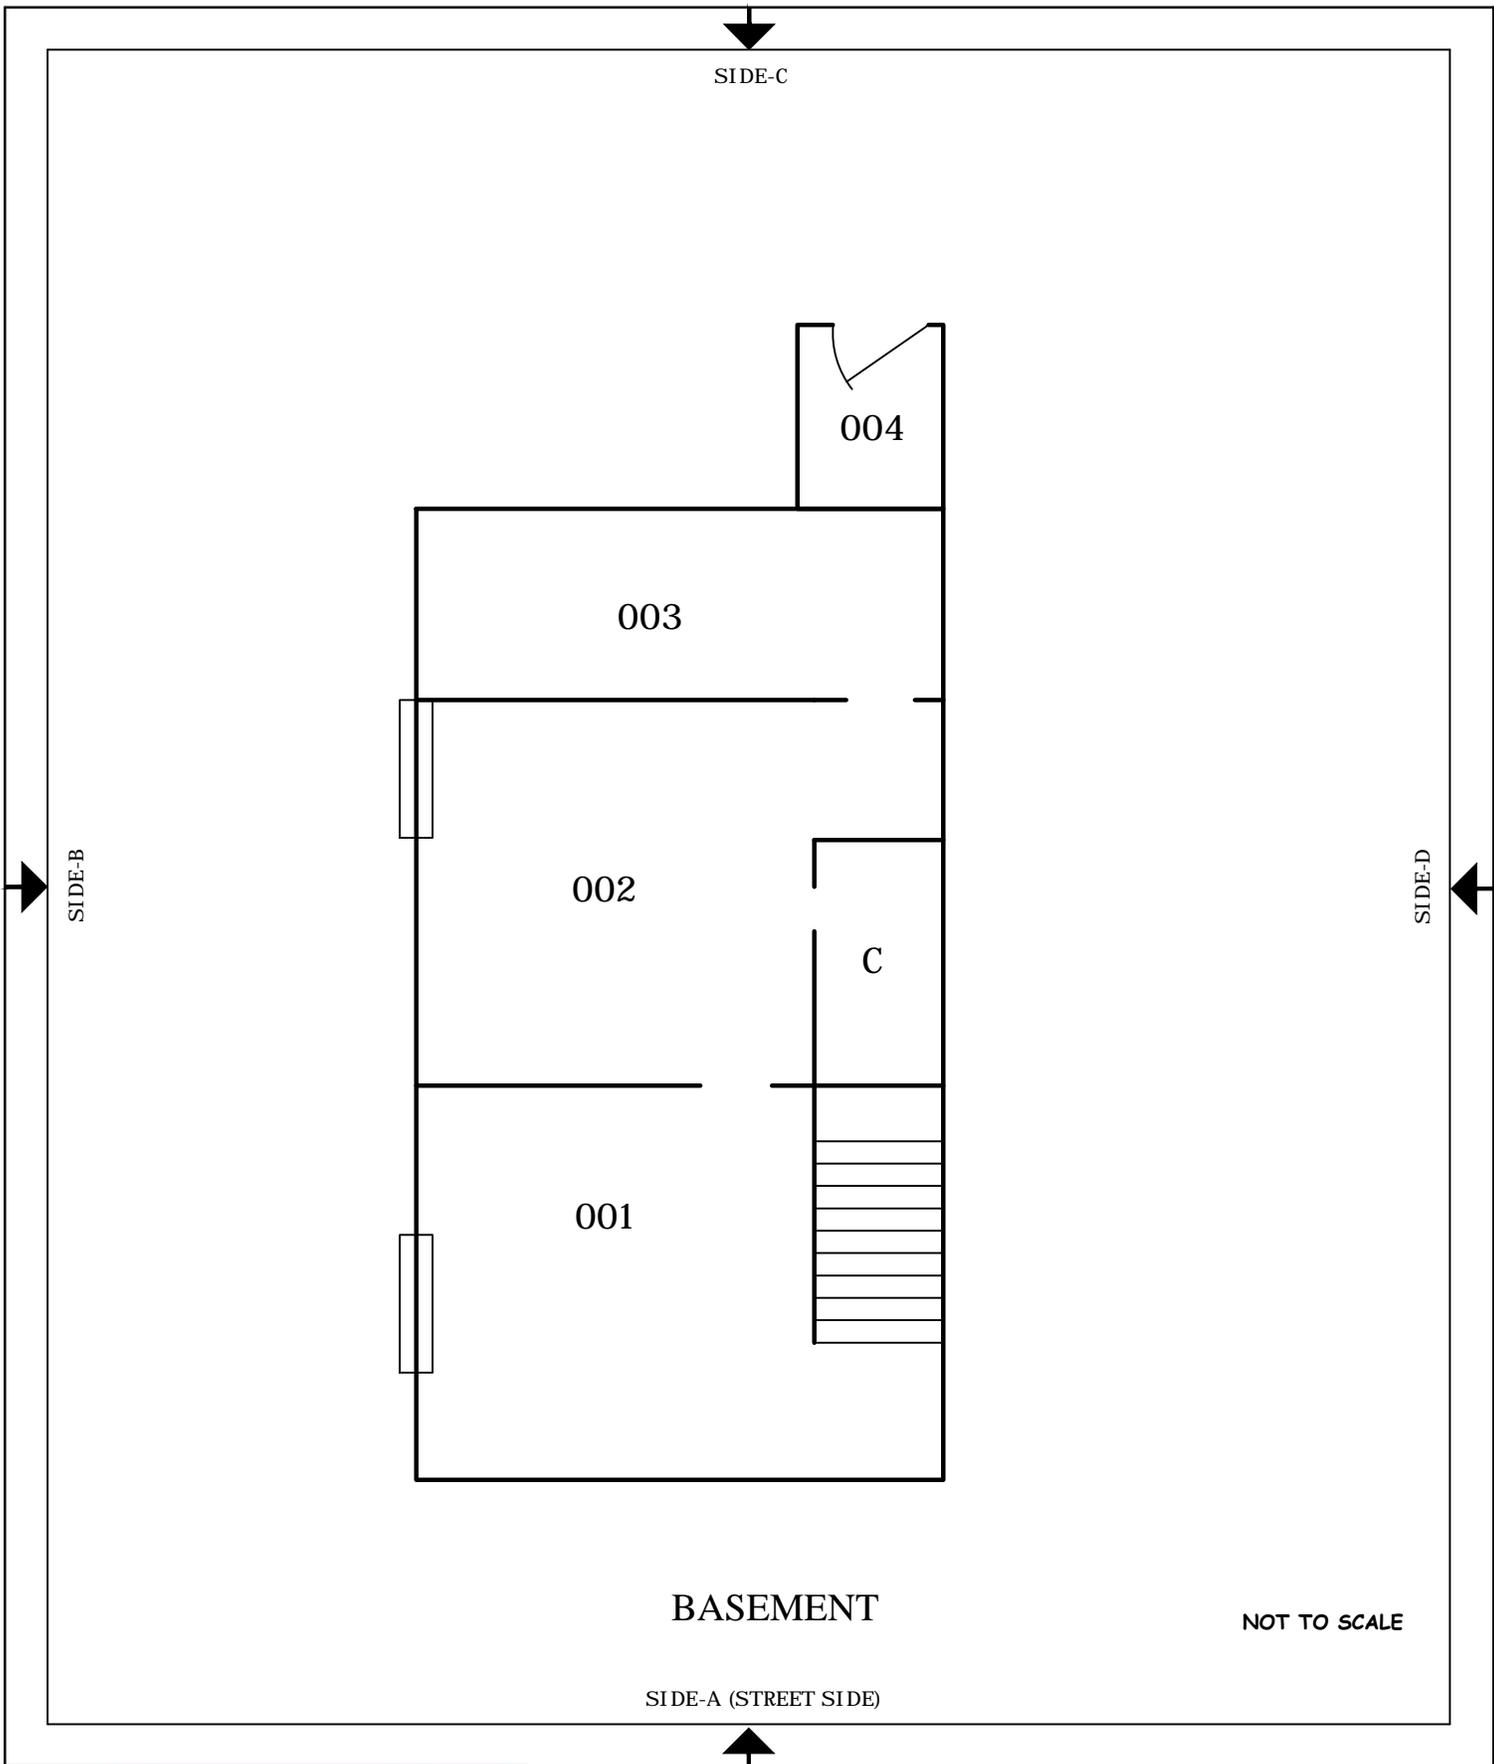
**FP-1**

Water intrusion incurred in the basement area through the walk out door. The Architect's report indicated that approximately two (2) inches of standing water were present in the basement during the event.

The physical inspection identified water impacted gypsum board, paneling, fiberglass bat insulation and wood framing. The basement is partially finished. Suspect mold spore growth was observed on the exposed ceiling and wall insulation within the basement area and gypsum board in the basement entrance. There are visible water stain marks on the lower wall sill plates at the floor and along the bottom of the wood paneling in Rooms 002 and 003 (refer to attached Floor Plans in Appendix 1. The sheetrock "B" side wall and ceiling within Room 004 have sustained significant damage which the homeowner indicated was due to water intrusion during the storm event.

BASEMENT

The result of the Radon testing was 4.6 pCi/L, which is above the USEPA action level. Based on the elevated results, it is recommended that a Radon mitigation system be installed in the basement.

The suspect spore growth on the insulation on the ceilings and walls was likely perpetuated by elevated moisture in the basement during and following the event. The insulation cannot be effectively cleaned and is recommended for removal. The impacted gypsum board and paneling is also recommended for removal. It is likely that spore growth has occurred on the backside of the gypsum board as well. Wood framing exposed during the gypsum board and insulation removal should be cleaned and dried. Concrete walls and floors should also be microbially cleaned as part of the microbial remediation work.
