PROJECT 1811 - 17 KOSSUTH STREET,
NORWALK, CONNECTICUT 06854

SCHEMATIC

FIRST FLOOR LAYOUT

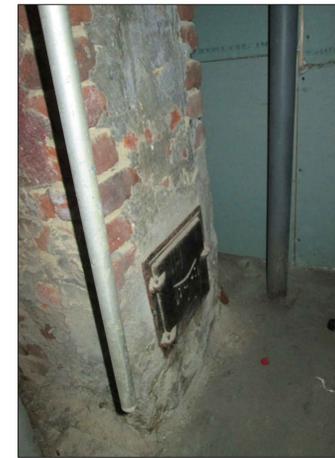
PHOTO 1
(CHIMNEY PIT)
(N.T.S.)

- 1 INSPECT CHIMNEY AND CLEAN CHIMNEY PIT
- 2 WATER DAMAGED WOOD PANELING IN FIRST FLOOR BEDROOM. REPAIR ACCORDING TO CONTRACT DOCUMENTS.

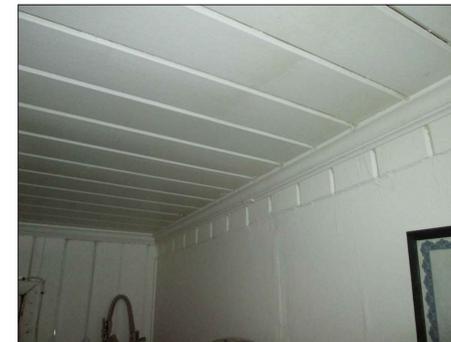
PHOTO 2
(BEDROOM WATER STAINS ON CEILING)
(N.T.S.)

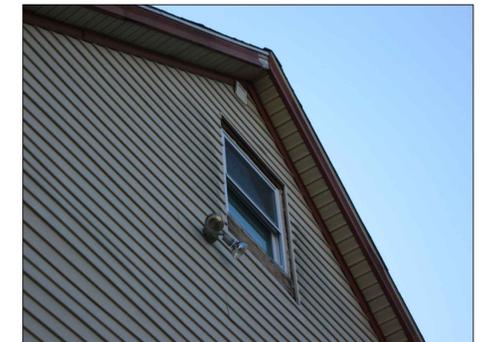
PHOTO 3
(DAMAGED STORM WINDOW TRIM AND ROOF LINE FASCIA)
(N.T.S.)

- 3 DAMAGED STORM WINDOWS TO BE REPAIRED. REPAIR ACCORDING TO CONTRACT DOCUMENTS
- 4 DAMAGED FASCIA BOARD AND MISSING GUTTERS. REPAIR AND REPLACE ACCORDING TO CONTRACT DOCUMENTS
- 5 DAMAGED WINDOW. REPAIR ACCORDING TO CONTRACT DOCUMENTS

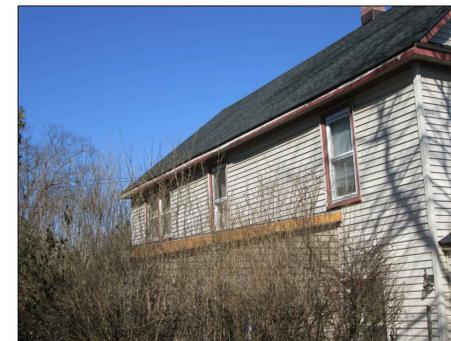
PHOTO 4
(DAMAGED FASCIA BOARD & MISSING GUTTER)
(N.T.S.)

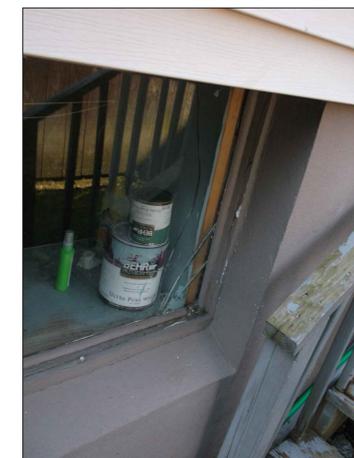
PHOTO 5
(DAMAGED BASEMENT WINDOW)
(N.T.S.)
