EAGLE
Environmental, Inc.

February 3, 2015

RE: Environmental Assessment Report
Department of Housing
CDBG-DR – Sandy Disaster Recovery Program
39 Attawan Avenue
Niantic, Connecticut
Application #1939
Eagle Project No. 14-028.12T10

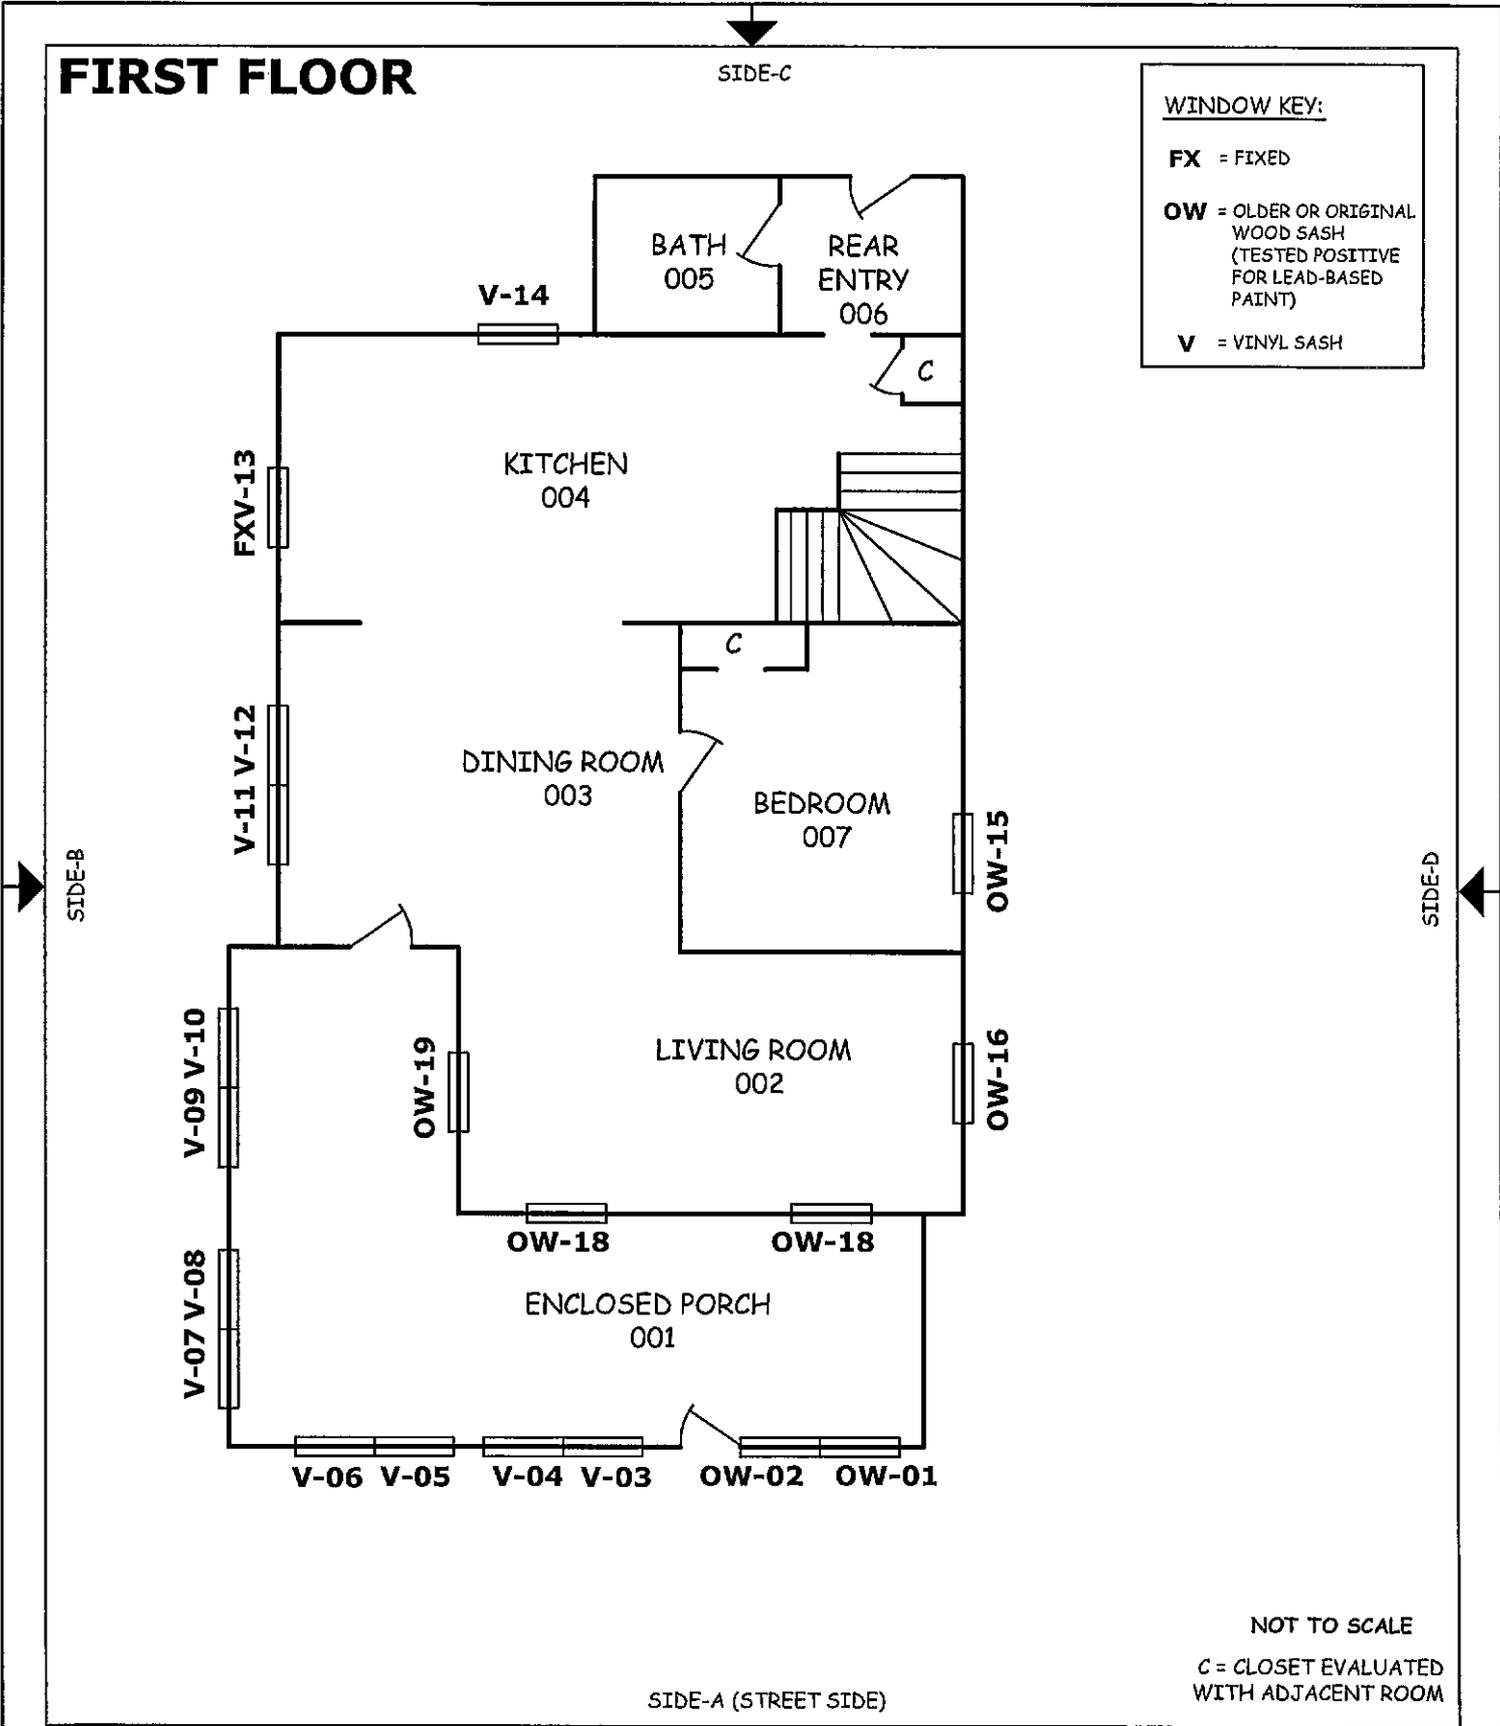
- FX** = FIXED
- OW** = OLDER OR ORIGINAL WOOD SASH (TESTED POSITIVE FOR LEAD-BASED PAINT)
- V** = VINYL SASH

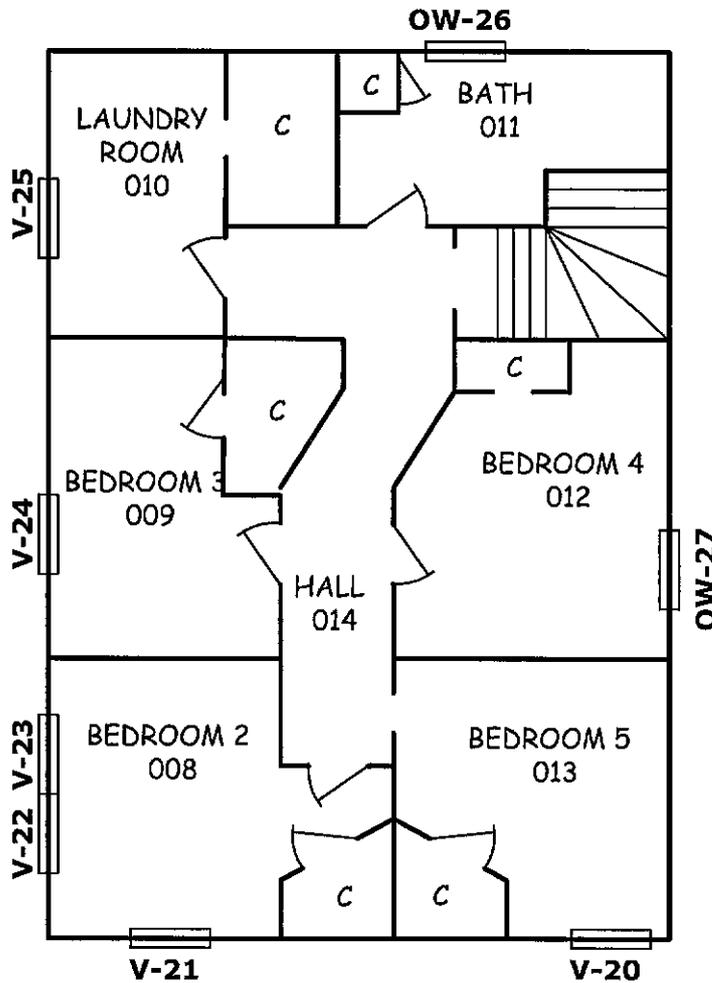
OW = OLDER OR ORIGINAL WOOD SASH (TESTED POSITIVE FOR LEAD-BASED PAINT)
