**RE: Environmental Assessment Report
Department of Housing
CDBG-DR – Sandy Disaster Recovery Program
28 Island Circle North
Groton, Connecticut 06340
Application #2106
Eagle Project No. 15-015.10T1**

ENVIRONMENTAL ASSESSMENT
28 ISLAND CIRCLE NORTH
GROTON, CONNECTICUT

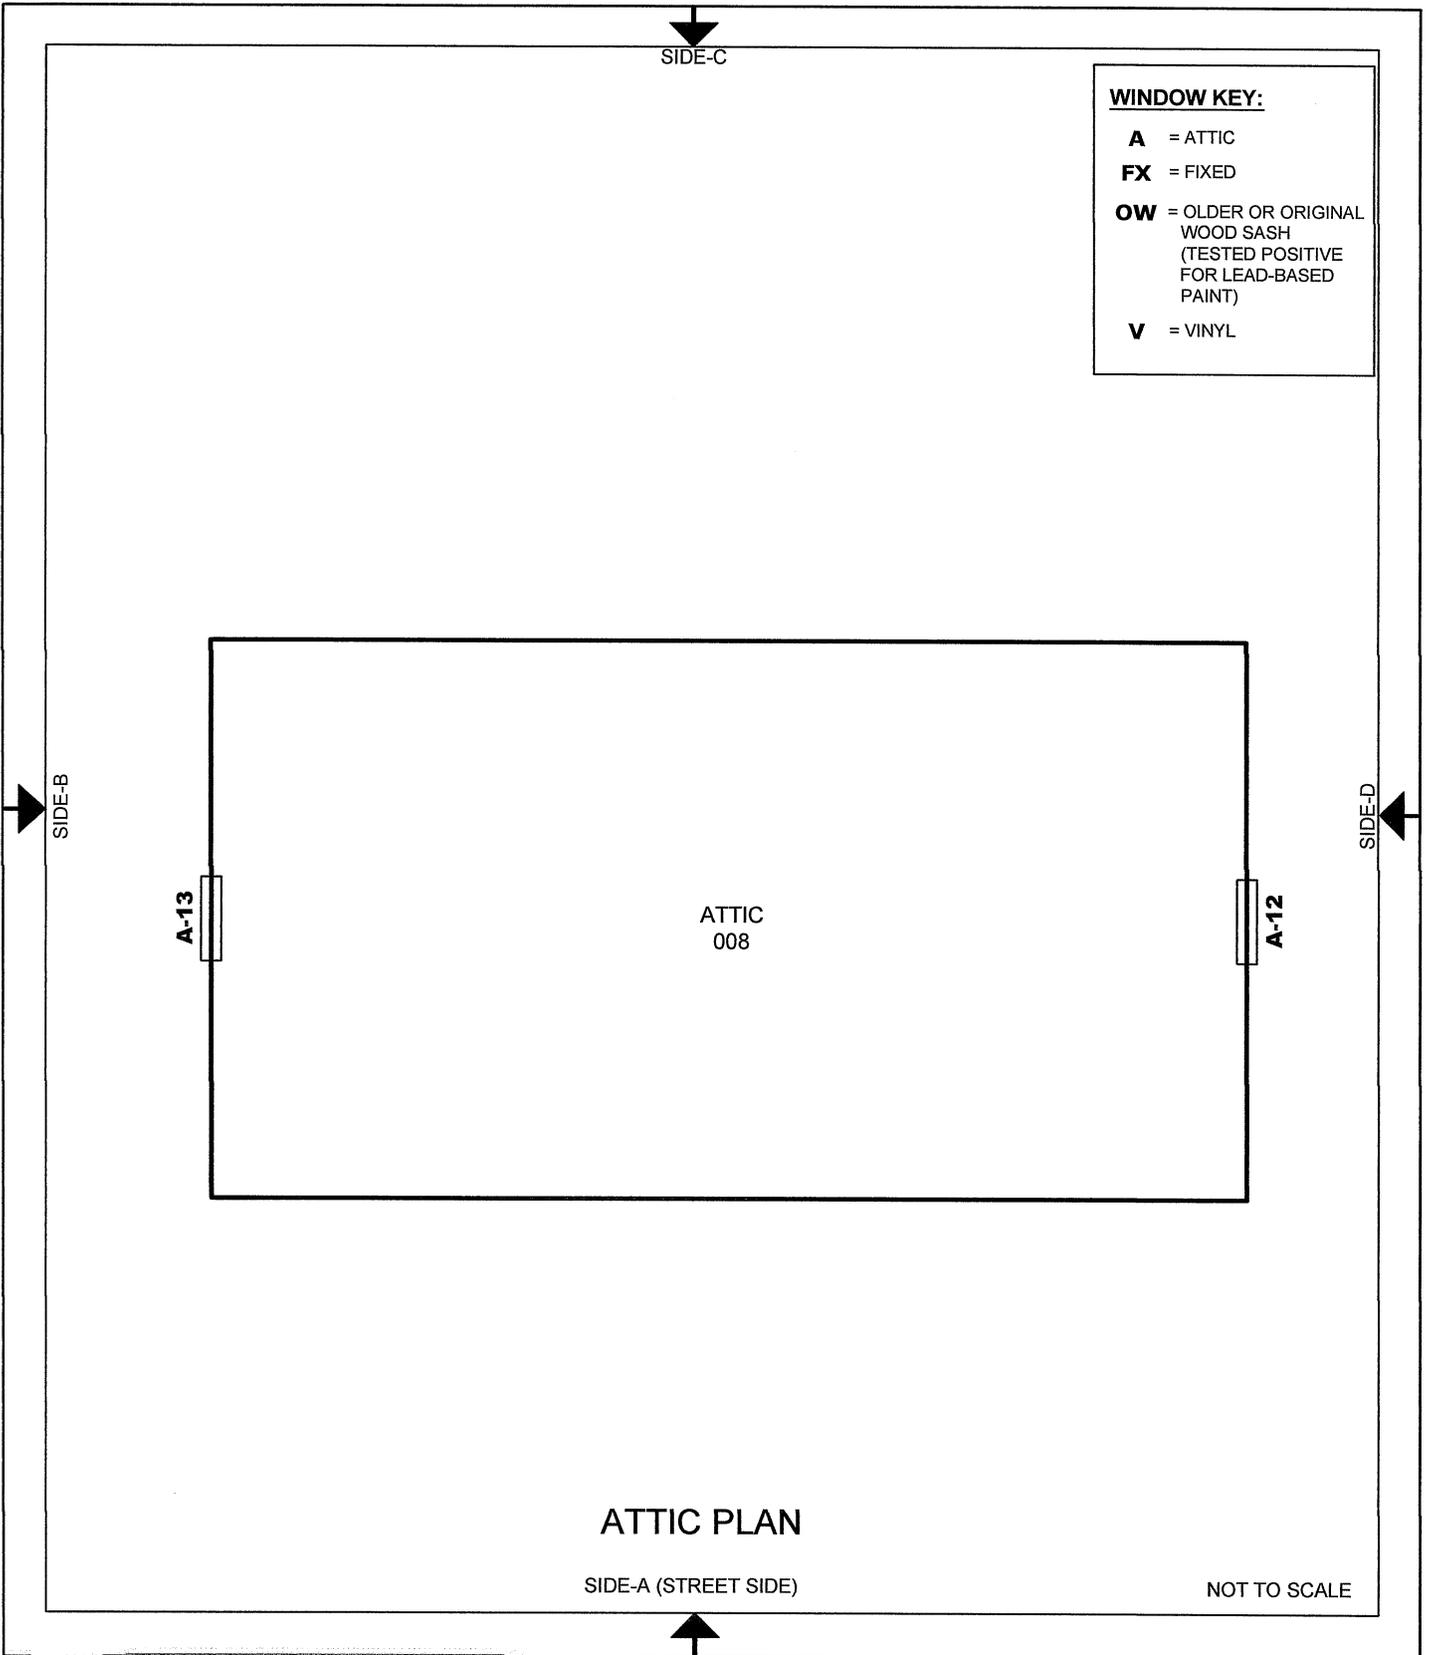
- A** = ATTIC
- FX** = FIXED
- OW** = OLDER OR ORIGINAL WOOD SASH (TESTED POSITIVE FOR LEAD-BASED PAINT)
- V** = VINYL
