STRUCTURE NO. 05588

ROUTE 74
over
HOCKANUM RIVER
VERNON

Special Inspection
on
5/26/2011

Bridge Inspection Report BRI-18

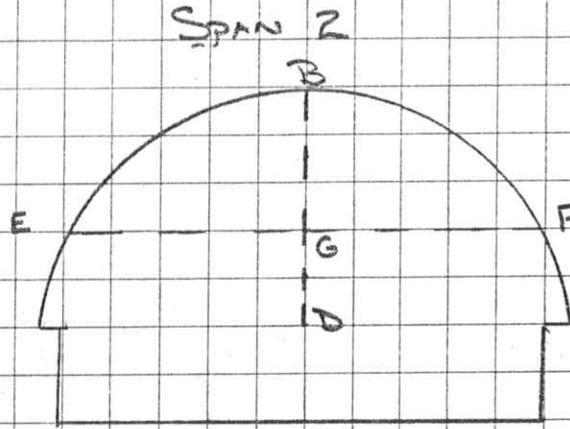
Date	North End		Center		South End	
5-27-08	E-F	122"	E-F	122"	E-F	121"
	B-G	24 1/2"	B-G	24 1/2"	B-G	24 3/4"
5/21/2010	E-F	122"	E-F	122"	E-F	121"
	B-G	24 1/2"	B-G	24 1/2"	B-G	24 3/4"
5/26/11	E-F	122"	E-F	122"	E-F	121"
	B-G	24 1/2"	B-G	24 1/2"	B-G	24 3/4"

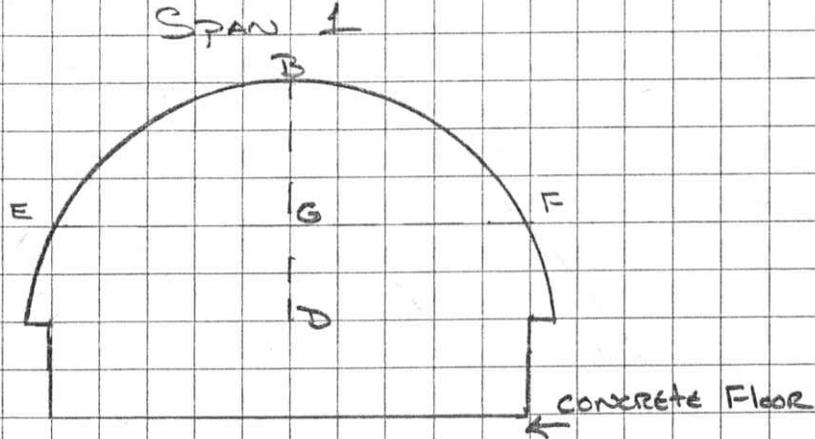
DATE	North End		Center		South End	
5-27-08	E-F	122"	E-F	122"	E-F	122"
	B-G	25"	B-G	25"	B-G	25"
5/21/2010	E-F	122"	E-F	122"	E-F	122"
	B-G	25"	B-G	25"	B-G	25"
5/26/11	E-F	122"	E-F	122"	E-F	122"
	B-G	25"	B-G	25"	B-G	25"

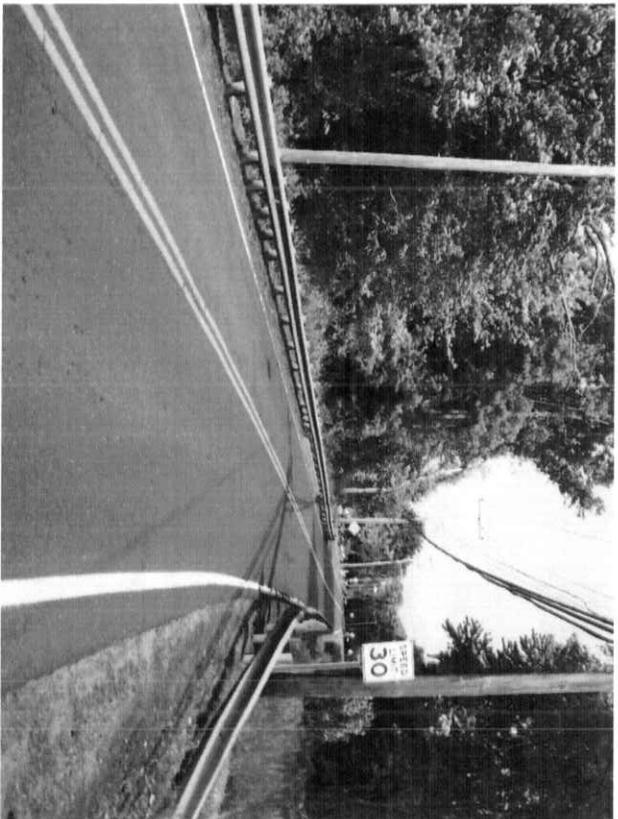
Photo # : LOOKING WEST OVER BRIDGE.

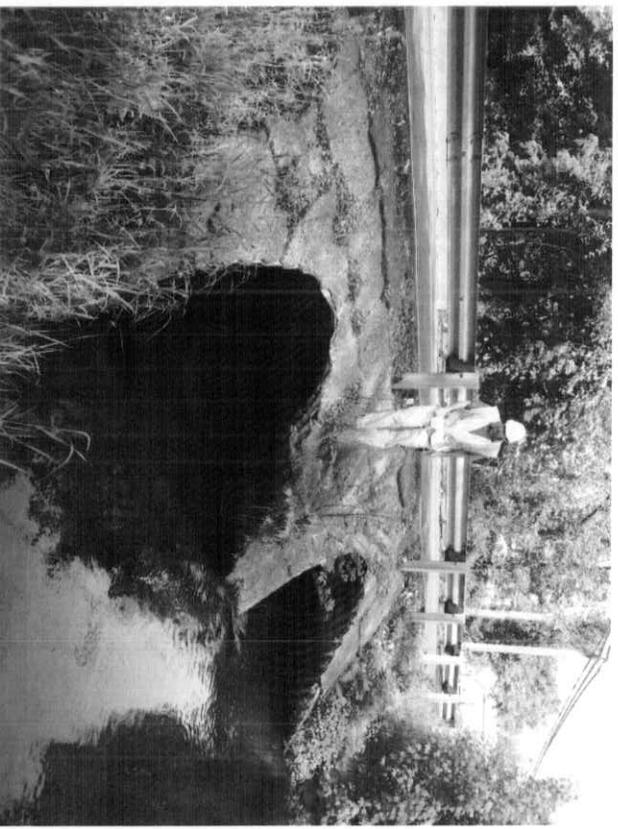
Photo # : NORTH ELEVATION. (UPSTREAM)

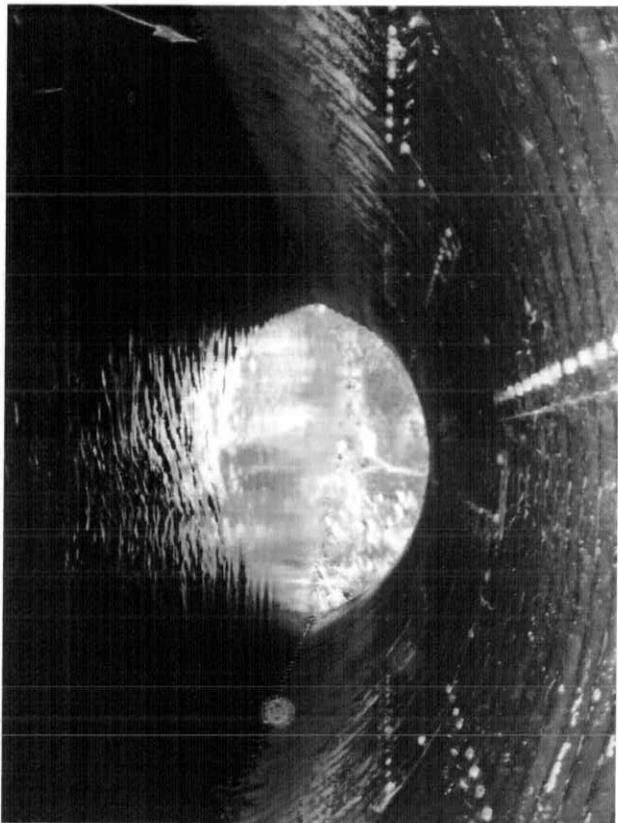
Photo # : LOOKING THRU A TYPICAL SPAN.

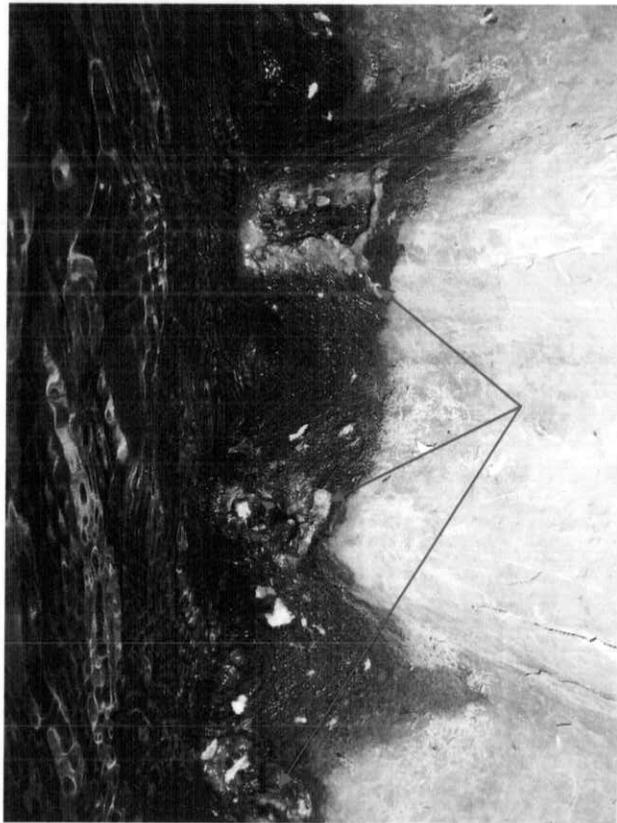
OVERLAY. EACH PIPE ARCH RESTS UPON A CONCRETE STEM, WITH A CONCRETE FLOOR. A MITERED CONCRETE PAVEMENT, IS USED ALONG EACH ELEVATION OF THE STRUCTURE, FOR BANK RETENTION.
CONCRETE:	5	THIS STRUCTURE SHOWS A CONCRETE FLOOR, WITH CONCRETE STEMS. IT IS ASSUMED ALL WERE CAST IN PLACE IN A MONOLITHIC FASHION. AT THE TIME OF INSPECTION, ONLY THE UPPER STEMS, AND THEIR CAPS WERE EXPOSED. ALL STEMS SHOW MODERATE SCALE, WITH POCKETS OF SEVERE SCALING TO THE STEM CAPS. THE FLOORS, WHERE NOT COVERED WITH DEBRIS, CANNOT BE REPORTED ON, DUE TO MURKEY WATER.
STEEL:	4	BOTH PIPE ARCHES ARE IN FAIR CONDITION, WITH A GOOD SYMMETRICAL APPEARANCE OF THE TOP ARC. THE BOLT LINES ARE STRAIT, WITH THE JOINTS SHOWING NO CUSPING, OR LEAKAGE INFILTRATION. AREAS OF THE ASPHALTIC COATING HAVE PAST WORN AWAY, UP TO 3 FEET HIGH, AND LIGHT TO HEAVY RUSTING, WITH LIGHT TO MODERATE LAMINAR SHEETS, AND RANDOM PERF HOLES, ARE NOTED ALONG THE WATERLINE, AT THE STEM JUNCTIONS. AT LEAST 12 CELL RIBS WITHIN THE WESTERLY CELL SHOW MULTIPLE PERF HOLES. THE WATER DEPTH WITHIN THE EASTERLY CELL IS AS LITTLE AS 14 INCHES, DUE TO SILT ACCUMULATIONS, AND AS MUCH AS 22 INCHES IN THE WESTERLY CELL. THERE ARE ISOLATED MISSING BOLTS ALONG THE BOTTOM EDGES OF BOTH PIPES. IN THE WEST PIPE, ONE OF BOLT HOLES APPEARS TO HAVE BEEN ELONGATED. THE VERY END OF THE WESTERLY CELL, ALONG THE NORTHWESTERLY CORNER WHICH ACTS AS A BANK RETENTION, SHOWS ABOUT FOUR LINEAR FEET OF HEAVY DETERIORATION TO THE UPPER PLATE EDGE. THIS AREA OF DETERIORATION APPEARS TO BE ABOUT 6.0 INCHES HIGH.

Photo # : PAST NOTED PER HOLES IN PIPE ARCH
