# STRUCTURE NO. 00253

I-95 SOUTHBOUND  
over  
I-395 NORTHBOUND  
EAST LYME

*Routine & Special Inspection*

**BRIDGE SAFETY INSPECTION**  
**STATE PROJECT NO. 170-3013**

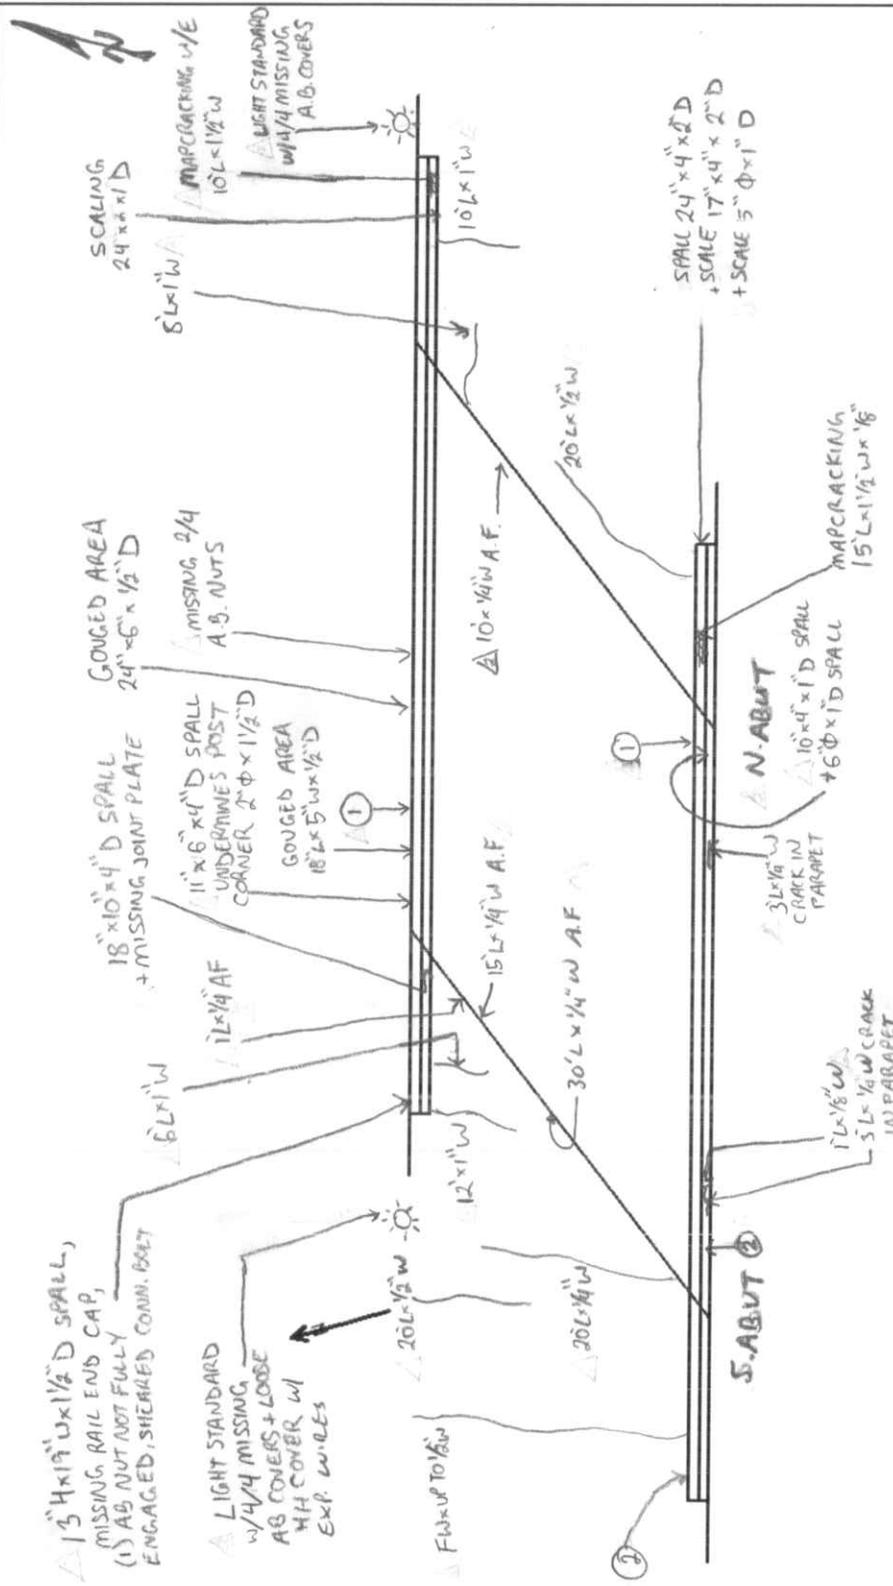
Field Original [X] Transcribed By RDM  
 DESCRIPTION: FIELD NOTES - TOP OF DECK

OVERLAY + APPROACHES W/RAND LONGITUDINAL CRACKS  
 + MAP CRACKING UP TO 1/4" W, MINOR WEAR/RAVEL  
 + PAVING SEAMS OPEN UP TO 1/2" W. MAPCRACKING  
 IS MOST NOTABLE IN LEFT LANE  
 - PARAPETS + SAFETY WALKS W/MINOR SCALE + RAND  
 CRACKS UP TO 1/16" W, FEW W/EFFLO  
 - AP'S W/FL\*FW RAVELOF PLUG MATERIAL ENDING,  
 AGGREGATE  
 - CURBS W/MINOR SCRAPES + CHIPPING  
 - SEE PARAPET MISALIGNMENT SHEET  
 - W CURB REVEAL = 7" H, E CURB REVEAL = 7 1/2" H

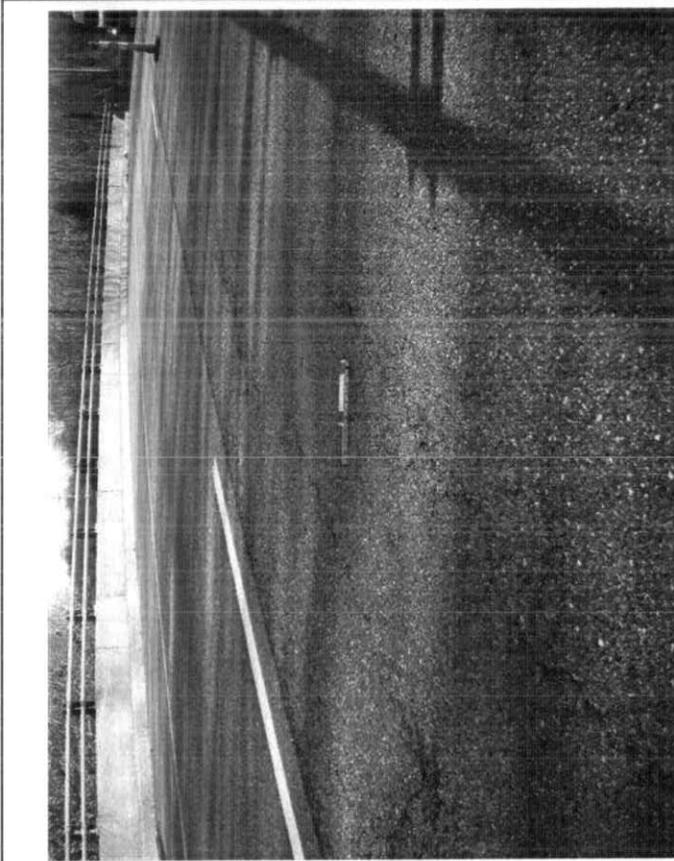
Photo # 11  
 1/31/2012  
 Bituminous overlay, Left travel Lane, looking northwest - Minor wear / raveling, map cracking up to 1/4-inch wide, and paving seam open up to 1/2-inch wide.

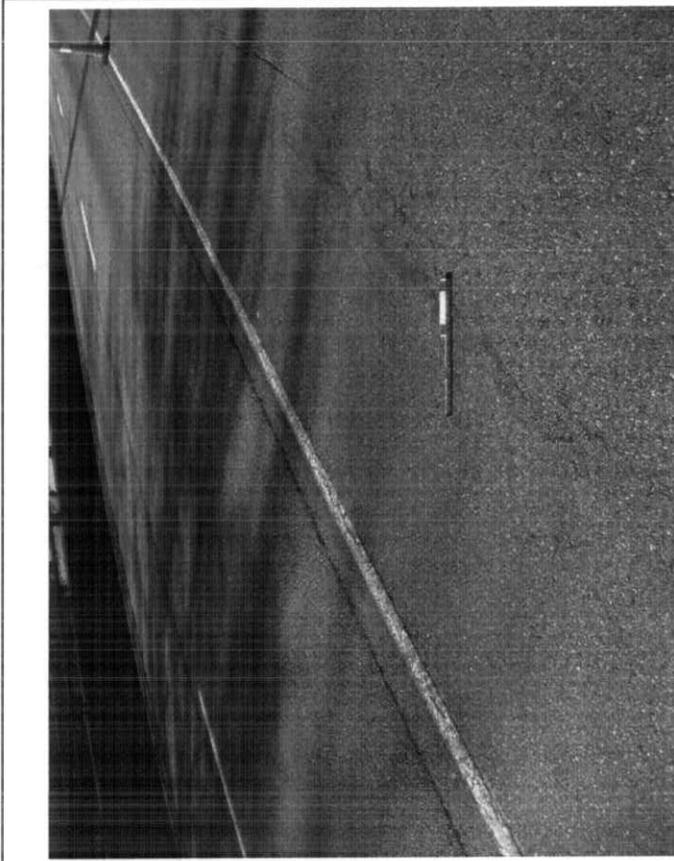
Photo # 12  
 1/31/2012  
 Bituminous overlay, right shoulder, 40-feet from South Abutment, looking southeast - minor wear / raveling and cracks open to 1/4-inch wide.

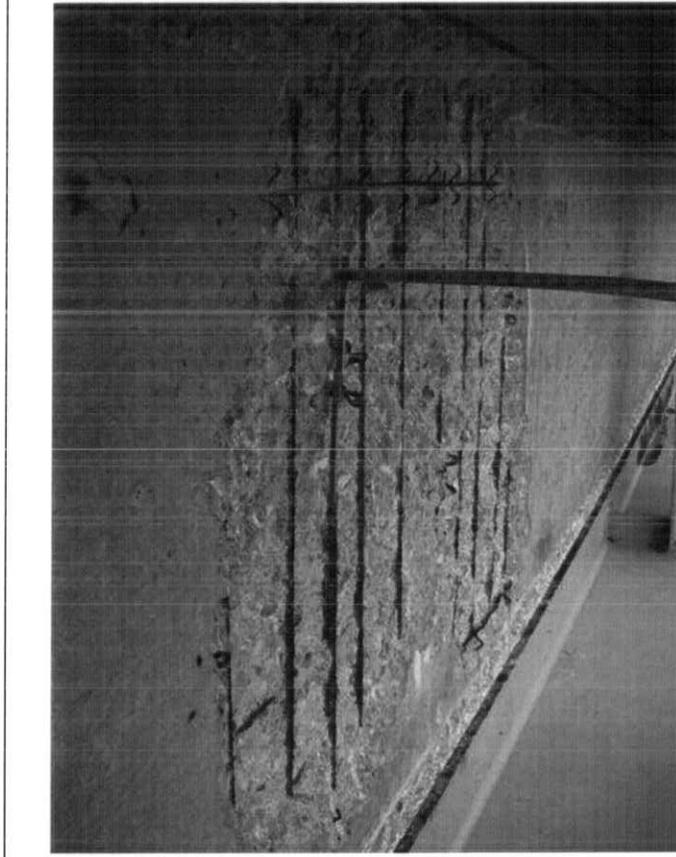
Photo # 13

Deck Soffit, between Girders 4 and 5, between 1st and 2nd intermediate diaphragms from South Abutment, looking northwest - 48" L x 50" W x 2.5" D spall with exposed steel reinforcement (previous noted delamination addressed under BMM #10-378).

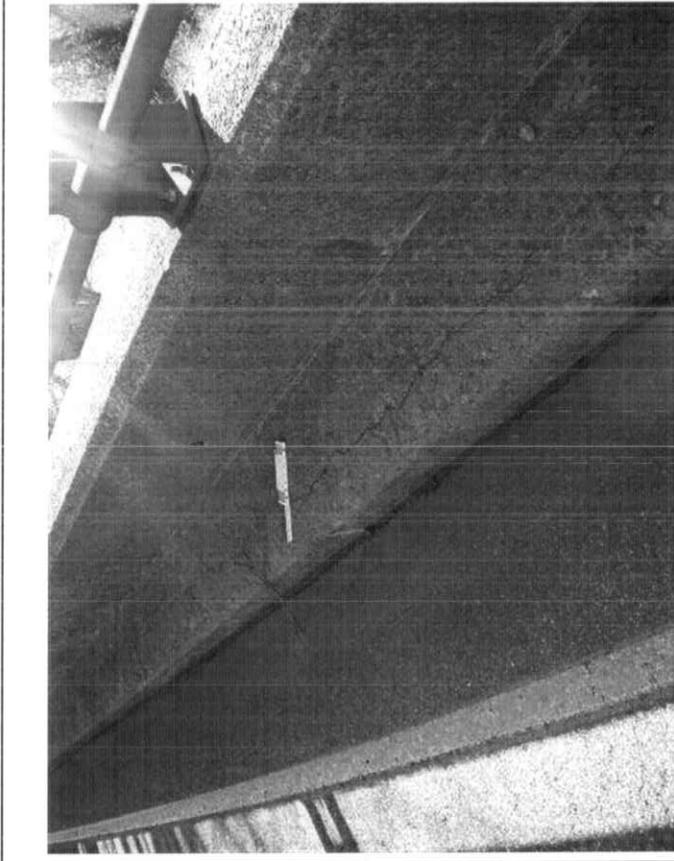
Photo # 17  
 North Approach, East Safety Walk, 15-feet from bridge, looking northeast - 15' L x 1.5' W map cracking open up to 1/8-inch wide.

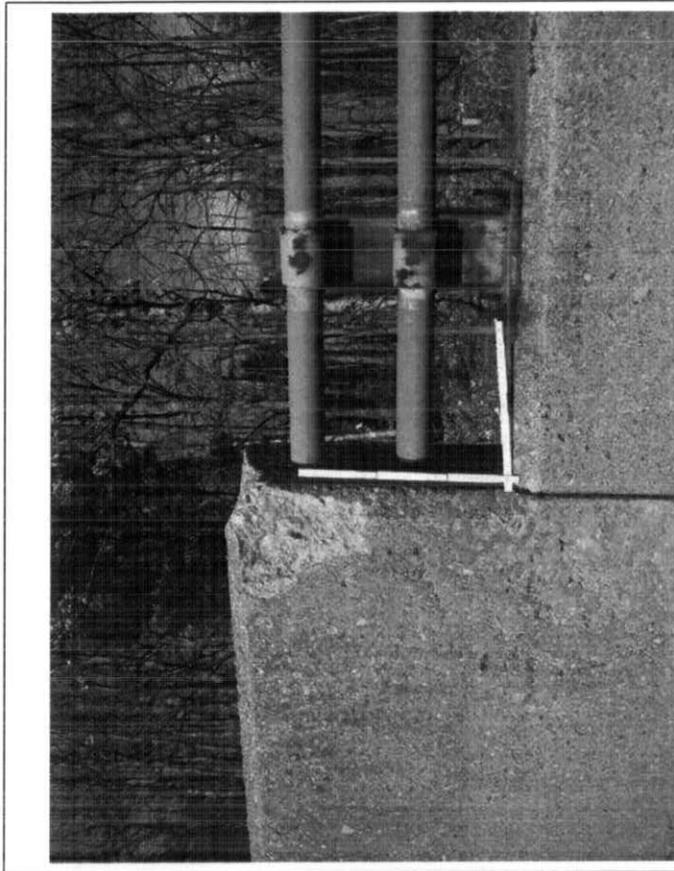
Photo # 18  
 South Approach, West Parapet end block, first railing post, looking west - railing post was replaced with a steel post and the end block with 13" H x 19" W x 1 1/2" D spall due to previous collision damage.

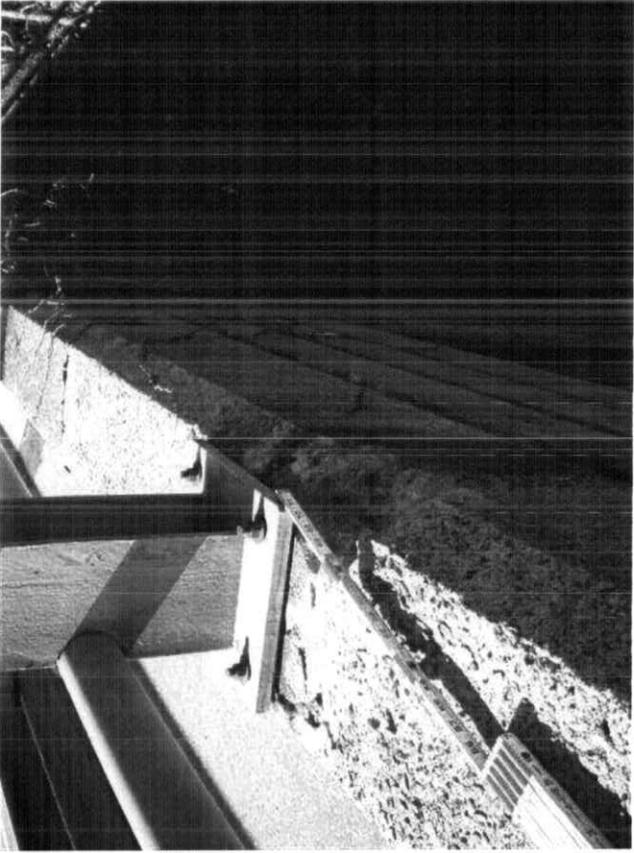
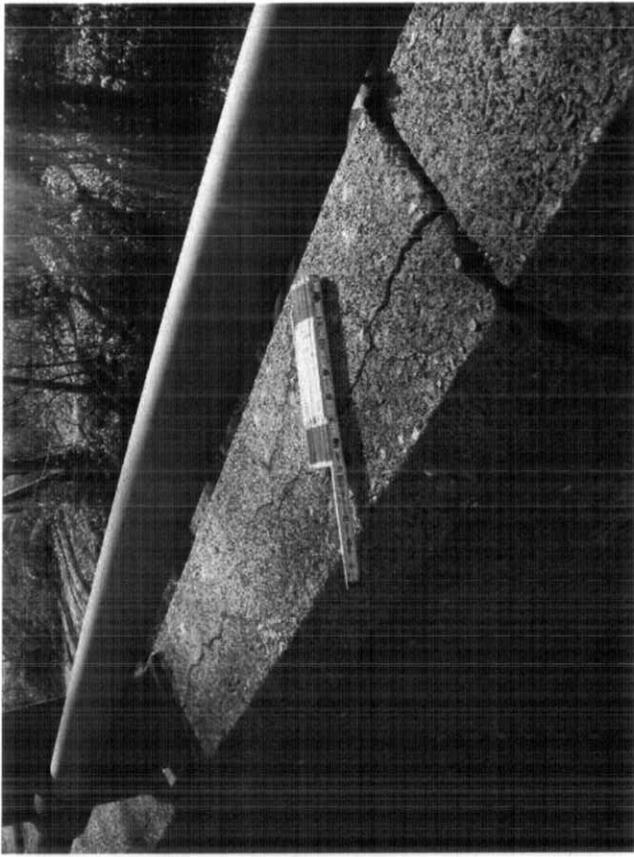
<p>Photo # 19</p> <p>1/31/2012</p> <p>West Parapet, at 3rd bridge rail post north of South Abutment, looking southeast - 11" L x 6" W x 4" D spall that undermines the northeast corner of the post 2" diameter x 1.5" D.</p>	<p>Photo # 20</p> <p>1/31/2012</p> <p>East Parapet, top face between the second and third posts from the South Abutment, looking northeast - 3' L x 1/4" W longitudinal crack.</p>

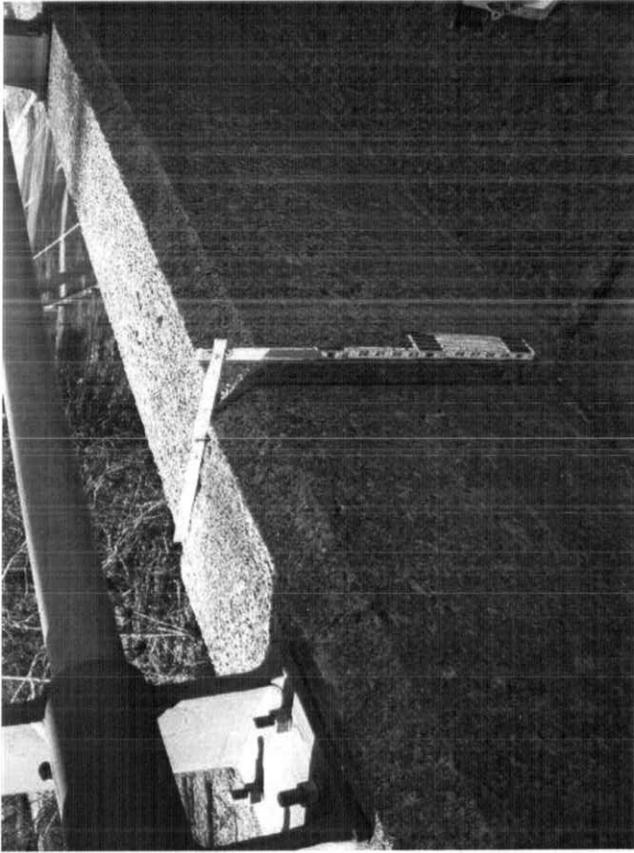
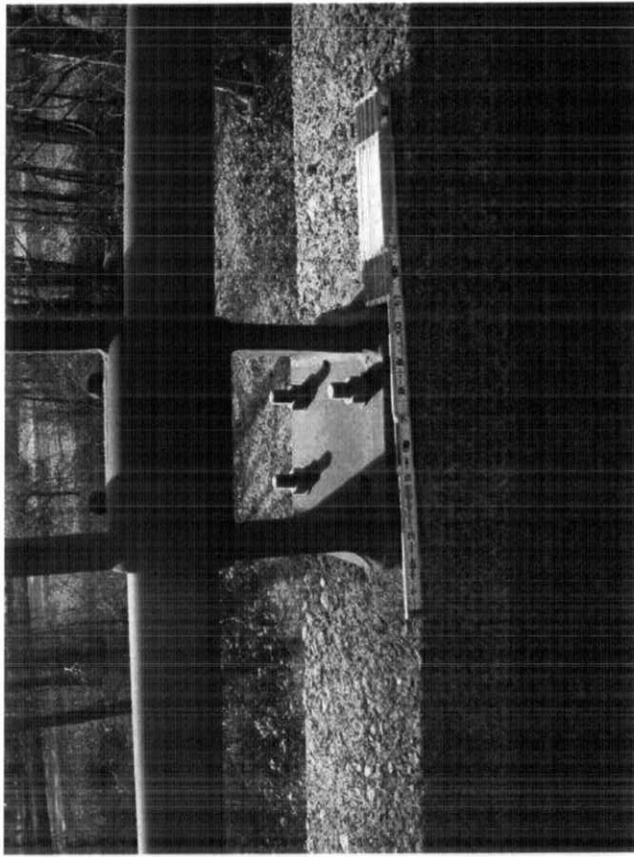
<p>Photo # 21 North Abutment, East Parapet Joint, looking southwest - 1 1/4-inch lateral misalignment to the west on the north side of the joint.</p>	<p>Photo # 22 East Parapet, first railing post from the North Abutment, looking east - One (1) of four (4) missing anchor bolts.</p>

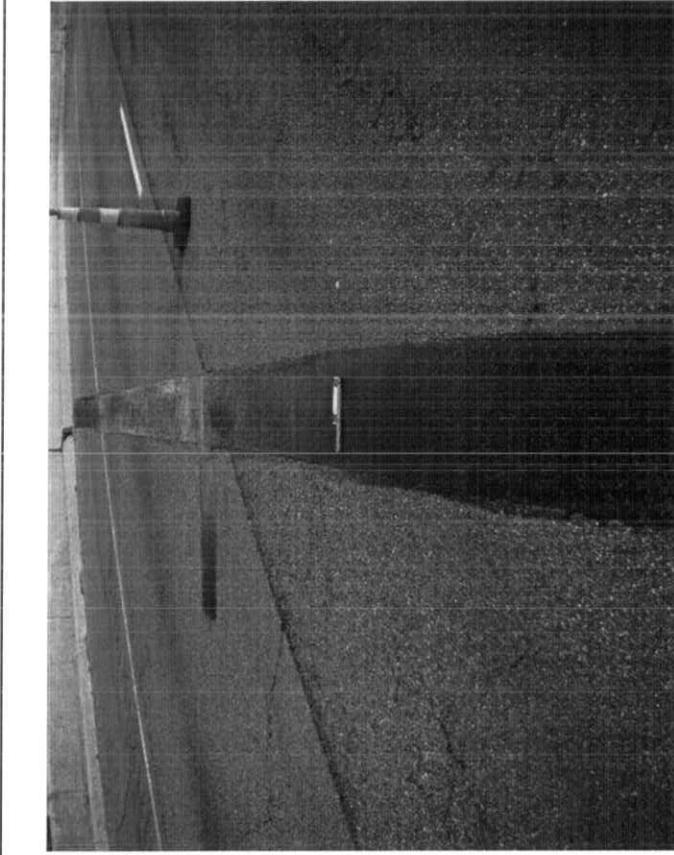
Photo # 23

South Abutment, asphaltic plug joint, looking west - 30' L x 1/4" W adhesion failure at the south side.

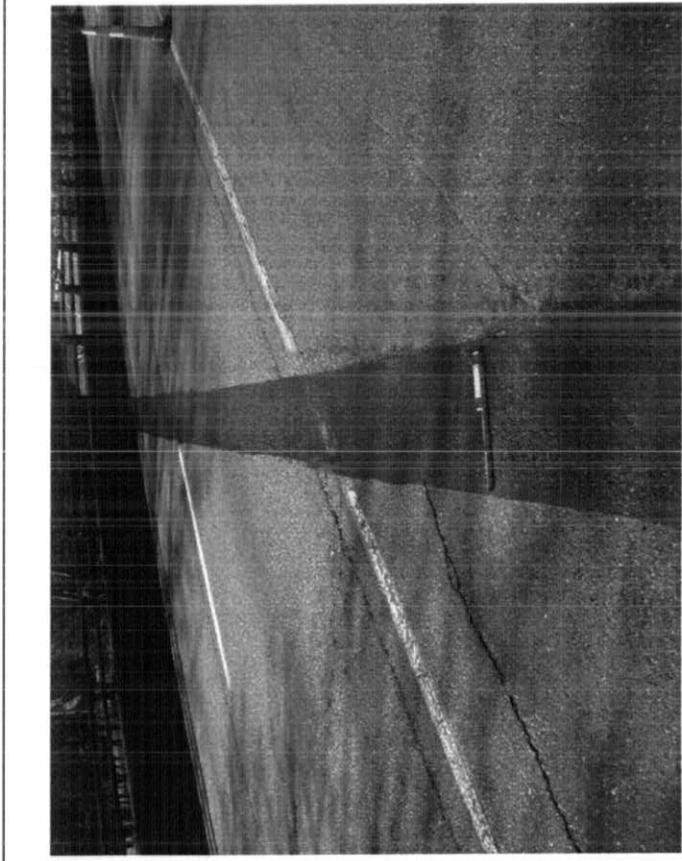
Photo # 25  
 1/31/2012  
 North Abutment, asphaltic plug joint, right shoulder and lane, looking east - 10' L x 1/4" W adhesion failure at the south side and minor raveling of plug material with exposed aggregate.

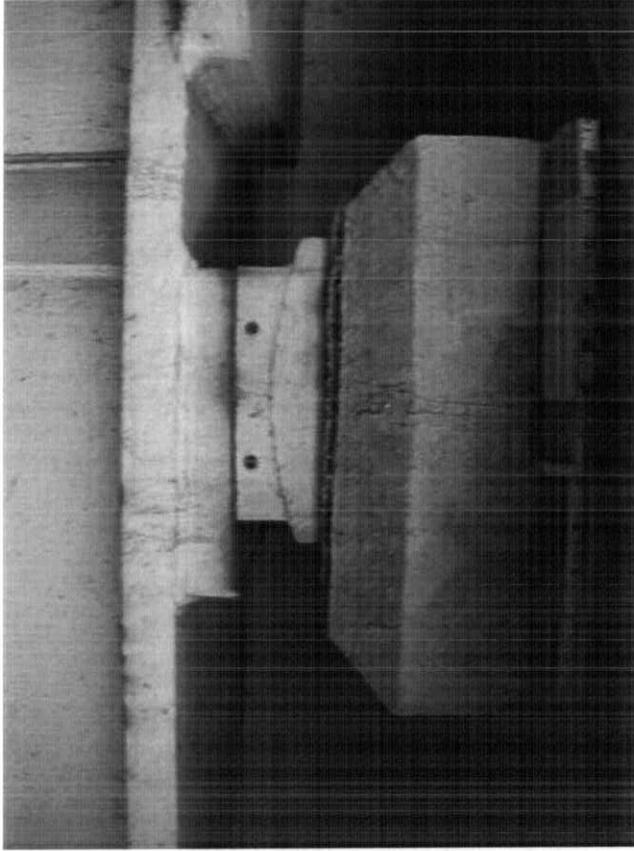
Photo # 26  
 1/31/2012  
 Girder 1, South Abutment, expansion sliding bearing, looking east - bearing in over-expanded position at 50°F with sole plate aligned up to 7/16-inch beyond edge of sliding plate and east anchor bolt sheared off.

1. Repair / replace the expansion sliding bearings at the South Abutment (7 EA).
2. Clean and paint the girders, diaphragms and bearings (500 SF).
3. Monitor the lateral movement of the bearings/superstructure.

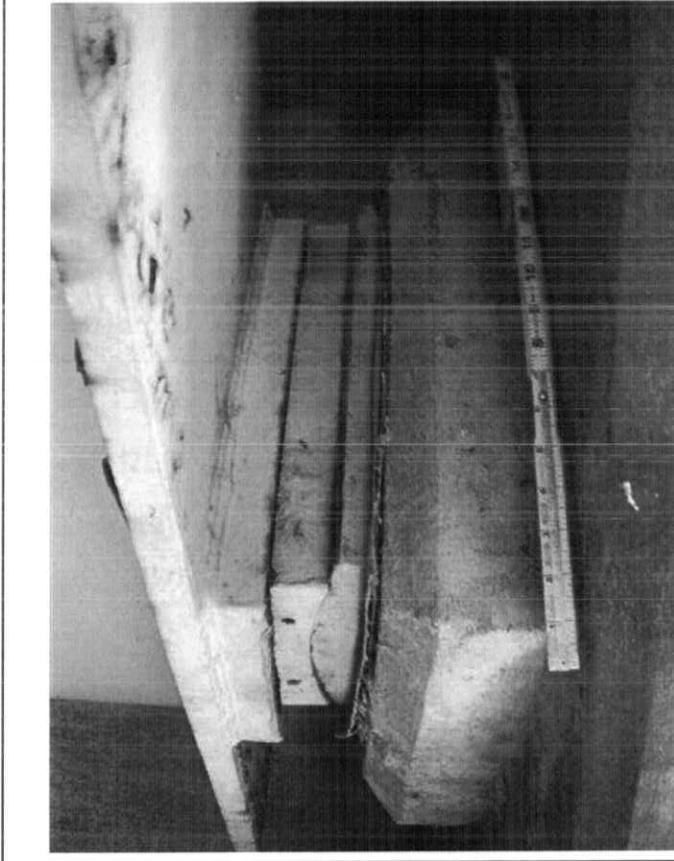
Photo # 27  
 1/31/2012  
 Girder 4, South Abutment, expansion sliding bearing, looking southwest - light rust on bearing plates, 1 1/8-inch misalignment (with 3/4-inch between sole and sliding plates and 3/8-inch between sliding and masonry plates) to the east and east anchor bolt sheared off.

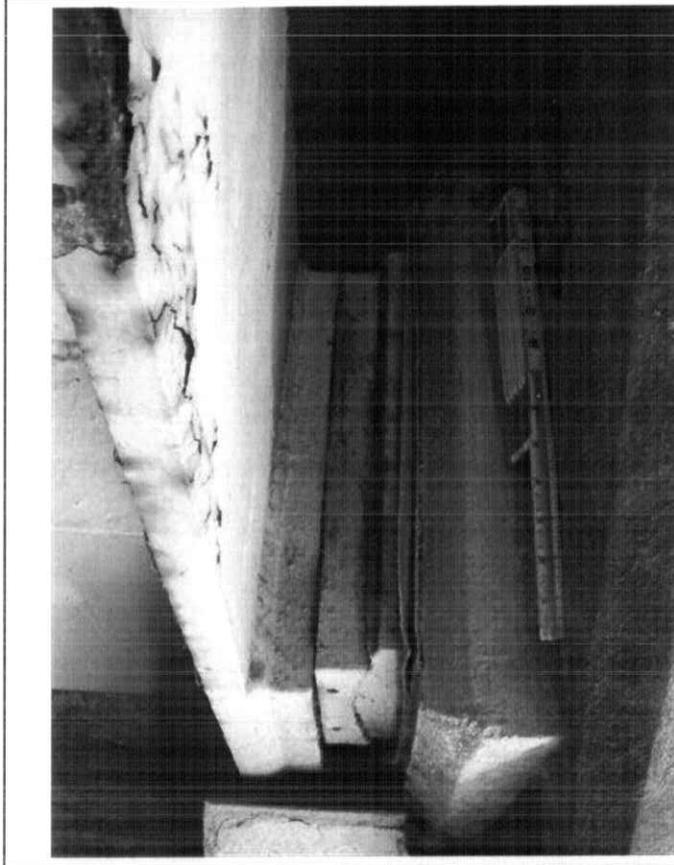
Photo # 28  
 1/31/2012  
 Girder 5, South Abutment, expansion sliding bearing, looking south - light rust on the bearing plates, 1 3/8-inch misalignment (with 11/16-inch between sole and sliding plates and 11/16-inch between sliding and masonry plates) to the east and east anchor bolt sheared off.

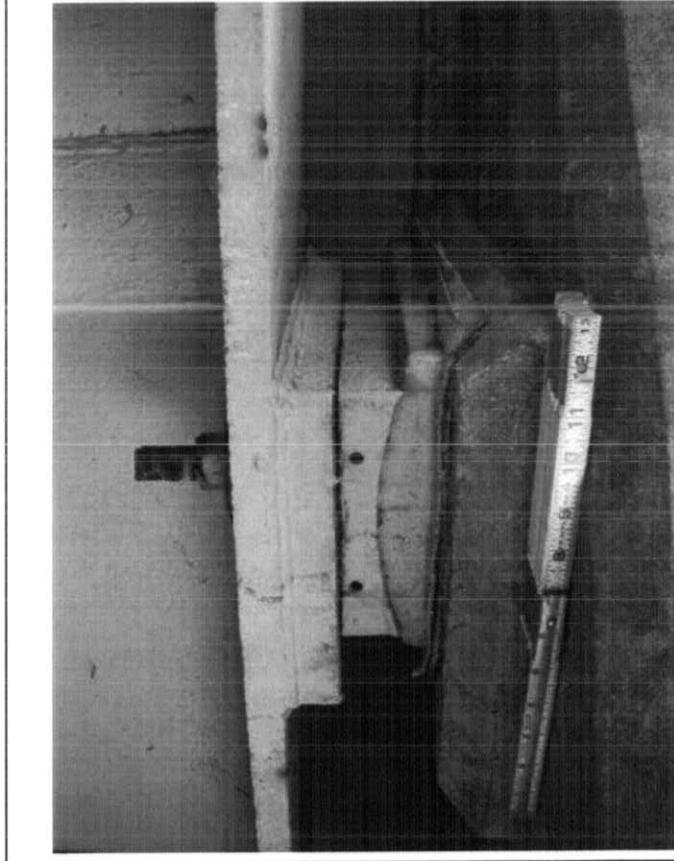
Photo # 29  
1/31/2012  
Girder 6, South Abutment, expansion sliding bearing, looking west - bearing in expansion position at 50°F with between 5/16-inch and 1 11/16-inch difference in measurements as compared to previous measurements taken at 87°F.

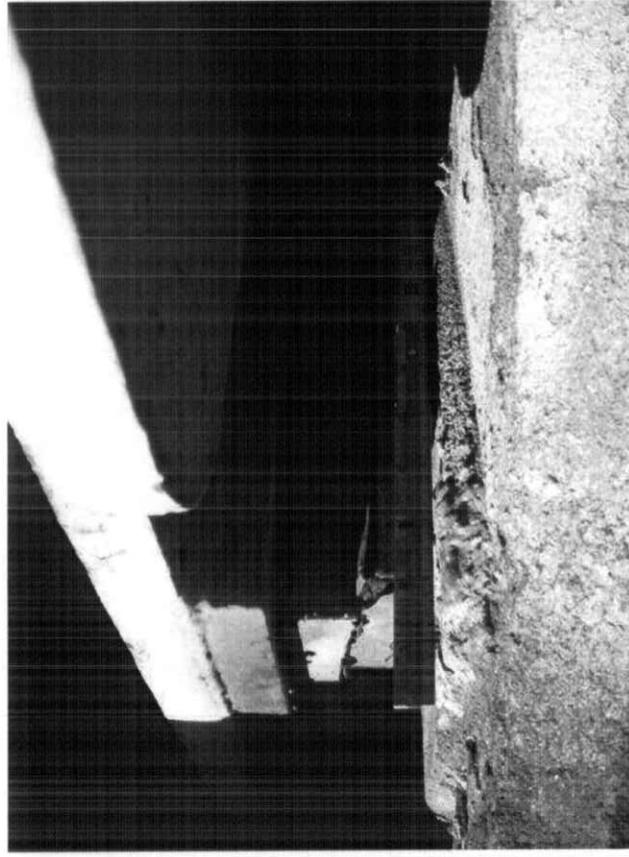
Photo # 30  
1/31/2012  
Girder 7, South Abutment, expansion sliding bearing, looking southwest - moderate rust on the bearing plates, 5/16-inch misalignment to the east of the sliding plate in relation to masonry plate and east anchor bolt sheared off.

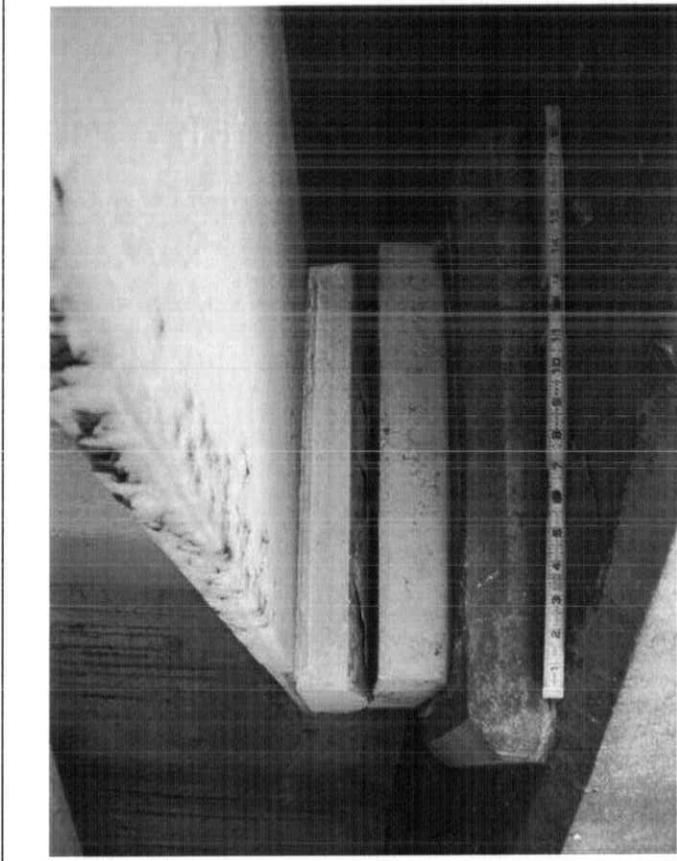
Photo # 31  
 1/31/2012  
 Girder 4, North Abutment, fixed bearing, looking northwest - 1/8-inch pack rust between the sole and masonry plates, and 1/2-inch misalignment to the west of the sole plate in relation to the masonry plate.

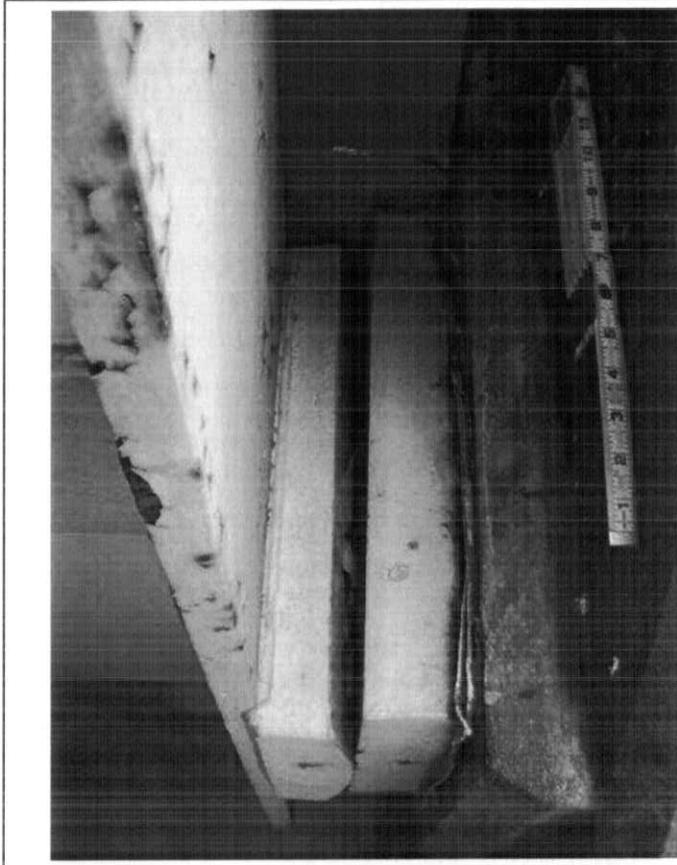
Photo # 32  
 1/31/2012  
 Girder 5, North Abutment, fixed bearing, looking northwest - 1/8-inch pack rust between the sole and masonry plates, and 1/2-inch misalignment to the west of the sole plate in relation to the masonry plate.

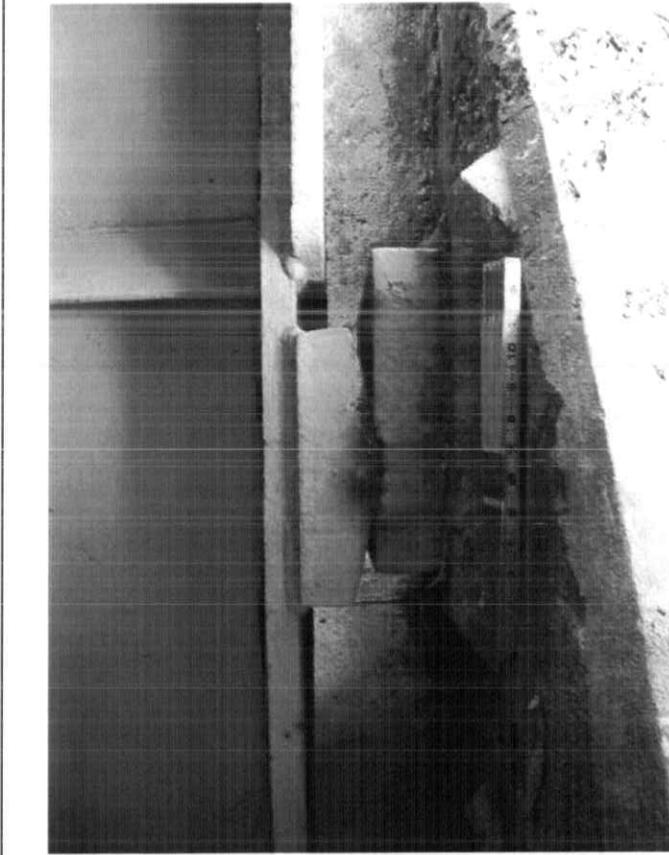
Photo # 33  
 1/31/2012  
 Girder 7, North Abutment, fixed bearing, looking east - 1/8-inch pack rust between sole and masonry plates and misalignment of 2.5-inch to north and 1/2-inch to east of sole plate in relation masonry plate. *(no change)*

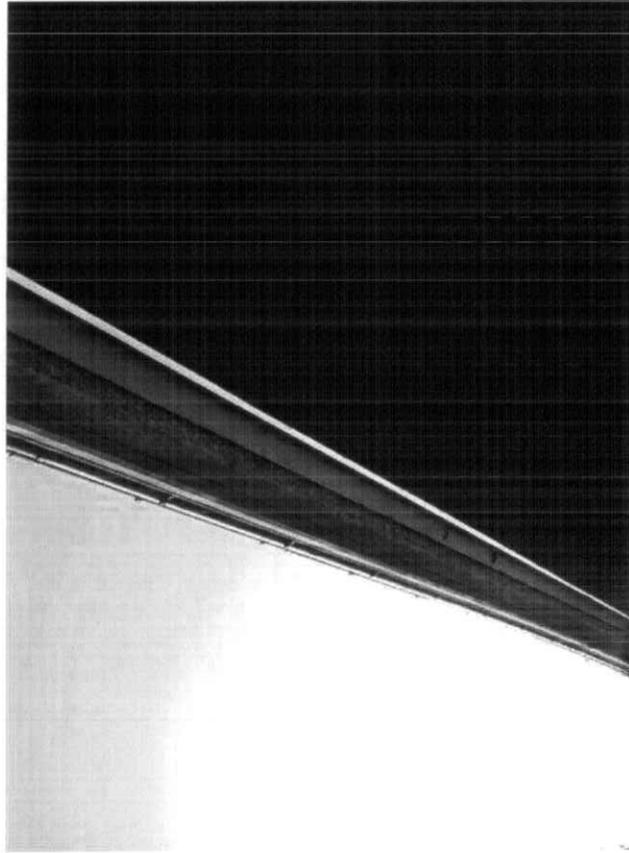
Photo # 34  
 1/31/2012  
 Girder 7, bottom flange, over right travel lane, looking southwest - 8-foot long area of minor collision scrapes up to 18" L x 1/8" D.

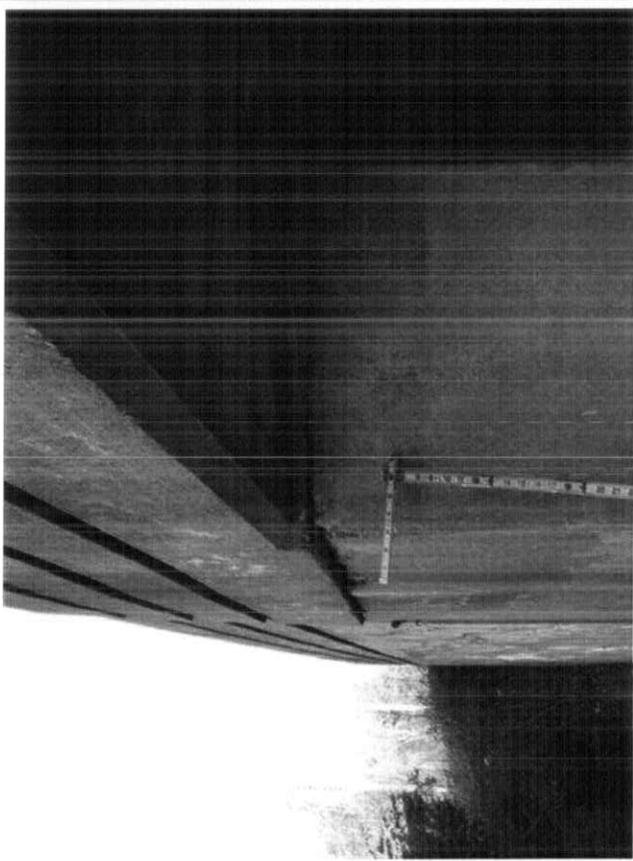
<p>Photo # 35</p> <p>1/31/2012</p> <p>Superstructure, West Fascia, North Abutment, looking north - superstructure laterally misaligned 1-inch to the west in relation to the wingwall.</p>

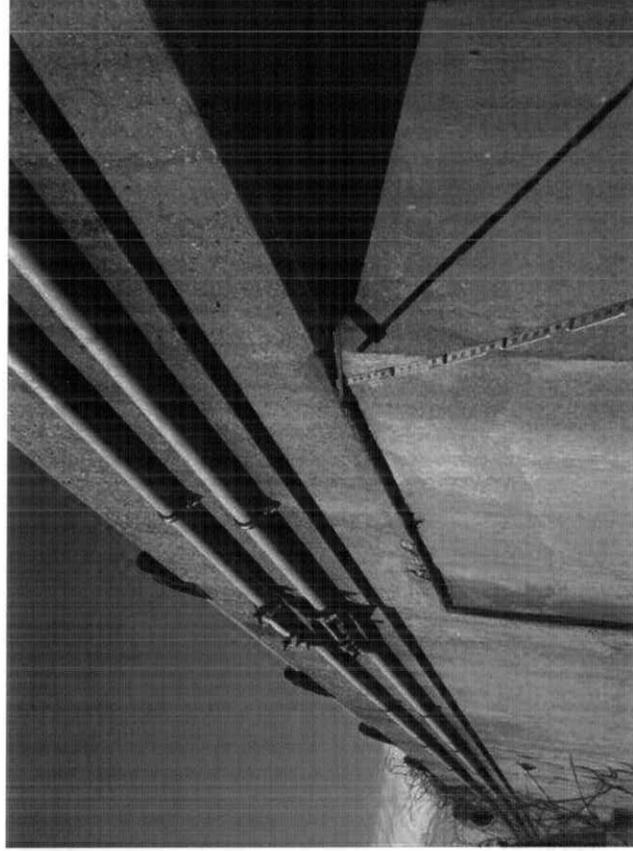
<p>Photo # 36</p> <p>1/31/2012</p> <p>Superstructure, East Fascia, South Abutment, looking southwest - superstructure laterally misaligned 1-inch to the east in relation to the wingwall.</p>

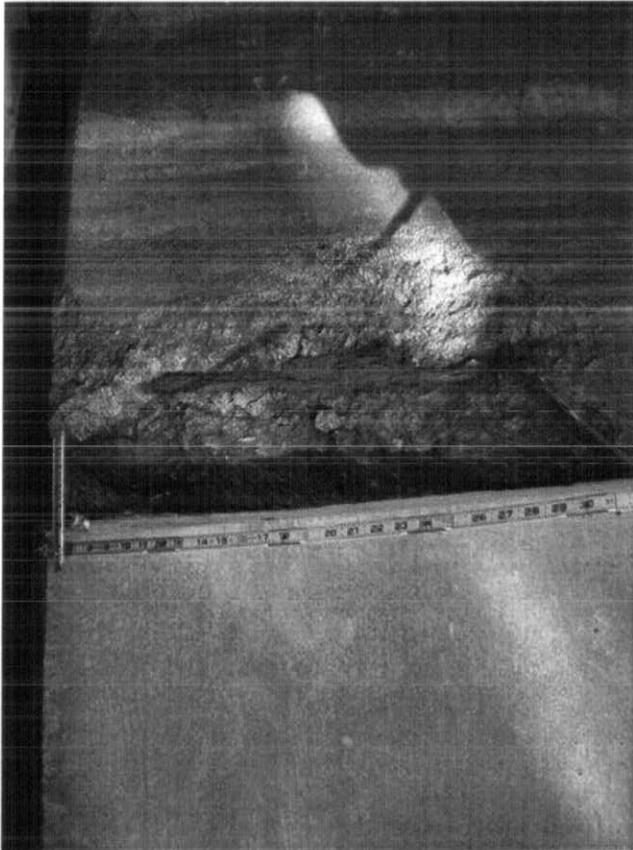
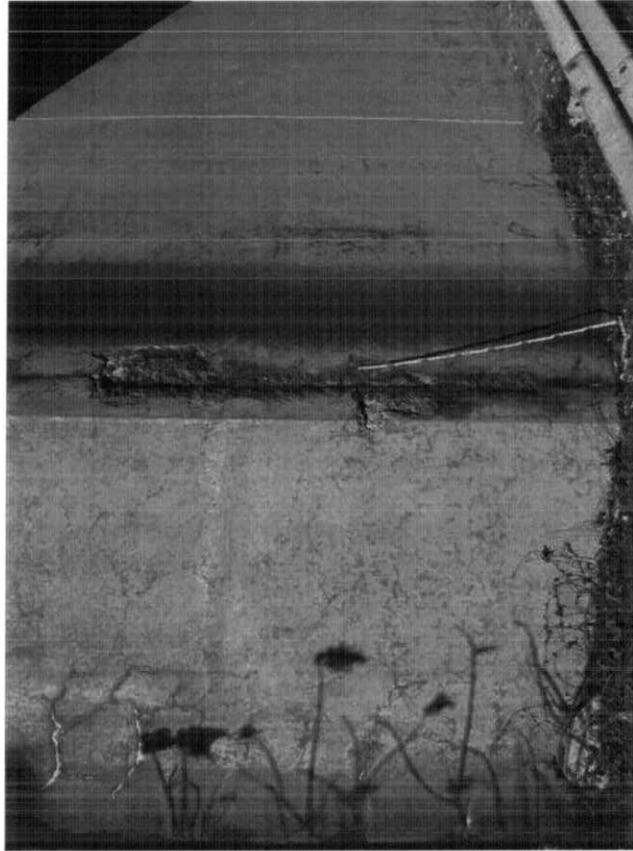
<p>Photo # 39</p> <p>1/31/2012</p> <p>South Abutment, top of stem, between Girders 4 and 5, along expansion joint, looking southwest - 34" H x 15" W x 6" D spall with corroded steel reinforcement.</p>	<p>Photo # 40</p> <p>1/31/2012</p> <p>South Abutment, east side of the stem, looking southwest - 9'-4" H x 16" W delamination with 12" H x 6" W x 1 1/4" D spall and 7'-7" H x 15" W x 1 1/4" D spall with exposed steel reinforcement (Up to 10% section loss on exposed steel reinforcement).</p>

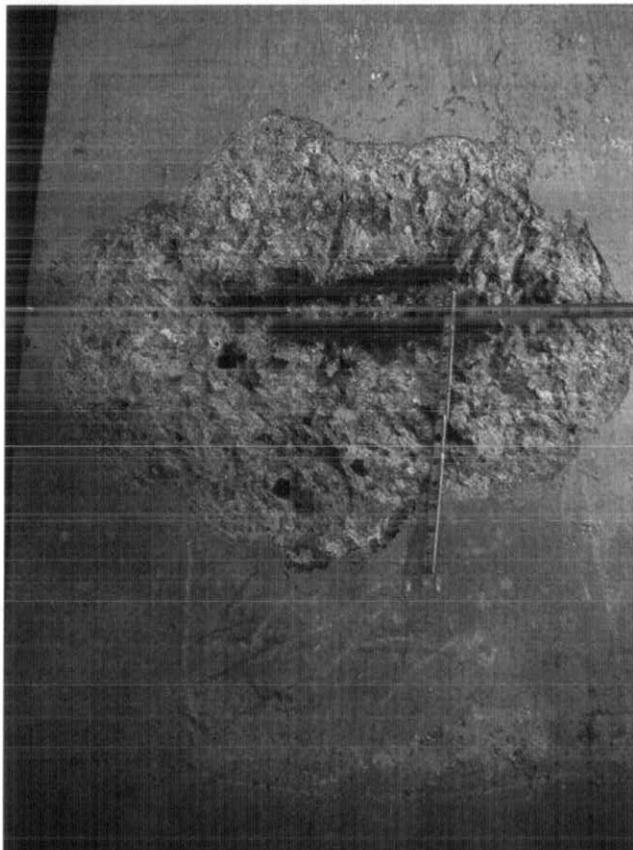
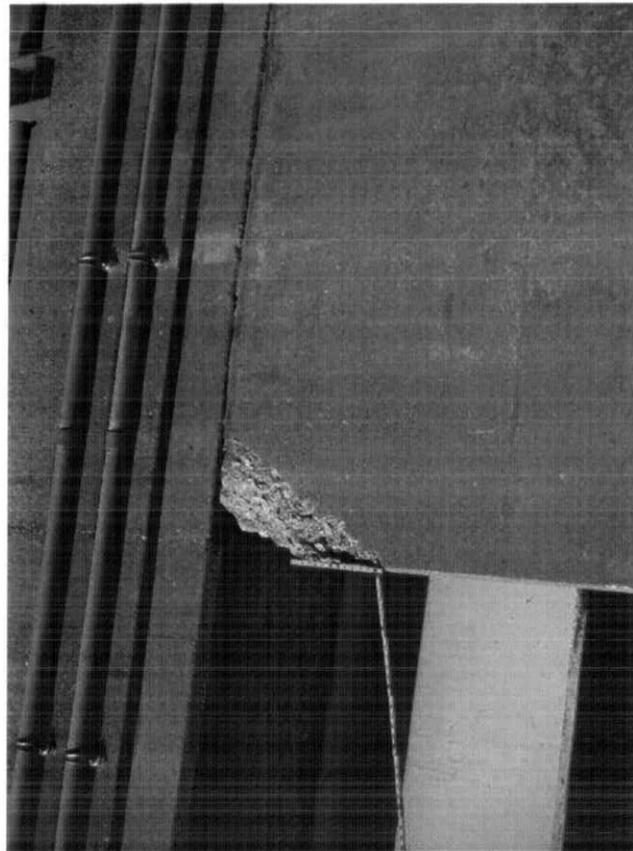
<p>Photo # 41</p> <p>1/31/2012</p> <p>North Abutment, top of stem, below Girder 6, looking north - 27" H x 20" W x 3" D spall with corroded steel reinforcement and adjacent 24" H x 12" W delamination.</p>	<p>Photo # 42</p> <p>1/31/2012</p> <p>North Abutment, upper corner of east cheekwall, looking west - 24" H x 12" W x 3" D spall.</p>

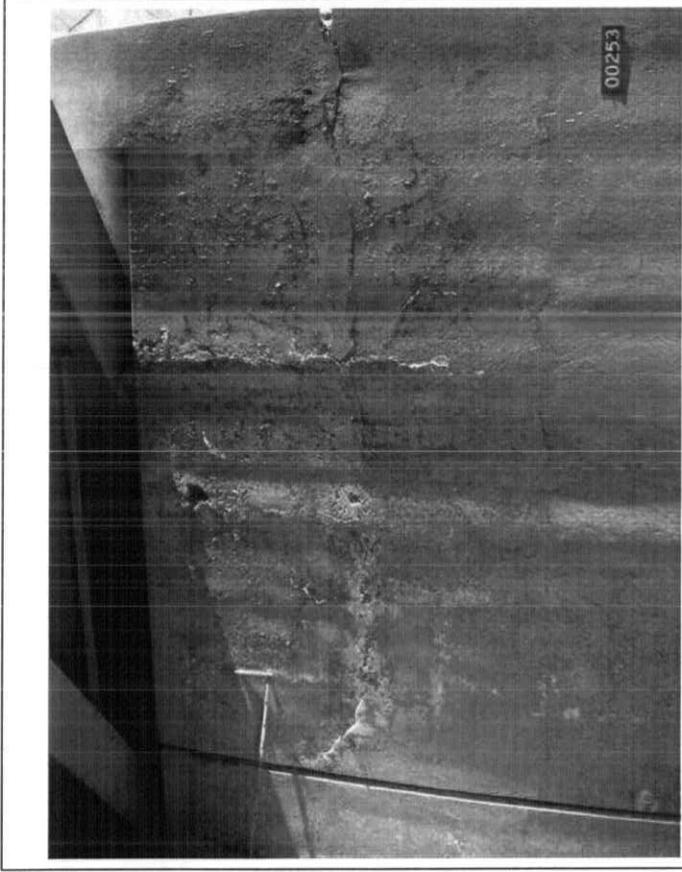
Photo # 43  
 1/31/2012  
 North Abutment, east end, top of stem, looking north - 120-square feet of map cracking open up to 1/8-inch wide with efflorescence and rust staining, scaling up to 1/2-inch deep, a 27" W x 14" H delamination, a 13" L x 3" W x 4" D spall, and a 10" H x 7" W delamination/spall.

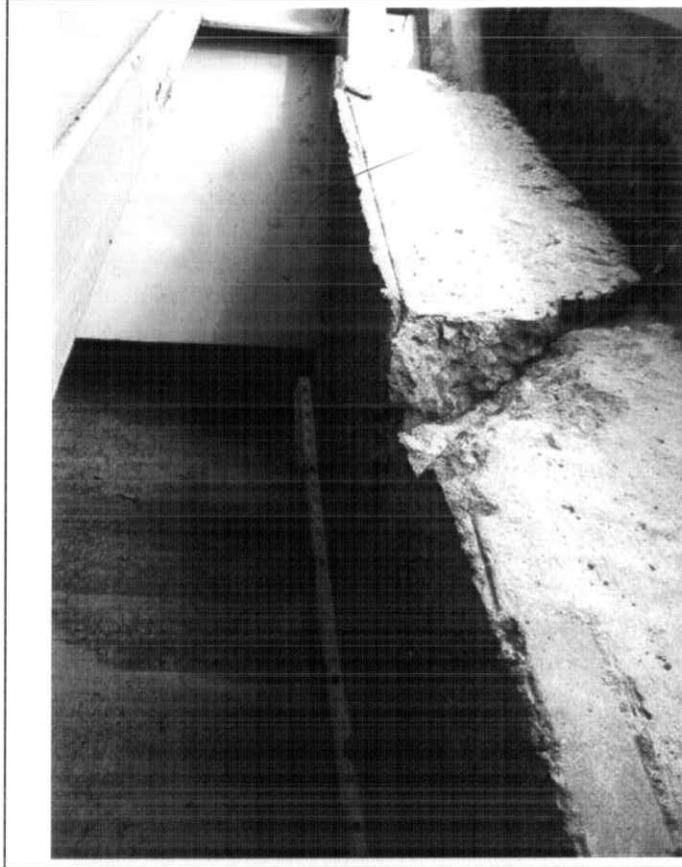
Photo # 44  
 1/31/2012  
 South Abutment, keeper block between Girders 5 and 6, looking southwest - full height x full width fracture in keeper block up to 1-inch wide with 8" L x 10" H x 3" D spall in front face of keeper block.

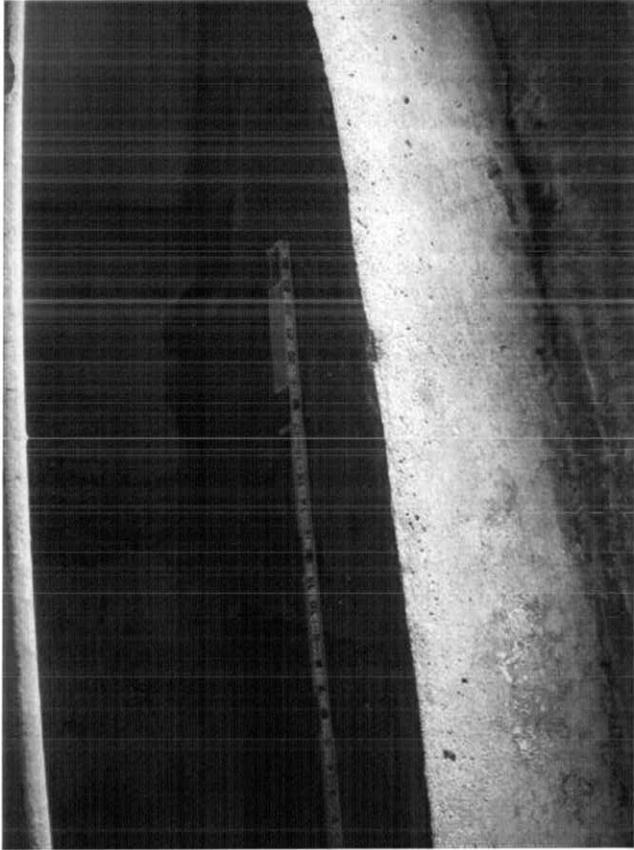
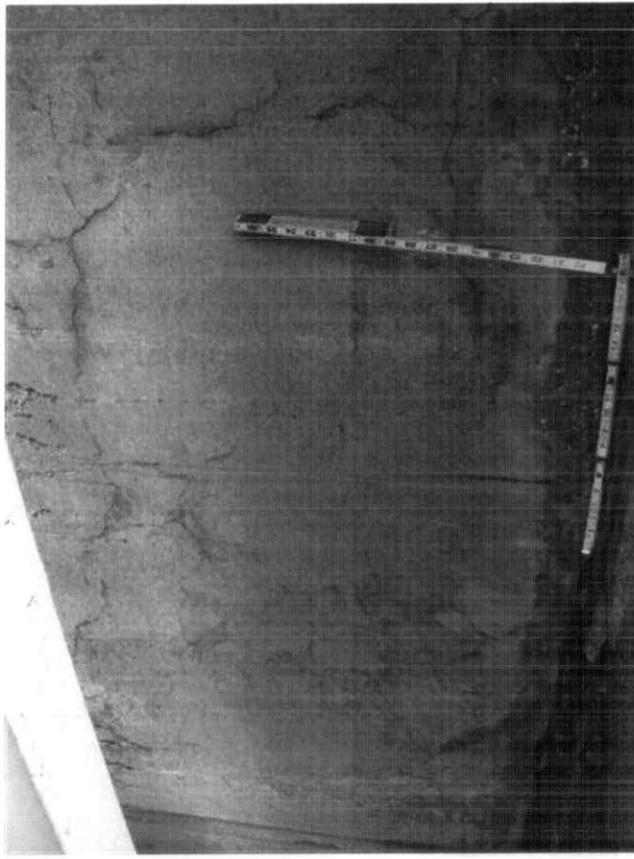
<p>Photo # 45 1/31/2012 North Abutment, keeper block between Girders 5 and 6, looking north - full height x full width fracture in keeper block up to 7/8-inch wide with 1/2-inch vertical misalignment.</p>	<p>Photo # 46 1/31/2012 North Abutment backwall, between Girders 6 and 7, looking north - 30 square feet area of hairline map cracking with efflorescence.</p>

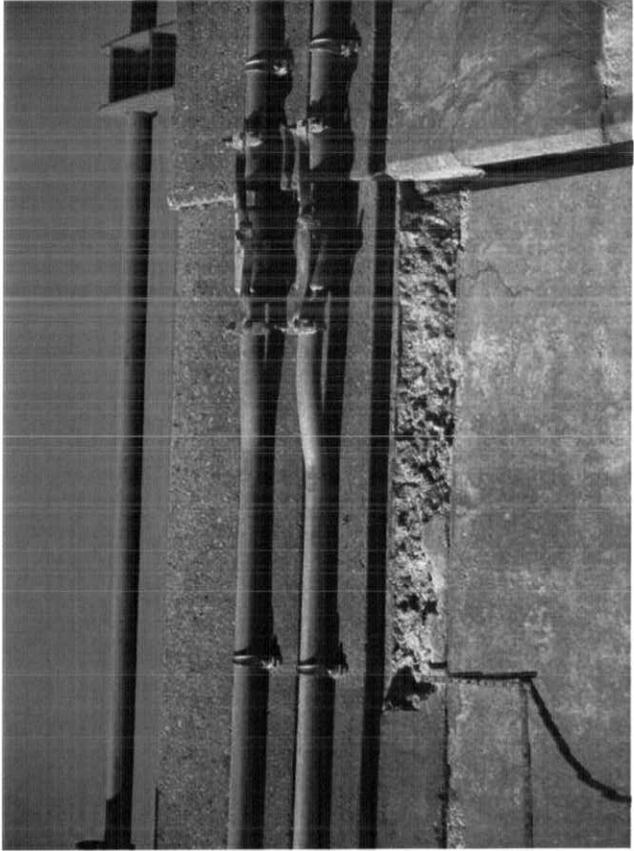
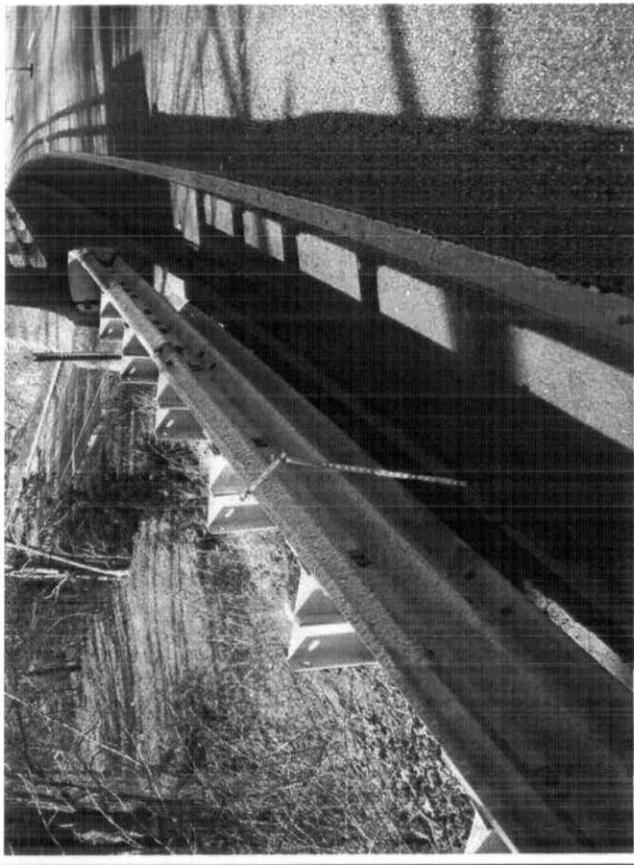
<p>Photo # 51 1/31/2012 Northeast Wingwall, near the North Abutment and adjacent to the East Parapet, looking west - 50" L X 9 1/2" H x 5" D spall with exposed steel reinforcement.</p>	<p>Photo # 52 1/31/2012 Northeast Guide rail Transition (leading edge), looking south - Does not comply with RB 350 safety standards.</p>

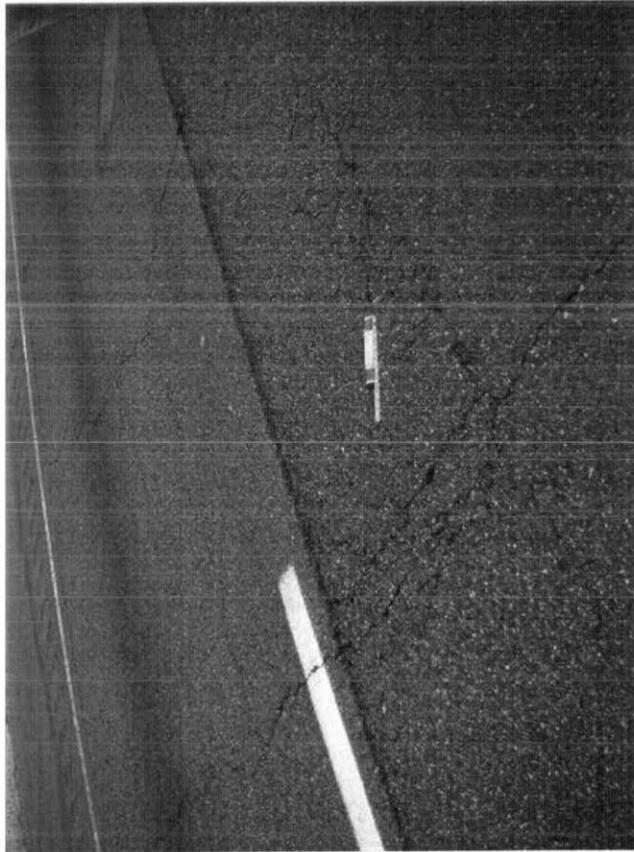
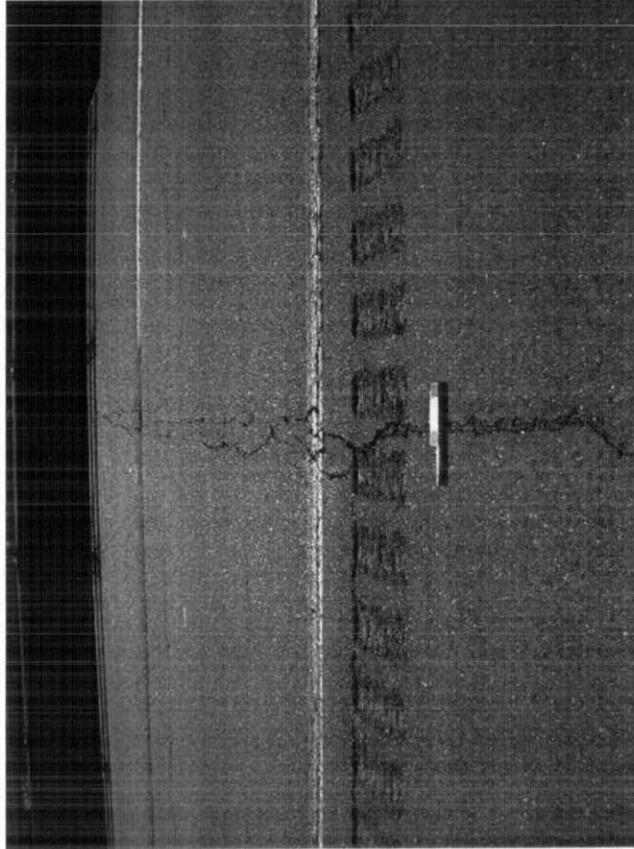
<p>Photo # 53</p> <p>1/31/2012</p> <p>South Approach, bituminous pavement, left travel lane, 5-feet from bridge, looking west - Minor wear / raveling, map cracking open up to 1/4-inch wide, and paving seams open up to 1/2-inch wide.</p>	<p>Photo # 54</p> <p>1/31/2012</p> <p>South Approach, bituminous pavement, 20-feet from bridge, looking east - Full Width x 1/2\" W transverse crack.</p>
