# STRUCTURE NO. 00253

I-95 SOUTHBOUND  
over  
I-395 NORTHBOUND  
EAST LYME

*Routine & Special Inspection*

**BRIDGE SAFETY INSPECTION**  
**STATE PROJECT NO. 170-3013**

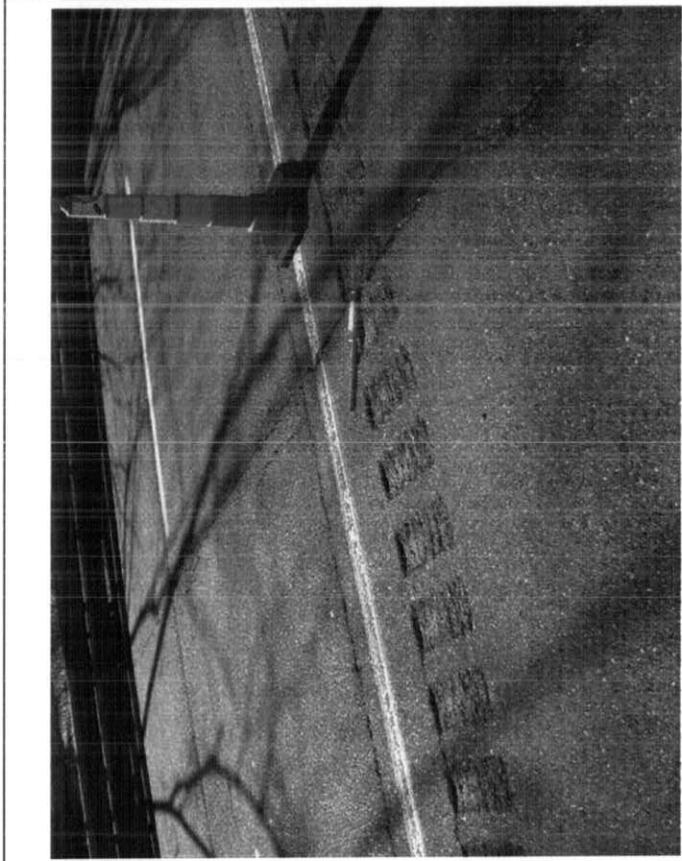
Photo # 55

North Approach, bituminous pavement, 30-feet north of bridge, looking southeast - paving seam open to 1/2-inch wide and full width x 1-inch wide transverse crack.

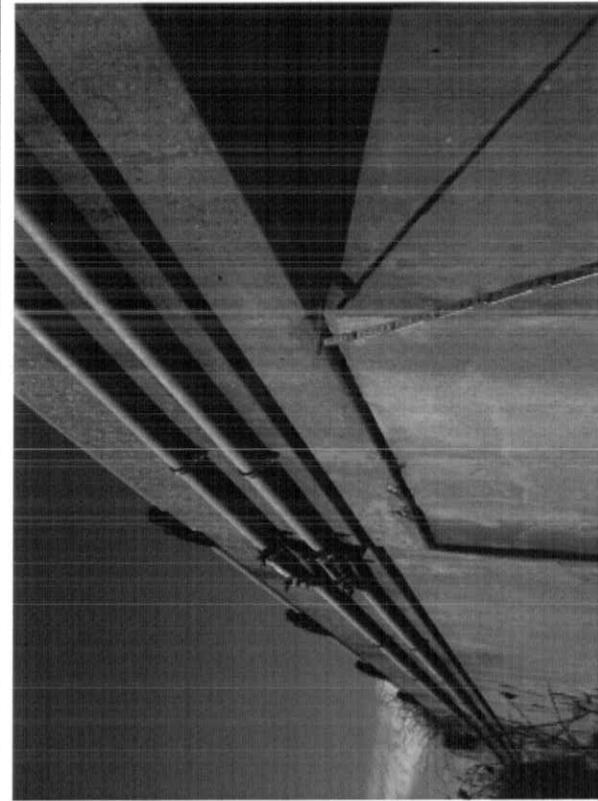
**Photo # 1: South Abutment, east end of abutment, looking southwest - Lateral movement of superstructure to the east up to 1-inch relative to the Southeast Wingwall and the cheekwall.**

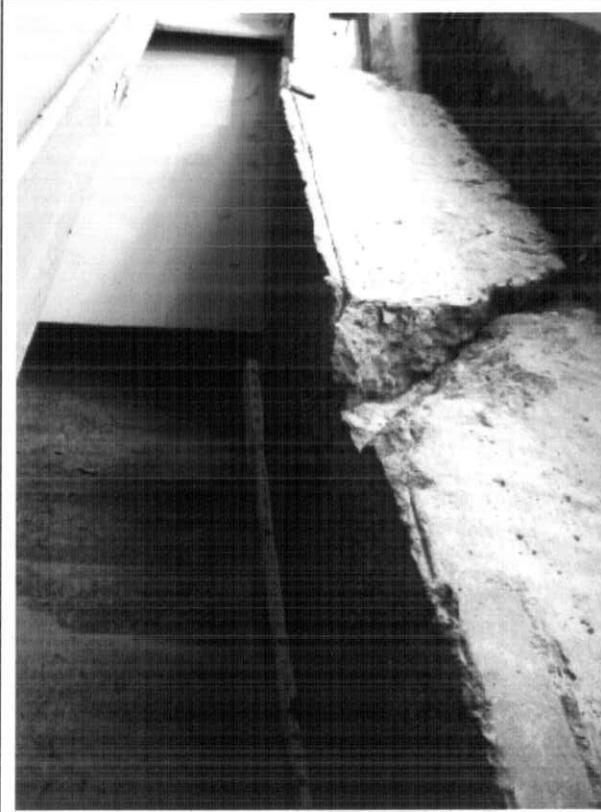
**Photo # 2: South Abutment, keeper block between Girders 5 and 6, looking southwest - Full height x full width fracture in keeper block up to 1-inch wide with a spall on the front face of the keeper block measuring 8" L x 10" H x 3" D.**

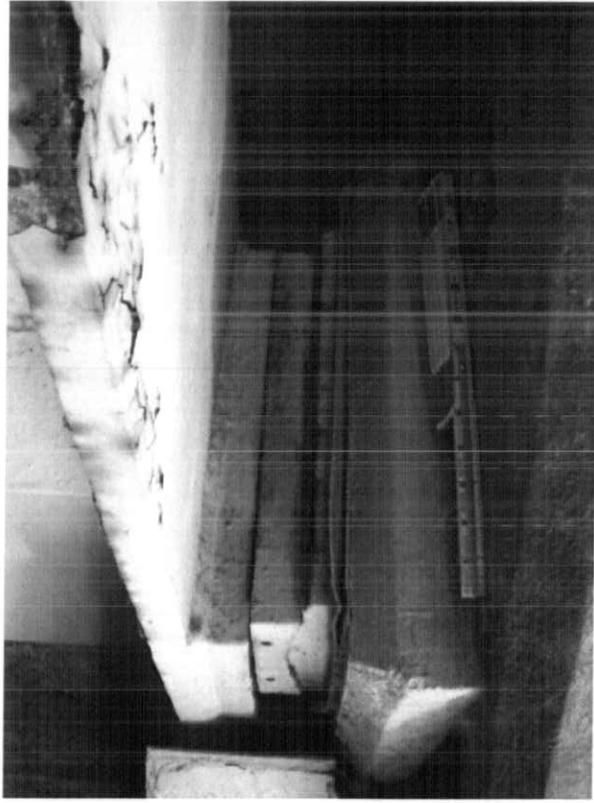
Photo # 3: Girder 5 Expansion Bearing, South Abutment, looking south – 11/16-inch misalignment to the east of the sliding plate compared to the masonry plate (note: anchor bolt sheared off).

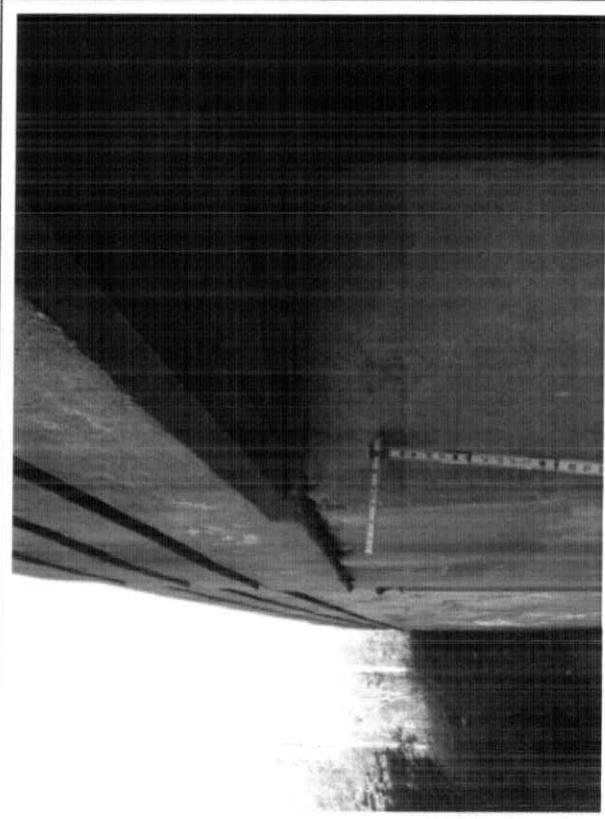
Photo # 4: North Abutment, west end of abutment, looking north – Lateral movement of superstructure to the west up to 1-inch relative to the Northwest Wingwall and the cheekwall.

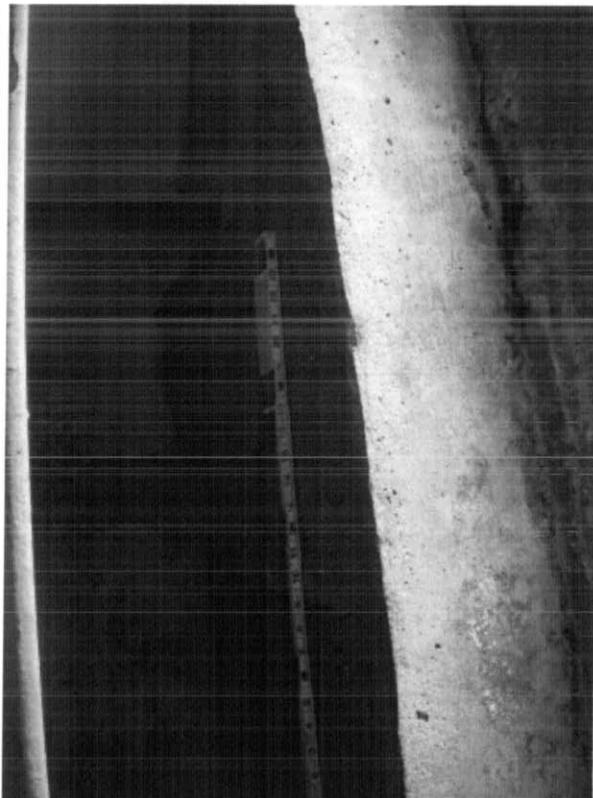
<p><b>Photo # 5: North Abutment, keeper block between Girders 5 and 6, looking northeast – 24" L x 22" W x 9" H fractured section of keeper block with a full width crack up to 1/2-inch wide and up to 1/2-inch of vertical misalignment in the top face of the keeper block along the crack.</b></p>
