# STRUCTURE NO. 01748

MAYFLOWER STREET

INTERSTATE-84

*Indepth & Special Inspection*

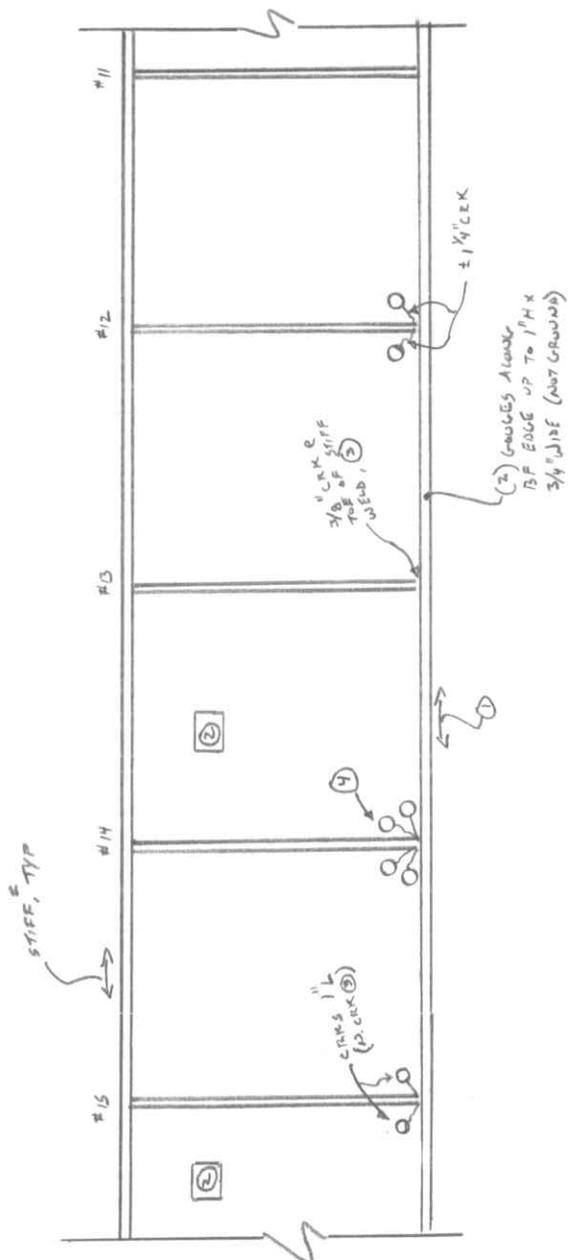
DESCRIPTION: SP #1, G1 IMP DAM / CRNS

Girder damage/cracks due to collision damage:  
 Span 1, girder 1 has numerous cracks at the base of the web between stiffeners 11 & 16 due to previous impact damage. Cracks in the web have stop holes drilled in this area, and no cracks propagate past the stop holes. One new crack was noted at web adjacent to the north side of stiffener 15 this inspection (stop hole previously in place) and the crack at the base of stiffener 14 weld has grown from 1" to 1-3/8" since the last inspection. Also, a new 3/8" crack was noted along the toe of the weld at the base of stiffener 13. New this inspection, the base of the span 1 girder web has a 5-1/8" long horizontal crack (no stop holes) just above the bottom flange fillet weld at the third intermediate diaphragm from the south abutment due to the diaphragm punching through the web. A 2.5" long diagonal crack in the web plate extends from this crack at the north side of the stiffener.

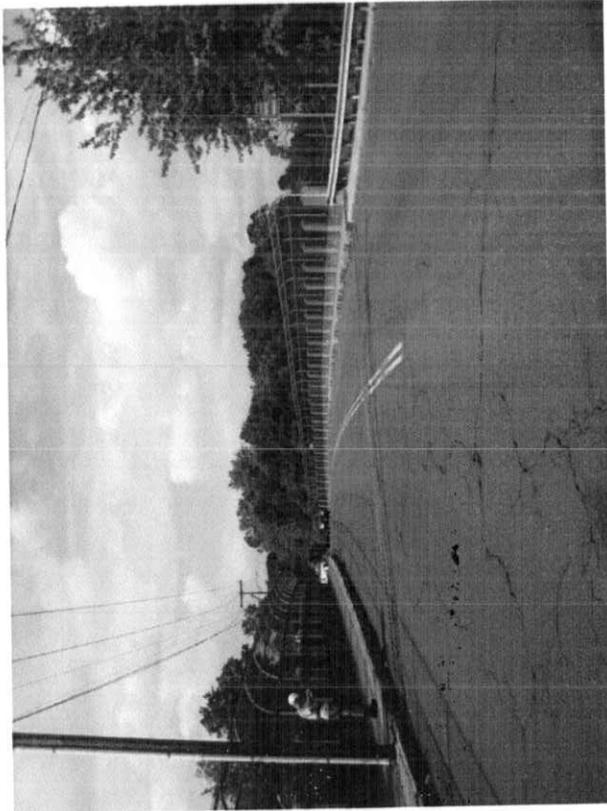
**Photo #5 :**  
 Bridge from the south approach.  
 Note the cracking in the approach pavement.

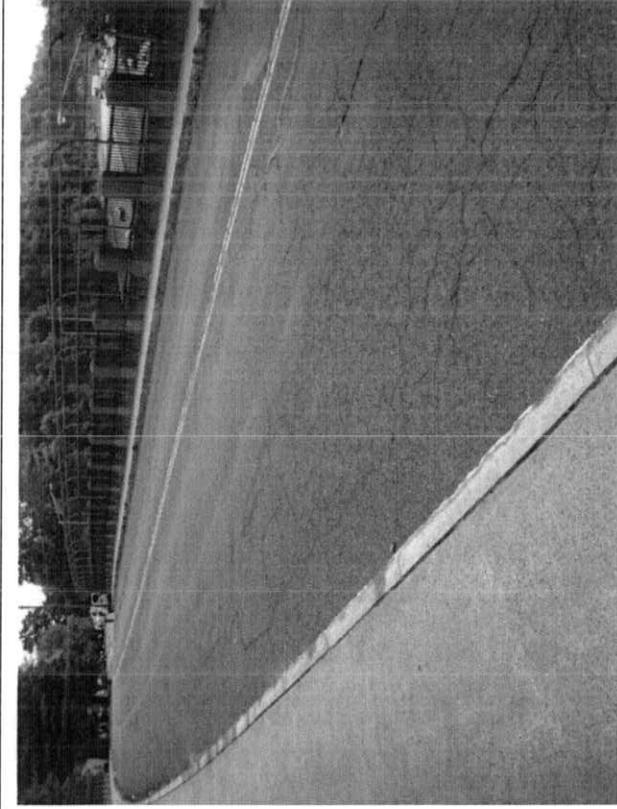
**Photo #9 :**  
 Typical top of deck.  
 Note the heavy cracking in the bridge overlay.

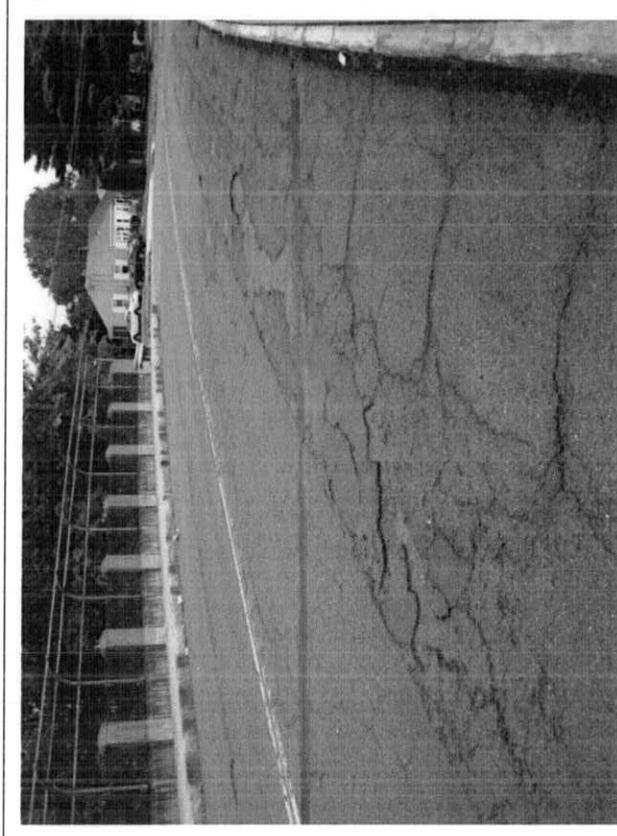
**Photo #10 :**  
 Deteriorated bridge overlay near the shiplap joint in span 1.

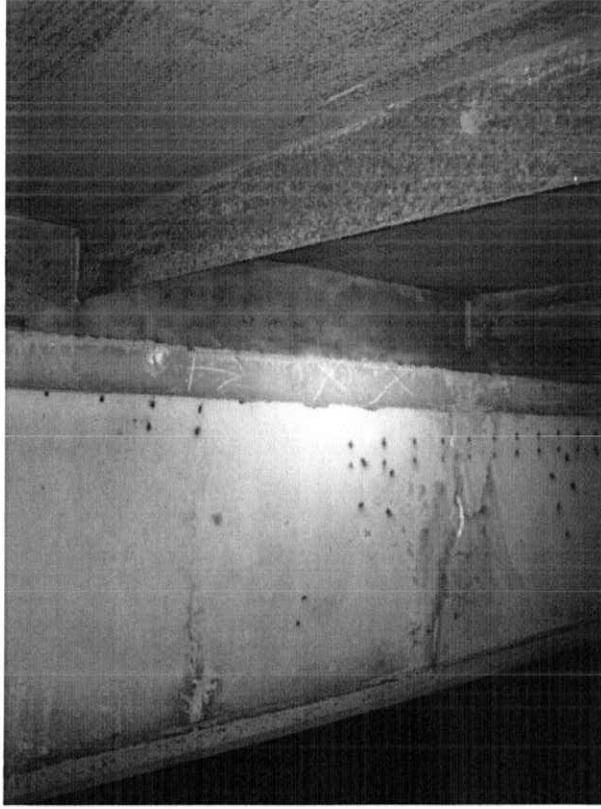
**Photo #11 :**  
Span 1, girder 7: Dull haunch over left and center lanes.

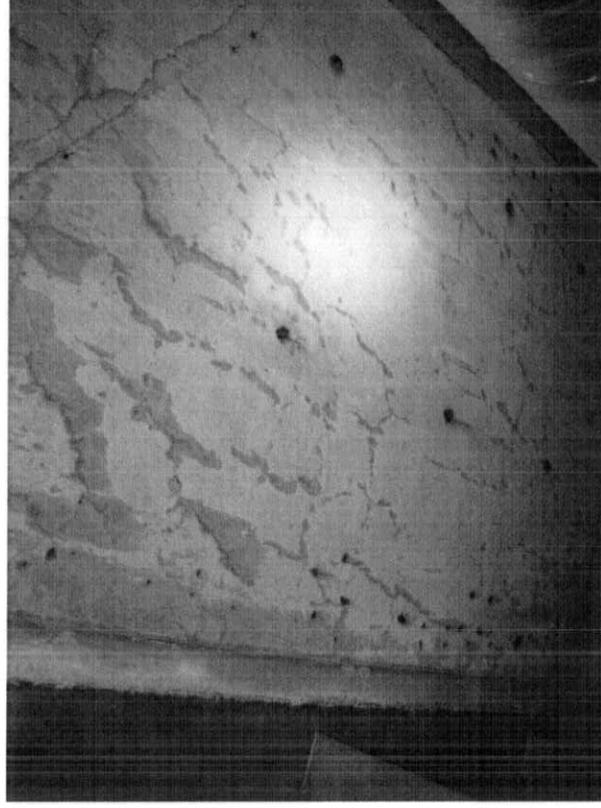
**Photo #12 :**  
Span 2, bay 5: Map cracking with dampness.

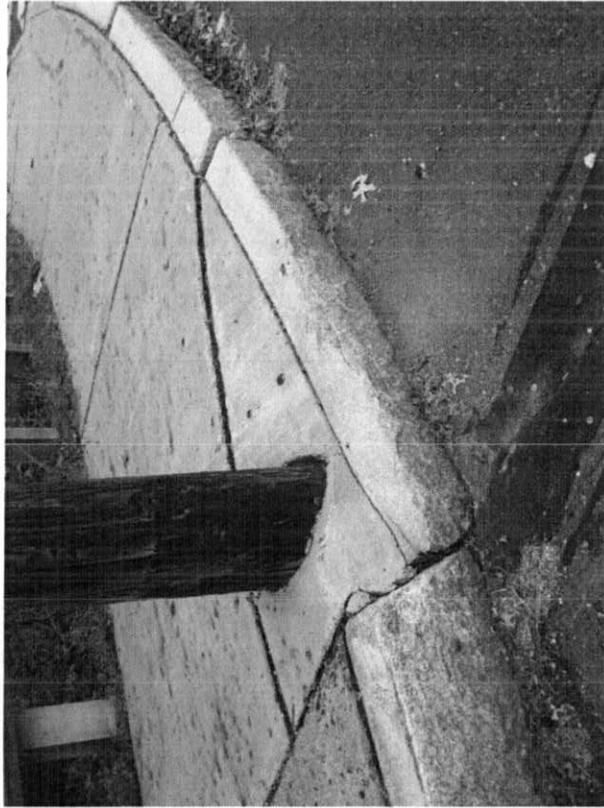
**Photo #13 :**  
Northwest approach. New approach sidewalk. Also note the approach curb settlement.

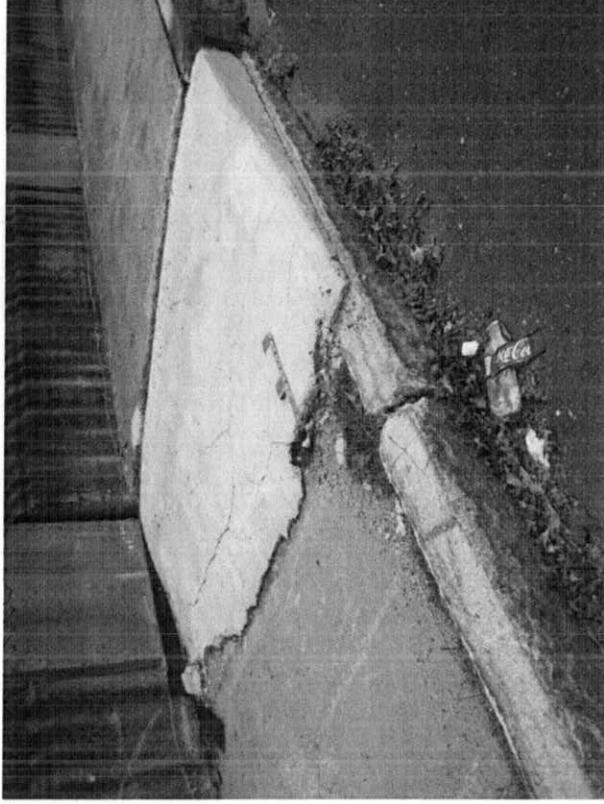
**Photo #14 :**  
Spalling of the concrete transition ramp at the northeast approach sidewalk.

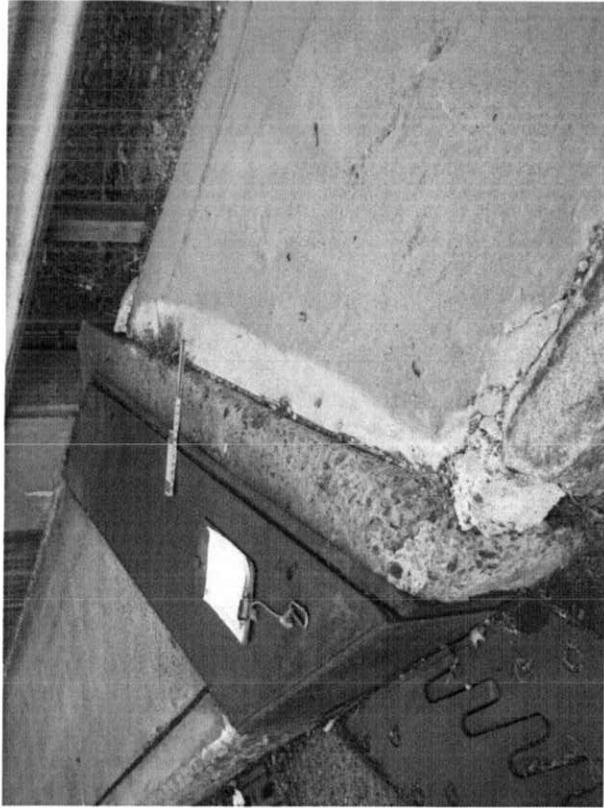
**Photo #15 :**  
 Concrete transition ramp is missing at the southeast approach sidewalk. Also note the spalling of the sidewalk joint header.  
*BMM ISSUED THIS INSPECTION 10/13/12*

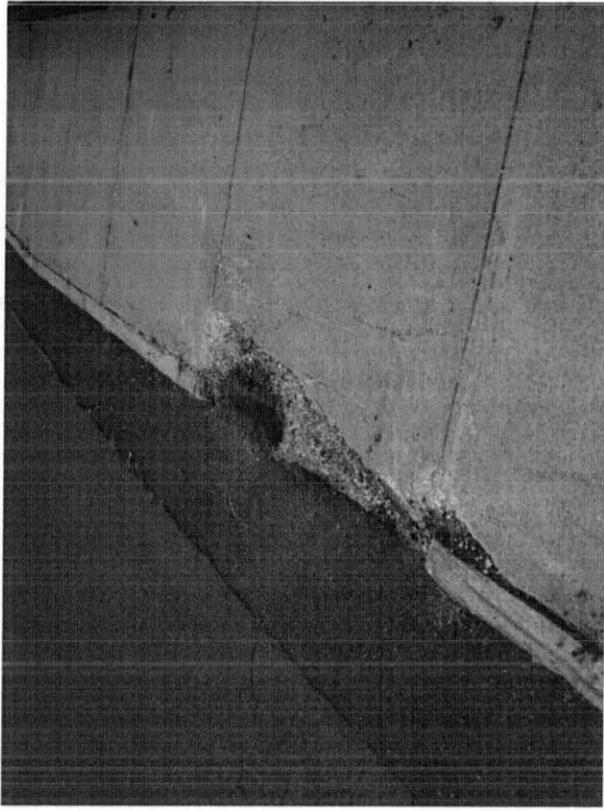
**Photo #16 :**  
 Southwest approach sidewalk with up to 4" deep scaling.

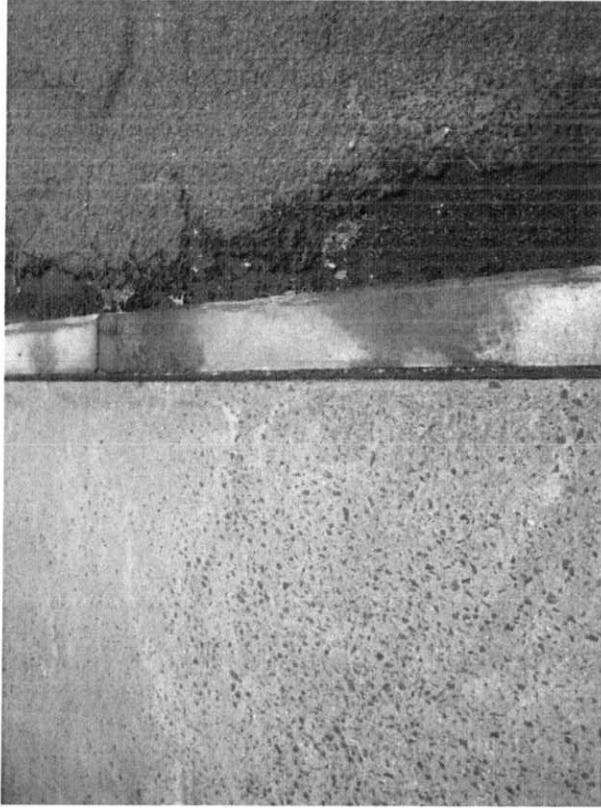
**Photo #17 :**  
 Typical deteriorated sealant between the curbs and sidewalks. Also note the raveling of the bridge overlay near the curb.

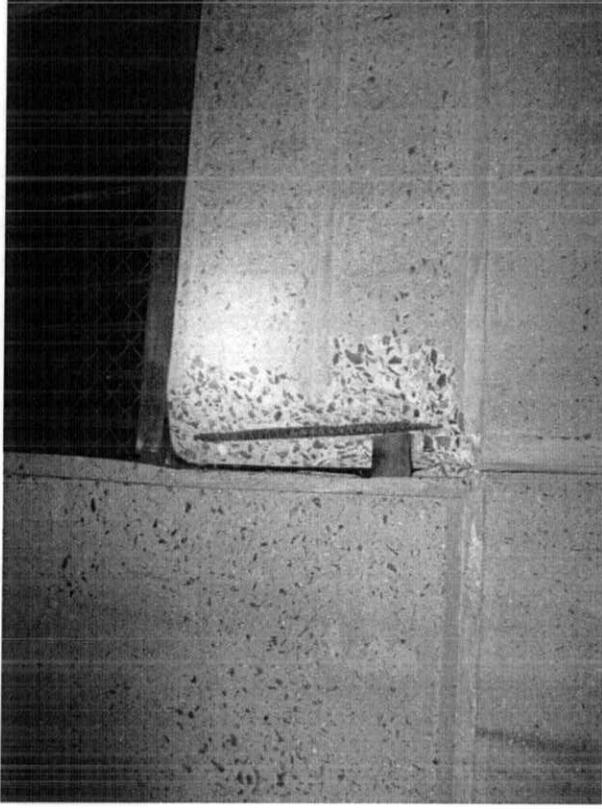
**Photo #18 :**  
 Span 1, east parapet: Spall with exposed rebar in the outside face of the parapet at the shiplap joint.

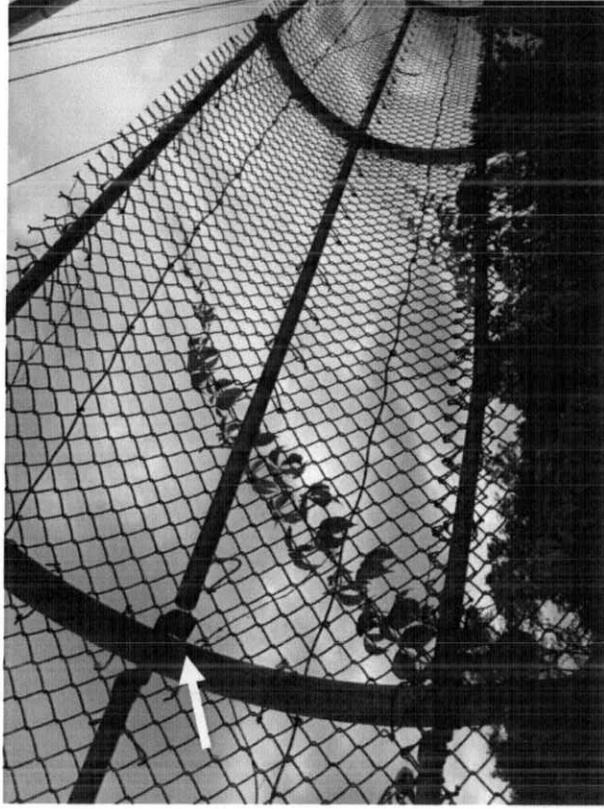
**Photo #20 :**  
Southwest approach: Disconnected horizontal fence rail.

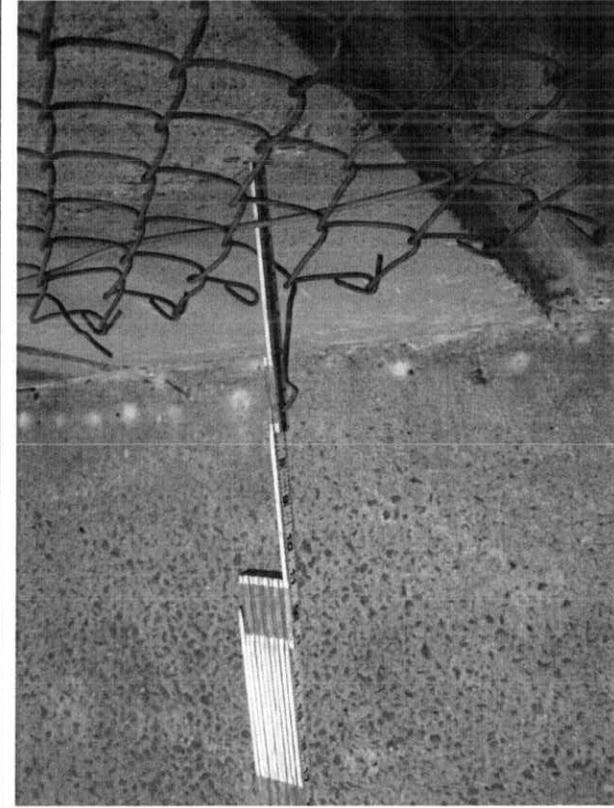
**Photo #21 :**  
Span 2: Bottom of the east fence is bent and protrudes into the sidewalk area.

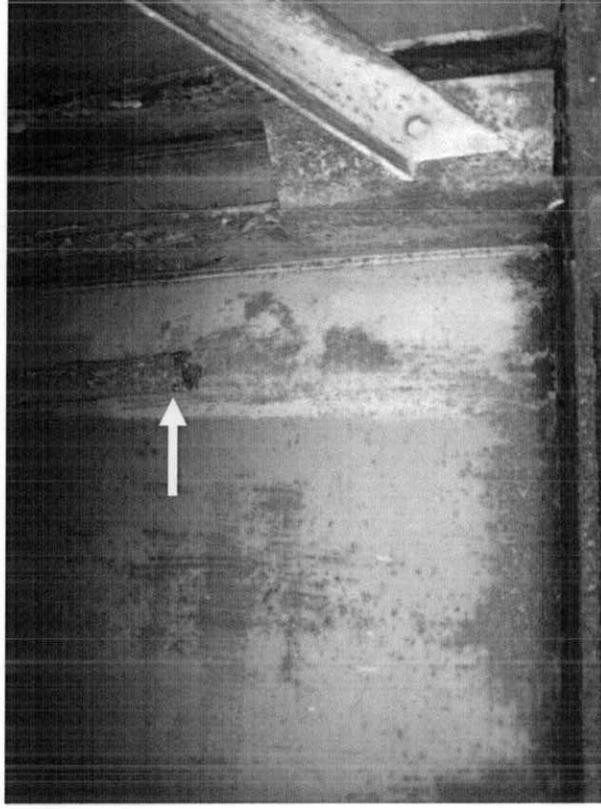
7. Scuppers are up to 60% clogged, but pipes are clear. The steel weep pipe in span 1, bay 5 near the south abutment is rusted out and split near its bottom and may drain onto girder 6. Clean scuppers (2 each) and repair the weep.

**Photo #22 :**  
Span 1, bay 5: Steel weep near the south abutment is rusted out and split near the bottom and may drain onto girder 6.

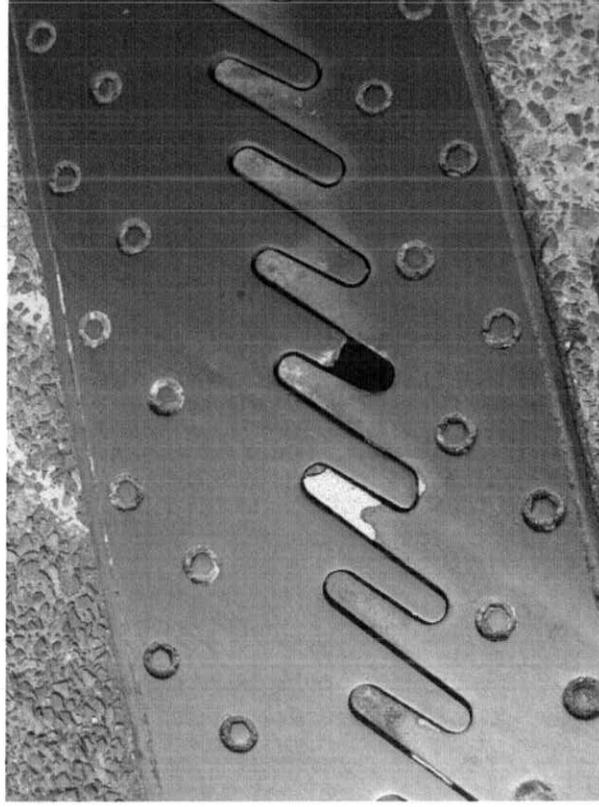
**Photo #24 :**  
Broken tooth in the south abutment finger joint. Note that the joint is almost closed at 80 degrees Fahrenheit.

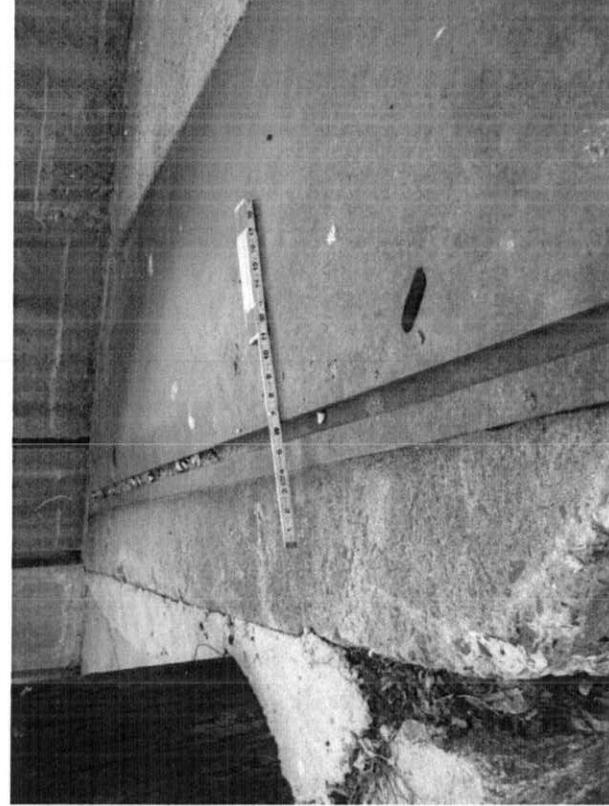
**Photo #25 :**  
South abutment joint: Joint plate at the west sidewalk is up to 3/4" higher than the sidewalk header.

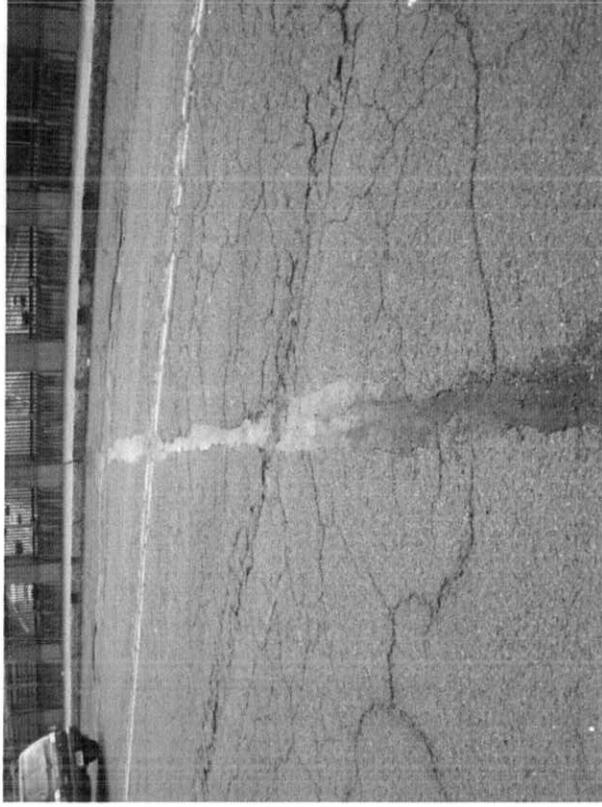
**Photo #26 :**  
Pourable sealant joint at the shiplap joint, span 1. Also note the deteriorated overlay.

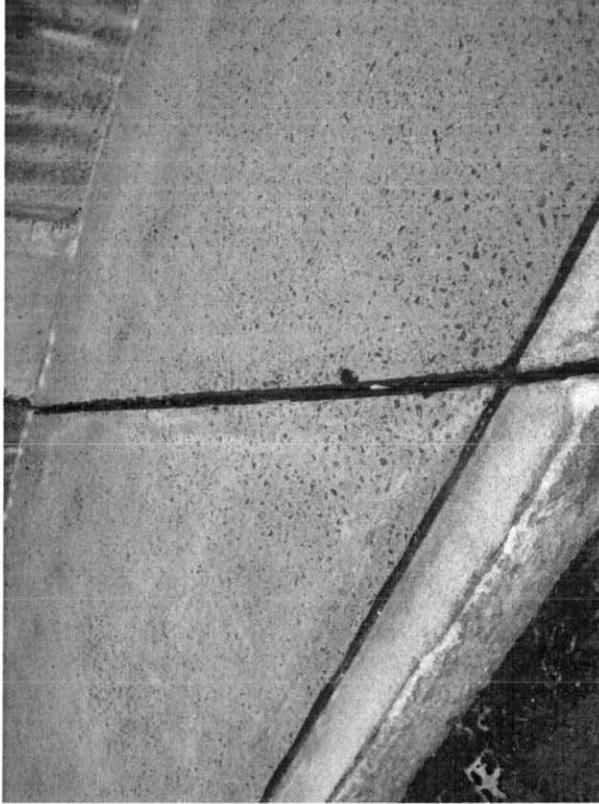
**Photo #27 :**  
Shiplap joint, east sidewalk: Missing sealant along the sidewalk joint.

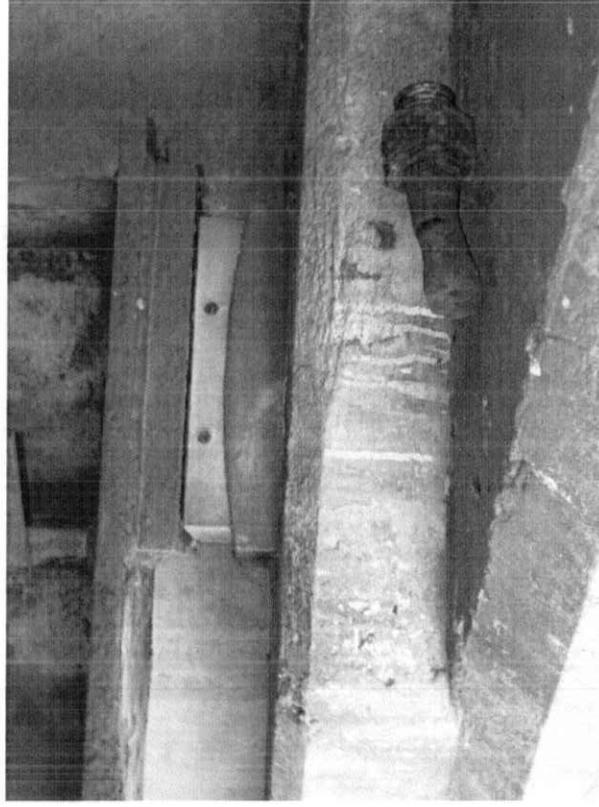
Sliding bearings:  
 Sliding bearings at the abutments have up to 3/16" impacted rust/gaps between the plates. There are random tipped anchor bolts, backed off nuts, and impacted rust below the anchor bolt washers. There are random sheared anchor bolts at the south abutment bearings. Anchor bolts are sheared at the north abutment bearings throughout, including both anchor bolts at some locations. Bearings exhibit no visible evidence of movement. Note that there are no previous bearing measurements for comparison. Rating reduced to "4" per CT BIM section 10.2 due to sheared anchor bolts and lack of evidence of movement. See sheets 19 & 20 and photo 28.

**Photo #28 :**  
Span 2, girder 5 bearing at the north abutment: Sheared anchor bolt and up to 3/16" impacted rust between the plates.

1. Sliding bearings at the abutments have up to 3/16" impacted rust/gaps between the plates. There are random tipped anchor bolts and backed off nuts. There are random sheared anchor bolts at the south abutment bearings. Anchor bolts are sheared at the north abutment bearings throughout, including both anchor bolts at some locations. Bearings exhibit no visible evidence of movement. Note that there are no previous bearing measurements for comparison. Clean, paint, and lubricate the sliding bearings (14 each) and consider replacing with elastomeric bearings.

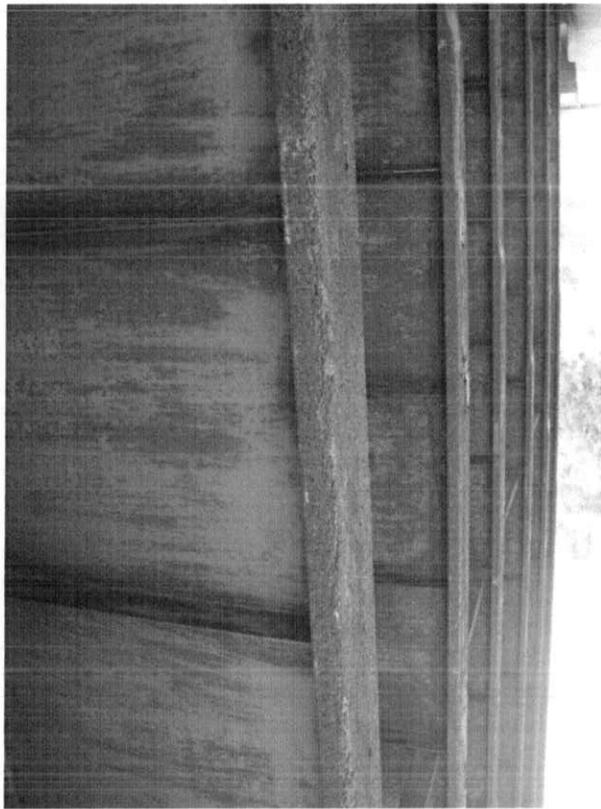
**Photo #30 :**  
Typical heavy to laminated rust with negligible losses along the bottom flanges.

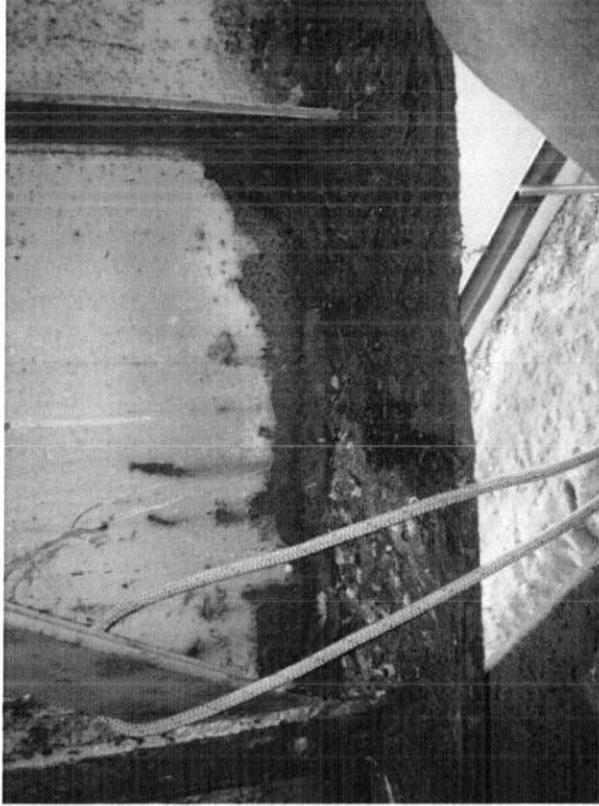
**Photo #31 :**  
Span 1, girder 6 near the south abutment: Laminated rust with section loss along the bottom flange and web base. Stiffener at the right side of the photo is rusted out at the base.

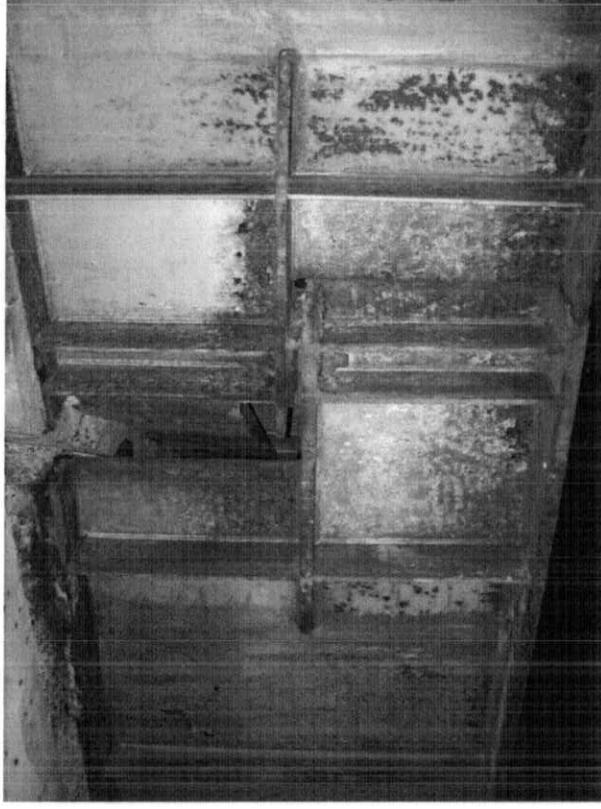
Fixed bearings at the shiplap joint:  
 Bearings have heavy to laminated rust. There is up to 1/2" impacted rust between the sole and masonry plates. Measurements at the shiplap joints were within 1/8" of all previous measurements except at girder 6. At girder 6, the "C" measurement varied by 1/4"; however, a large amount of laminated rust was removed, possibly causing the discrepancy. The girder 6 "D" measurement varied by 3/16", but the 2011 measurement matched a previous measurement that was already written on the girder web. See sheet 21 and photos 32-34.

**Photo #32 :**  
Span 1, girder 1 shiplap joint, typical. Note the spalled girder haunch and heavily rusted fixed bearing.

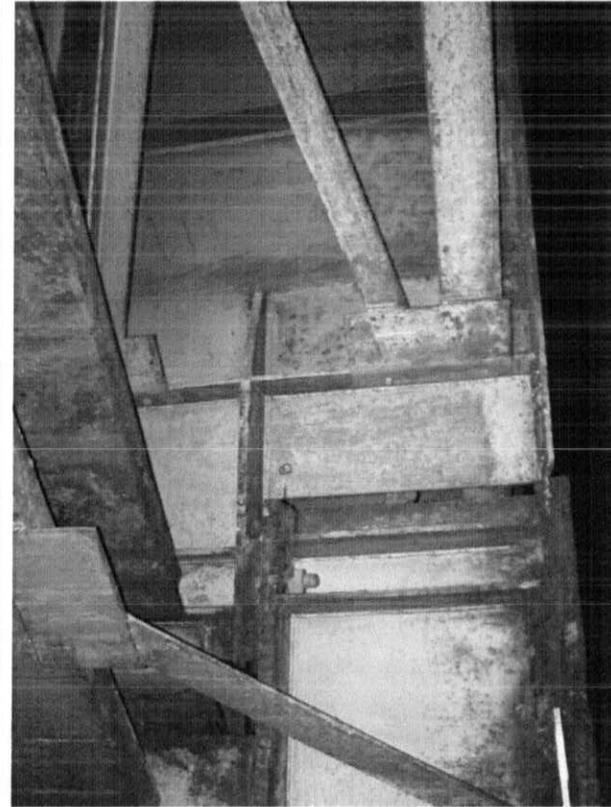
**Photo #33 :**  
Span 1, girder 4 shiplap. Note the laminated rust and section loss at the base of the web and bottom flange. Also note the rusted bearing.

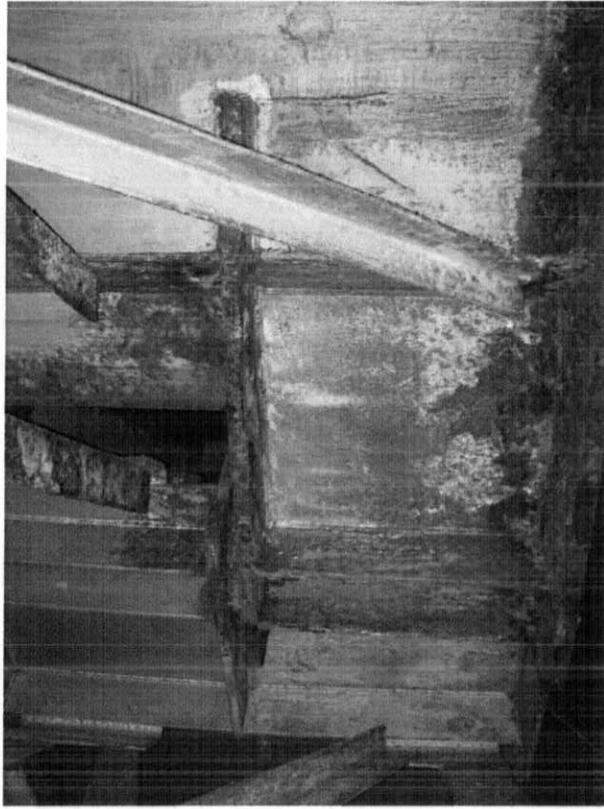
**Photo #34 :**  
Span 1, girder 6 shiplap. Note the laminated rust and section loss at the base of the web and flanges. Also note the rusted bearing.

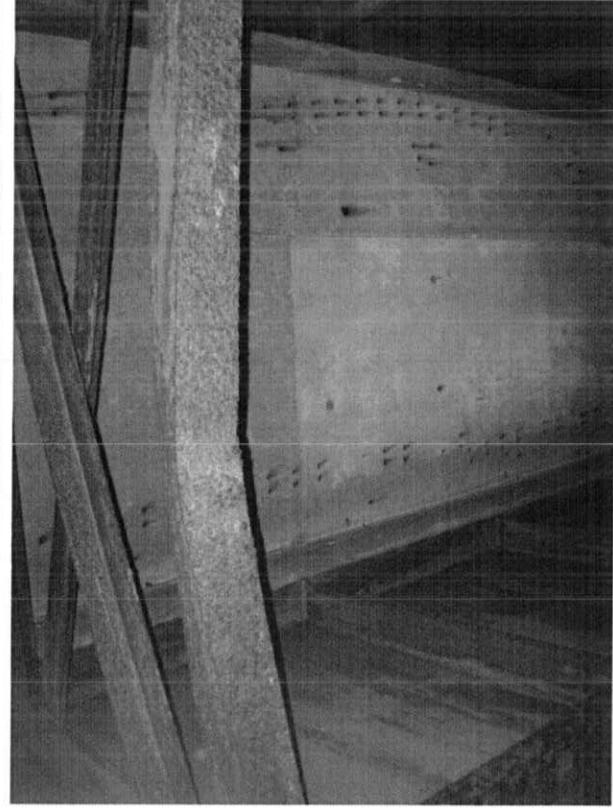
**Photo #35 :**  
Span 1, bay 2: Bent diaphragm member.

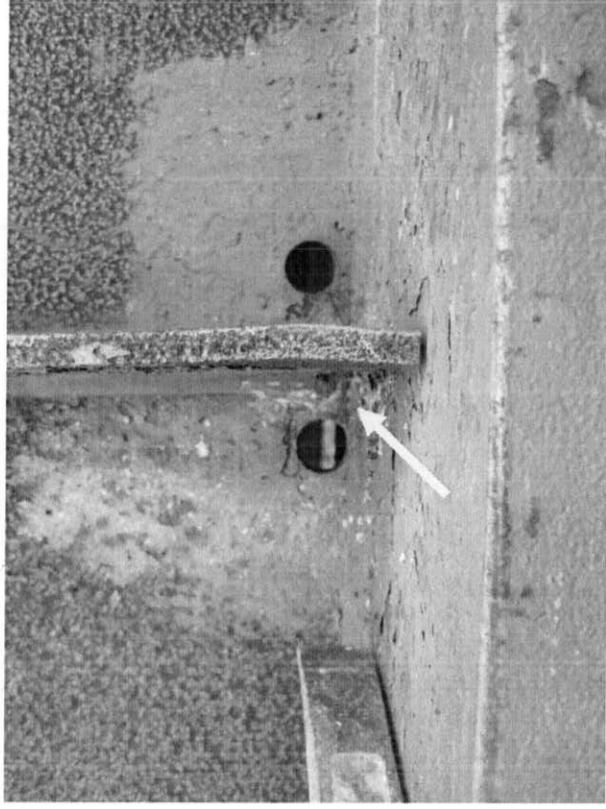
**Photo #36 :**  
Span 1, girder 1 at intermediate stiffener 15: Stop holes with cracks; note that the crack at the left side of the photo is new this inspection.

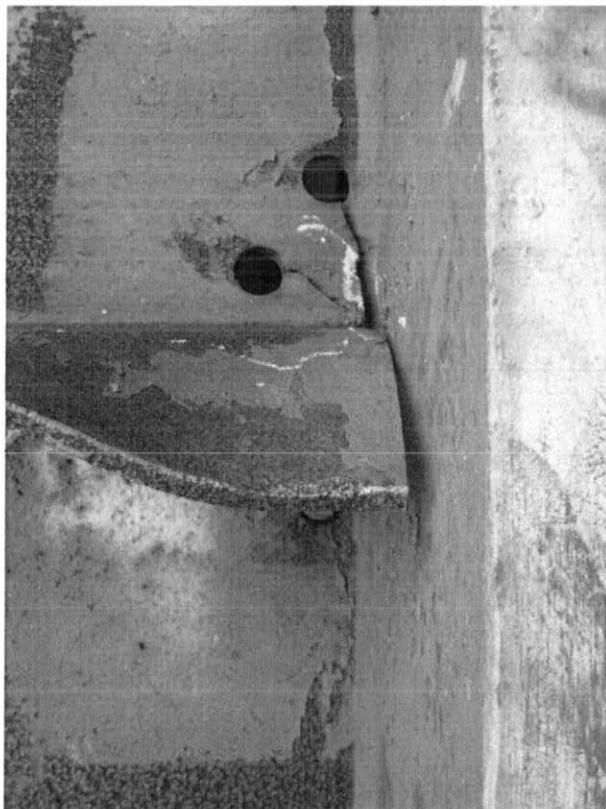
**Photo #37 :**  
Span 1, girder 1 at intermediate stiffener 14: Cracks with stop holes at the base of the web.  
*BMM ISSUED THIS INSPECTION 10 1-31-12*

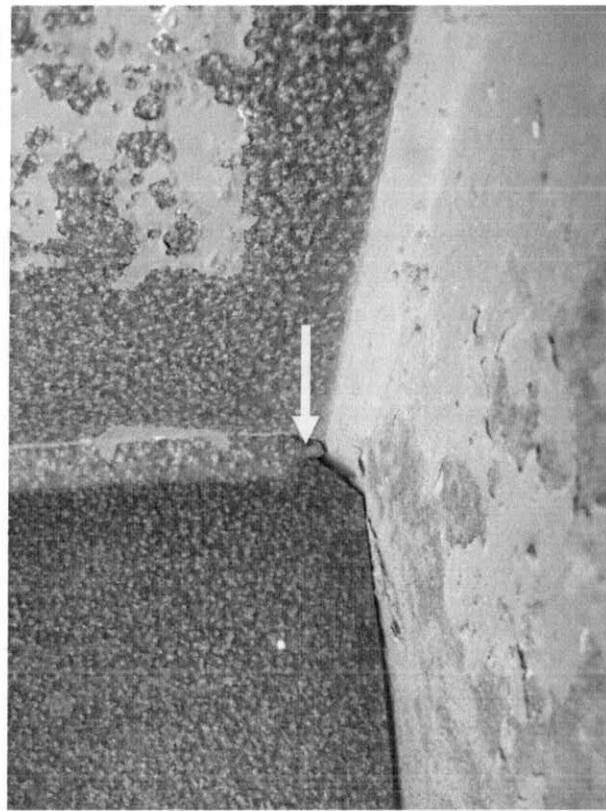
**Photo #38 :**  
Span 1, girder 1 at intermediate stiffener 13: Crack at the toe of the stiffener weld, ±3/8" long. Crack is new this inspection.

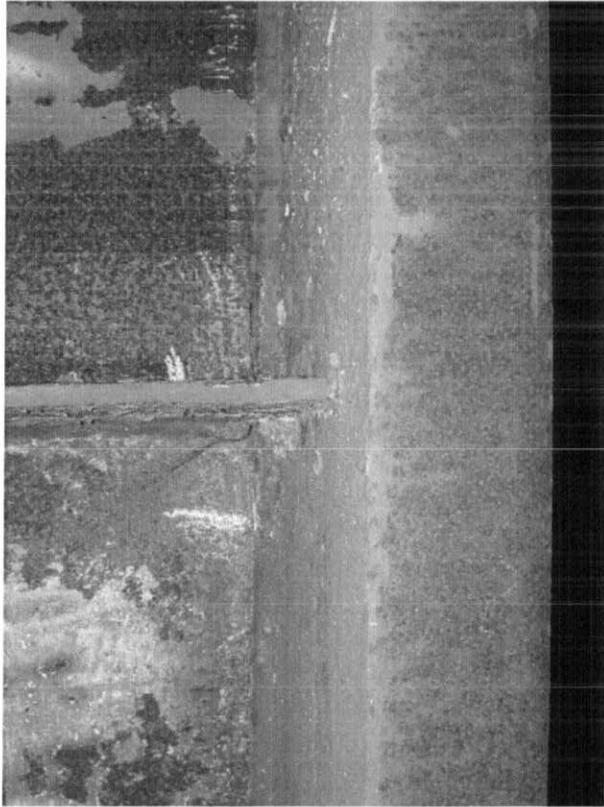
**Photo #39 :**  
Span 1, girder 1 at the third intermediate diaphragm, west elevation with cracks at the base of the web. Cracks are new this inspection.

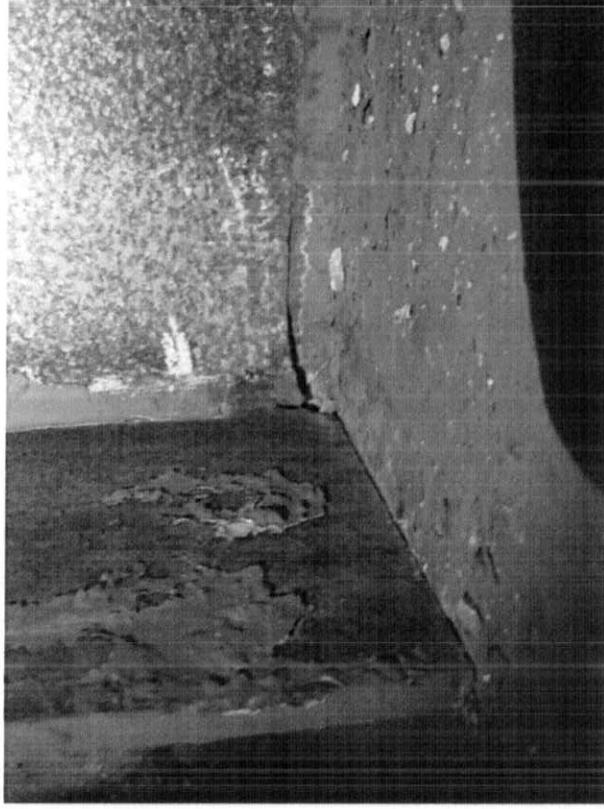
**Photo #40 :**  
Same as photo 39, but looking from right side of the stiffener.

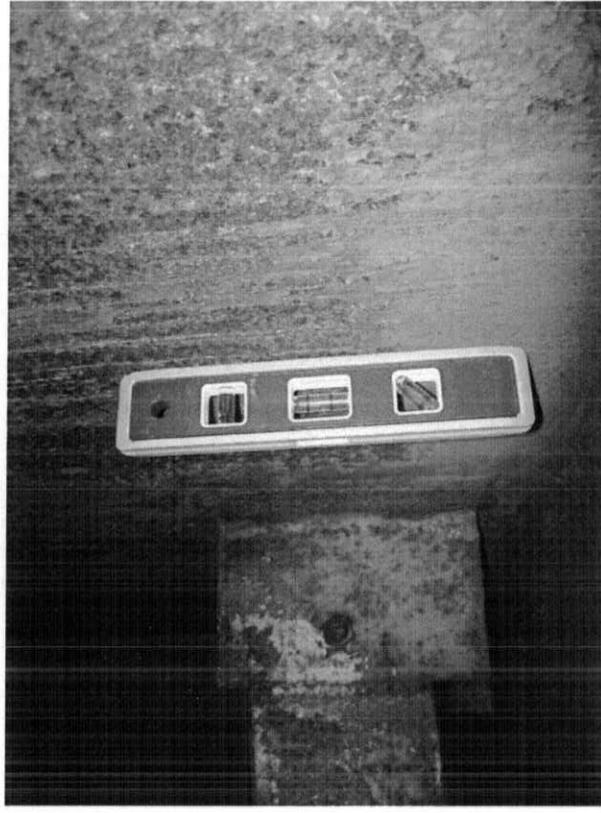
**Photo #42 :**  
Span 1, girder 1 out of plumb at area with impact damage.

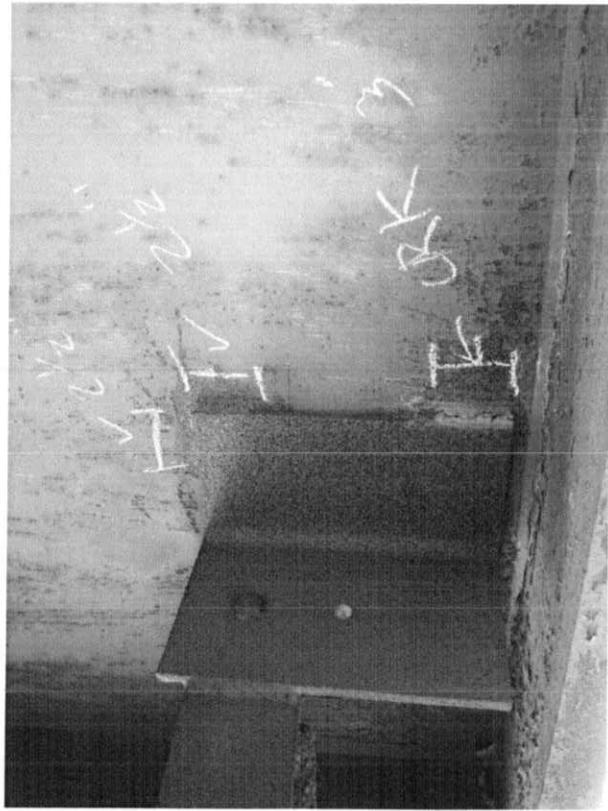
**Photo #43 :**  
Span 2, girder 7. Weld at lower right of OHSS base plate is broken.

5. An OHSS base plate weld is broken at the span 2, girder 7 web in panel 4. BS&E was notified about the cracked OHSS weld via email on 09/22/2011. Repair weld (<1 linear foot).

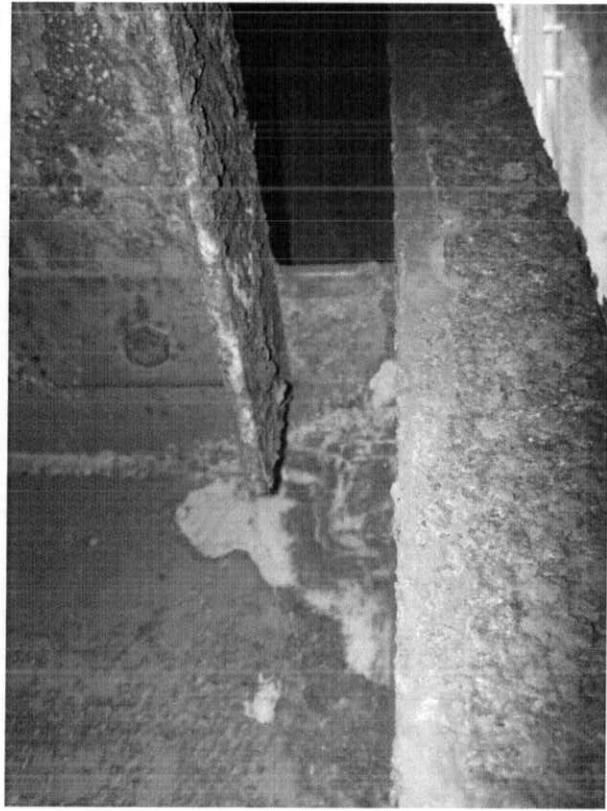
**Photo #44 :**  
Typical missing overhead weld along the underside of the diaphragm lower struts.

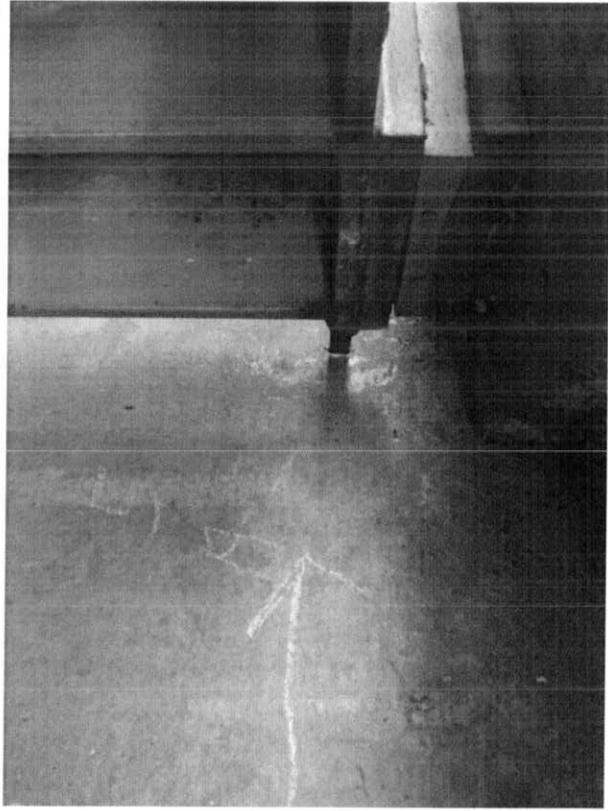
**Photo #45 :**  
Span 2, girder 5 at the north abutment: Only 1/8" gap between the bottom flange end and the backwall.

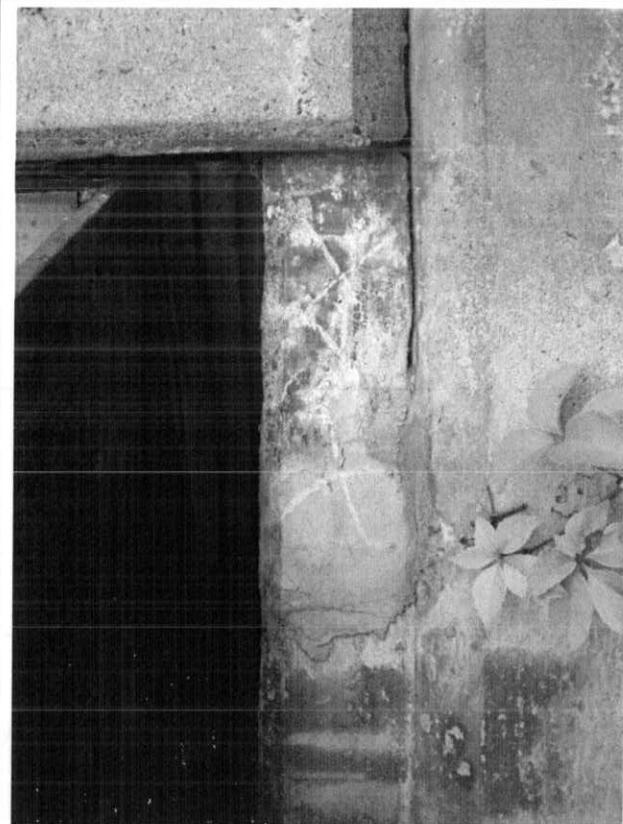
**Photo #47 :**  
North abutment, girder 7 pedestal with hollow concrete and concrete patch.

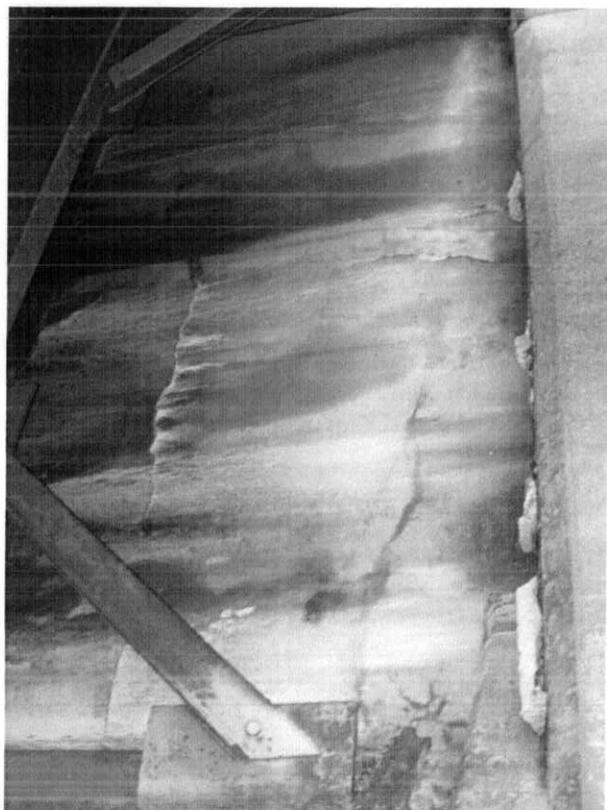
**Photo #48 :**  
South abutment backwall, bay 3: Backwall with map cracking, efflorescence, rust staining, hollow area, and up to 1" deep scaling.

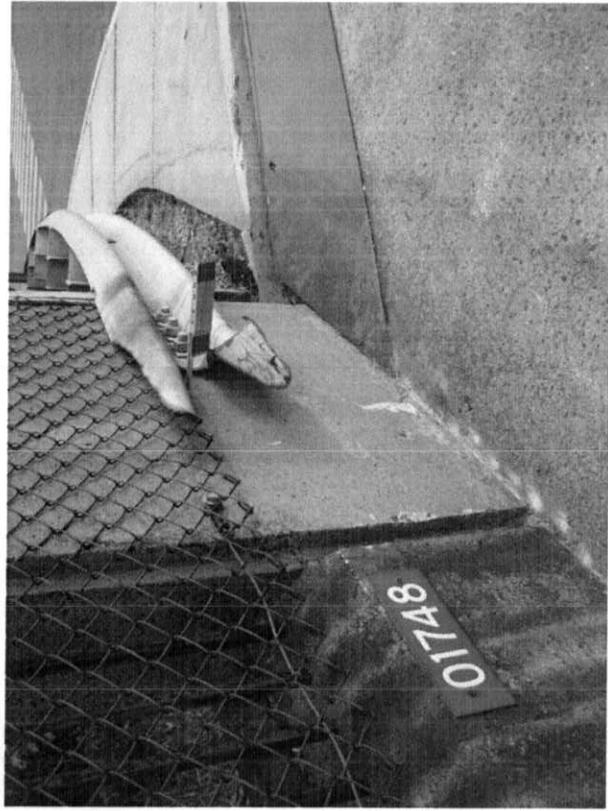
**Photo #51 :**  
 Southeast guide rail transition is damaged and protrudes into the roadway. Note that there is no rub rail. Also note the steel blockouts.

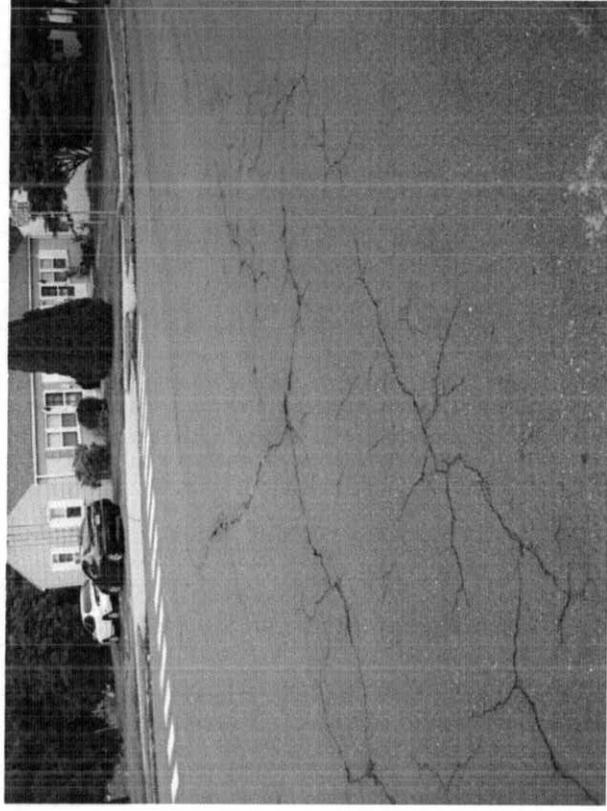
**Photo #52 :**  
 Cracking in the south approach pavement.

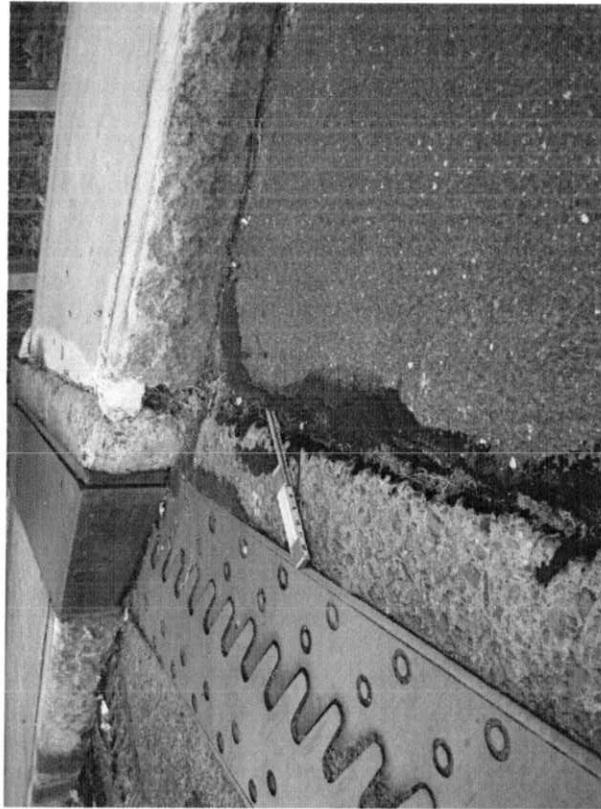
**Photo #53 :**  
Settlement of the south approach pavement at the east end of the south abutment finger joint.

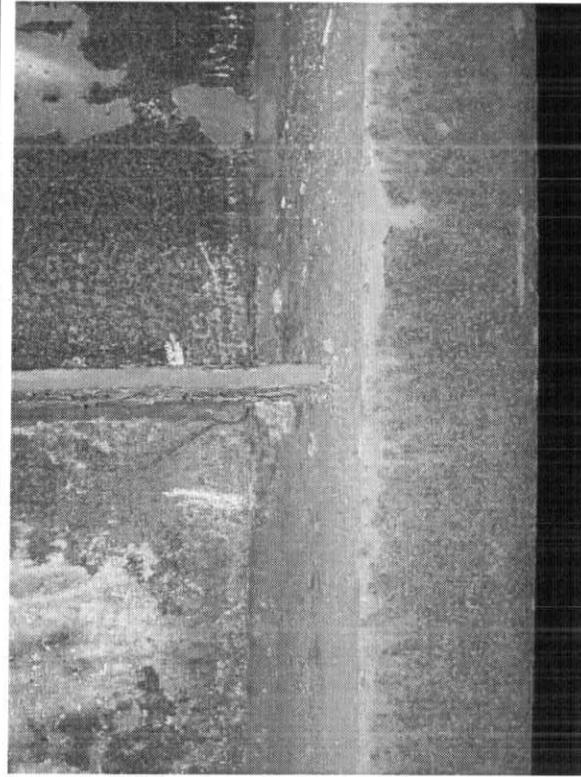
**Photo #2 :**  
Span 1, girder 1 at the third intermediate diaphragm, west elevation with cracks at the base of the web. Cracks are new this inspection
