# STRUCTURE NO. 02917

CURTIS STREET

ROUTE 72

Routine Inspection

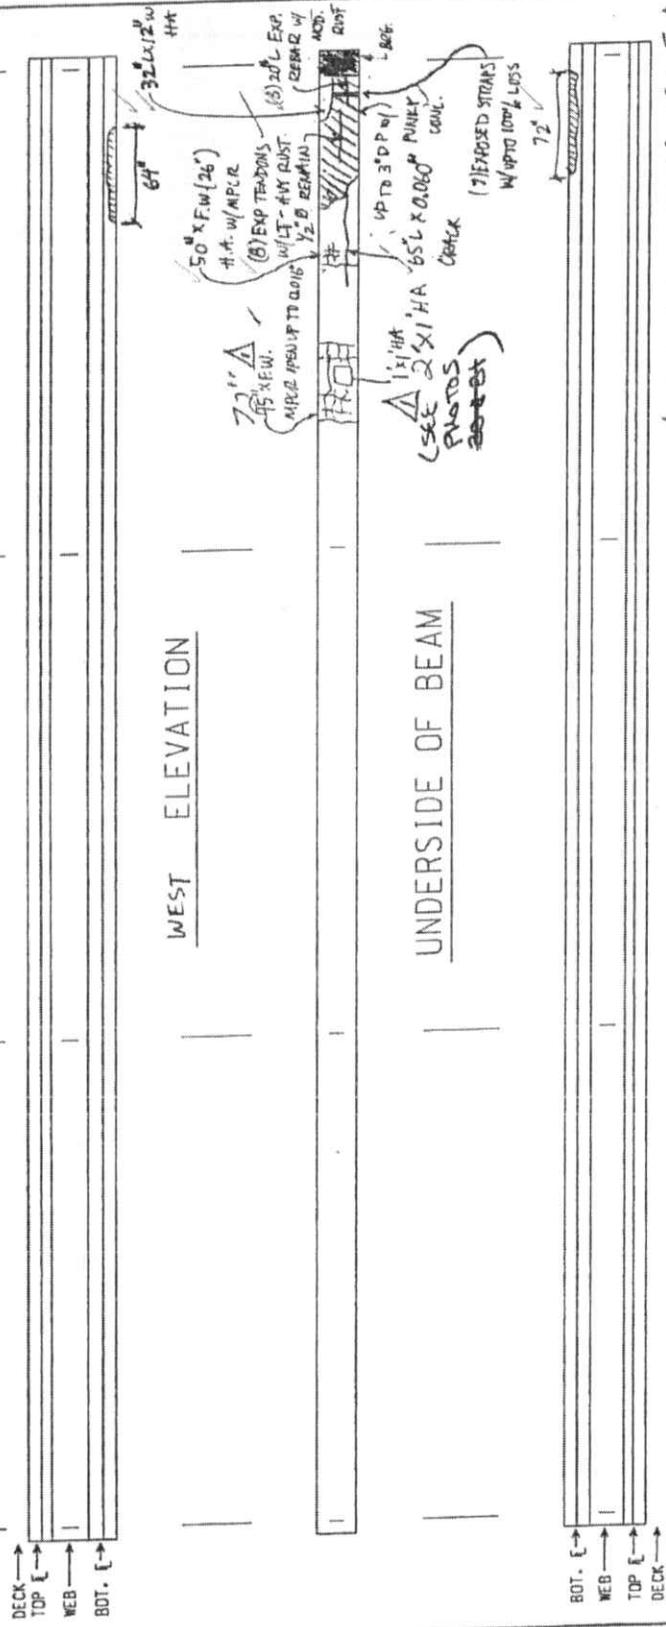
EAST ELEVATION  
SPAN 2 - GIRDER 0

△ ALL SPALLS AT ABUT. 2 END HAVE BEEN PATCHED.

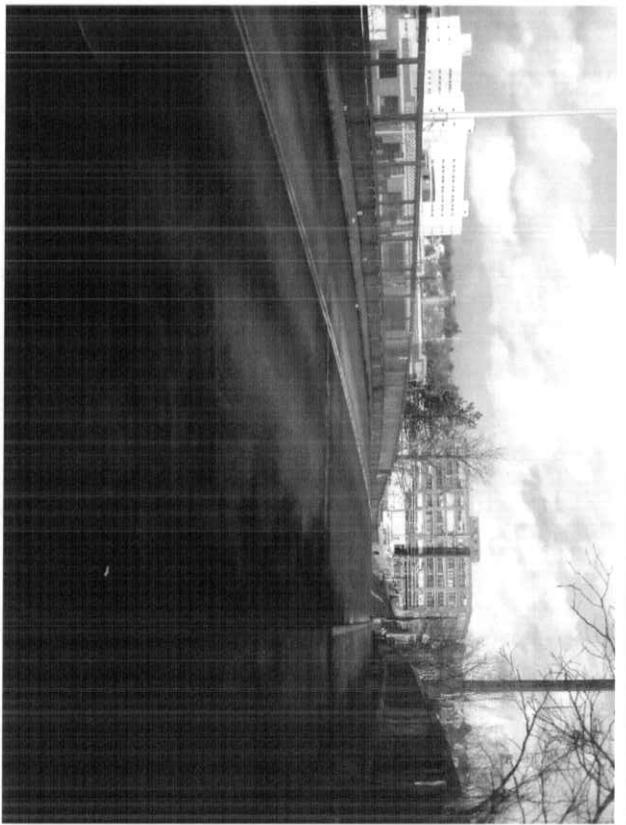
**Photo # 1: LOOKING NORTH.**

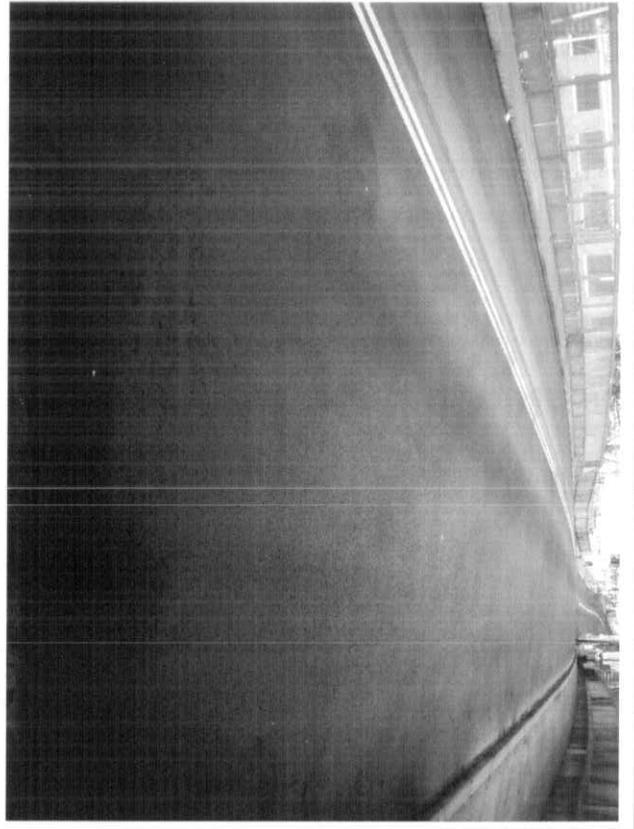
**Photo # 2: GENERAL VIEW OF NEW BITUMINOUS WEARING SURFACE.**

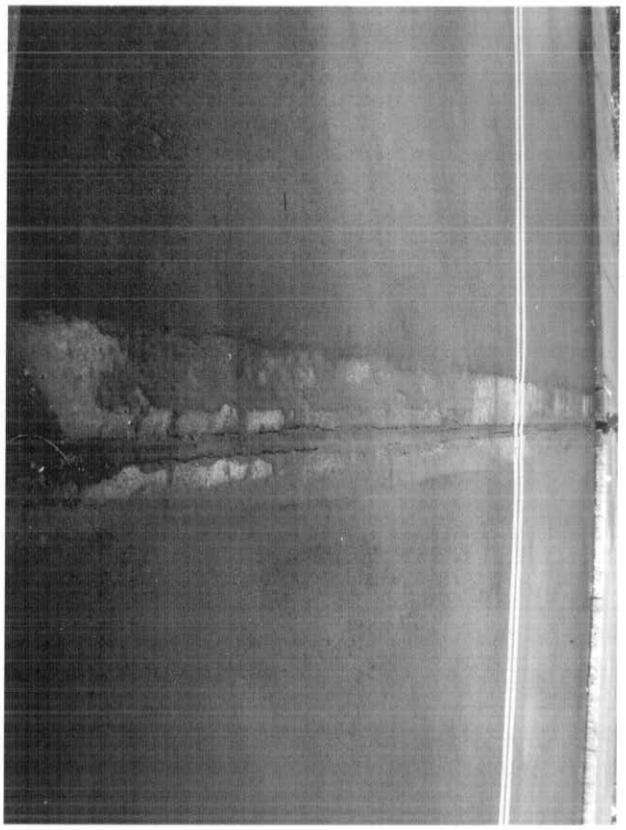
**Photo # 3: GENERAL VIEW OF CONCRETE HEADER AT ABUTMENT # 1.**

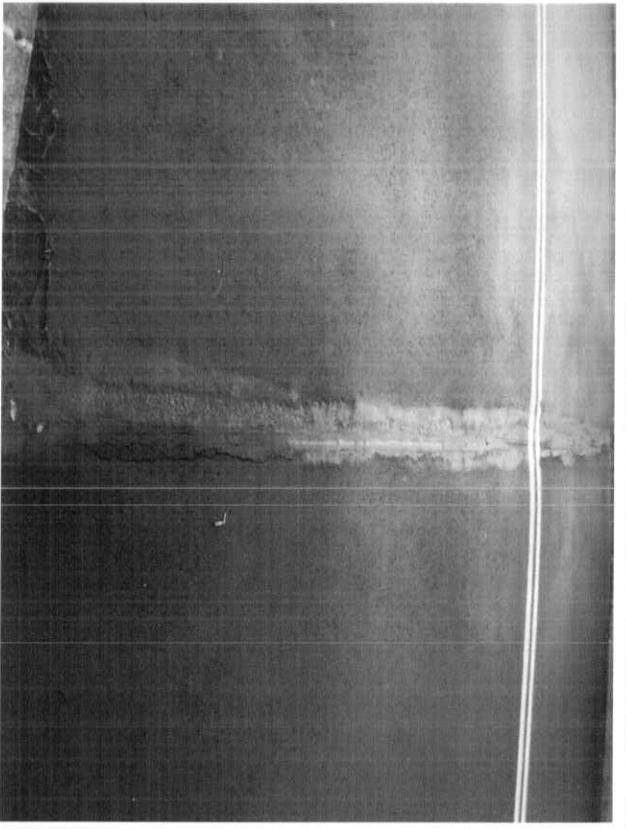
South and north abutments are partially paved over in areas with bituminous.

The bituminous patch is beginning to break up and the joint is filling with sand.

The compression seal joint has bituminous pretty much full width at both abutments.

**Photo # 4: GENERAL VIEW OF CONCRETE HEADER AT ABUTMENT # 2. NOTE CONCRETE HEADER PAVED OVER IN AREAS.**

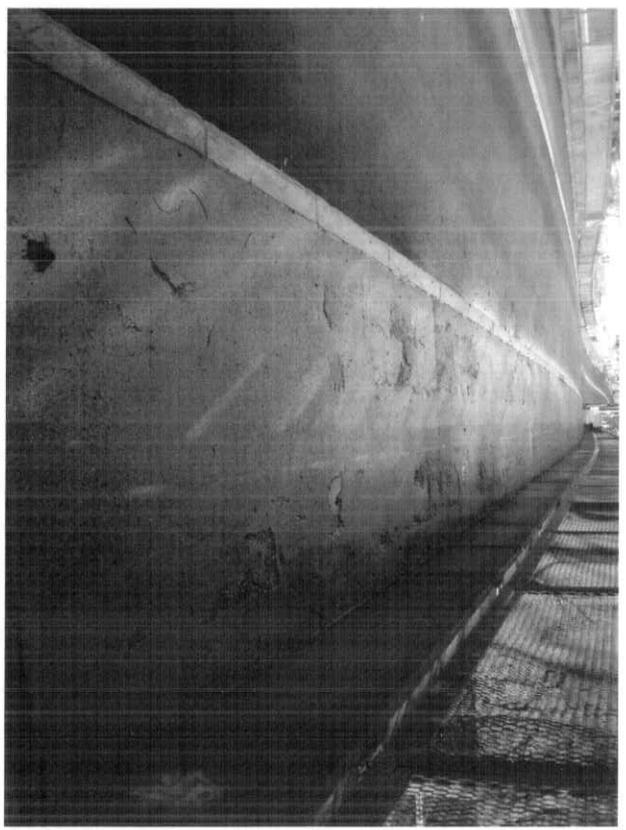
<b>MEDIAN:</b>	N	-
<b>SIDEWALKS:</b>	6	<p>The concrete sidewalks have several random areas of heavy scaling and spalls up to 2' long x 2" wide x 1/2" deep.</p> <p>East sidewalk has approximately 25sf. x up to 1.5" deep scale with rebar, total.</p> <p>West sidewalk has approximately 20sf. x up to 3/4" deep scale, total.</p> <p>Several of the spalls have been patched, but some patched areas are starting to deteriorate.</p> <p>There are also a couple of random hairline cracks and a 6' wide x 10' long area of hairline map cracking at the southwest corner.</p> <p>The approach sidewalks are in similar condition as the bridge sidewalks with random spalls and patched areas.</p> <p>A cracked slab at the southeast approach.</p> <p>Northwest settled approximately 1".</p> <p>The last sidewalk section near abutment #2, east has water coming up from under the slab it appears.</p>
<b>PARAPET:</b>	7	<p>The parapets have some random vertical full length hairline cracks with and without efflorescence.</p> <p>There are also a couple of edge spalls at the southeast corner up to 4" diameter x 1/2" deep.</p>

**Photo # 5: GENERAL VIEW OF EAST SIDEWALK.  
NOTE SEVERE SCALE IN AREAS.**

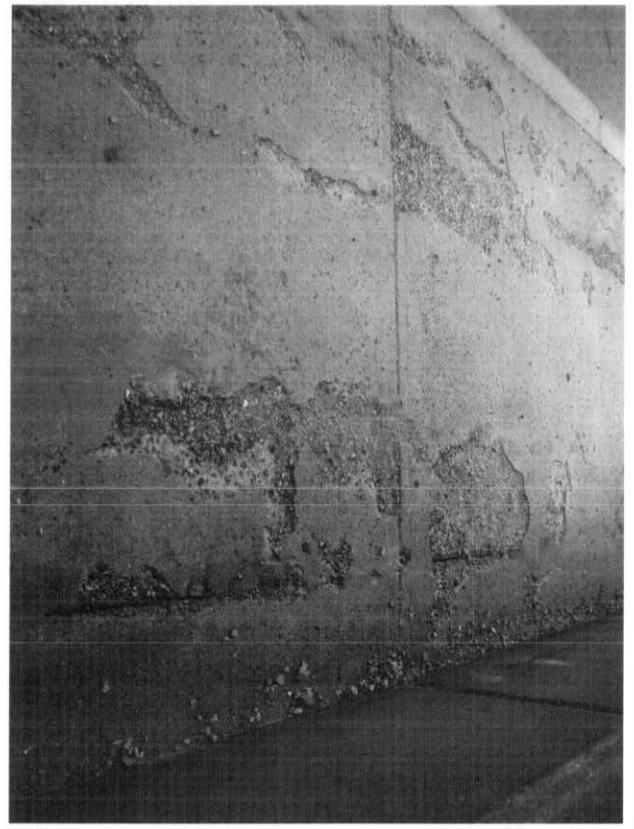
**Photo # 6: CLOSEUP OF SEVERE SCALE ON EAST  
SIDEWALK WITH EXPOSED REBAR.**

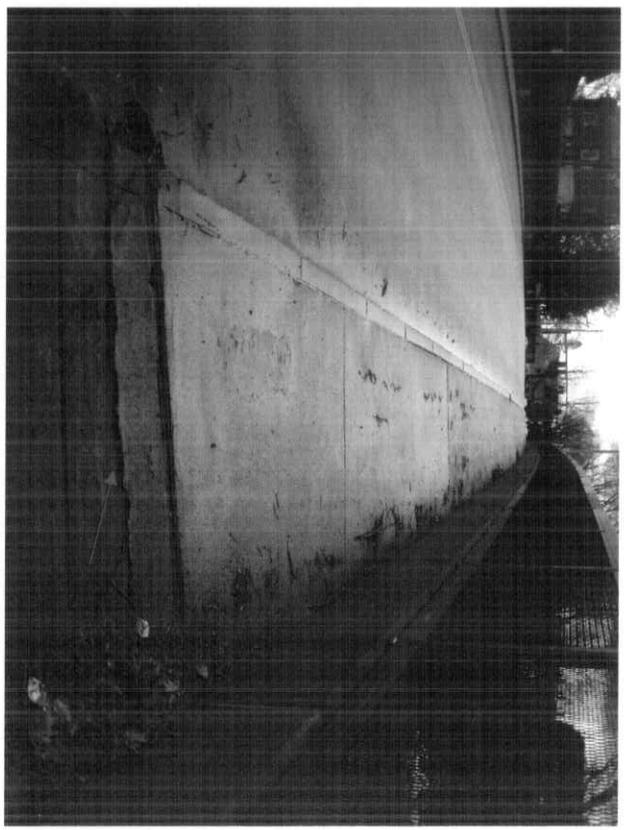
**Photo # 7: GENERAL VIEW OF WEST SIDEWALK. NOTE CRACKED AND SETTLED PORTION OF SLAB AT NORTH END.**

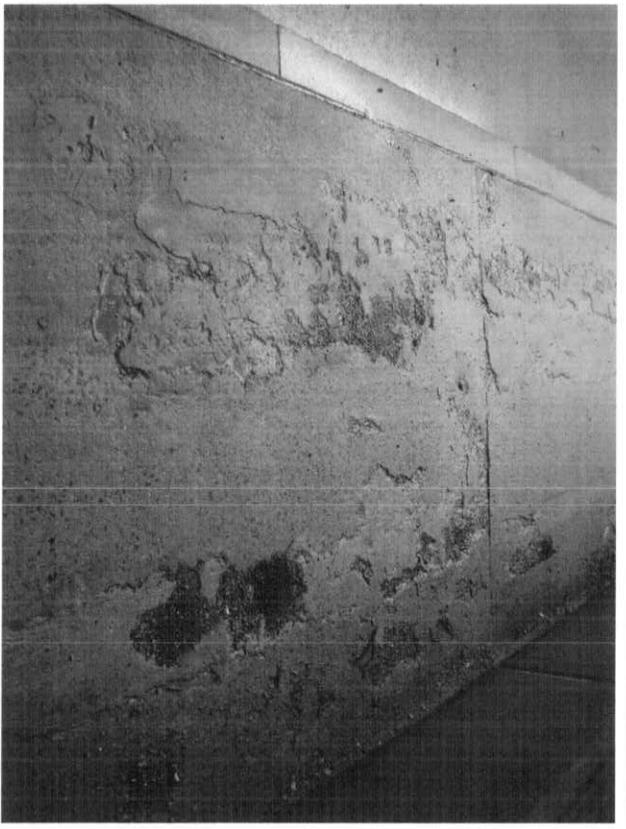
**Photo # 8: AREAS OF SEVERE SCALE ON WEST SIDEWALK.**

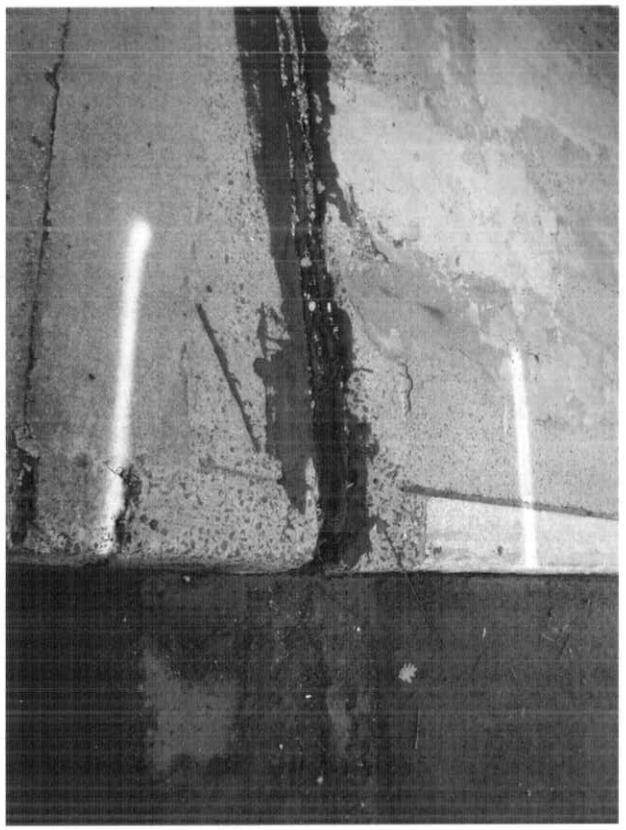
**Photo # 9: SPALLED CONCRETE CURBING AT ABUTMENT # 1 JOINT.**

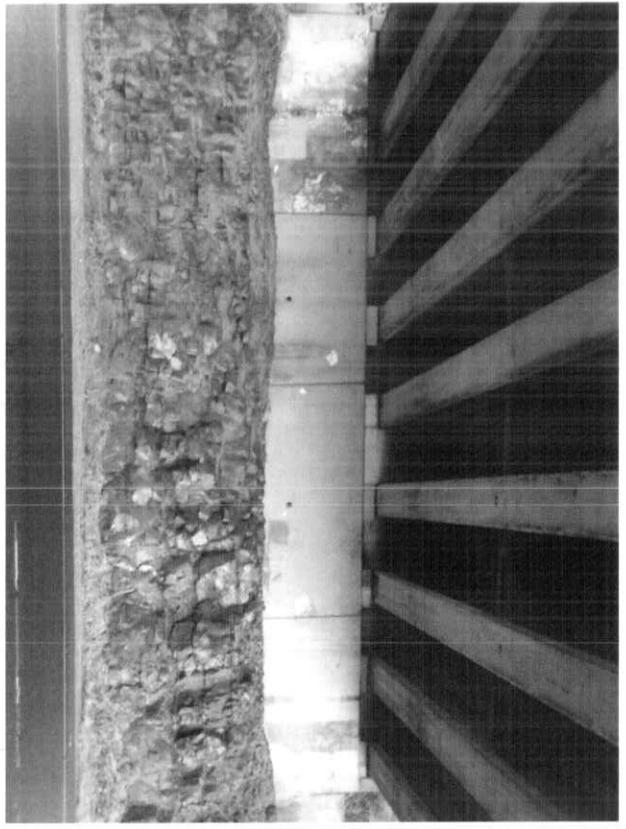
**Photo # 10: GENERAL VIEW OF ABUTMENT # 1.**

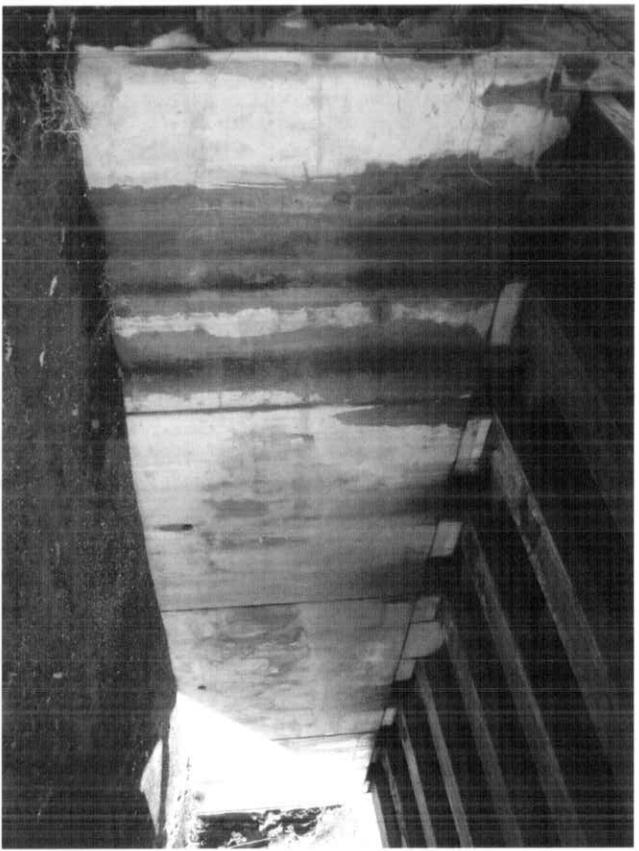
**Photo # 11: GENERAL VIEW OF ABUTMENT # 2.**

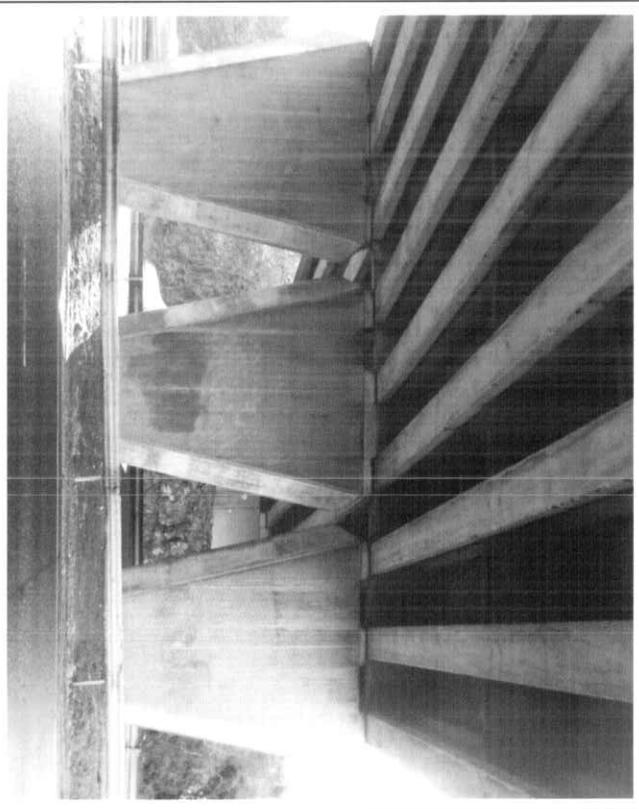
**Photo # 12: GENERAL VIEW OF NORTH FACE OF PIER.**

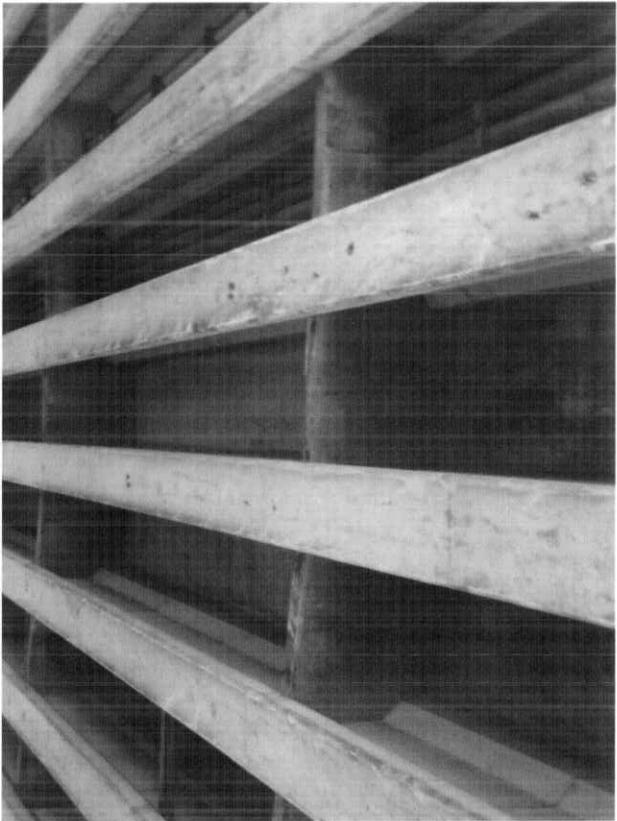
Photo # 13: GENERAL UNDERSIDE OF SPAN # 1.

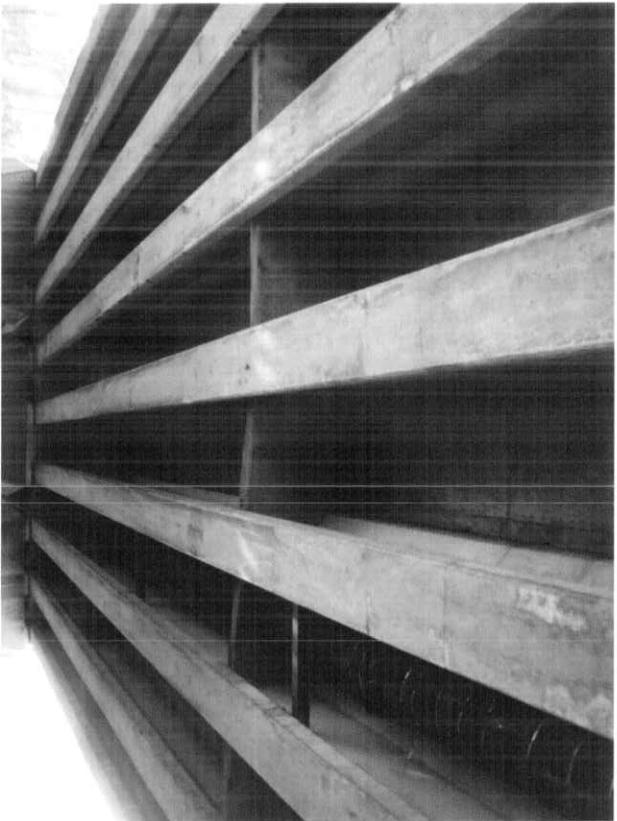
Photo # 14: GENERAL UNDERSIDE OF SPAN # 2.

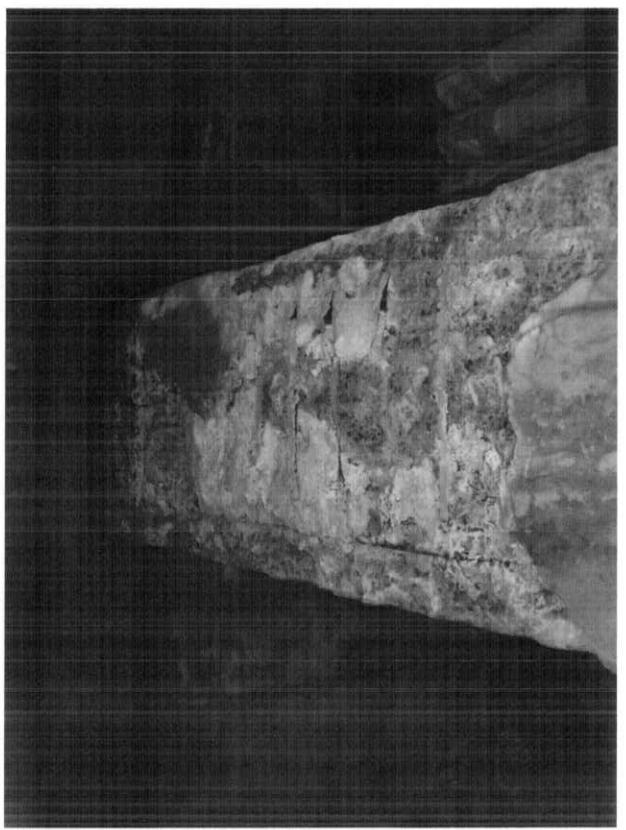
Inspectors shall monitor the cracking on the Prestressed Concrete Beams. Look for shear cracks at beam ends, especially beam 8, span 2 at the abutment. RAP 05/26/2010

**Photo # 15: GENERAL VIEW OF BOTTOM OF GIRDER # 8 IN SPAN # 2 AT ABUTMENT # 2.**

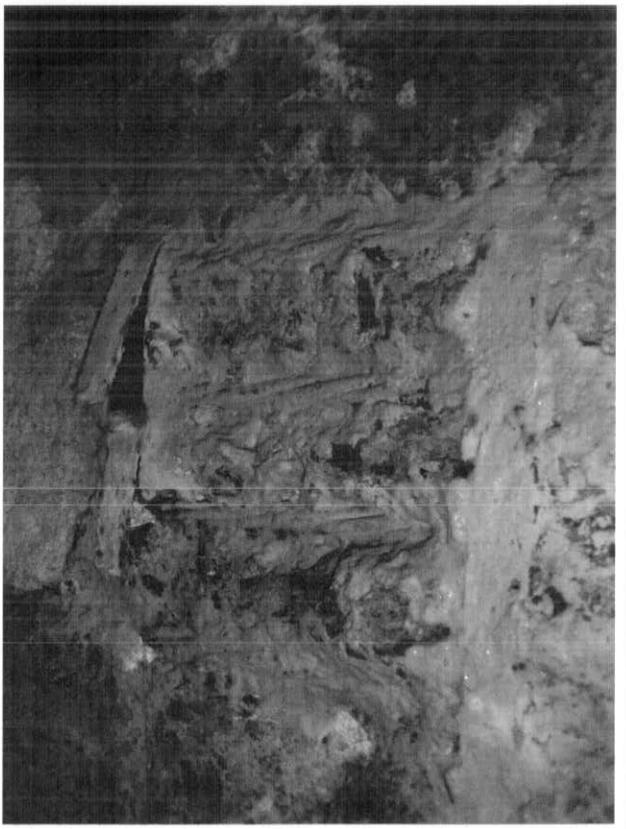
**Photo # 16: CLOSEUP OF VISIBLE STRANDS ON LEFT SIDE BOTTOM OF GIRDER # 8 IN SPAN # 2 AT ABUTMENT # 2.**

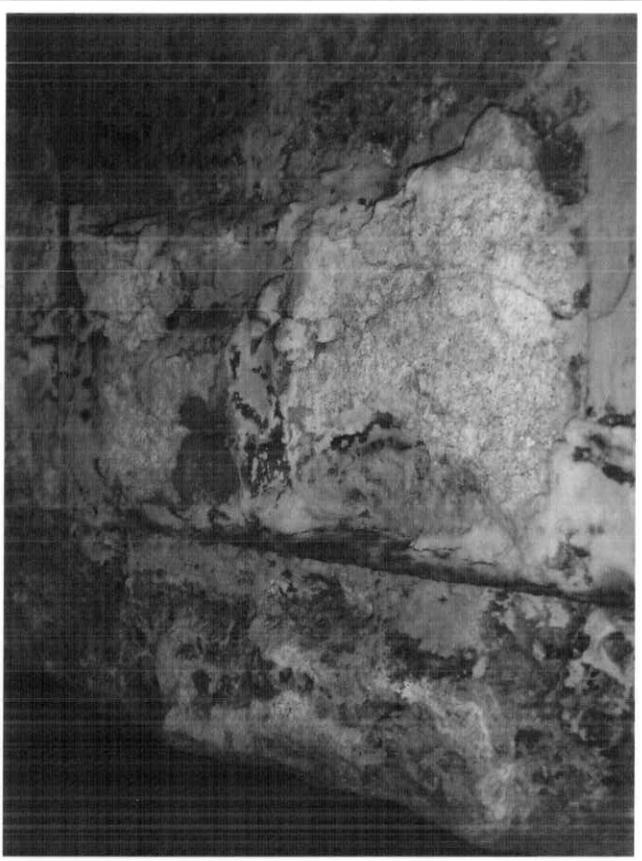
**Photo # 17: CLOSEUP OF STRANDS ON RIGHT SIDE BOTTOM OF GIRDER # 8 IN SPAN # 2 AT ABUTMENT # 2.**

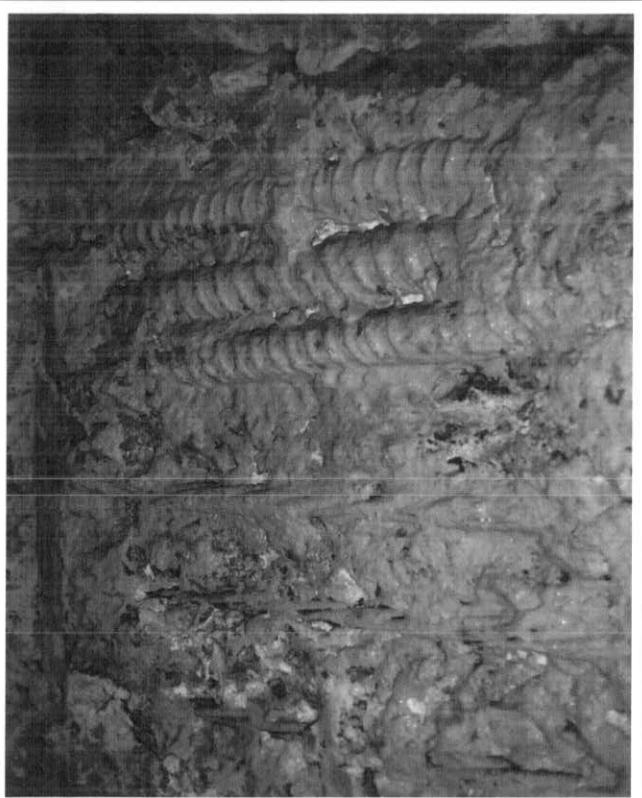
**Photo # 18: REBAR THAT IS VISIBLE ON BOTTOM OF GIRDER # 8 IN SPAN # 2 AT ABUTMENT # 2.**

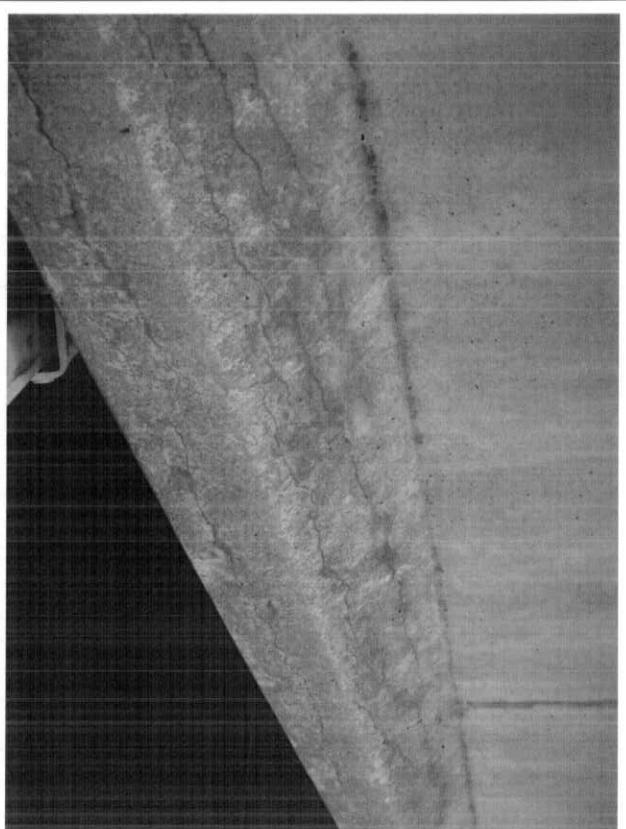
**Photo # 19: TYPICAL HORIZONTAL CRACKING AT BOTTOM FASCIA OF GIRDERS IN SPAN # 2.**

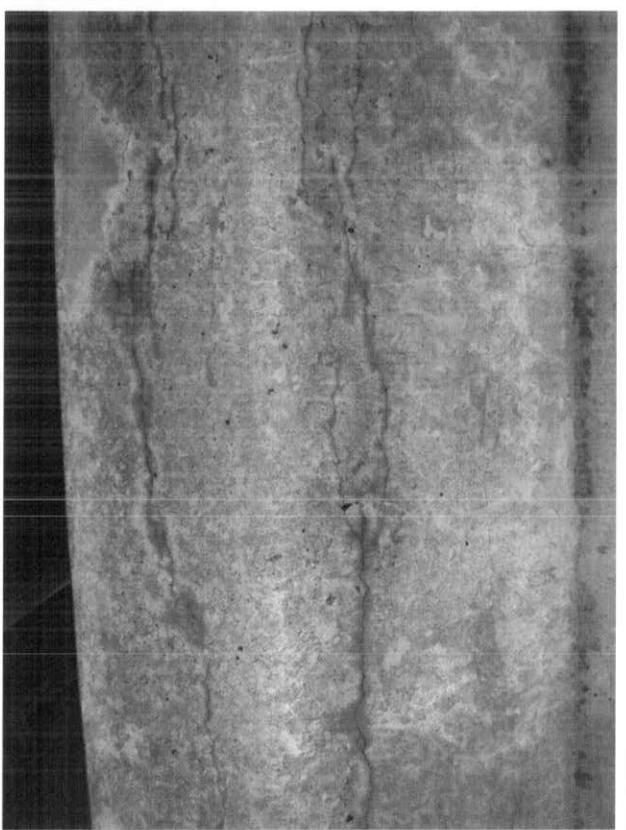
**Photo # 20: CLOSEUP OF HORIZONTAL CRACKING IN BOTTOM FASCIA OF GIRDERS IN SPAN # 2.**

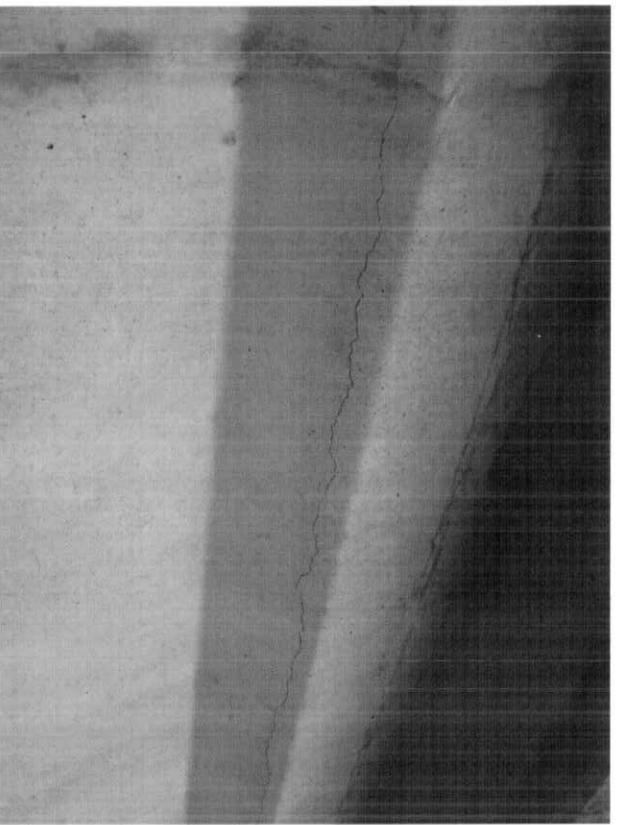
**Photo # 21: TYPICAL HORIZONTAL CRACKING AT TOP FASCIA OF GIRDERS IN SPAN # 2.**

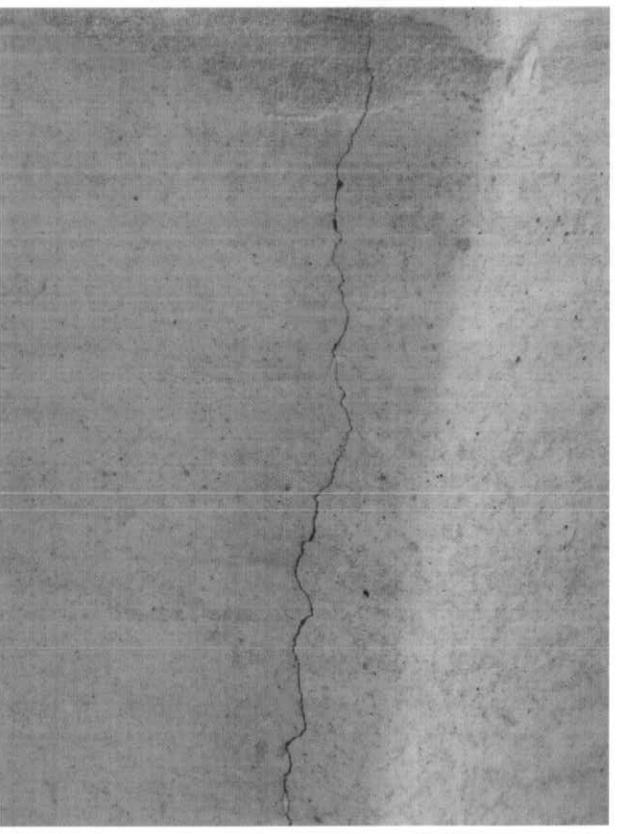
**Photo # 22: CLOSEUP OF HORIZONTAL CRACKING IN TOP FASCIA OF GIRDERS IN SPAN # 2.**

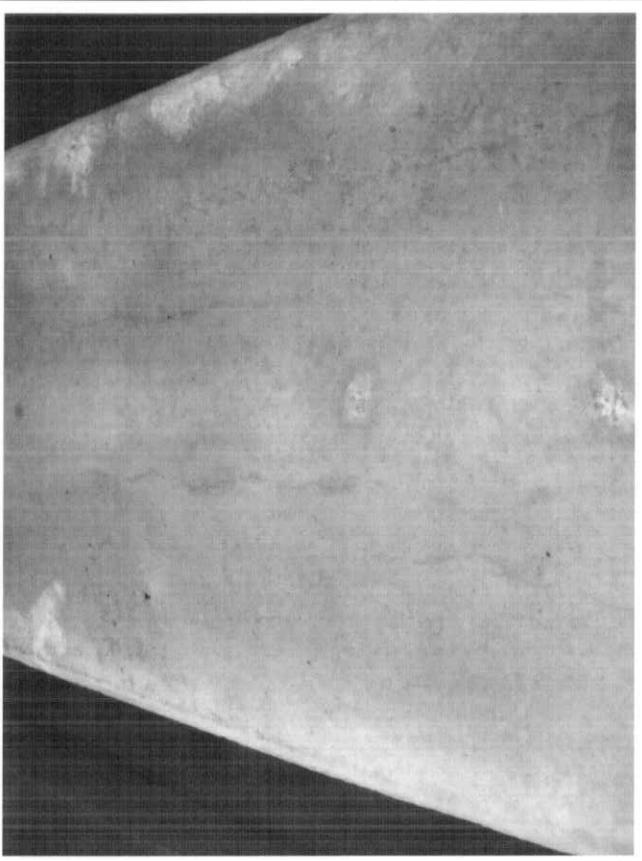
**Photo # 23: TYPICAL LONGITUDINAL CRACKING IN GIRDER BOTTOMS IN SPAN # 2.**

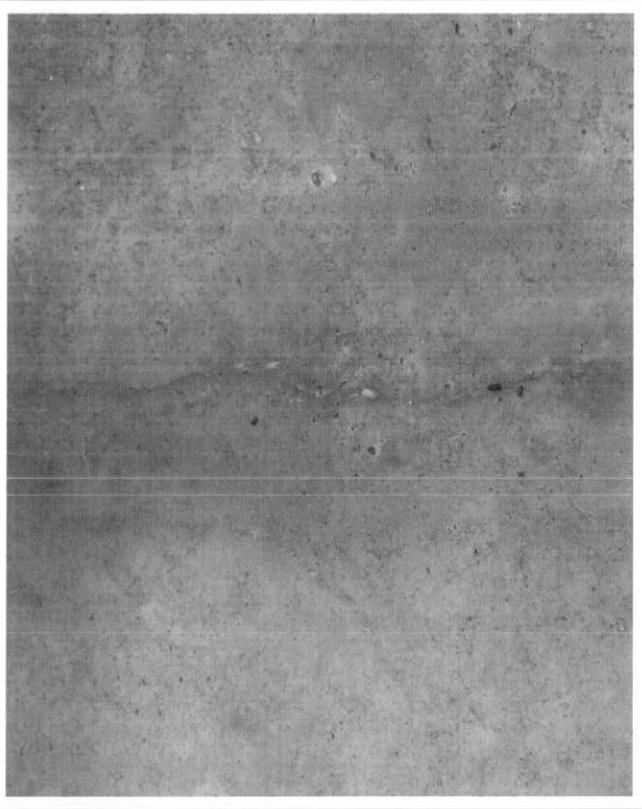
**Photo # 24: CLOSEUP OF LONGITUDINAL CRACKING IN GIRDER BOTTOMS IN SPAN 3 2.**

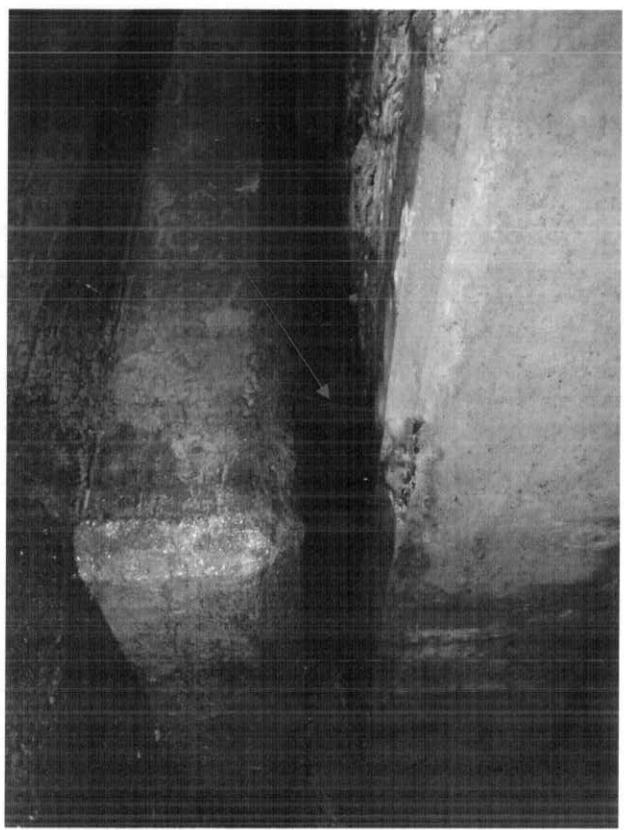
<b>BEARING DEVICES:</b>	5	<p>The elastomeric bearings at the pier in span 2 are tilted to the southeast up to 1/2" with minor bulging and curling.</p> <p>Abutment #2, bearing #8 might have what appears to be rust, bleeding through.</p> <p>The bearing pad in span 1 under girder G8 has a short horizontal tear at the west side.</p>
<b>STRINGERS:</b>	N	-
<b>GIRDERS:</b>	5 <i>4'</i> <i>AM</i>	<p>There are a total of nine prestressed concrete I-girders.</p> <p>Girders have numerous horizontal cracks up to full length of the girders on both sides of flanges and webs with and without efflorescence and discoloration, open up to 0.030" wide.</p> <p>The bottoms of the bottom flanges have areas of honeycombing and random longitudinal cracks full girder length x up to 0.020" wide.</p> <p>Fascia girders have hairline map cracking throughout.</p> <p>Girder G2 in span 1 at the pier has diagonal hairline cracks at the girder end extending downwards from the top flanges.</p> <p>There are several spalls on the bottoms of the bottom flanges with exposed rebar and straps, up to 18" in diameter and 1" deep.</p> <p>Most of the spalls are located in span 2, and the rebar in the spalls near the north abutment have been epoxy coated.</p> <p>Girders G5 and G9 in both spans 1 and 2, near the piers, have spalls up to 10" x 10" x 3 1/4" deep with exposed straps, two prestressed strands and rebar.</p> <p>There are random hollow areas adjacent to the spalls on the bottom flanges.</p> <p>The bottom flange of girder G8 in span 2, near the north abutment, has a 6' x full width x up to 3" deep deteriorated area with exposed rebar, 7 rusted straps and 5 exposed prestressed strands, and 3 rebar all of which have been epoxy coated.</p> <p>The remaining concrete in this area is punky.</p> <p>The tendons have light to heavy rust, with no section loss or broken strands.</p> <p>Girder G8 also has a 65' long longitudinal crack open to 0.060" extends from the previously described spall to an adjacent 50" long x full width hollow area with map cracks.</p> <p>There is another 6" long x full width area of map cracking with cracks open up to 0.016".</p>

**Photo # 25: GENERAL VIEW OF ELASTOMERIC BEARING # 8 AT ABUTMENT # 2. NOTE RUST BLEEDING FROM BEARING.**

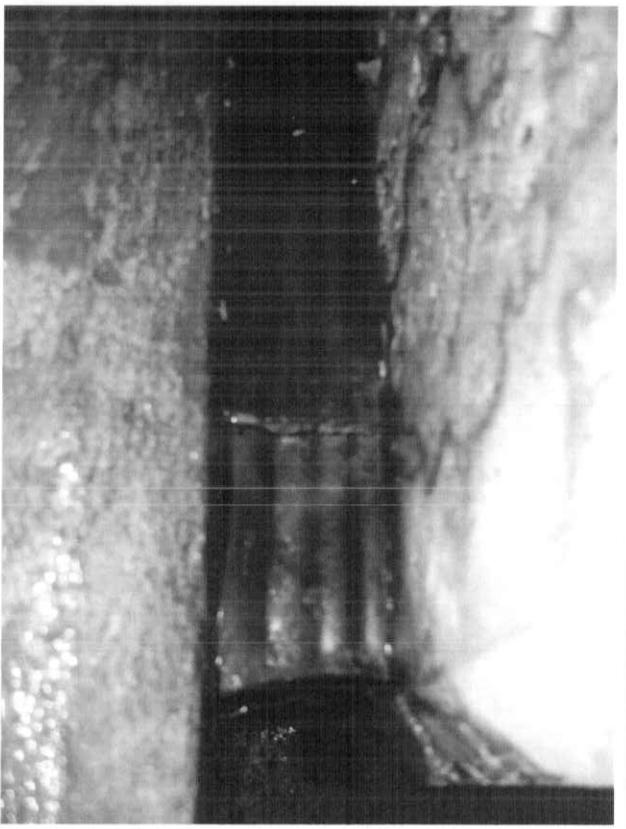
**Photo # 26: CLOSEUP OF RUST BLEEDING FROM BEARING # 8 AT ABUTMENT # 2.**

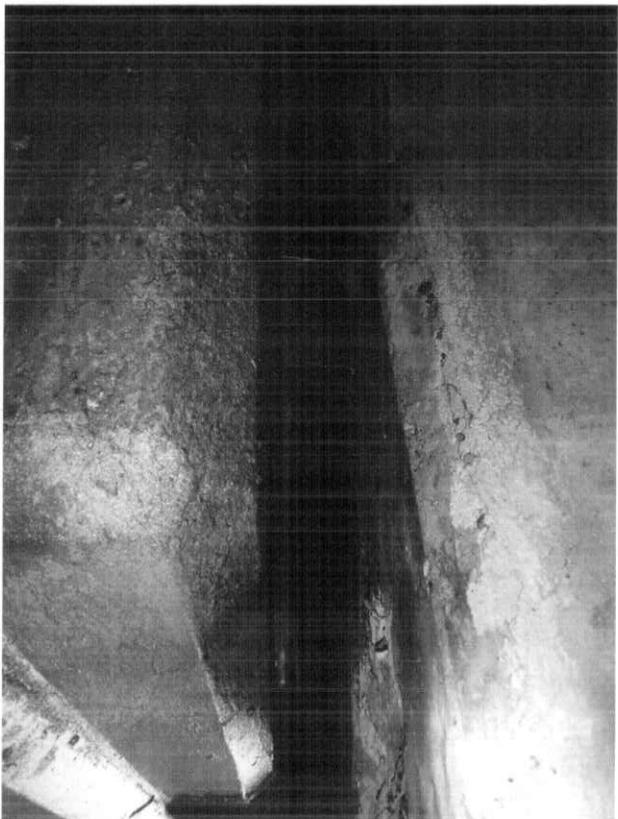
**Photo # 27: BULGING ELASTOMERIC BEARING # 9 AT ABUTMENT # 2.**

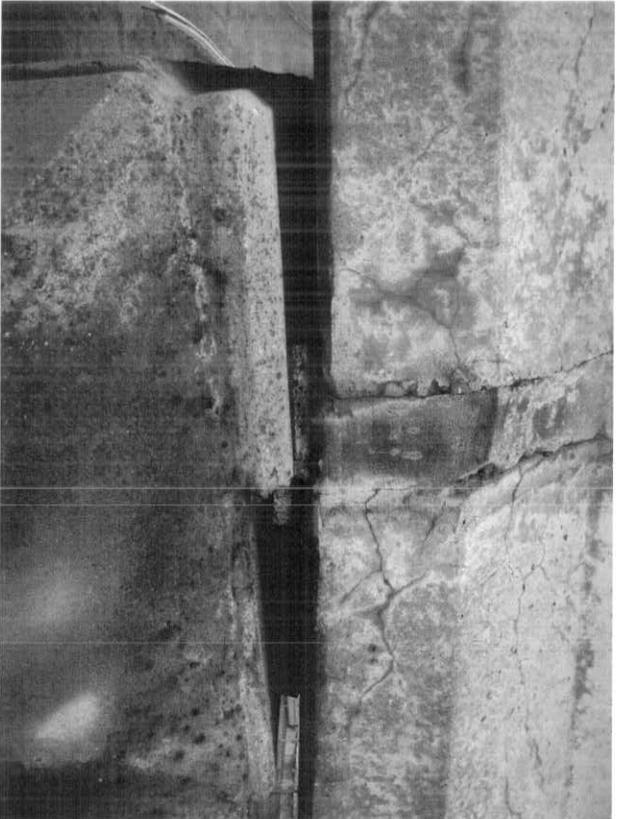
**Photo # 28: TYPICAL VIEW OF BEARINGS ON PIER.**

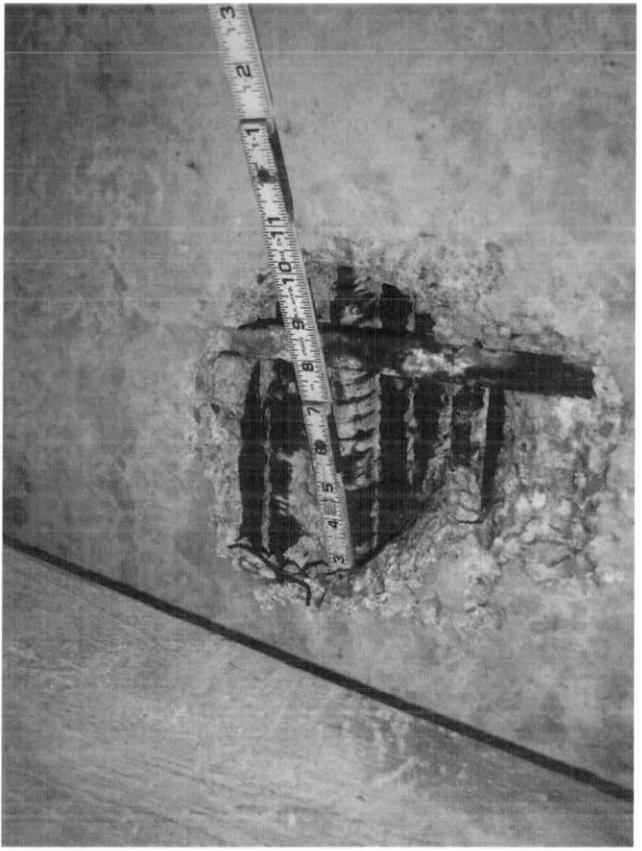
**Photo # 29: HOLE IN BOTTOM OF GIRDER # 5 IN SPAN # 2 NEXT TO PIER.**

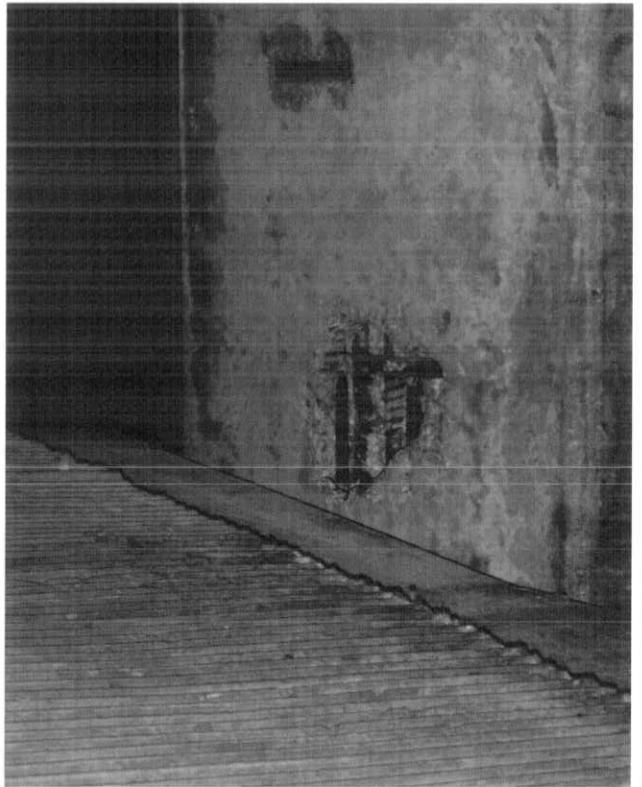
**Photo # 30: GENERAL VIEW OF HOLE IN GIRDER # 5 IN SPAN # 2 NEXT TO PIER.**

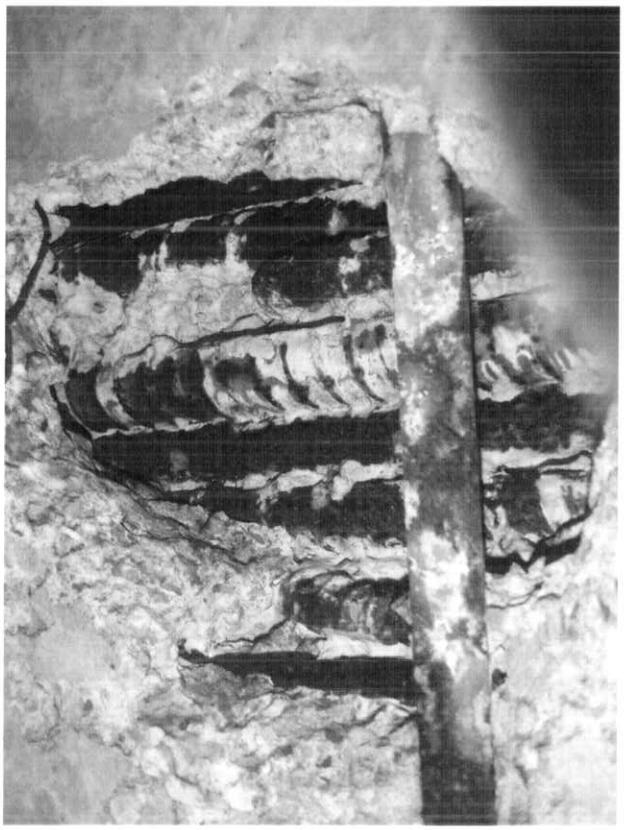
**Photo # 31: CLOSEUP OF HOLE IN BOTTOM OF GIRDER # 5 IN SPAN # 2 NEXT TO PIER.**

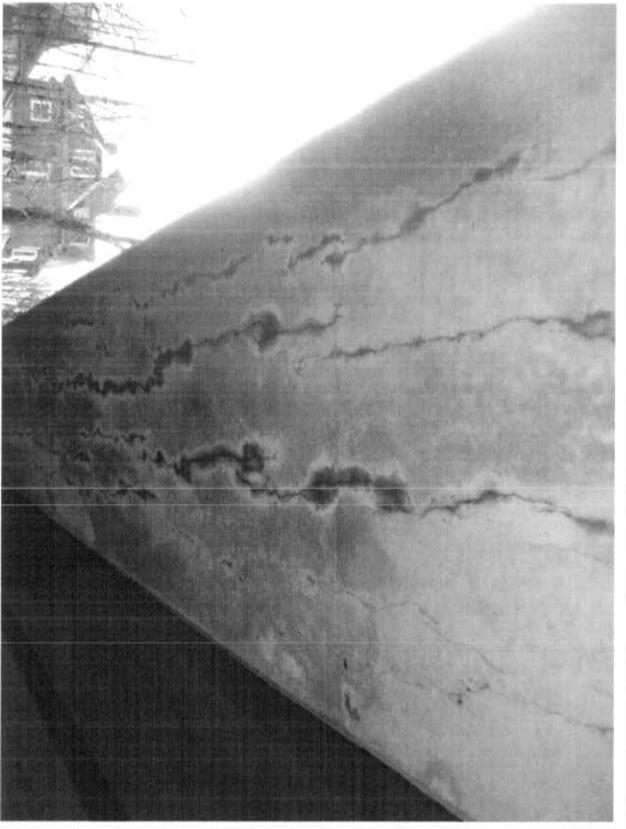
**Photo # 32: TYPICAL LONGITUDINAL CRACKING IN BOTTOM OF GIRDERS IN SPAN # 1.**

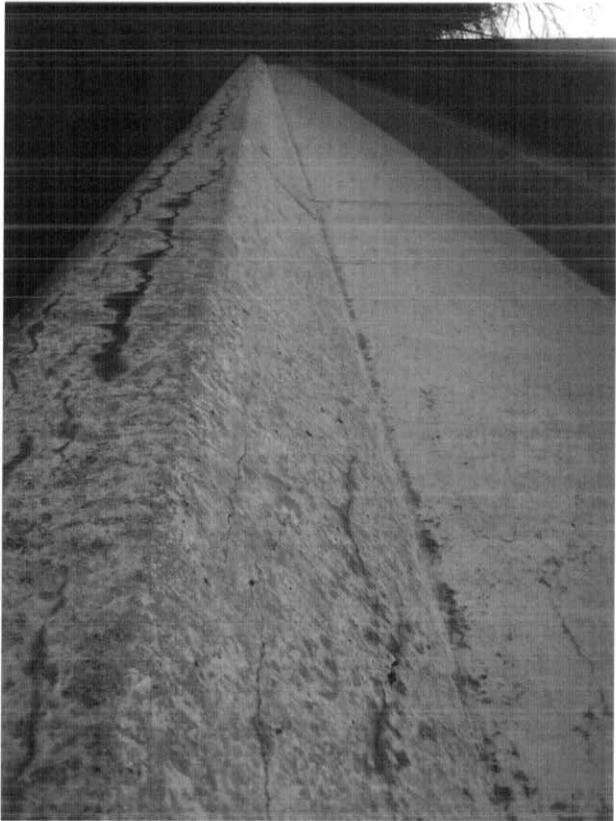
**Photo # 33: TYPICAL HORIZONTAL CRACKING FOUND ON GIRDER FASCIAS IN SPAN # 1.**

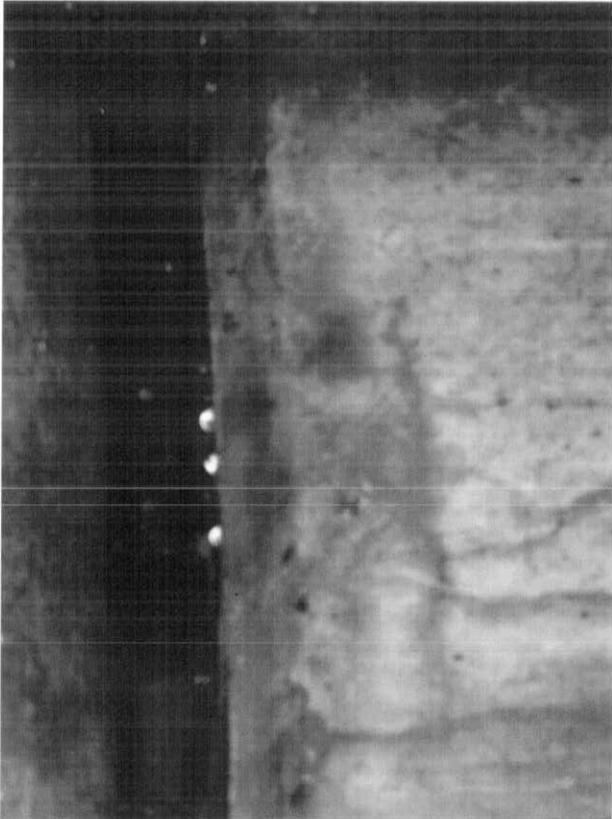
**Photo # 34: TYPICAL ELASTOMERIC BEARING AT ABUTMENT # 1.**

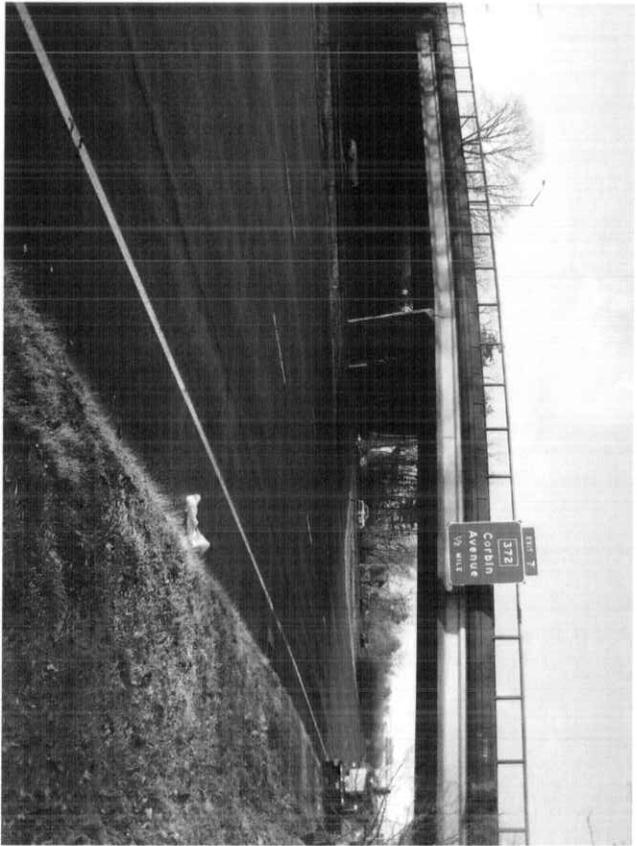
Photo # 35: EAST ELEVATION.

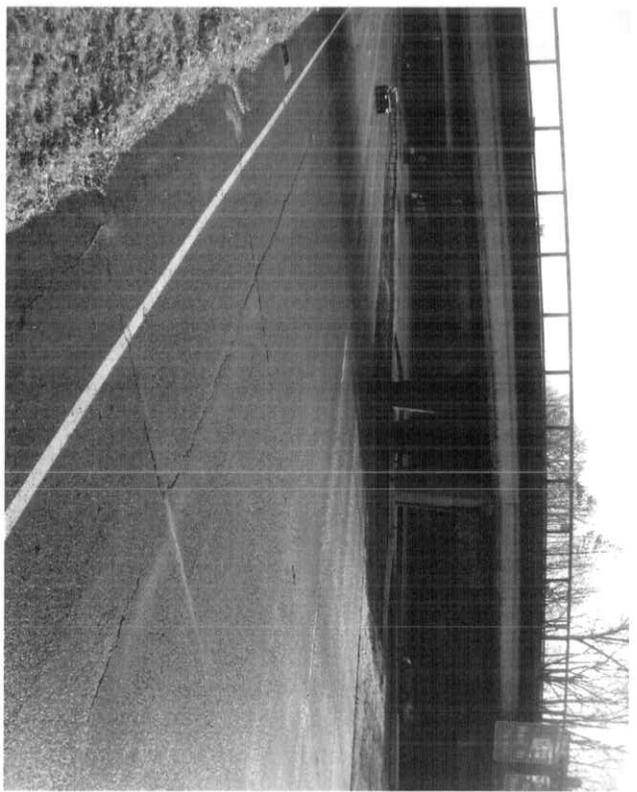
Photo # 36: WEST ELEVATION.
