STATE OF CONNECTICUT
DEPARTMENT OF TRANSPORTATION
STATE PROJECT NO. 300-097
AGREEMENT NO. 9.07-01(10)

MECHANICAL/ELECTRICAL INSPECTION REPORT

METRO-NORTH RAILROAD, DEVON BRIDGE
OVER HOUSATONIC RIVER - STRATFORD, CT
CONNDOT BRIDGE NO. 08080R
MAIN LINE MP 60.42

INSPECTION COMPLETED ON:
MARCH 25, 2012

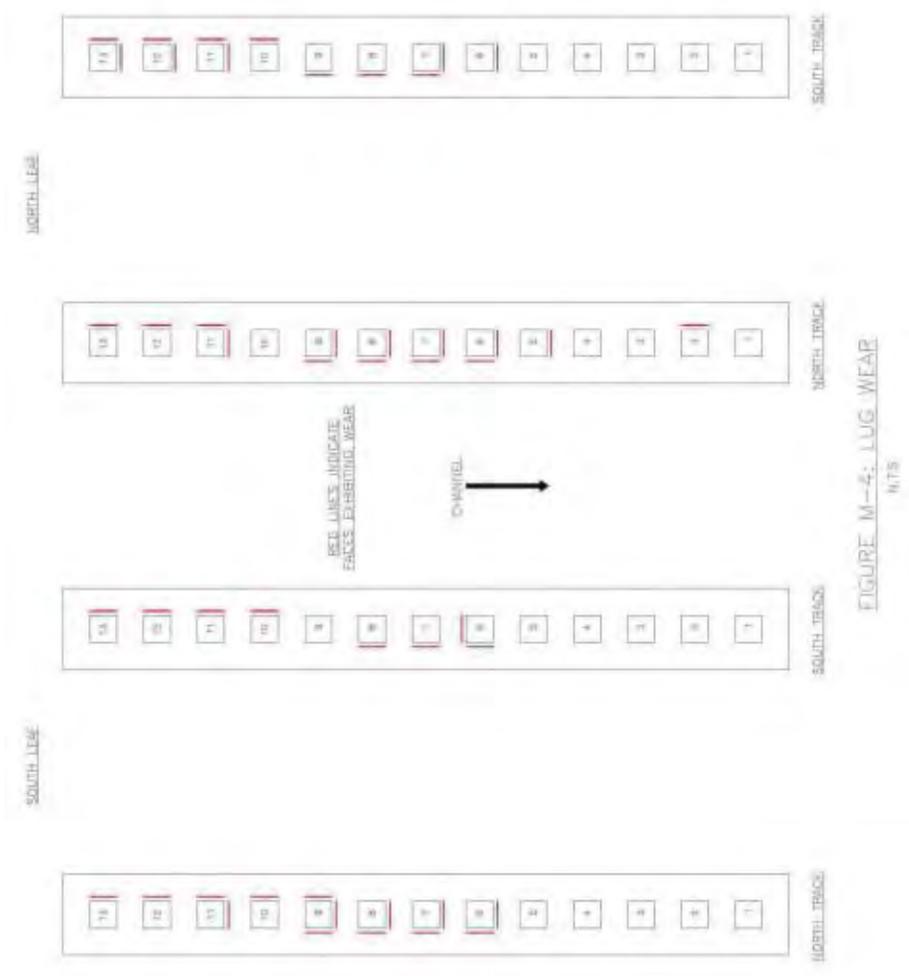
FIGURE M-4. LUG WEAR
NTS

At all locations, lug wear was present on one or more of the four outer faces, (See Photo M-32, Appendix B). For each lug, the faces exhibiting wear was noted and illustrated, (See Figure M-4, Lug Wear, Appendix A). In addition, sample lug thicknesses were measured and found to be between 2" to 2-1/16" thick.

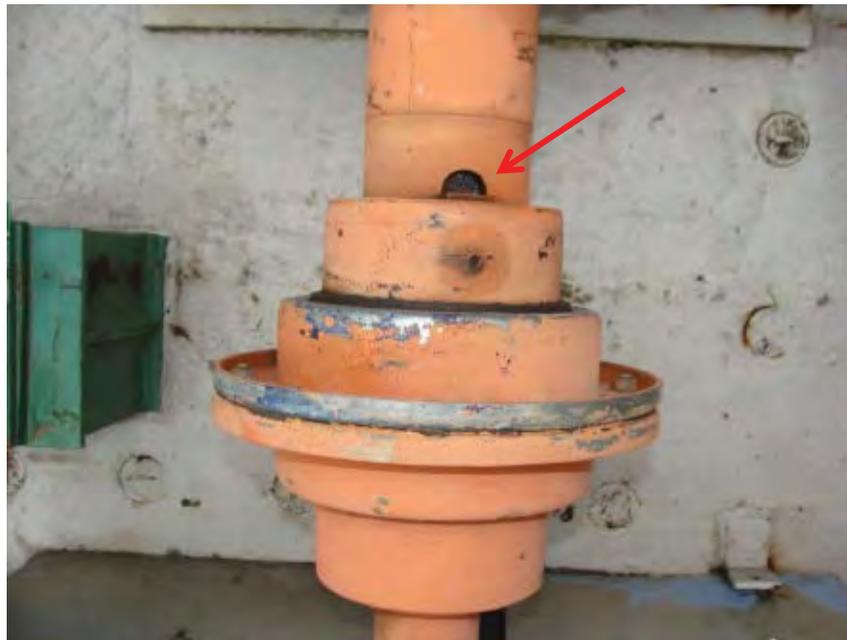
Photo M-02. North Leaf, South Motor Coupling.

1. Re-align motor coupling key at the north leaf, south motor coupling.
2. Replace span drive bearing shims with new stainless steel shims with holes for mounting fasteners.

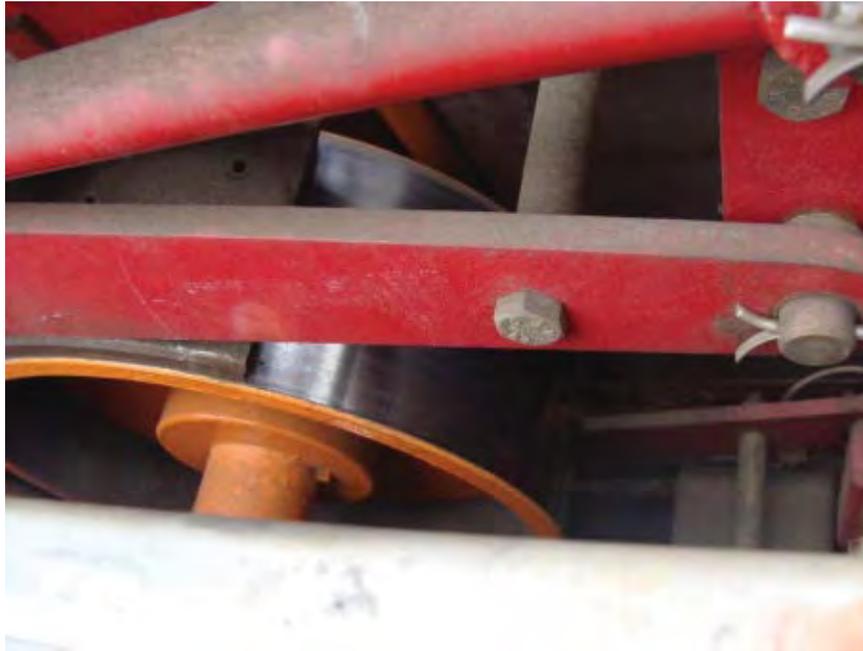
Photo M-08. North Leaf Brake Wheel. (Minor corrosion)

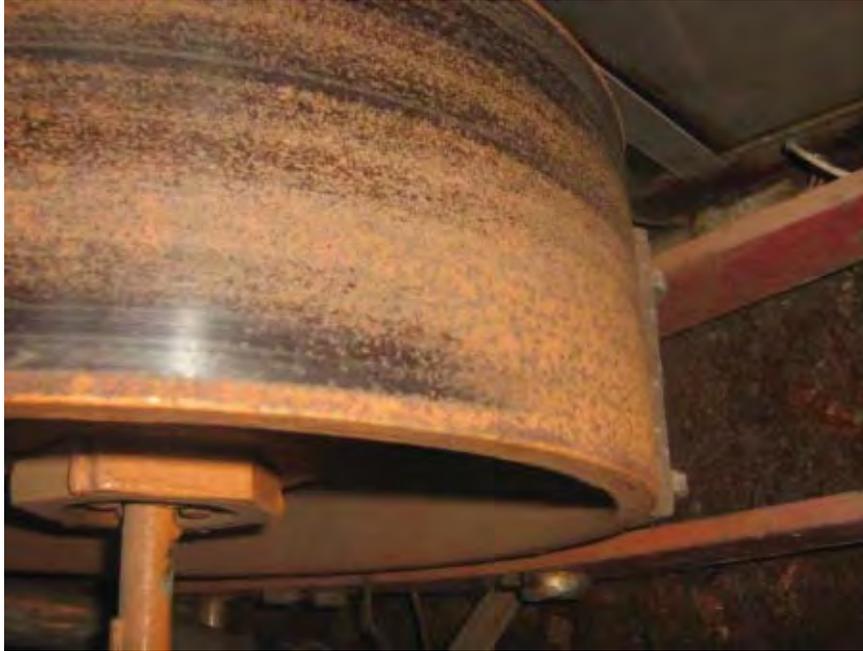
Photo M-09. South Leaf Brake Wheel. (Moderate corrosion)

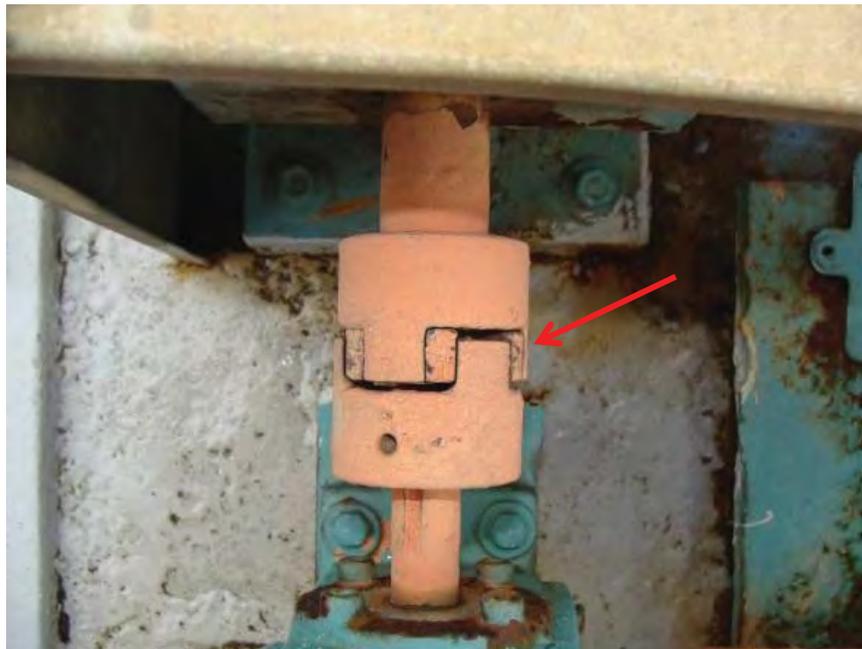
Each set of span drive machinery is equipped with two (2) motor couplings, two (2) cross shaft gear couplings and two (2) instrument drive jaw type couplings. All coupling components, such as hubs, keys, keyways and lubrication holes were visually inspected for signs of damage or distress such as relative movement between halves, cracks on keys/keyways, and twists/deformations. All couplings have scattered areas of paint failure with light corrosion and grease build-up on their covers and fasteners, (See Photos M-10 & M-11, Appendix B). Affected couplings should be cleaned and the paint touched-up, as necessary. In addition, grease fittings were found to be un-painted, indicating proper access to lubricate. Protruding grease fittings from a coupling is a safety hazard. Fittings should be used only to add grease, then removed and replaced with a recessed plug after maintenance. At the north leaf, instrumentation coupling C3 exhibited sizeable gaps between the coupling inserts and

hubs, (See Photo M-12, Appendix B). This coupling and instrumentation unit should be disassembled, realigned, and reassembled. During multiple operations of the bridge, all coupling assemblies operated smoothly with no vibration, heat build-up or noise. Overall, the span drive coupling assemblies were found to be in good condition.

Photo M-12. North Leaf, Coupling C3.

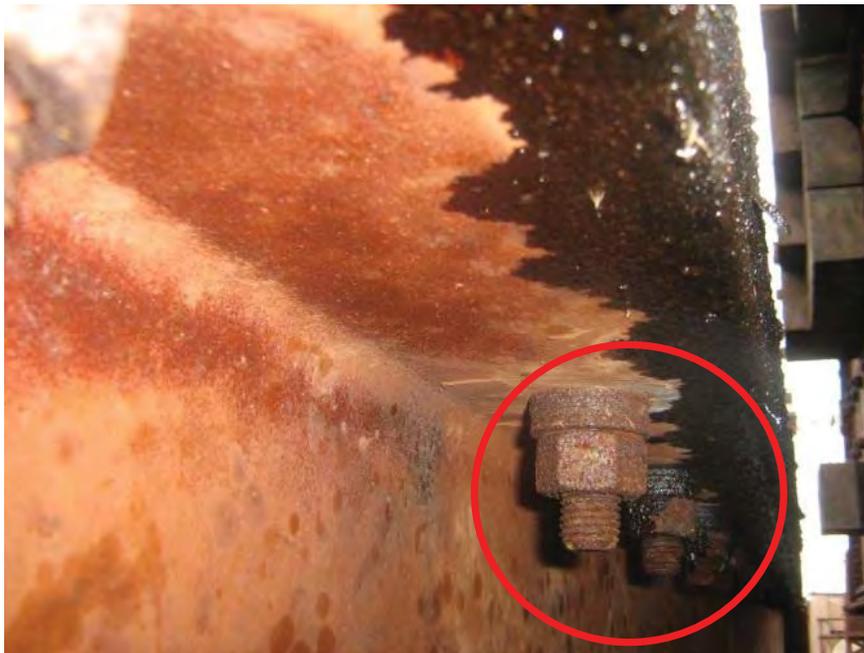
Photo M-16. South Leaf, South Rack (Note corrosion on fasteners).

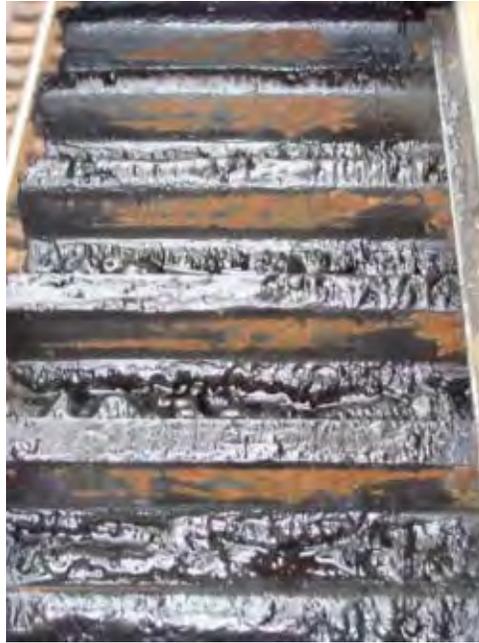
Standing water not found. Most likely dried up.

Photo M-17. South Leaf, Gear Bs (Note standing water on open gearing).

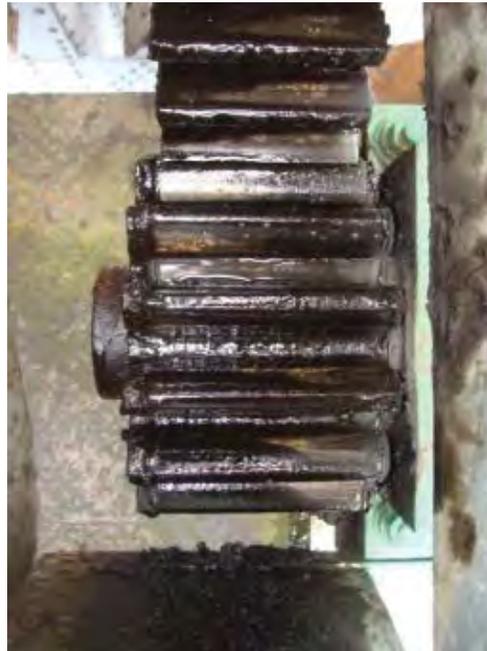
Standing water not found. Most likely dried up.

Photo M-18. North Leaf, Pinion C_N (Note standing water on open gearing).

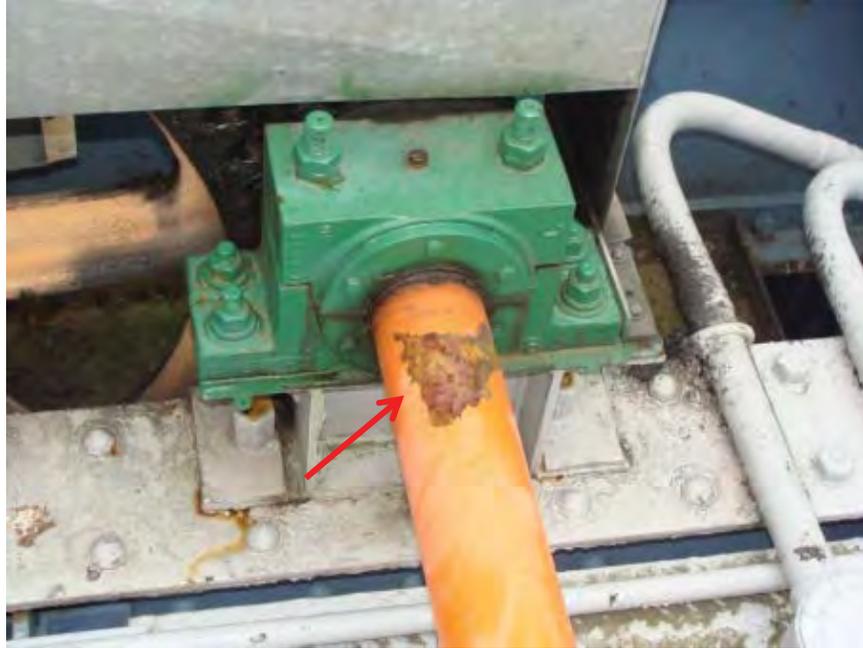
Photo M-19. North Leaf, Shaft S3s (Note paint failure and surface rust).

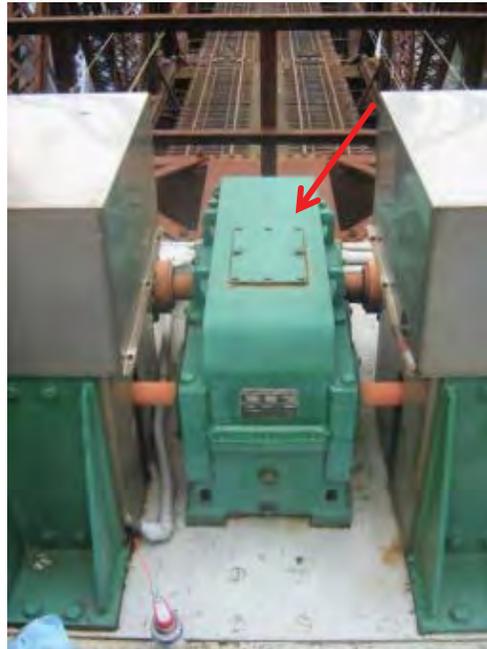
Photo M-20. South Leaf, Main Reducer (Note minor corrosion).

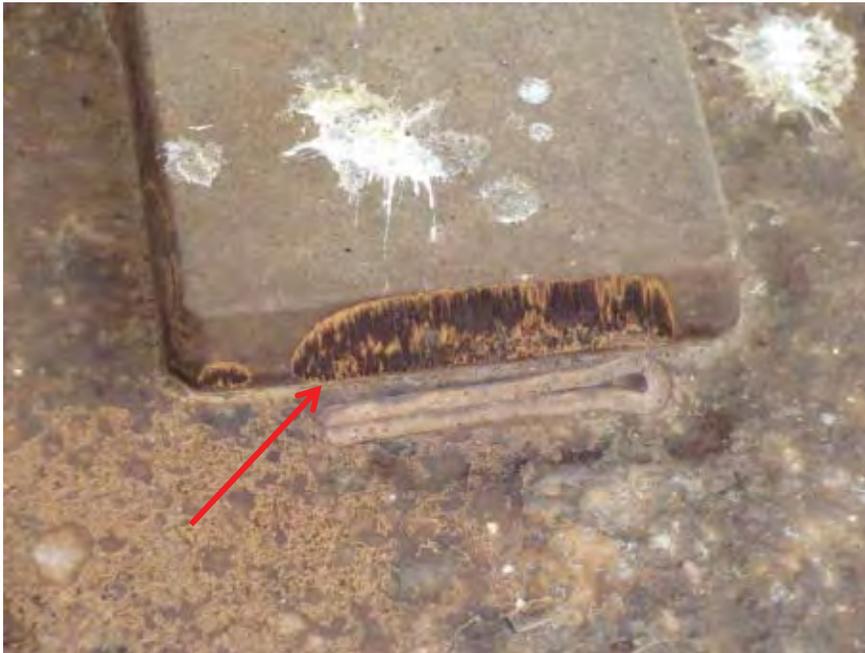
Photo M-32. Lug Wear.

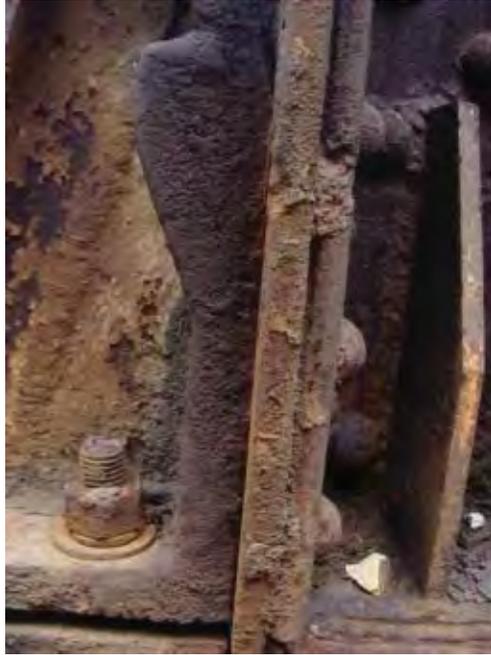
Each span is equipped with two (2) centering devices mounted at the toe of the leaf. All centering devices were visually inspected for signs of damage or distress. Assemblies were found to exhibit moderate to severe rust, (See Photo M-35, Appendix B). Affected areas should be cleaned and the paint touched-up, as necessary. During multiple operations of the bridge, all centering devices operated smoothly with acceptable misalignment and no unusual noise. Overall, the centering devices were found to be in good condition.

Photo M-35. North Leaf, South Centering Guide.

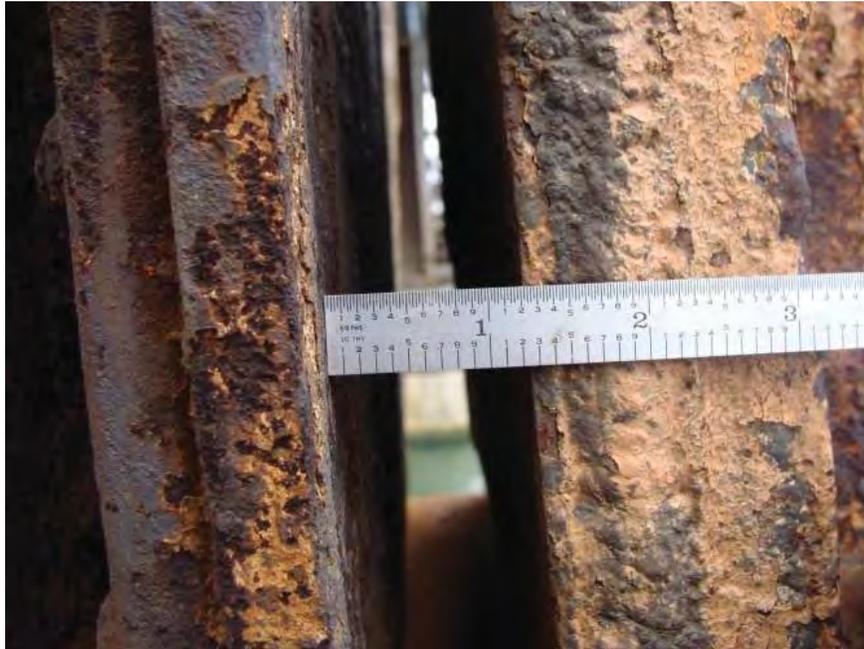
At all locations, clearances between the centering devices were measured, (See Photo M-36, Appendix B). The measurements were then tabulated, (See Table M-4, Span Support Machinery – Centering Device Clearance Measurements, Appendix B). Centering device clearance measurements were found to be slightly larger than previous measurements but acceptable.

Photo M-36. North Leaf, North Centering Guide Clearance.

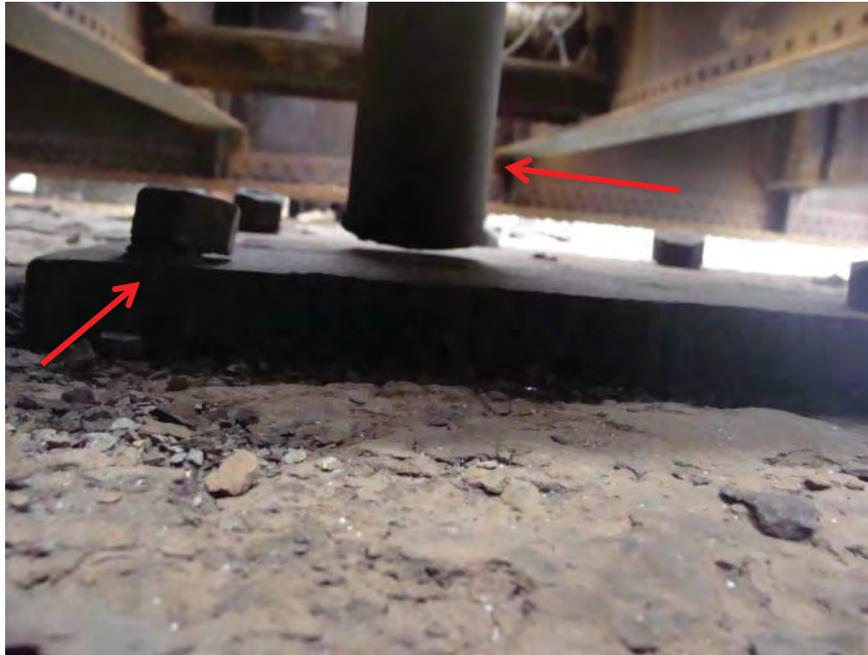
Each span is equipped with one (1) air buffer and strike plate assembly located at the center of the movable span, near the span lock machinery. The air buffers have been inoperable for some time and were not inspected at the time of this inspection. Air buffer rods did not reach the strike plate and the strike plate fasteners seemed to be bent and unsecure, (See Photo M-37, Appendix B). Air buffers should be refurbished and placed back into service as soon as possible. Overall, the air buffers were found to be in poor condition.

Photo M-37. South Leaf, Air Buffer Strike Plate.

10. Span lock enclosed gear reducers should have an oil level gauge installed.
11. Air buffers should be refurbished and placed back into service.
12. Replace protruding grease fitting from span drive couplings with recessed fittings.

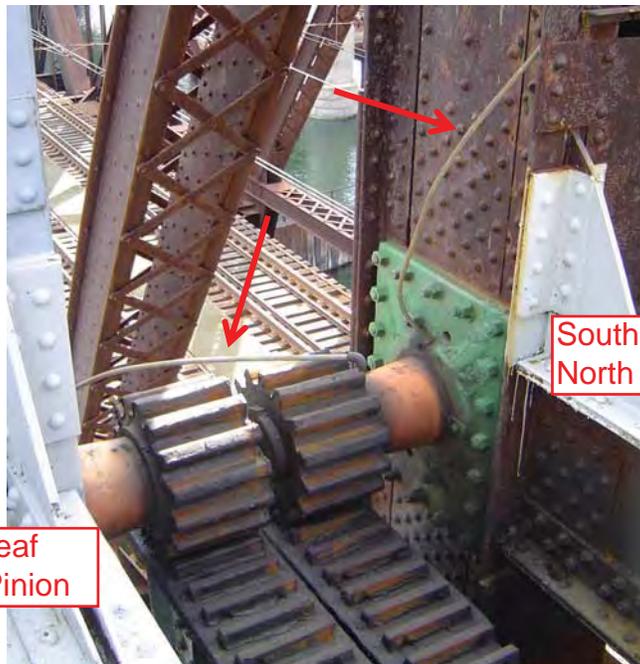
Lubrication tubing was found to be loose in the vicinity of the open gearing. See Photo M-V38.

Photo M-V38. Pinion Bearing Grease Tubing is loose, over North Leaf (South Pinion) and South Leaf (North Pinion)

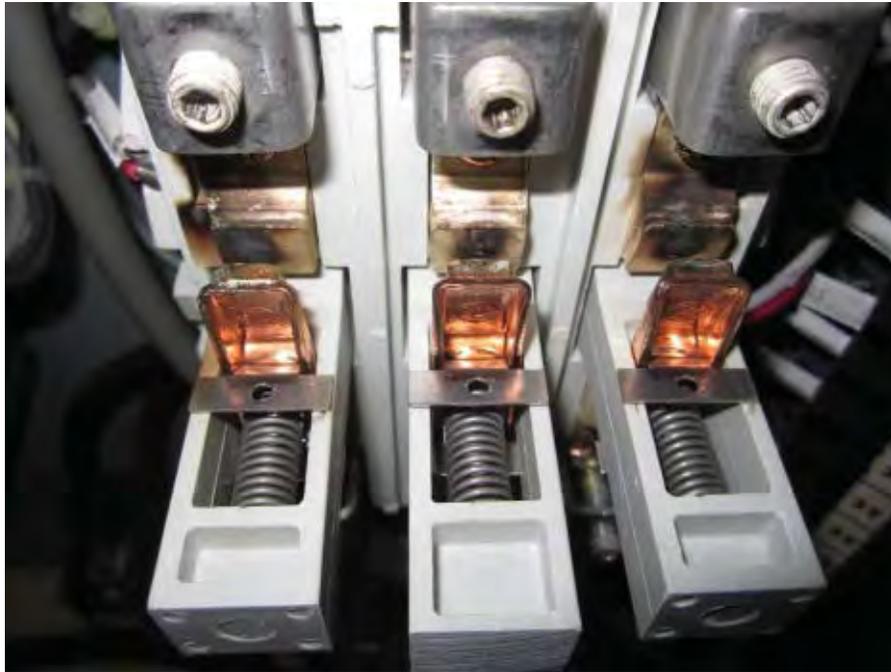
Photo E-03. Typical contactor contact assembly showing minimal signs of wear.

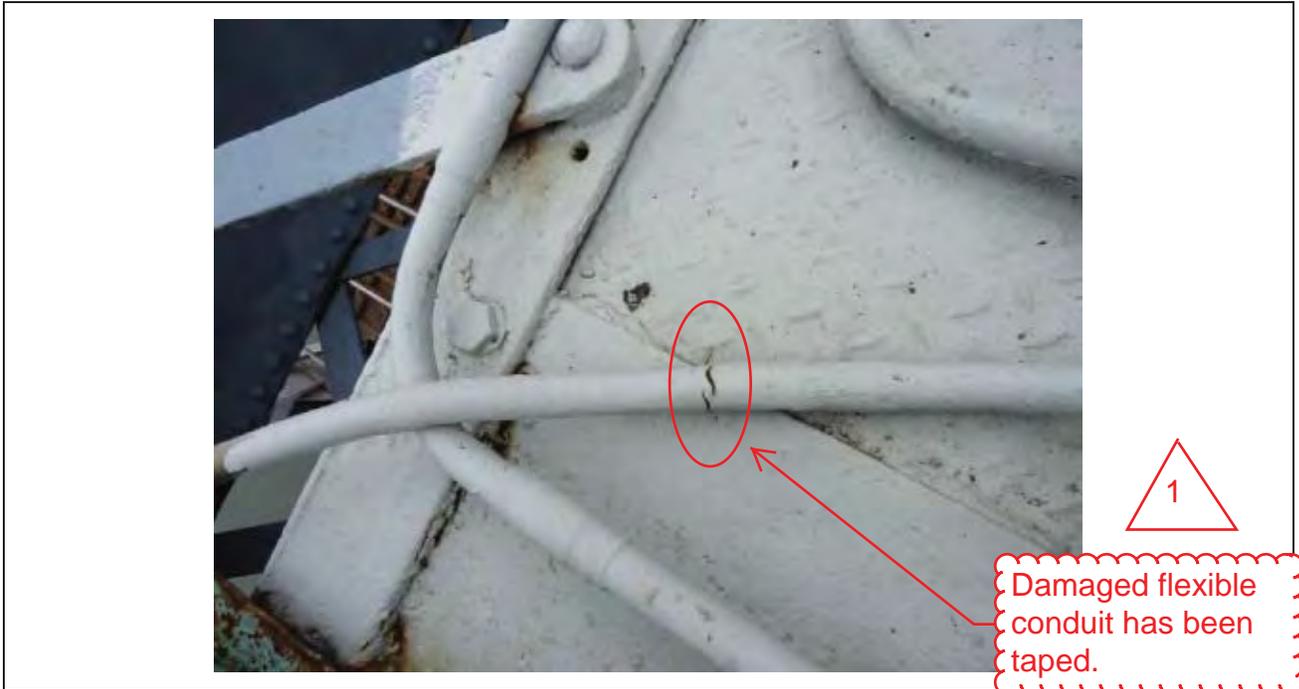
Photo E-23. Damaged Flexible Conduit Attached to North Span Position Indicator.
