**REHABILITATION STUDY REPORT**

**STATE PROJECT NO. 126-170**

**BRIDGE NO. 00571A  
ROUTE 8 OVER THE HOUSATONIC RIVER**

**July 2014**

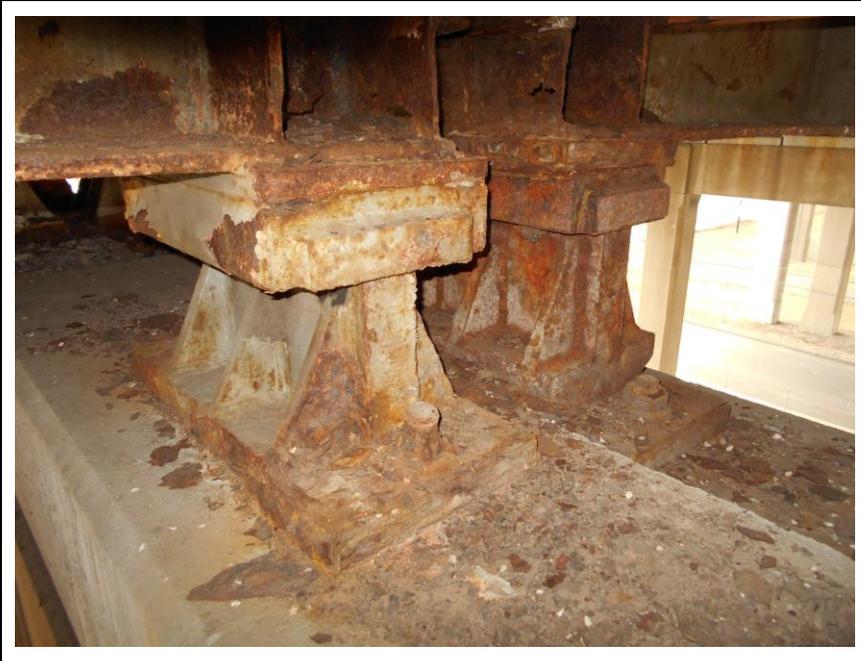
**Photo 7:** Bridge No. 00571A, Typical Condition at Original Girders Fixed Bearing in Approach Spans. Note the 90% Section Loss to Anchor Bolt Nut.

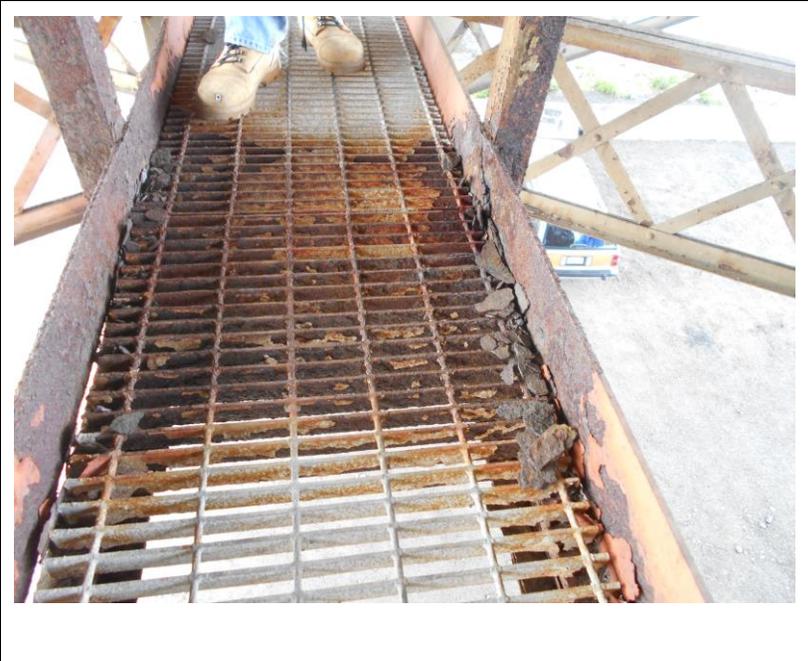
**Photo 8:** Bridge No. 00571A, Heavy Corrosion of Inspection Walkway Grating.

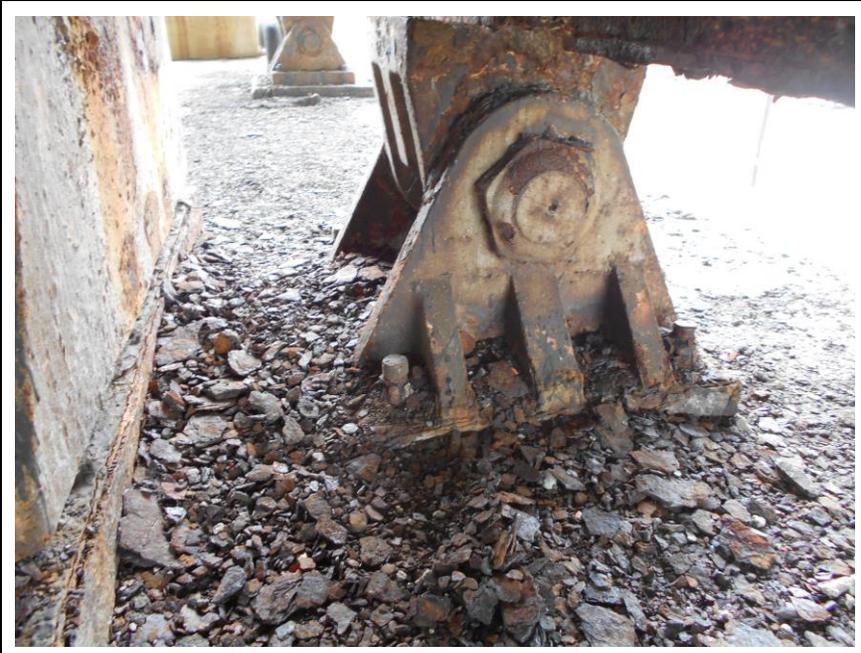
**Photo 9: Bridge No. 00571A, Significant Rust Accumulation at Steel Truss Bent at Pier No. 8.**

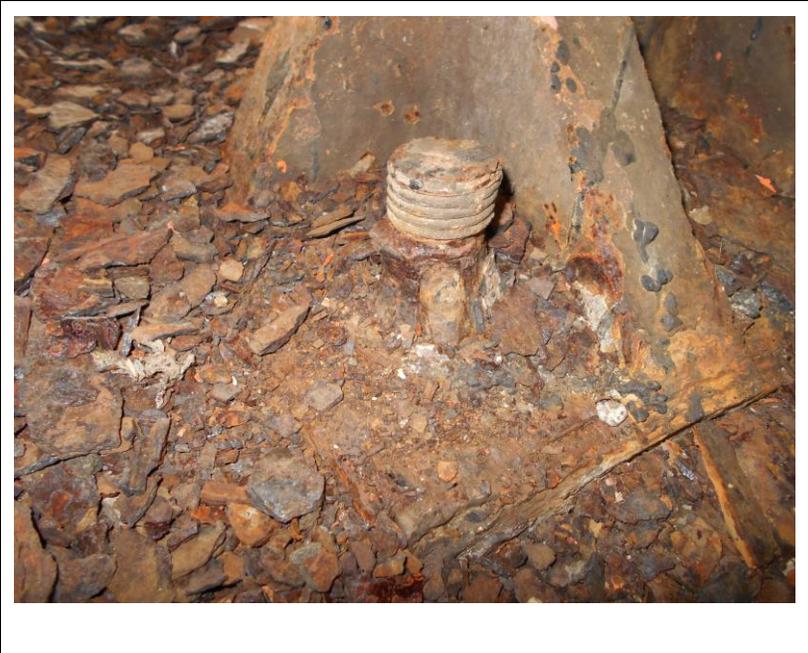
**Photo 10: Bridge No. 00571A, Severe Anchor Bolt Nut Section Loss at Bearing of Steel Truss Bent at Pier No. 8.**

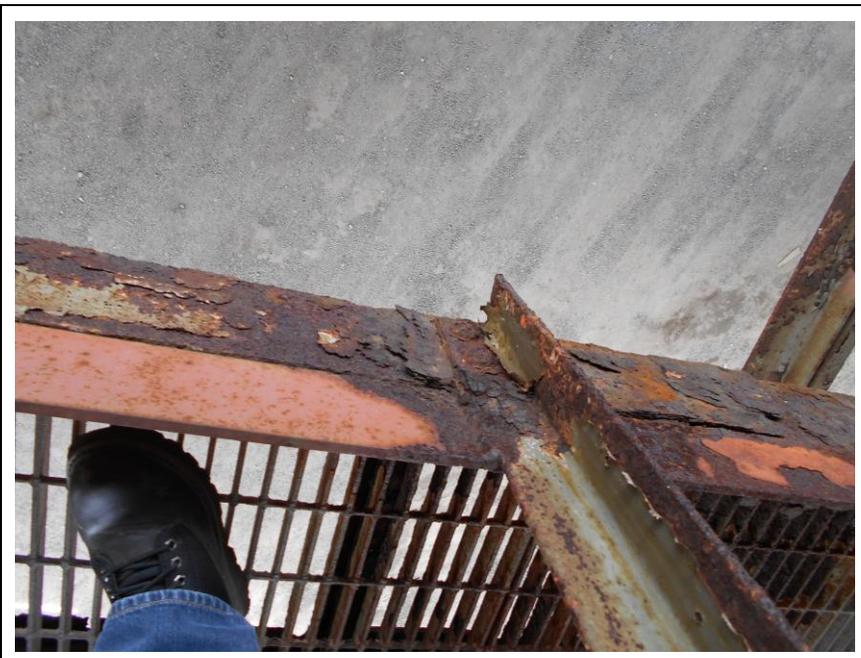
**Photo 13:** Bridge No. 00571A, Heavy Corrosion of Inspection Walkway Channel Member.

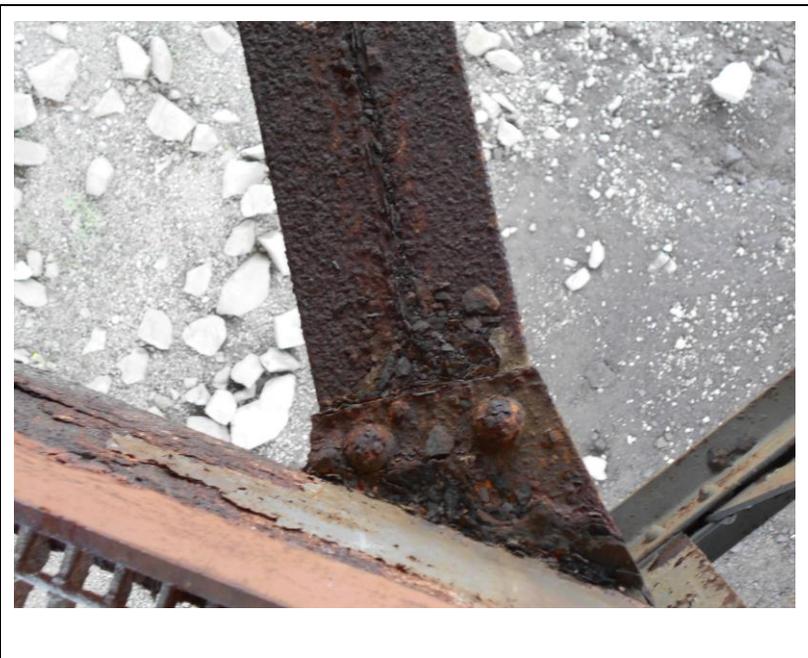
**Photo 14:** Bridge No. 00571A, Corrosion of Cross Bracing Member and Gusset Plate.

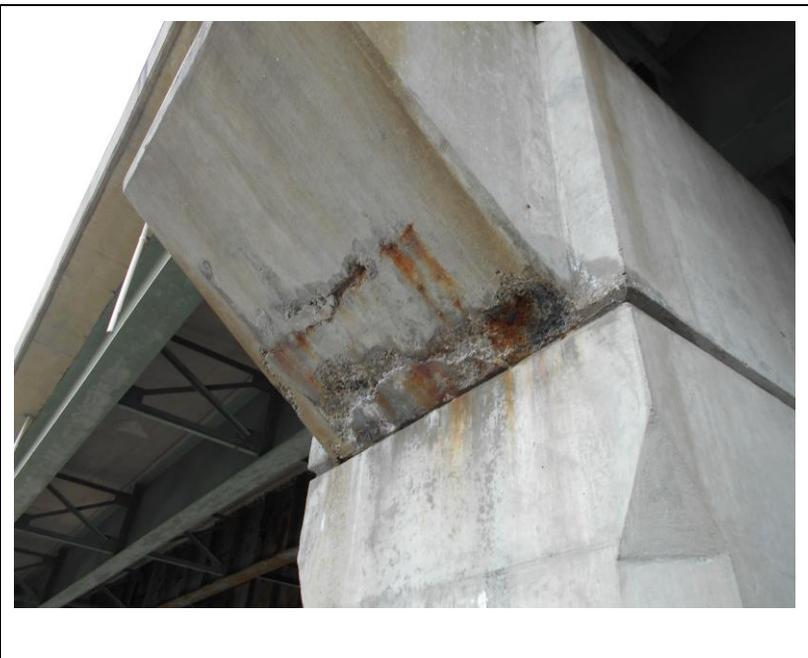
**Photo 18:** Bridge No. 00571A, Deterioration and Exposed Rebar at Pier No. 1.

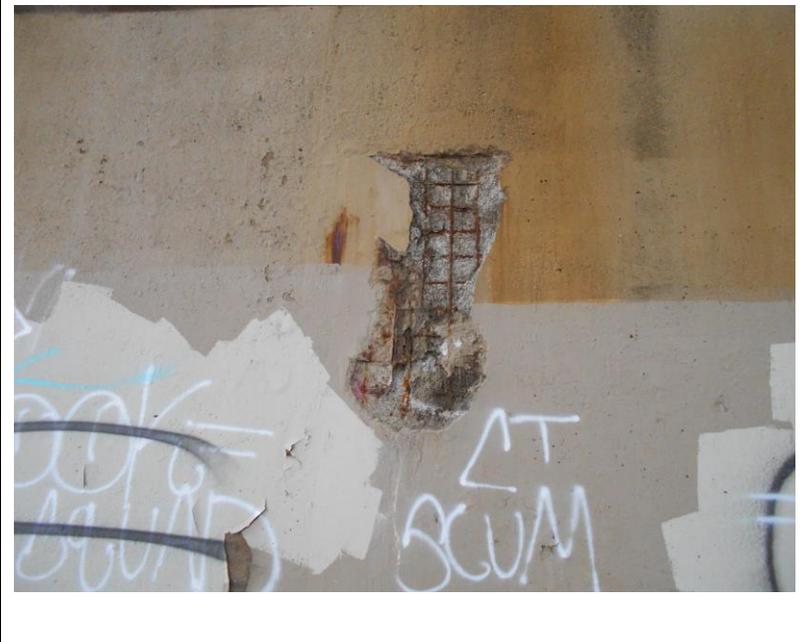
**Photo 20:** Bridge No. 00571A, Exposed Rebar and Spall at Pier No. 8.

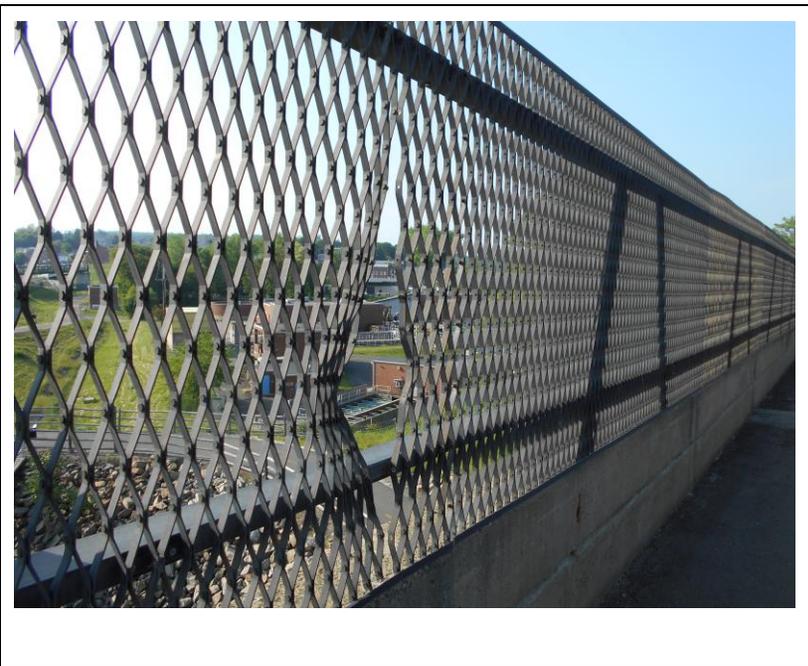
**Photo 22: Bridge No. 00571A, Aluminum Fencing Damage.**

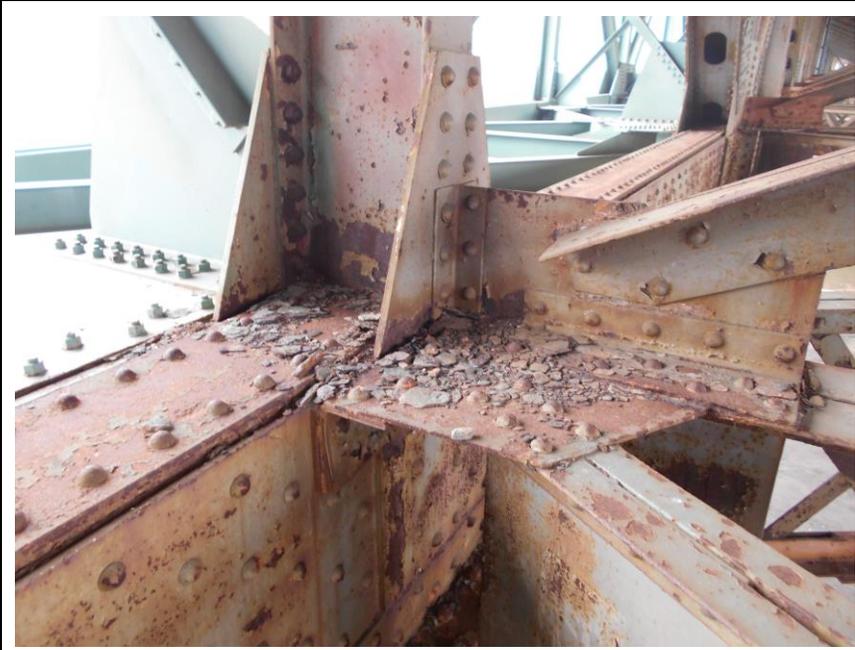
**Photo 23:** Bridge No. 00571A, Rust Accumulation around Horizontal and Vertical Gusset Plates at Bottom Chord of Span Truss.

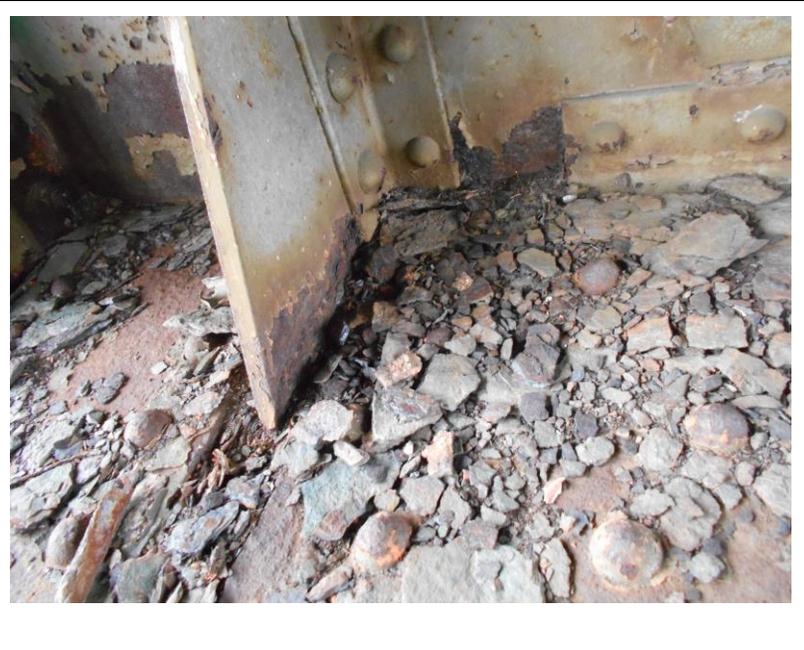
**Photo 24:** Bridge No. 00571A, Deterioration of Vertical Gusset Plate due to Rust Accumulation on Horizontal Gusset Plate.

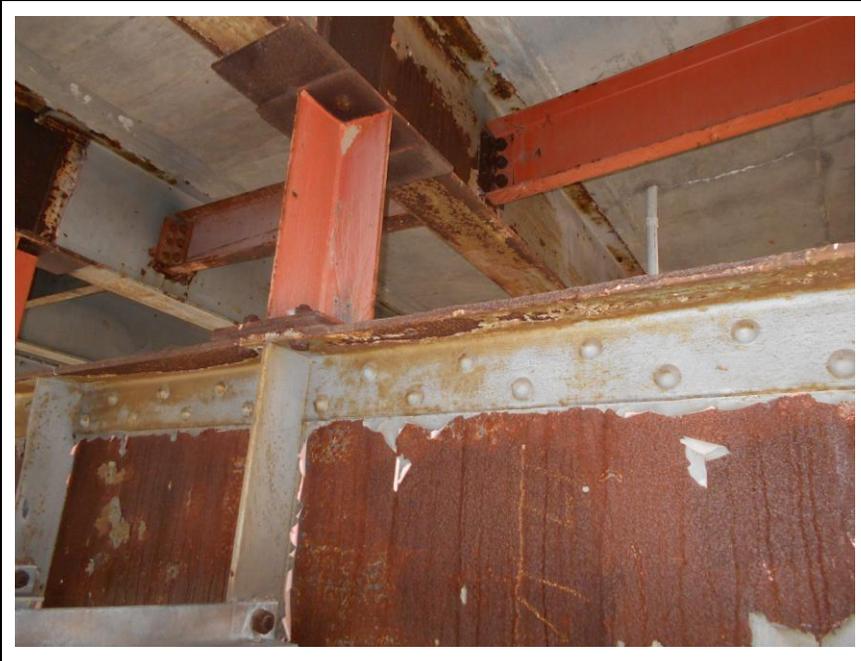
**Photo 25:** Bridge No. 00571A, general state of Floorbeam Deterioration.

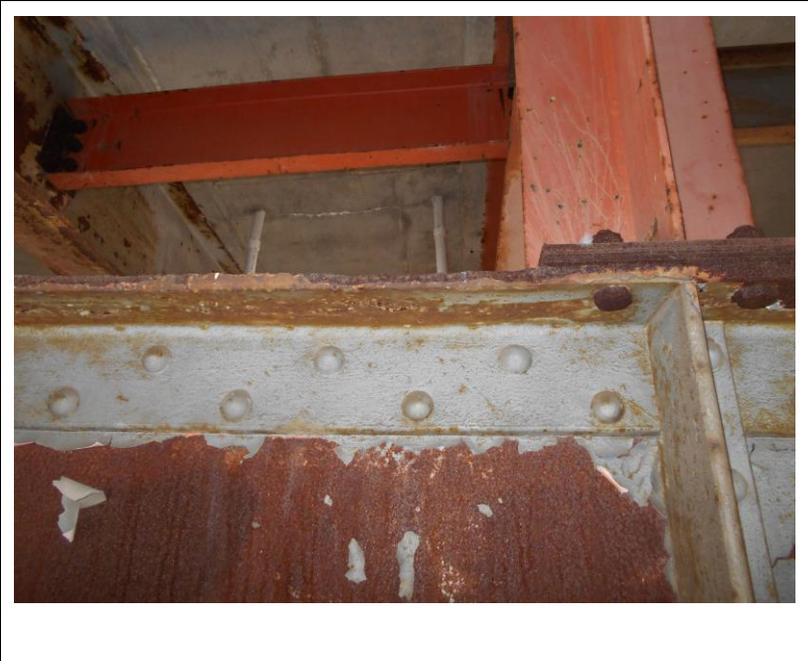
**Photo 26:** Bridge No. 00571A, Section Loss of Top Flange of Floorbeam due to leakage.

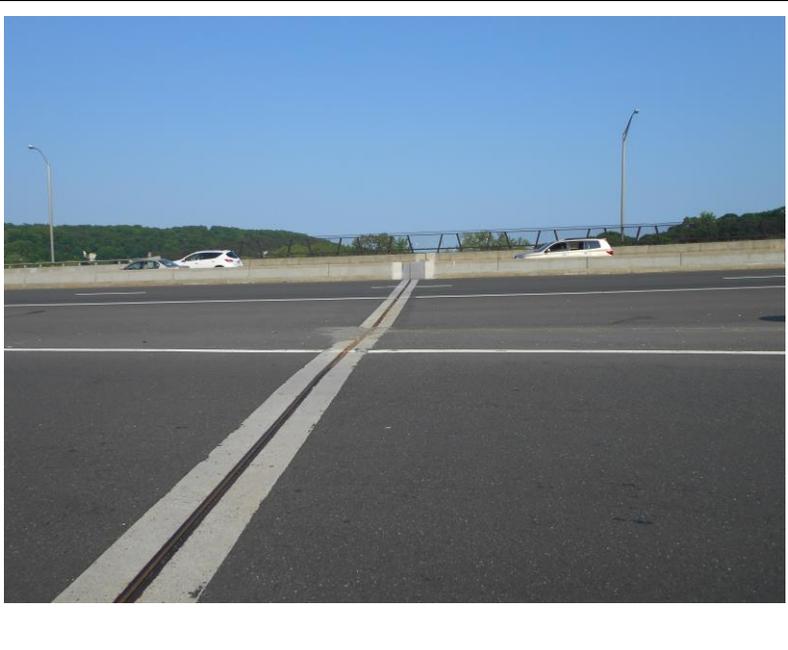
**Photo 30: Bridge No. 00571A, Deck Joint in good condition with Minor Debris Accumulation.**

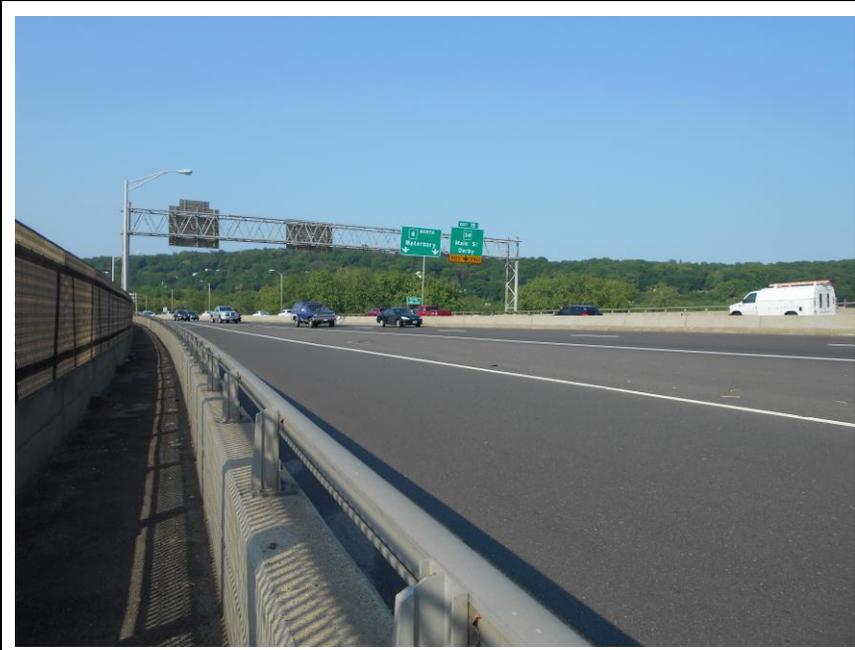
**Photo 31:** Bridge No. 00571A, general condition of Bridge Wearing Surface.

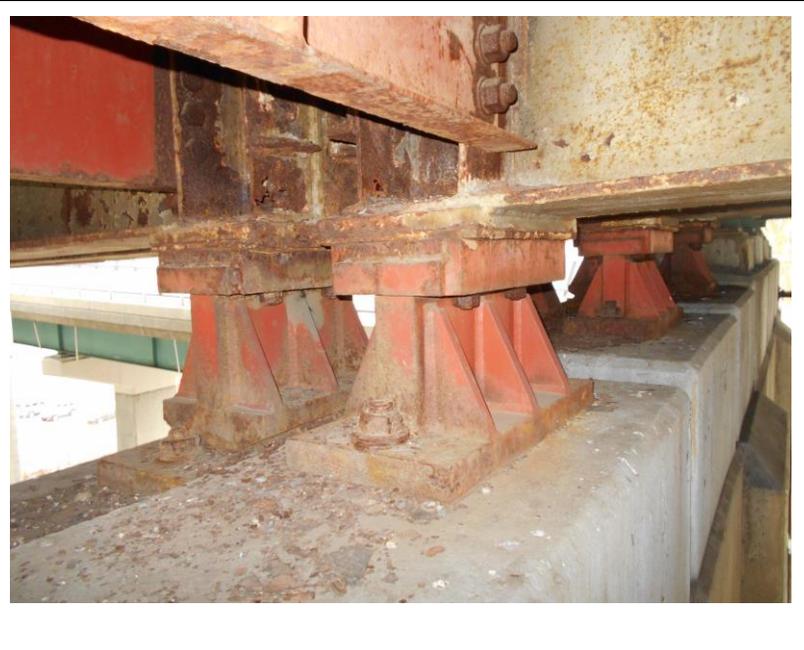
**Photo 32:** Bridge No. 00571A, general condition of Fixed and Rocker Expansion Bearings replaced during Project No. 126-119.

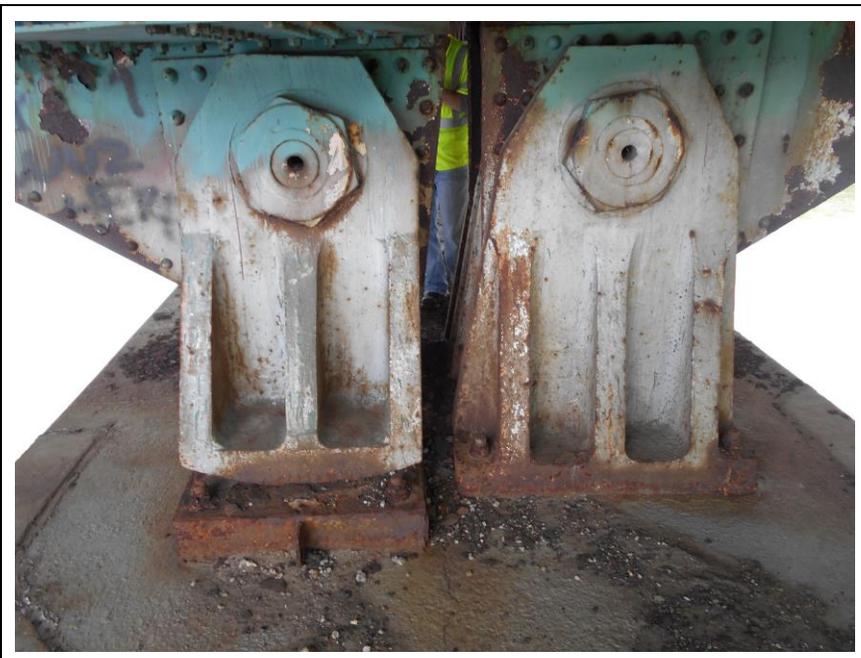
**Photo 33:** Bridge No. 00571A, general condition of Fixed and Expansion Bearings of Original Trusses in Spans 9, 10 and 11.

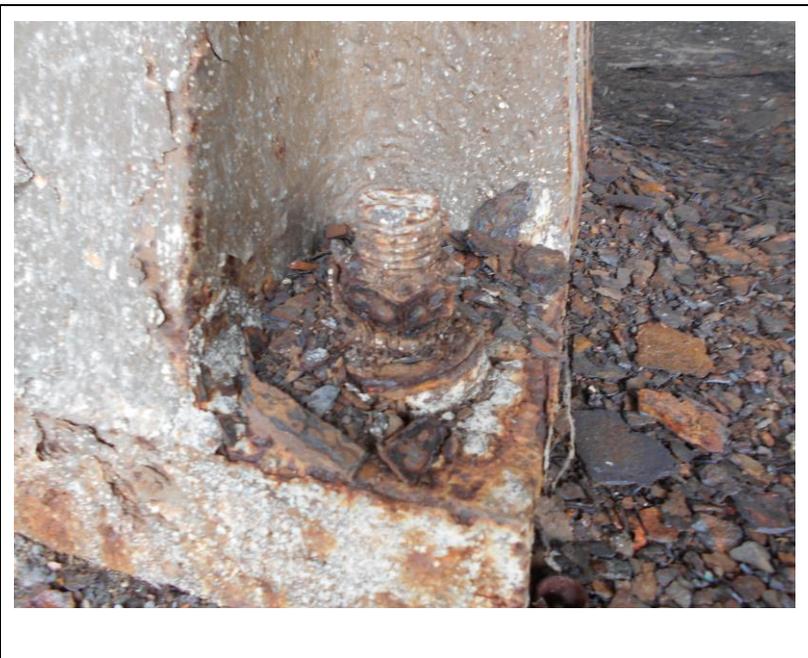
**Photo 34:** Bridge No. 00571A, severe section loss of Fixed Bearing Anchor Bolt Nuts in the Original Trusses in Spans 9, 10 and 11.

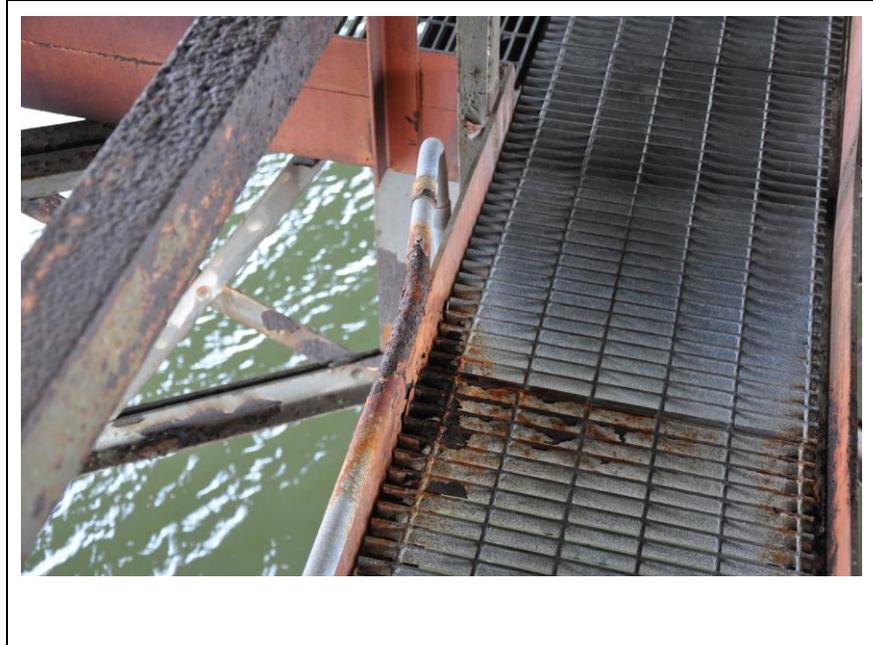
**Photo 37: Bridge No. 00571A, Corrosion of 1" RGS Conduit.**

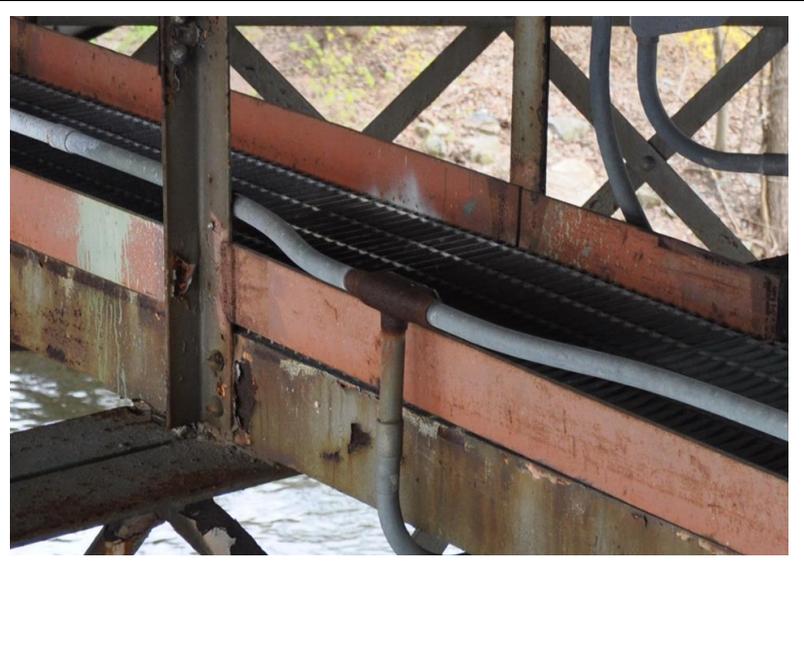
**Photo 38: Bridge No. 00571A, Junction in 1" RGS Conduit, note corrosion.**
