STRUCTURE NO. 01061

ROUTE 67
over
LITTLE RIVER
SEYMOUR

Above & Underwater Inspection
on
10/23/06

BRIDGE NO. 01061
ROUTE 67 OVER LITTLE RIVER
SEYMOUR, CONNECTICUT
OCTOBER 23, 2006

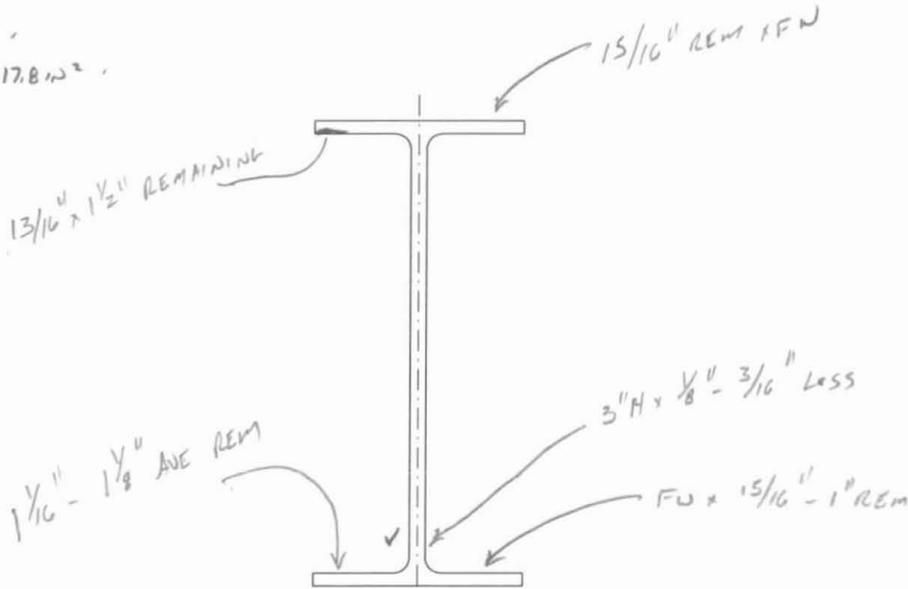
(3) [FB #8, TYP X-SECTION THRU-OUT (MEAS NEAR G2); LOOKING SOUTH]

W33x240 ORIG
 WEB = 33.5" x 0.830"
 FLG = 15.865" x 1.40" = 22.211"

TF LOSS = 187
 BP LOSS = 48

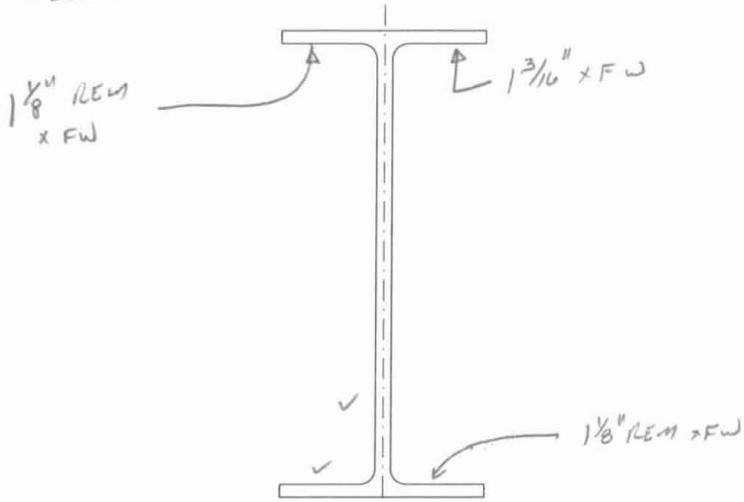
⑤ [FB #12, ± 15' FROM GZ, LOOKING SOUTH (± 4' L), SIMILAR @ MIDSPAN]

W33 x 240 ORIG
 WEB = 33.5 x 0.83
 FLG = 15.865 x 1.40 = 22.2 in²

TF LOSS = 16%
 BF LOSS = 9%

UP TO 3" W x 1/8" LOSS @ U-SIDE TF
 (TYP ALSO AT OTHER RAND LOC'S ALONG BEAM)

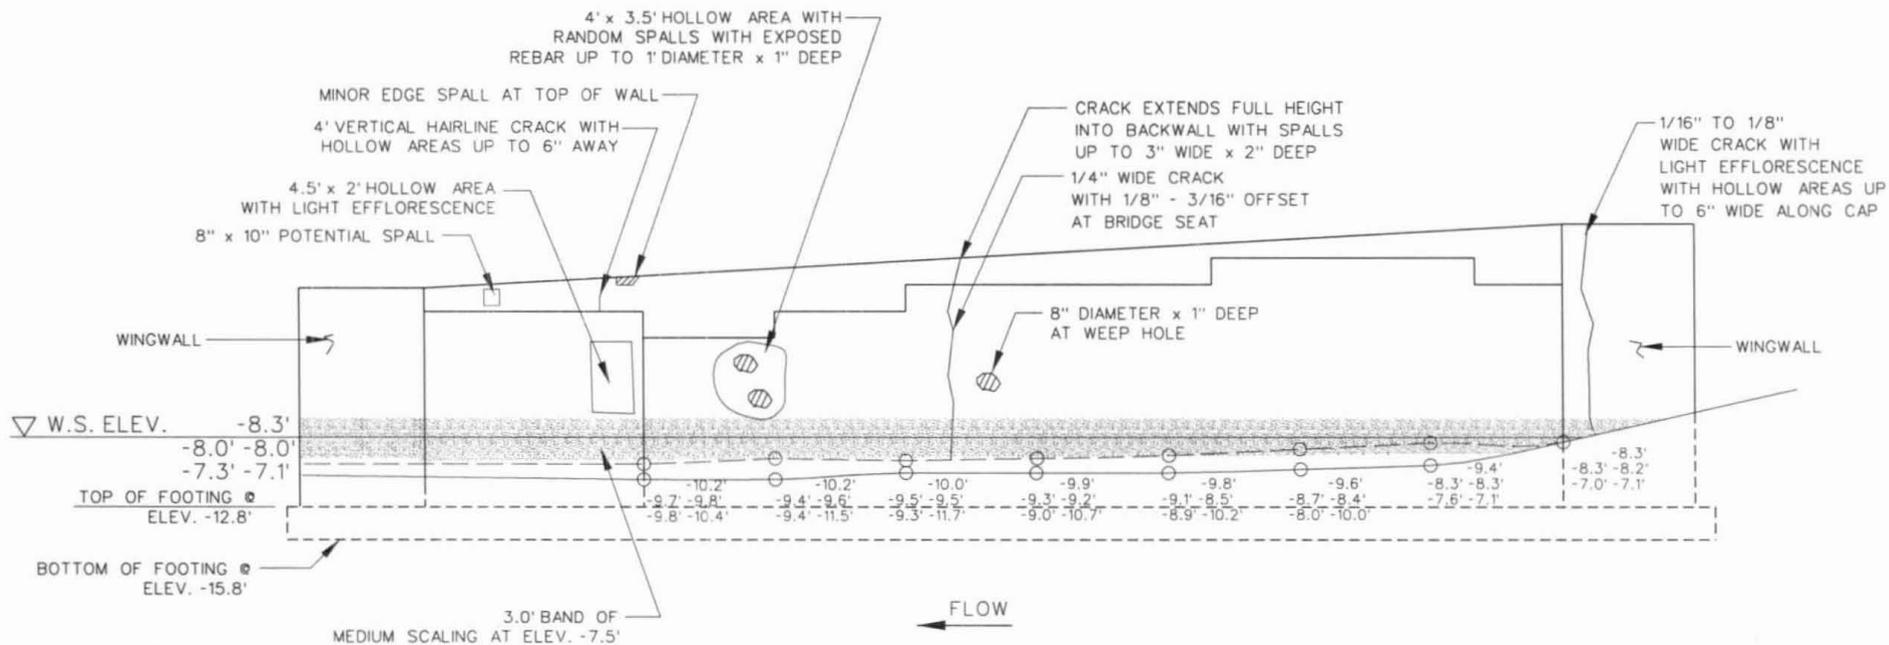
SHEET 21 OF 40

- 1. FOOTING ELEVATIONS BASED ON FIELD MEASUREMENTS.
- 2. FOOTING IS EXPOSED OVER 20' IN LENGTH.

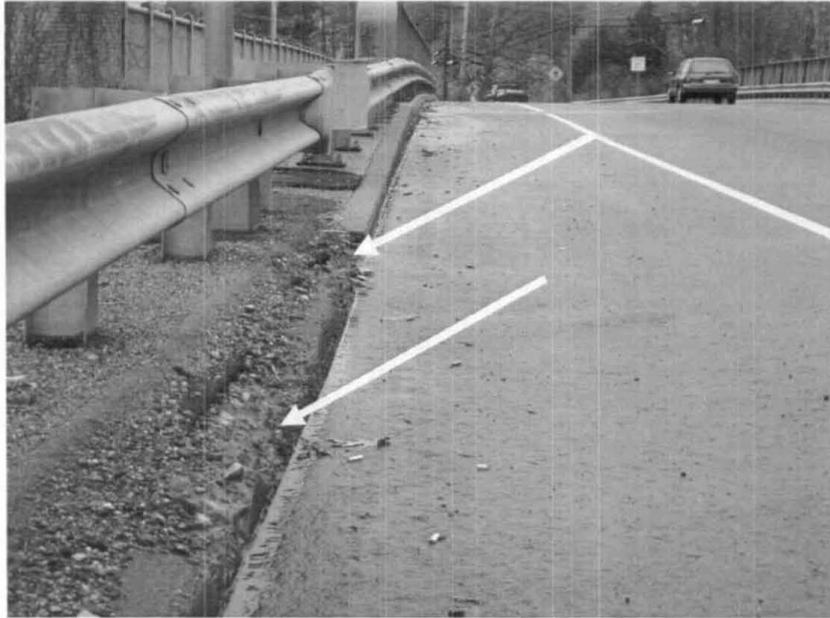
2. The concrete approach curbs at the southeast corner of the bridge exhibit several areas of severe spalling/scaling, up to full height x full width x 7.5' long. Repair approach curbs (¼ cubic yard).

Photo #7:
Description: Severe scaling/spalling of the southeast approach curb.

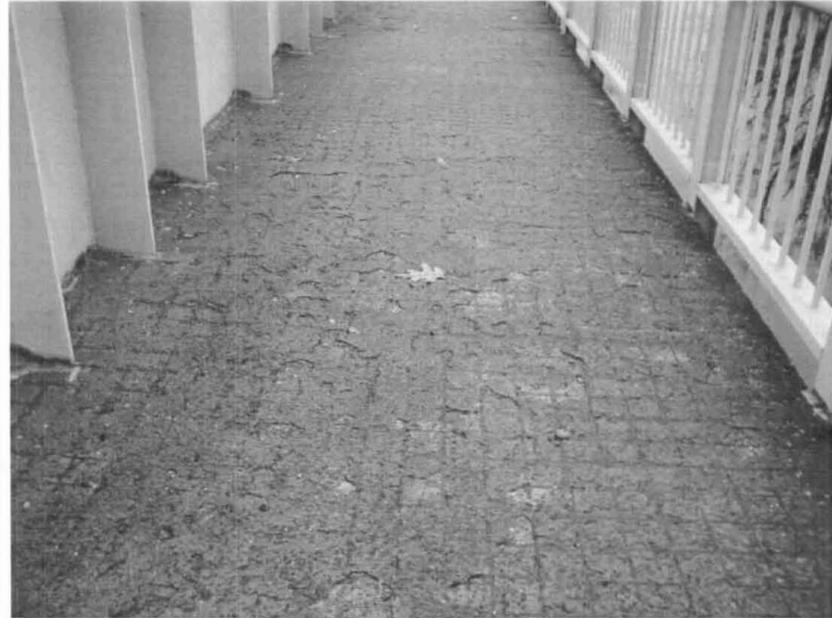
Photo #8:
Description: Scaling and delamination of the sidewalk up to 1/2" deep exposing the steel grid.

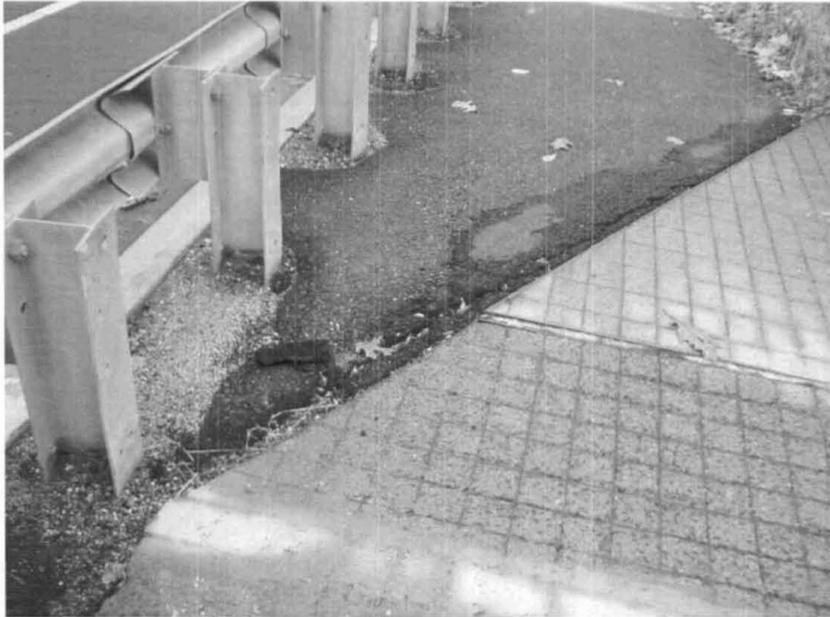
1. The bituminous ramp at the southeast corner of the bridge sidewalk is cracked, breaking up, and exhibits potholes up to 1.5 feet long x 3 inches wide x 1.5 inches deep. There are other deficiencies causing the concrete filled grid sidewalk to be rated poor (4).
2. Both the asphaltic plug joints over the abutments exhibit depressed areas up to ½ inch deep, heaved/pushed areas up to 1 ¼ inches high and minor adhesion cracking with active leakage noted.
3. There is one broken weld at the utility support bracket connection to the sidewalk stringer between floorbeams 16 and 17, leaving the bracket unsupported at this side.

Photo #9:
Description: Cracked and breaking up bituminous ramp at the southeast corner of the bridge.

1. Repair ramp at southeast corner.
2. Repair joints (160 linear feet).
3. Repair connection (1 location).

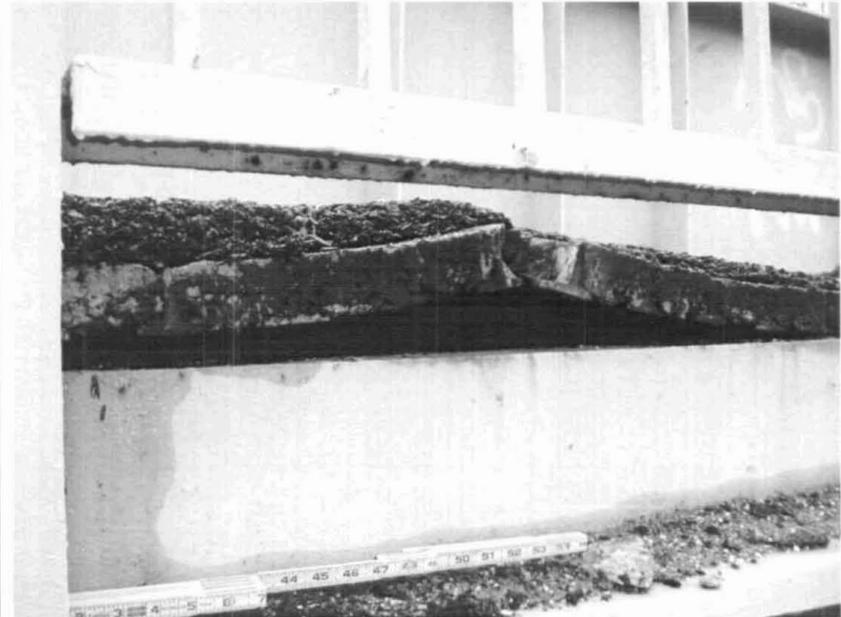
Photo #10:
Description: Concrete filled grid deck is not in contact with the south sidewalk stringer, one longitudinal grid bar is broken and a small section of concrete is missing below the railing.

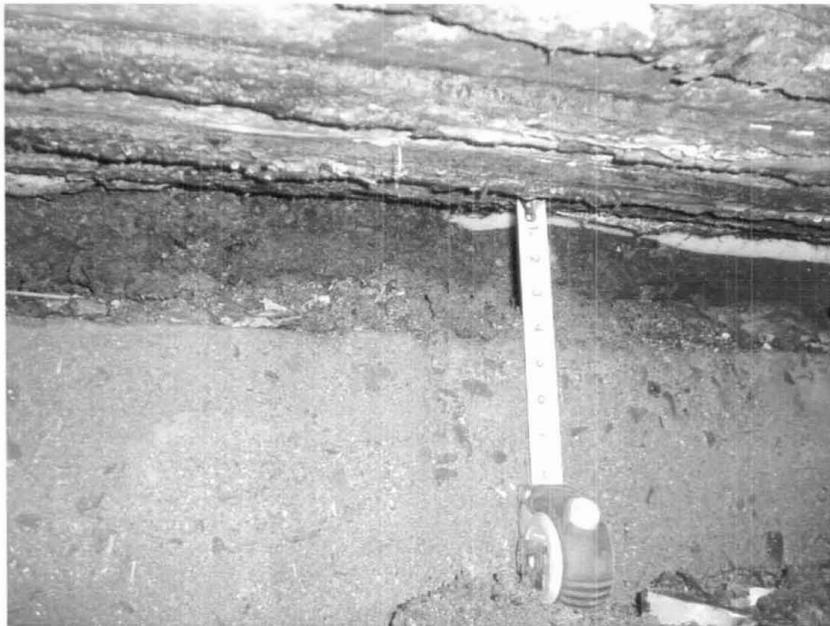
Photo #11:
Description: Gap up to 4.25" between the underside of the sidewalk and the top of the west abutment backwall. Note the bituminous on top of the backwall.

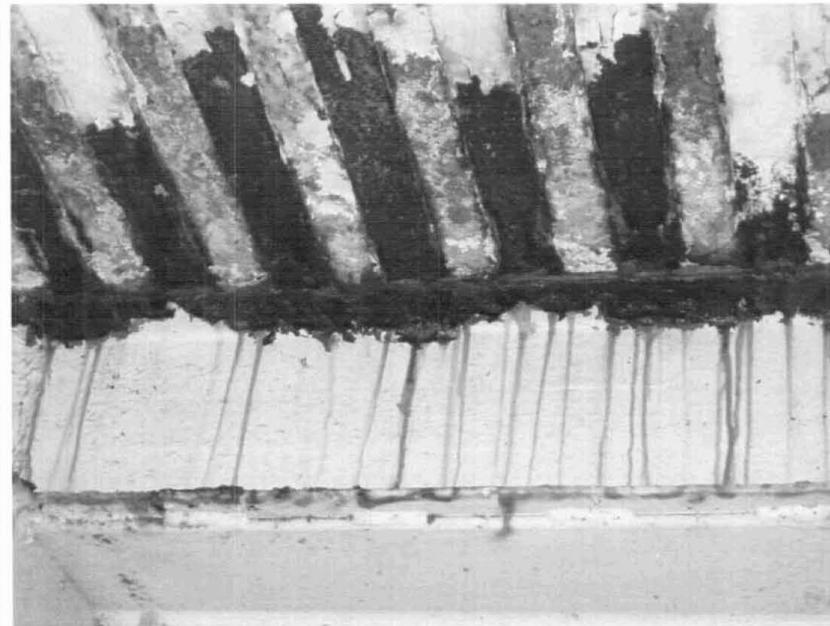
2. The sidewalk stringers exhibit areas of laminated rust with loss, with the worst loss locations along the south steel channel. The top flange of this channel exhibits areas of heavy rust and up to 1/2" loss of width with knife edging. The bottom flange of the channel exhibits knife edging up to 1" wide and random perforations up to 1/2" wide x 1' long. Continue to monitor these conditions. Consideration should be given to replacing the south stringer (108 linear feet).

Photo #12:
Description: Bearing bars with heavy rust and areas of loss of width along their bottom flanges. South sidewalk stringer (channel) with heavy laminated rust, knife edging, and perforations along the top flange.

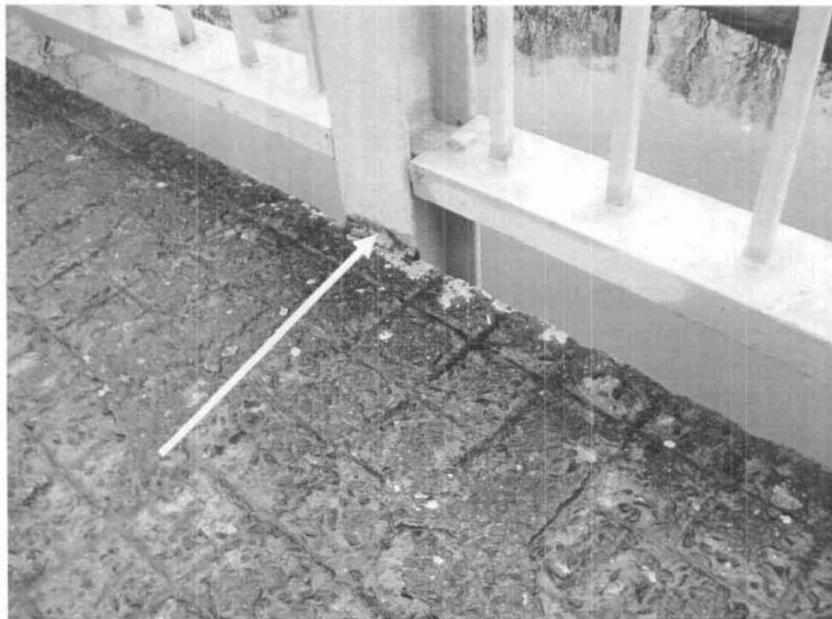
Photo #13:
Description: Typical painted over section losses along the base of the railing posts, just above the junction with the sidewalk.

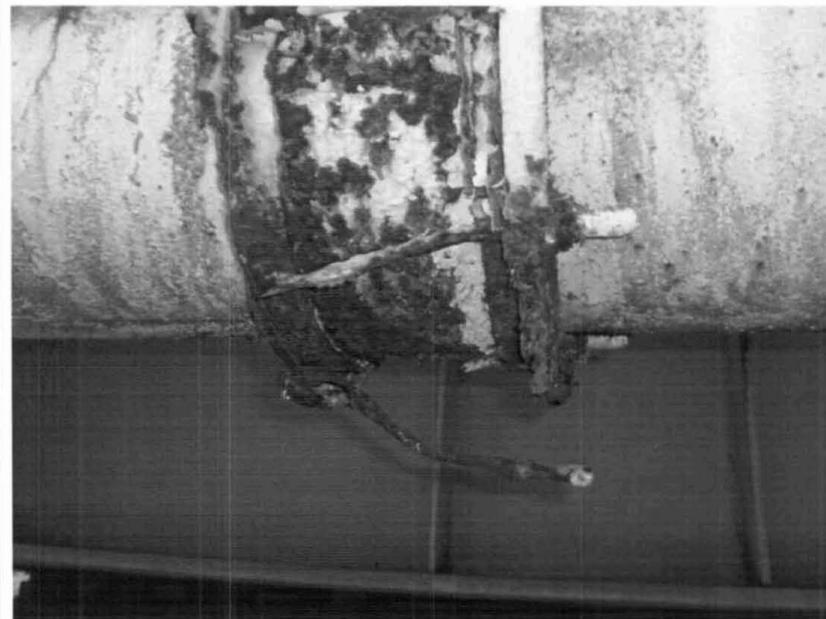
4. The coupling/splice bolts (nine at each splice) for the water main exhibit heavy laminated rust and up to 75% section loss on up to 3 bolts per splice. In addition, at the splice in the fifth sidewalk panel from the west abutment, up to 1' of the pipe flanges at the splice and two splice bolts exhibit up to 100% section loss. Finally, there are a total of five hangers that do not support the water main, four of which are consecutive and near the east end of the bridge. Repair splice bolts (20 each) and hanger connections (5 each).

Photo #14:
Description: Water pipe below the sidewalk exhibits rusted out flanges and bolts with up to 100% section loss at a splice in the fifth sidewalk panel from the west abutment.

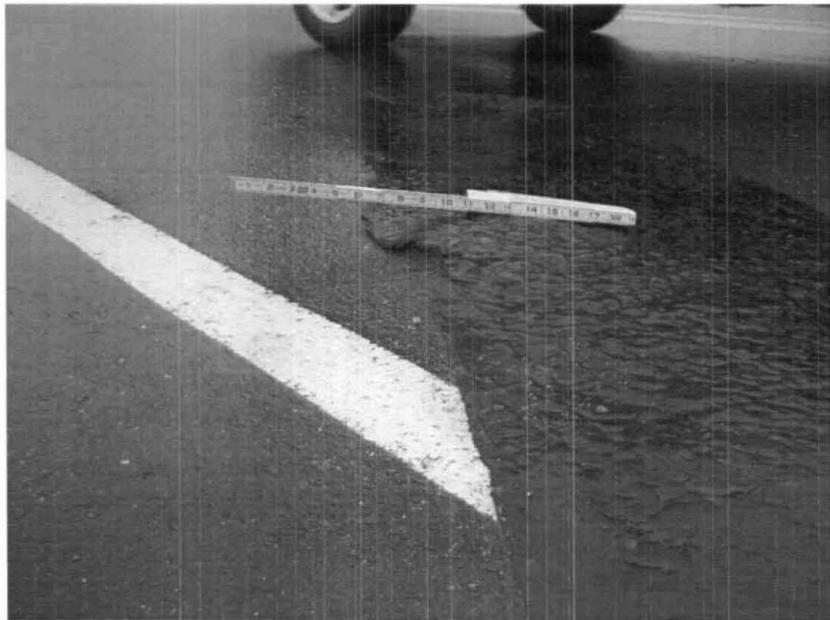
5. Both the asphaltic plug joints over the abutments exhibit depressed areas up to 1/2" deep, heaved/pushed areas up to 1.75" high and minor adhesion cracking. Both joints also exhibit active leakage. Repair joints (160 linear feet).

CONSTRUCTION JOINTS	N	
EXPANSION JOINTS	5	Asphaltic plug joints: The west abutment exhibits depressed areas up to 1/2" deep and heaved/pushed areas up to 1.75" high, mostly along the south end of the joint. The east abutment joint exhibits a 2' long section of heaved and segregated material, up to 1" high, and a 2' long x 1/8" wide adhesion crack. Both joints exhibit active leakage. See sheet 13 and photo 15.

Photo #15:
Description: Asphaltic plug joint at the west abutment, south end, with heaved and depressed areas.

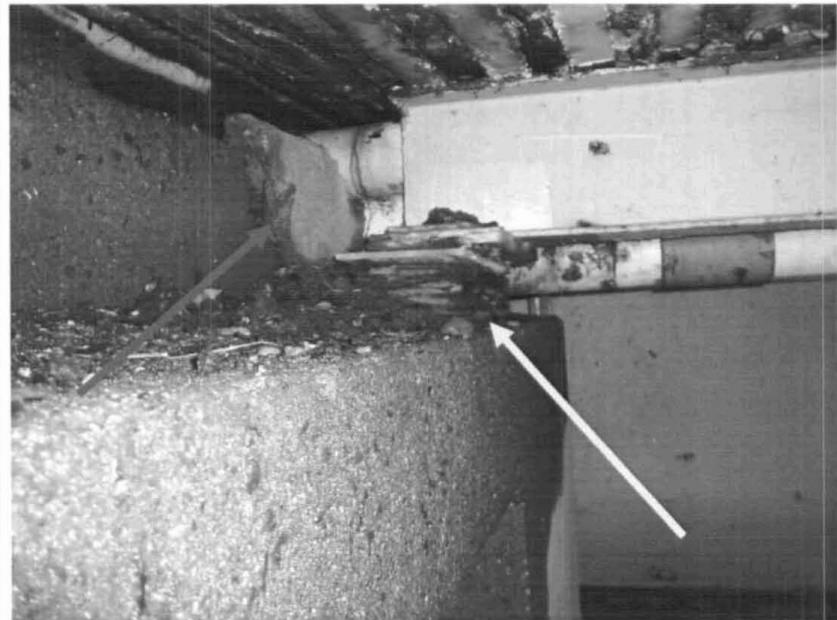
ABUTMENTS-BACKWALL	5	West abutment: The west abutment backwall exhibits a full height x 1/4" wide crack that extends from the abutment stem with spalling up to 3" wide x 2" deep along the crack. The backwall below the sidewalk exhibits minor edge spalling, a vertical hairline crack with hollow areas up to 6" away, and a 10" x 8" potential spall. See sheet 21 and photos 16 & 27.

Photo #16:
Description: Heavy laminated rust between the stacked plates at the north sidewalk stringer bearing at the west abutment. Also note the potential spall at the top of the backwall.

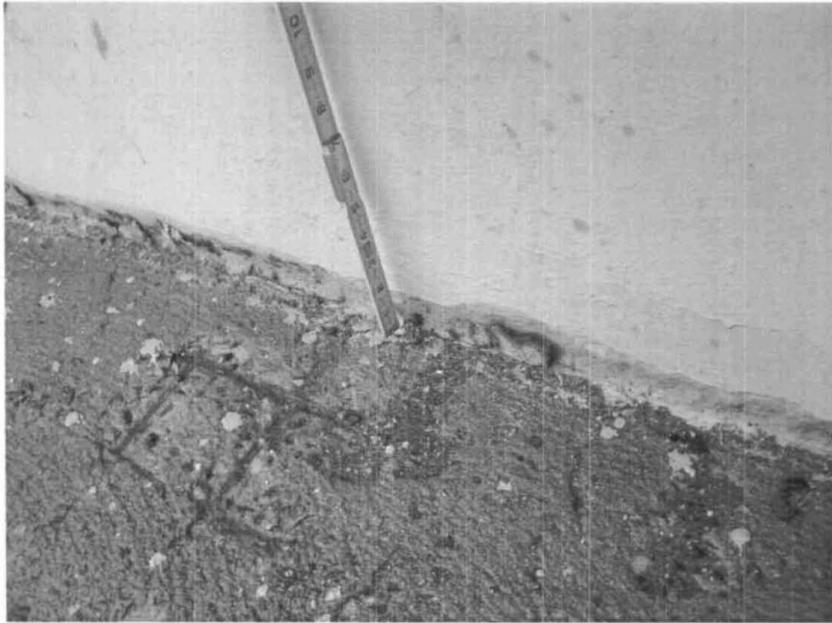
Photo #17:
Description: Painted over section loss along the girder 2 web, just above the sidewalk.

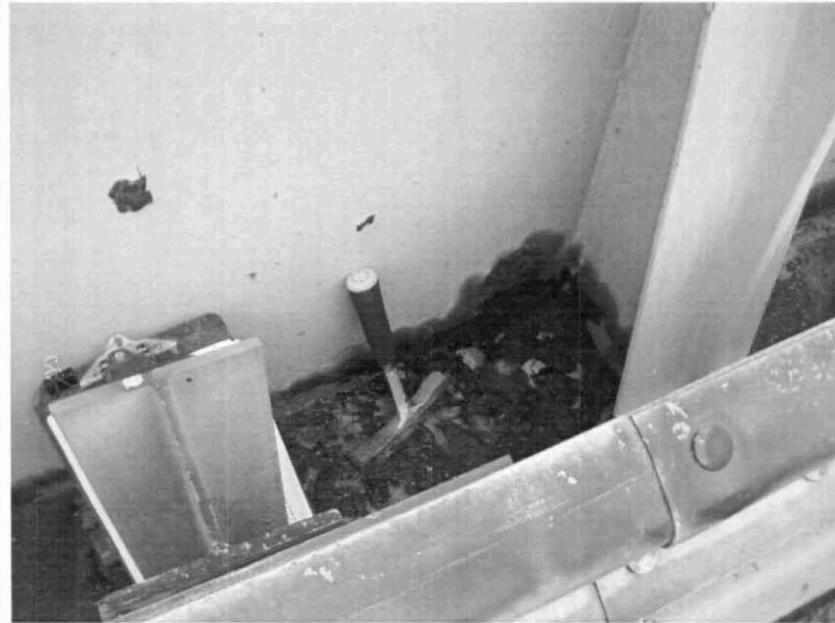
3. The inside faces of the main girder webs and stiffeners exhibit areas of laminated rust with up to 8" high x 1/8" deep (isolated areas up to 1/4" deep) section losses just above the curbs. Continue to monitor this condition.

Photo #18:
Description: Laminated rust and section loss along the south elevation of the girder 1 web, just above the curb line.

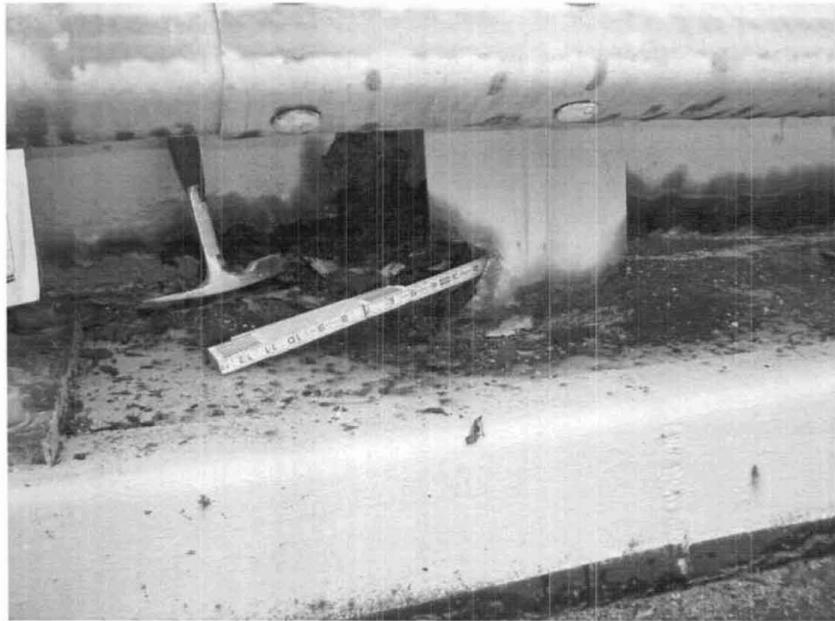
GIRDERS	6	Steel thru-girders: Girders exhibit random areas of light to moderate rust. The inside faces of the webs and stiffeners exhibit areas of laminated rust with up to 8" high x 1/8" deep (isolated areas up to 3/16" deep) section losses just above the curbs. The south elevation of the girder 2 web and stiffeners exhibits painted over section losses up to 1/4" deep x 2" high with random re-occurring rust. Impacted rust fills the gap between the girder 2 and floorbeam 10 bottom flanges ($\pm 3/4"$). See sheets 13 and 15 and photos 17, 18 & 21.
FLOOR BEAMS	4	During rehabilitation, new floorbeams were added at locations throughout the structure. The new floorbeams are in good condition. The remaining original floorbeams exhibit painted over section losses to the flanges and webs. Maximum section loss to the webs in shear areas is estimated to be 6% (floorbeam 16 at the east abutment). Maximum section losses to the top and bottom flanges in areas of high moment were found to be 18% (floorbeam 10) and 13% (floorbeam 8), respectively. Note also that remnants of old stringer connections are still in place along the old floorbeams. The floorbeam knee braces exhibit 1/8" deep section losses just above the curb lines. In addition, the third knee brace from the east abutment along the south elevation of girder 1 exhibits a rusted through hole up to 2.5" x 3.5" in one flange and 1/16" - 1/8" remaining x up to 2" high along the other flange, just above the curb line. The end of the concrete floorbeam cantilever at the southeast corner of the bridge exhibits spalls up to 2.5" deep with exposed rebar. Rating lowered to a "4" based on section 10.5 of CDOT BIM. See sheets 13 and 15-19 and photos 19, 20 & 22.

Photo #19:
Description: Third floorbeam knee brace from the east abutment along girder 1 exhibits a rusted through hole in the flange.

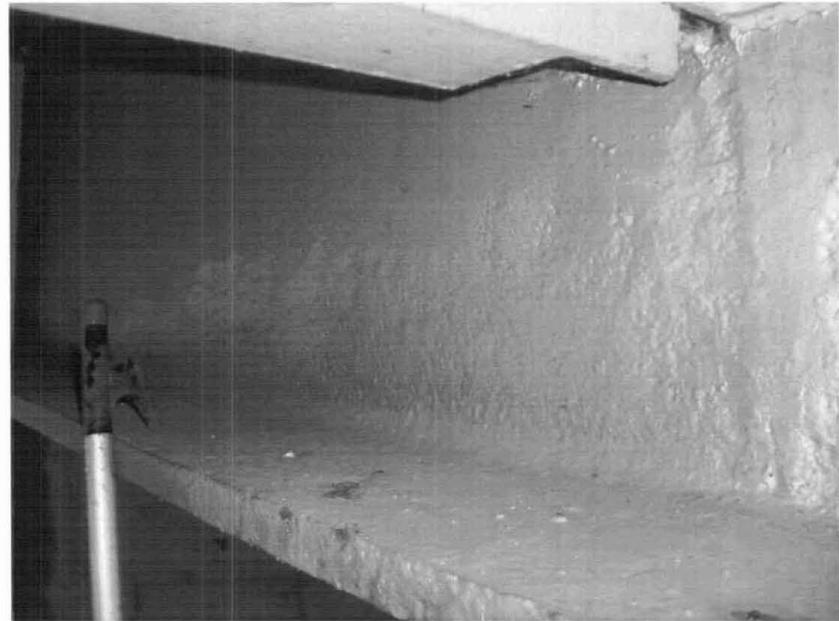
4. The original floorbeams exhibit painted over section losses to the flanges and webs. Maximum section loss to the webs in shear areas is estimated to be 6% and maximum section losses to the top and bottom flanges in areas of high moment were found to be 18% and 13%, respectively. The third knee brace from the east abutment along the south elevation of girder 1 exhibits a rusted through hole up to 2.5" x 3.5" in one flange and 1/16" - 1/8" remaining x up to 2" high along the other flange, just above the curb line. Provide repair plates at loss locations if re-evaluation of structure warrants strengthening of the floorbeams (7 locations). Rating lowered from "5" to "4" due to pitting losses along the floorbeams.

Photo #20:
Description: Section losses to the web and bottom flange of floorbeam 14.

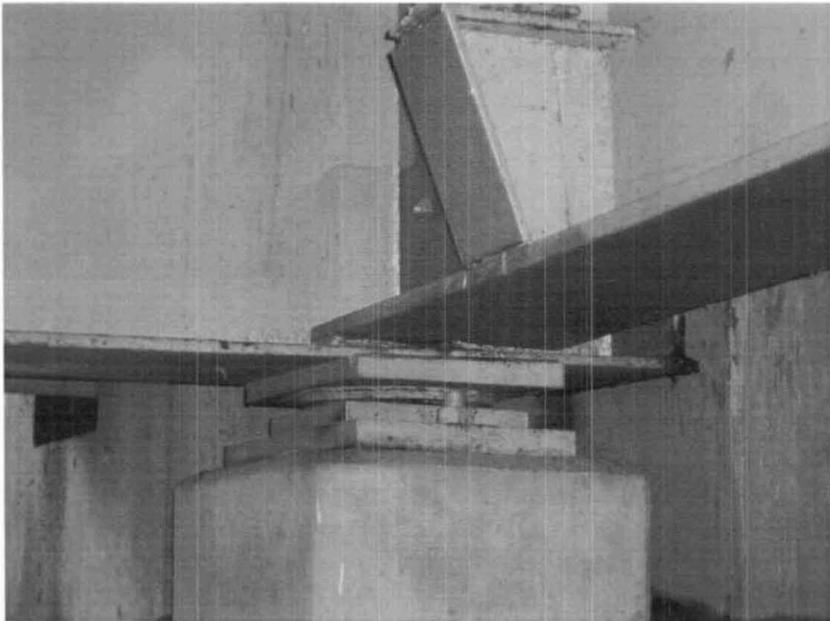
Photo #21:
Description: Impacted rust between the girder 2 and floorbeam 10 bottom flanges.

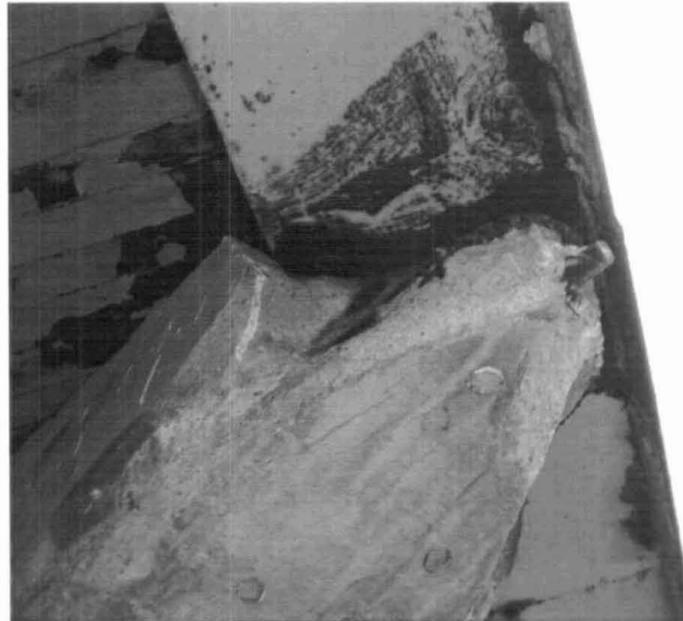
Photo #22:
Description: Spalls with exposed rebar in the floorbeam cantilever at the south elevation of girder 2 near the east abutment.

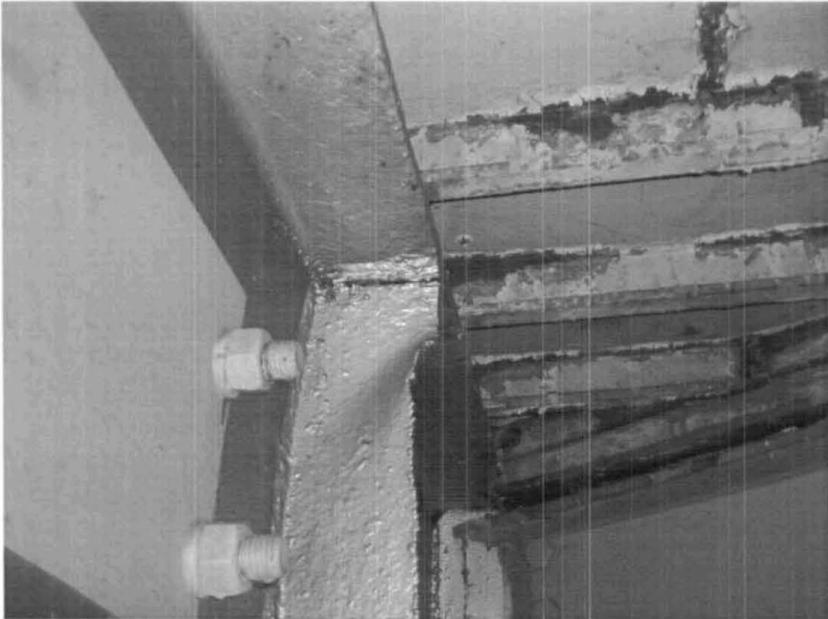
Photo #23:
Description: Broken weld between the top flange of floorbeam 4 and the vertical stiffener. Appears to be construction damage that occurred during rehabilitation while removing the stringers.

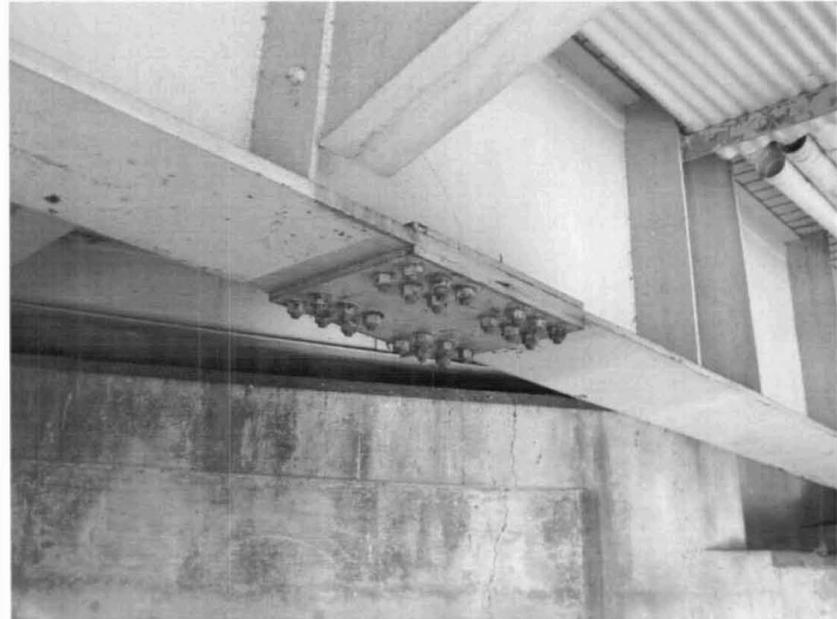
Photo #24:
Description: Bolted retrofit along the bottom flange transition weld of girder 2 near the east abutment.

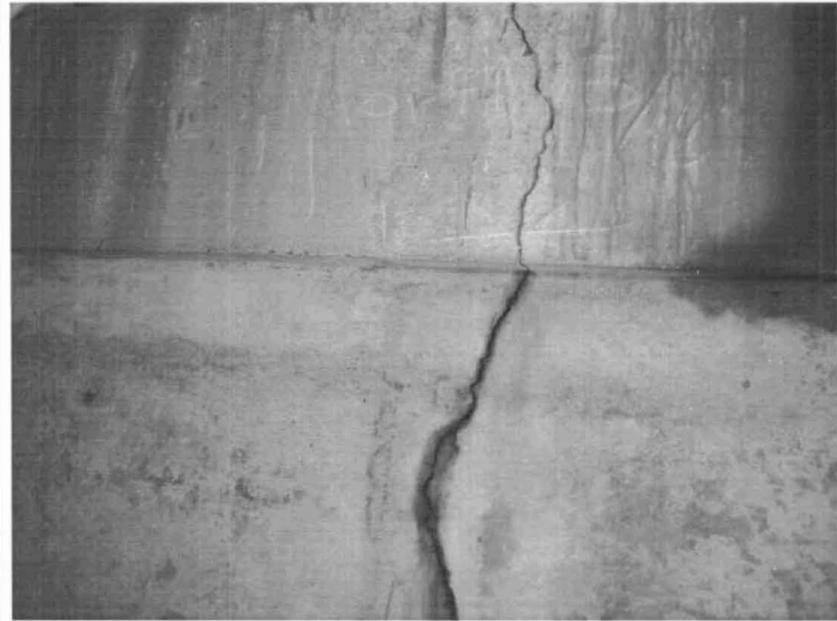
1. Both abutments exhibit full height cracks up to 1/4" wide, isolated hollow areas up to 4' x 3.5' and isolated spalls up to 1' diameter x 1" deep with exposed rebar. The west abutment stem is horizontally offset 1/8" to 3/16" along the crack at the top of the bridge seat. Continue to monitor these conditions. Rating lowered from "6" to "5".
2. The north end of the east abutment footing is exposed up to 0.6' over 20' long with no significant deficiencies noted along the footing. Install additional rip-rap at this location (2 cubic yards).

Photo #26:
Description: Up to 1/4" wide crack at the west abutment stem.

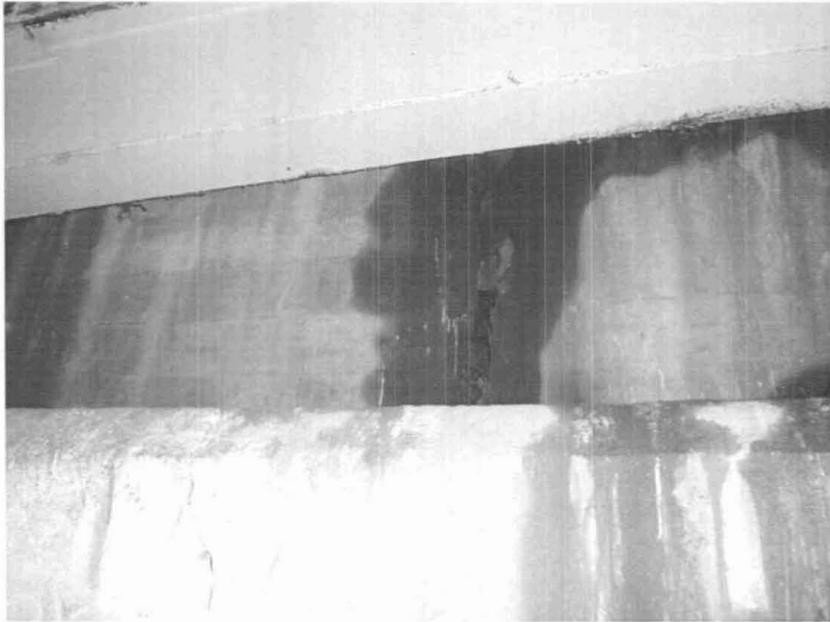
Photo #27:
Description: Crack up to 1/4" wide in the west abutment backwall with spalling along the crack.

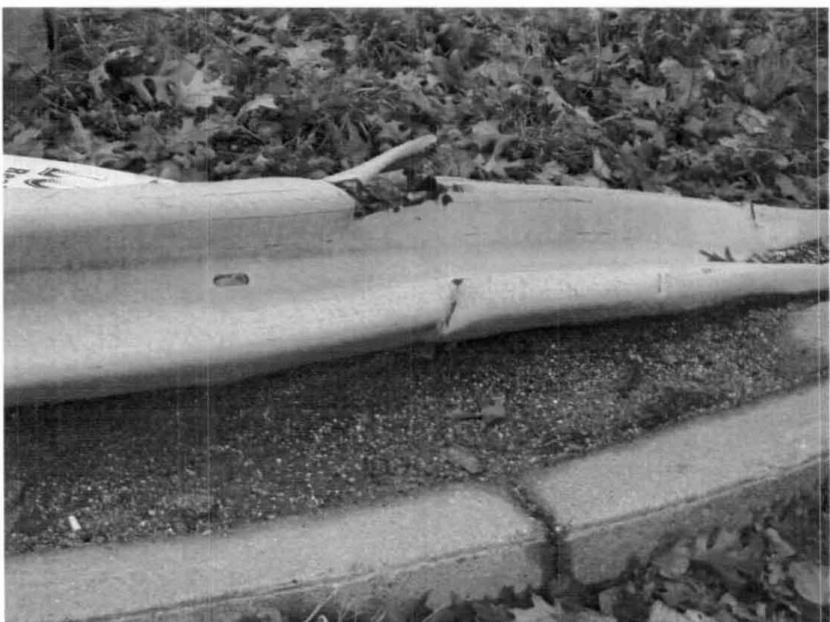
1. Both approach pavements exhibit random cracking up to 1" wide. Seal cracks (100 linear feet).
2. The northeast approach guide rail exhibits a 10" x 3.5" tear near the guide rail end and the southeast guide rail exhibits a 9" x 1" tear. Repair sections of rail (2 linear feet).

Photo #30:
Description: Tear in the northeast guide rail near the guide rail end.
