STRUCTURE NO. 01428D

I-91 TR 840
over
I-91 NB,US44 EB,RR,CT RV
HARTFORD

Routine Inspection
on
3/22/2007

Bridge No. 01428D carries Interstate 91 TR840 over Interstate 91 Northbound, US Route 44 Eastbound, Railroad and the Connecticut River in Hartford. The bridge consists of a 5 span, steel multi-girder superstructure with a reinforced concrete deck. The bridge is supported by concrete piers, one of which has a steel pier cap. The bridge is abutted by adjacent structures at each end (Bridges 00980A & 01428A). The bridge has an overall length of 408 feet and a curb-to-curb measurement of 25 feet. The bridge was constructed in 1961 and rehabilitated in 1990. According to information on file at ConnDOT, the bridge has an inventory load rating capacity of 51 tons for an AASHTO HS Loading. Note that this load rating did not include a steel pier cap analysis. Section losses found on the steel pier cap may warrant re-analysis of this structure. The bridge was found to be in fair condition during this routine inspection completed in April 2007.

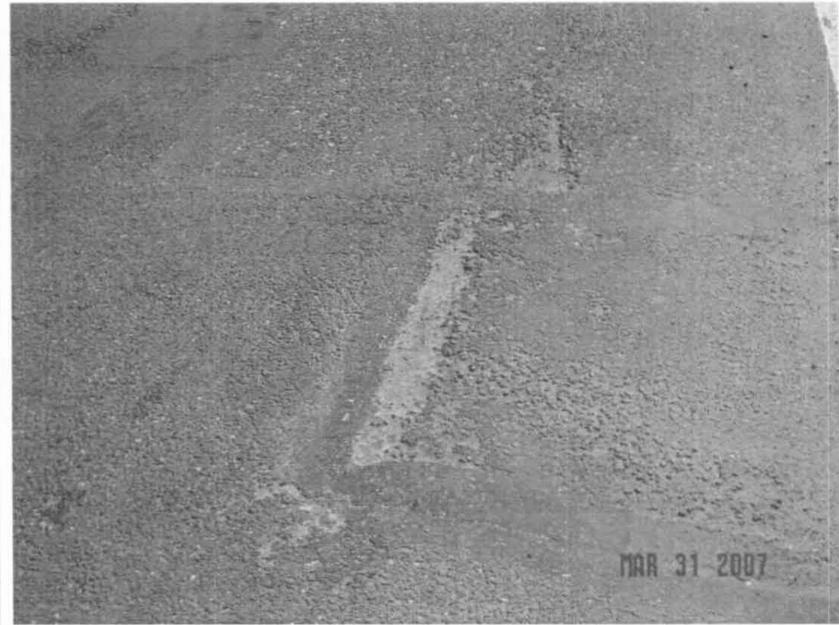
RATING	
OVERLAY	6	The bituminous overlay exhibits cracks up to 1.5" wide, random potholes up to 2' x 6" x 1" deep, areas of raveling, and random settled/depressed areas up to 1/2" deep. See sheets 13-15 and photos 9-12 .
DECK STR. CONDITION	7	The stay-in-place forms have small areas of light rust around PVC drains. The bare concrete deck overhangs have transverse hairline cracks at random locations. Note that since there are stay-in-place forms, a BRI-10 was not generated. The total deck deterioration is less than 1%. See sheets 18-22 and photo 8.
CURBS	7	Sloped Granite. Random scrape marks and a few random spalls up to 9" x 4" x 2" deep with isolated exposed rebar at the joints where the curbs are concrete. The average curb reveal is 3". See the "Expansion Joint" item below for the loose curb plate. See sheets 13-15 and photo 14.
MEDIAN	N	
SIDEWALKS	6	North side only in Spans 4 and 5. The sidewalk exhibits a few random transverse hairline cracks, minor light debris and an accumulation of sand. There is up to 1-1/2" of settlement/vertical misalignment at the end of the sidewalk over pier 4. See sheets 13-15 and photo 13.

Photo # 10: Raveling of bituminous overlay in span 2.

1. Repair potholes and depressed areas in the overlay (<1/2 Ton).
2. Repair the settlement of the approach sidewalk at pier 4 (<1/4 Cubic Yard).
3. Repair short and/or missing weeps that drain onto bridge elements below (± 25 Linear Feet).
4. Repair areas of active leakage along the piers 1 and 5 deck joints (± 25 Linear Feet).

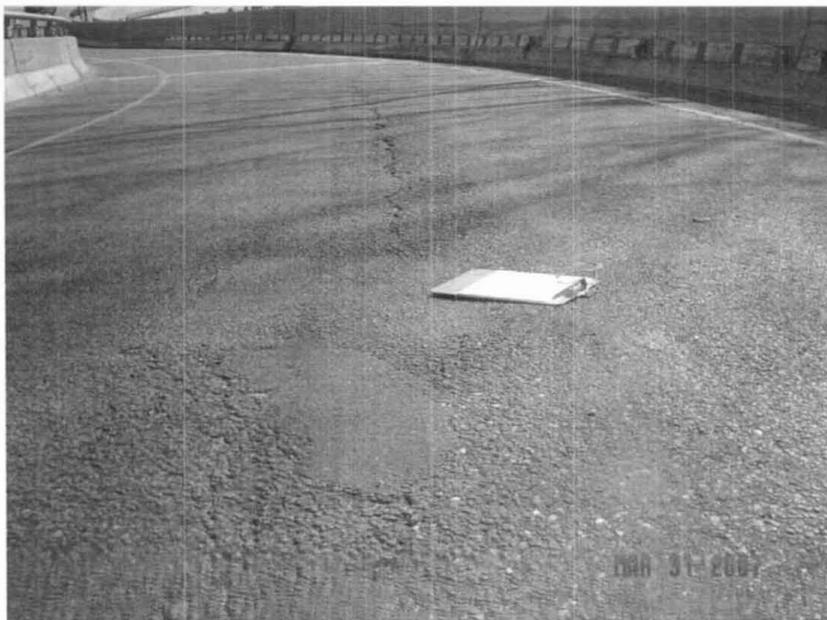
Photo # 11: Uneven overlay and a 1" wide crack with raveling bituminous in span 3.

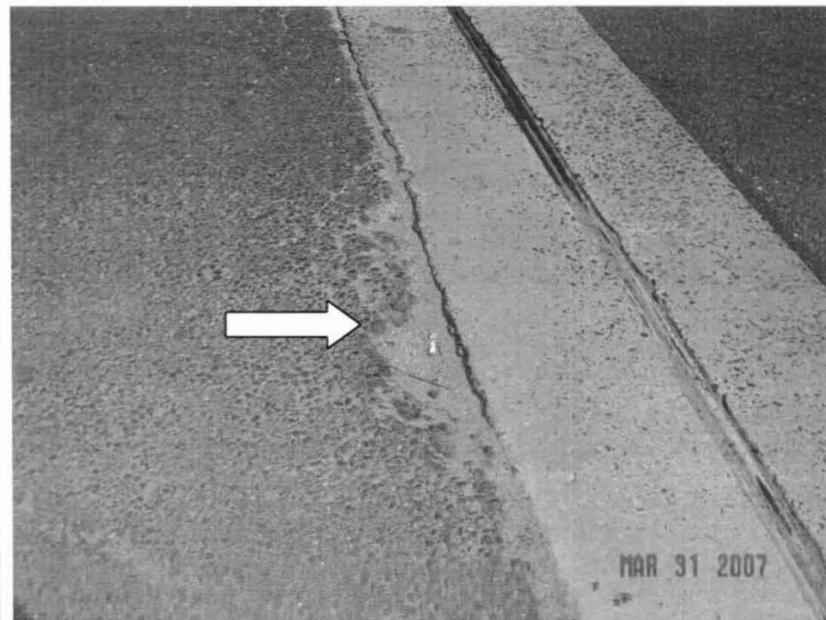
Photo # 12: Pothole/raveling adjacent to the concrete header in span 1 over pier 2.

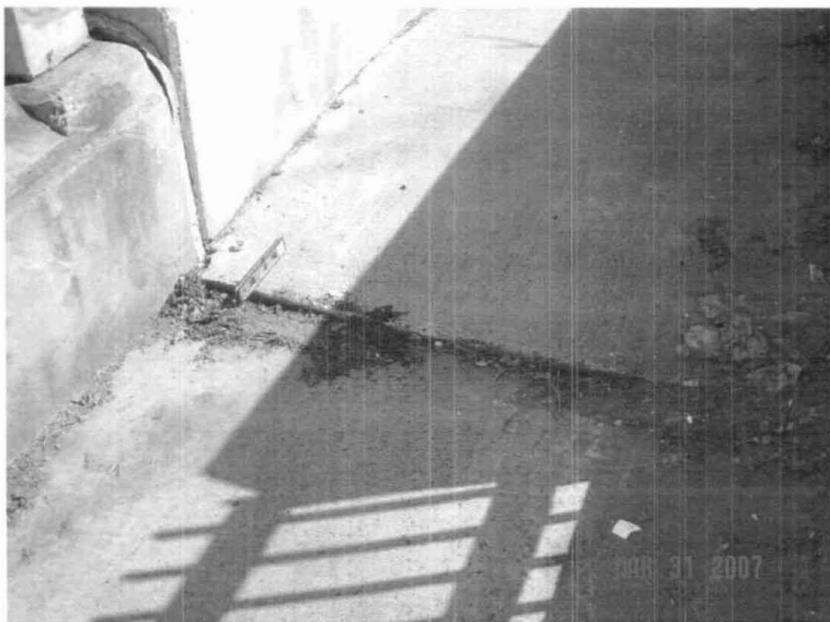
1. The approach sidewalk at Pier 4 has settled approximately 1.5 inches.
2. There is a spall at the top of Pier 1, column 2 that undermines the bearing for the steel cap girder.
3. There are leaking deck joints over piers 1 and 5.
4. There are cracked tack welds along the cap girder batten plates.

Photo # 13: Settlement up to 1-1/2" in the sidewalk over pier 4.

1. Repair the sidewalk (<1/4 CY)
2. Repair the spall that undermines the cap girder bearing at pier 1, column 2 (<1/4 CY).
3. Repair the leaking deck joints (25 LF).
4. Remove the cracked tack welds along the cap girder batten plates (± 6 LF).

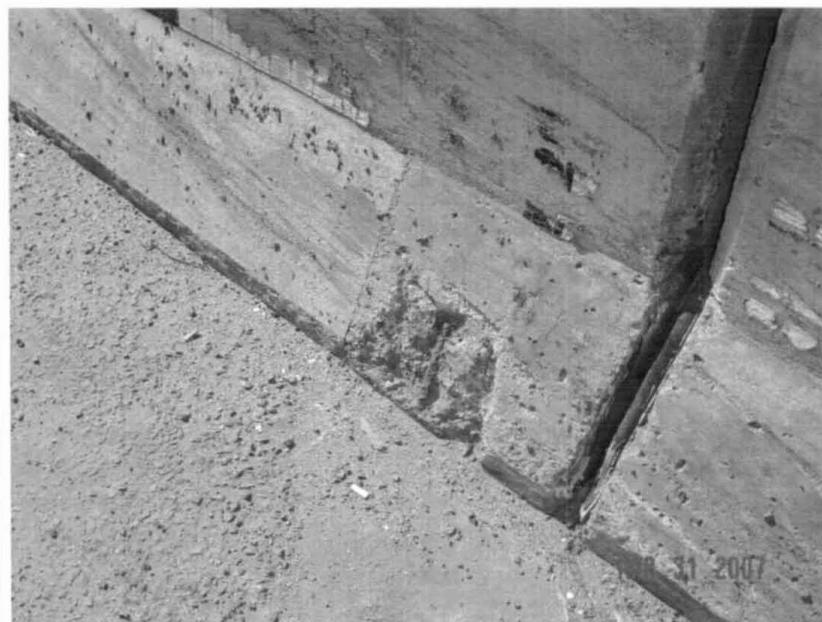
Photo # 14: Spall with exposed rebar in the south curb over pier 1.

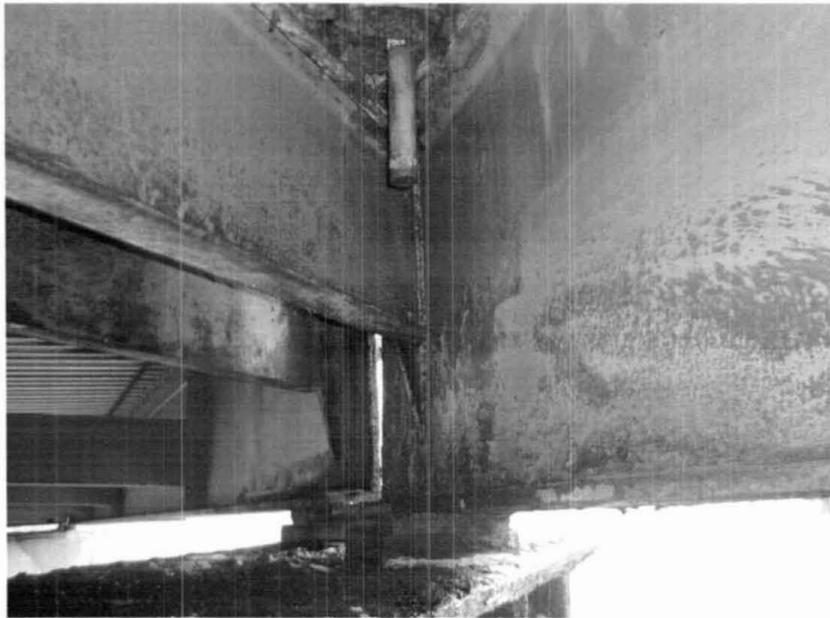
Photo # 15: Short weep draining onto the top of the pier cap (pier 1) from bridge 01428A at the southwest end.

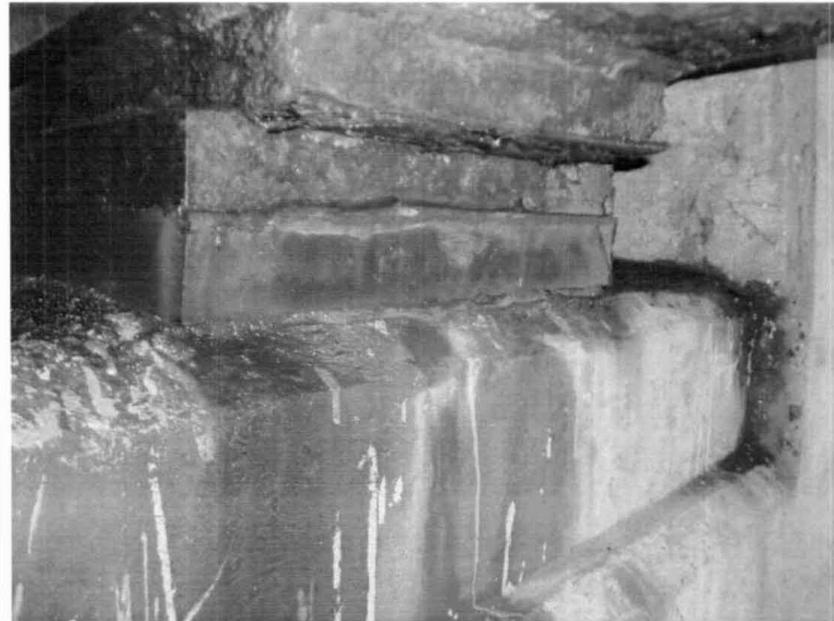
The superstructure was found to be in fair condition. The bearings have heavy to laminated rust with up to 1/8" deep section losses on plates, impacted rust between bearing plates/elements, up to 100% anchor bolt nut loss, and random missing anchor bolt nuts. A spall below the cap girder bearing at pier 1, column 2 has caused minor undermining of the bearing, approximately 2%. The girder ends exhibit areas of heavy rust to laminated rust, causing areas of section loss to the webs over the bearings, up to 3/16" deep, resulting in 5.0% web loss. There is a 1" long x 1/16" wide crack and stop hole in the bottom web cope of girder 2 in span 1 near pier 2 (crack does not propagate past the stop hole). No cracks were noted in the over-cut in the top cope of the web at this location. Girder flanges in spans 1-4 exhibit no significant deterioration away from the bearings. Riveted girders in span 5 exhibit areas of up to 1/2" impacted rust, random bolt/rivet heads are not flush with the plates (backed off, but are not loose), and there are gaps up to 1/8" at the top flange field splices. A sloppy overhead diaphragm weld between a diaphragm lower strut and connection plate has cracked in span 1, south elevation of girder 3, second intermediate diaphragm (all remaining welds are in good condition at this connection). Previously reported cracked diaphragm weld along girder 3 in span 3 has been repaired since the last inspection.

Photo # 20: Heavy rust and section loss on expansion (elastomeric) bearing plates on pier 5 in span 4.

1. Repair the spall that undermines the cap girder bearing at pier 1, column 2 (<1/4 Cubic Yard).
2. Clean and paint the girder ends and bearings (1500 Square Feet). *Rehab*
3. Continue to monitor span 1, girder 2 copes near pier 2 for cracking.
4. Repair the cracked diaphragm weld at the south elevation of girder 3, span 1 at the second intermediate diaphragm lower strut (0.5 Linear Feet).

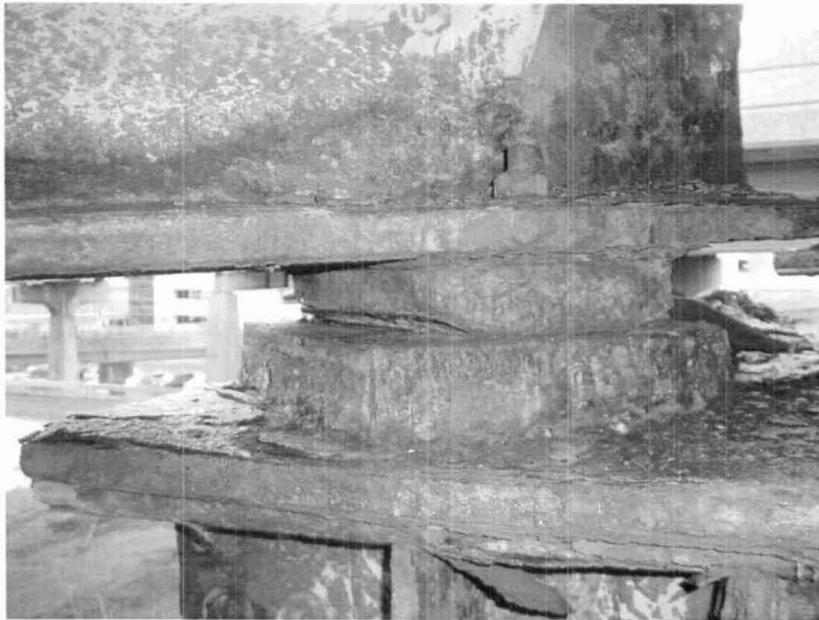
Photo # 21: Heavy rust and section loss on the fixed bearing plates on pier 1 in span 1.

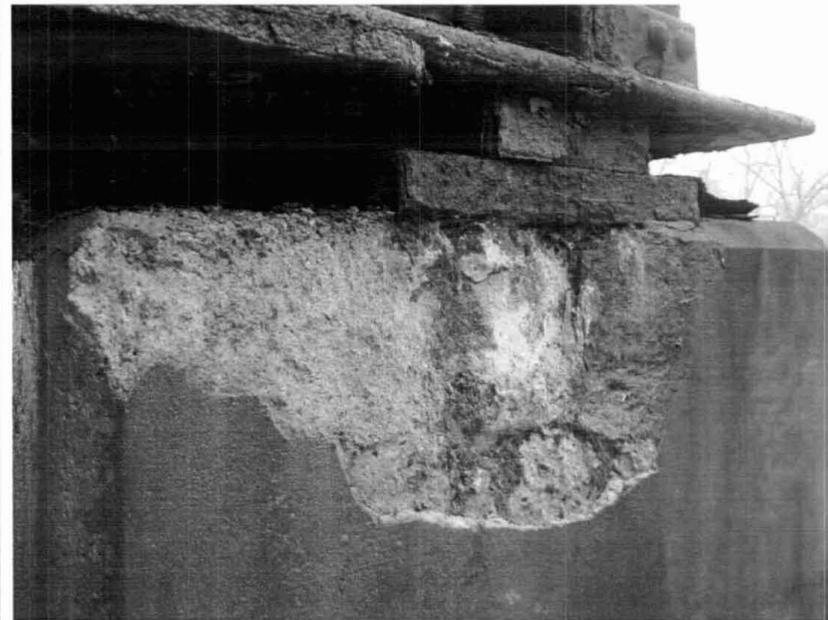
RATING	
BEARING DEVICES	5	<p>The fixed and elastomeric bearings exhibit moderate to heavy laminated rust to the steel plates with up to 1/8" deep section losses. Fixed bearings have up to 1/4" impacted rust between sole and masonry plates. There are random tilted anchor bolts, random missing anchor bolt nuts and random anchor bolt nuts with up to 100% section loss. See sheets 18-22 and photos 18-21.</p> <p>Rocker bearings at pier 5: Rocker bearings exhibit light to moderate rust, up to 100% loss of anchor bolt nuts, and up to 1/8" impacted rust below the rockers. Bearings exhibit evidence of movement, based on comparison with previous measurements. See sheet 17.</p> <p>Cap girder bearings at pier 1: The curved sole plate bearings for the steel cap girder exhibit heavy laminated rust with up to 1/16" deep section loss to the plates. The cap girder bearing at column 2 is undermined 11" x 1" (approximately 2%) due to a spall below. See sheets 23 & 24 and photo 22.</p>

Photo # 22: Spall on column 2 of pier 1 exposing/undermining the masonry plate of the bearing for the steel pier cap.

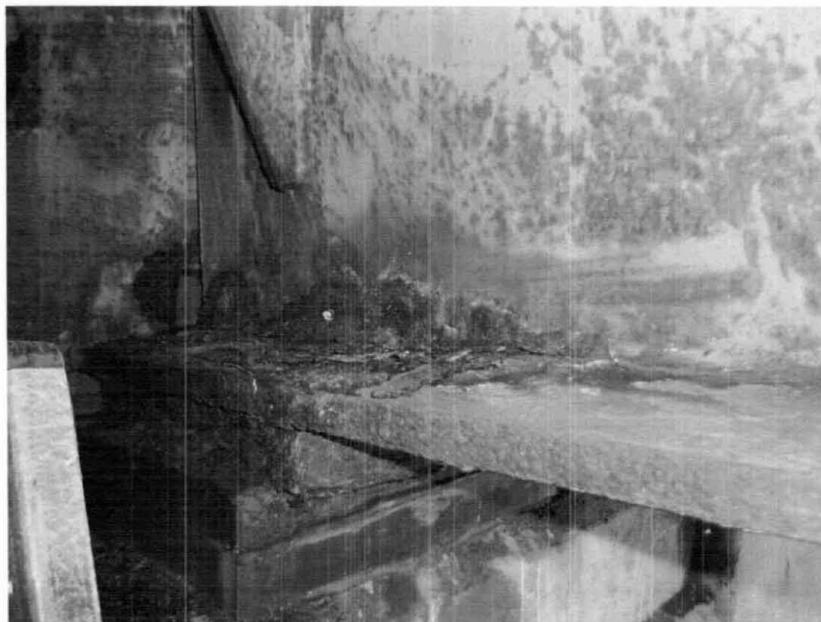
STRINGERS	N	
GIRDERS	5	<p>There are random areas of light to moderate rust and isolated areas of heavy laminated rust and painted over section losses up to 3/16" deep, mostly at the girder ends. Girder webs over the bearing areas exhibit up to 5% section loss (girder 1, span 4 over pier 4). Girder flanges in spans 1-4 exhibit no significant deterioration away from the bearings. Girders in span 5 exhibit areas of up to 1/2" impacted rust (built-up girders), random rivet/bolt heads are not flush with the plates (but are not loose), and there are gaps up to 1/8" at the top flange field splices (no significant change). See sheets 18-22 and photos 23 & 24.</p>
FLOOR BEAMS	N	
TRUSSES-GENERAL	N	
TRUSSES-PORTALS	N	
TRUSSES-BRACING	N	
PAINT	7	Random areas of peeling and chipping paint throughout the structure (<10% of area).
RUST	5	See above items.
MACHINERY MOV SPAN	N	
RIVETS & BOLTS	7	<p>Random bolt/rivet heads are not flush with the plates in span 5 (backed off, but are not loose). There is up to 1/8" gap at top flange splice plates at random locations in span 5 (no change). ✓ Random erection bolts missing in diaphragm connections (diaphragm connections are welded). See sheets 18-22. ✓</p>

Photo # 23: Section loss in the web of girder 4 on pier 5, north elevation.

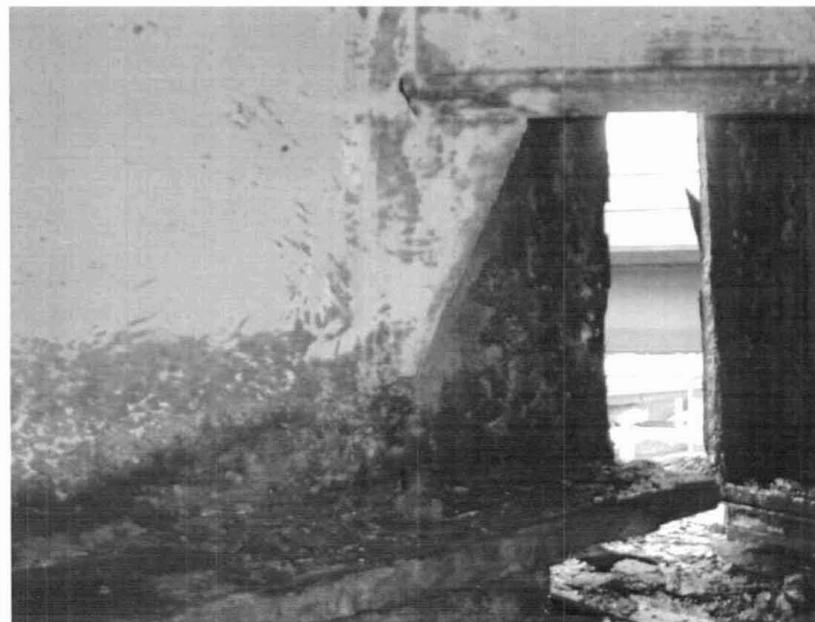
Photo # 24: Section loss in the web of girder 5 on pier 1. Also note active leakage on to the steel pier cap.

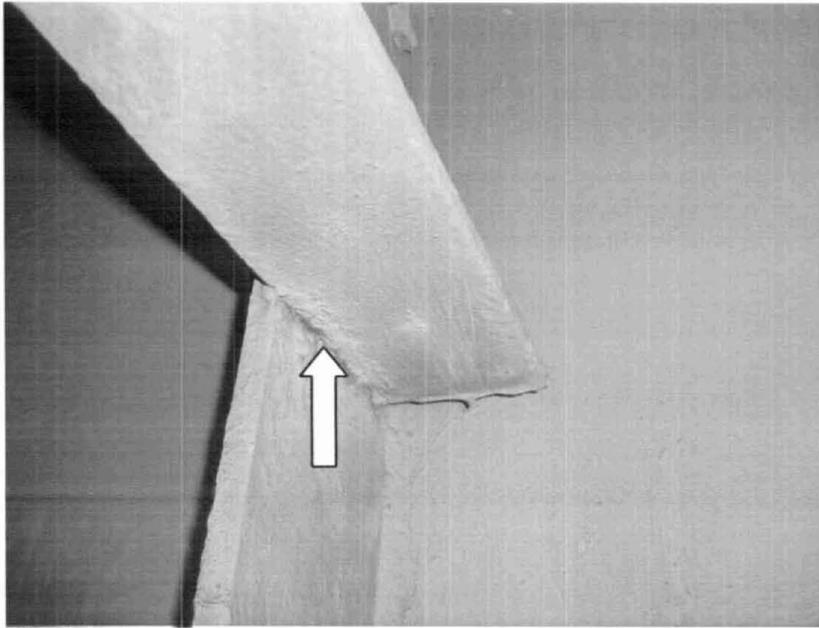
<u>BMM No.</u>	<u>Item</u>
03-356	5. There is a 1" x 1/8" over-cut in the top web cope of girder 2 in span 1 near pier 2 (fabrication error). (Priority C)
	6. There is a cracked weld at a diaphragm connection to girder 3 in span 1 (south elevation of the beam, the second intermediate diaphragm, lower strut connection). (Priority C)
	8. There are large spalls, popouts, hollow areas, and spalls with exposed rebar in the substructure at random locations. (Priority E)

Photo # 25: Sloppy/cracked weld between the web stiffener and diaphragm in span 1 on girder 3.

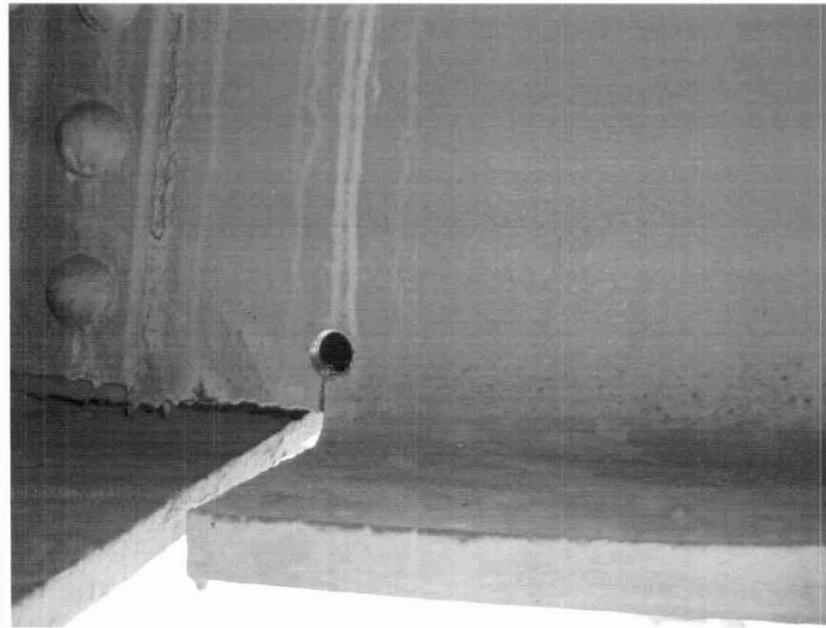
Photo # 26: Crack in web of girder 2 of span 1 at cope, stop hole in place.

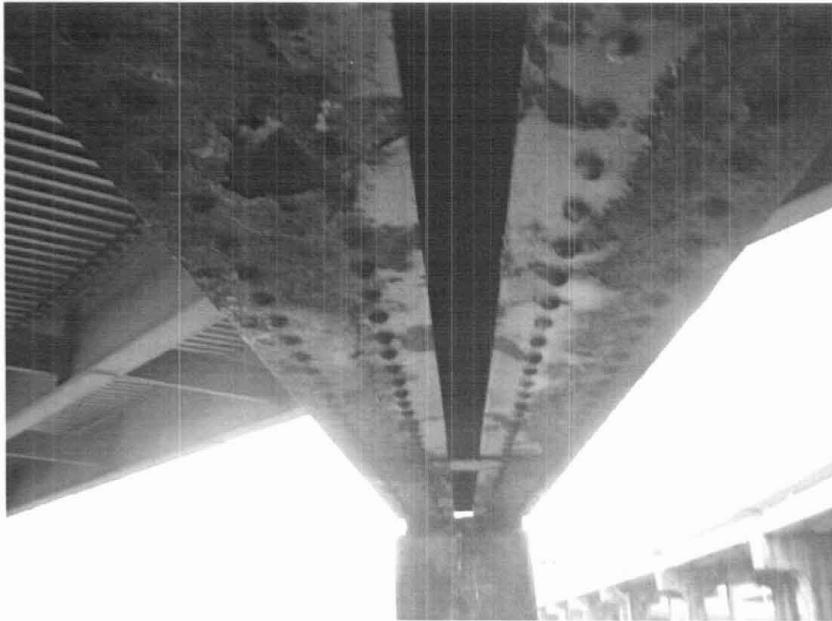
Substructure is Poor based mainly on condition of steel pier cap Pier 1. There are section losses to the pier cap with a max of 10% avg loss to top flange, 5% section loss to bottom flange, and 5% section loss to webs. There is up to 3/16" impacted rust between the cover plates and angles.

Photo # 29: Condition of the underside of the steel pier cap (pier 1).

1. Clean and paint the steel cap girder at pier 1 (700 Square Feet). *Rehab*
2. Remove the cracked tack welds along the cap girder batten plates (± 6 Linear Feet).
3. Repair areas of deteriorated concrete along the piers (± 2 Cubic Yards). *Repair / Rehab*

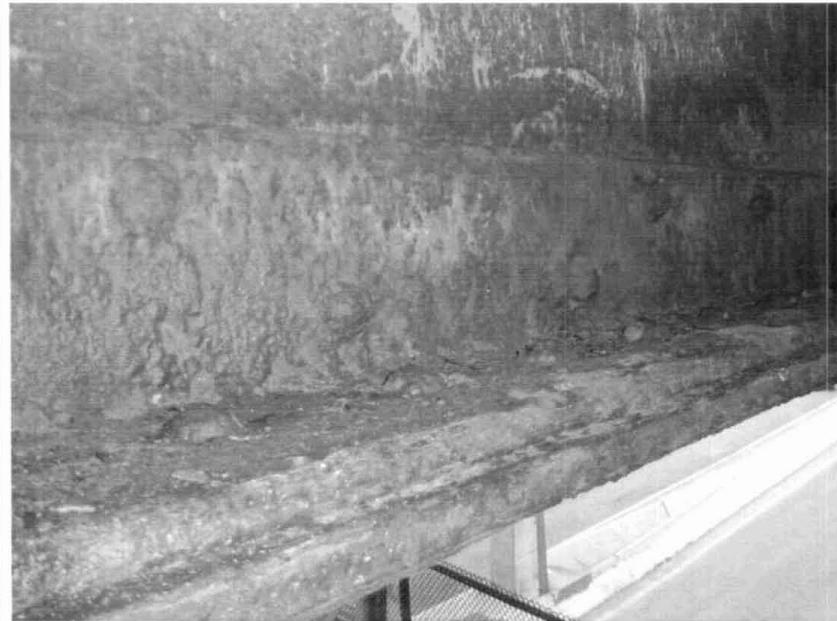
The substructure was found to be in poor condition. The steel cap girder at pier 1 exhibits areas of heavy rust to laminated rust causing up to 10.3% top flange loss, 4.6% bottom flange loss, and up to 5% web loss at critical locations. In addition, several tack welds are broken on the batten plates between the adjacent girder bottom flanges that comprise the cap girder. The concrete pier caps and columns exhibit hollow areas up to 3' x 3.5', spalls up to 5' x 3' x 4" deep with exposed rebar with isolated section losses, varying degrees of scaling (up to 1" deep at isolated locations), and cracking up to 1/16" wide with rust and/or efflorescence.

Photo # 30: Heavy rust with section loss in the bottom flange angle and cover plate of the steel pier cap (pier 1).

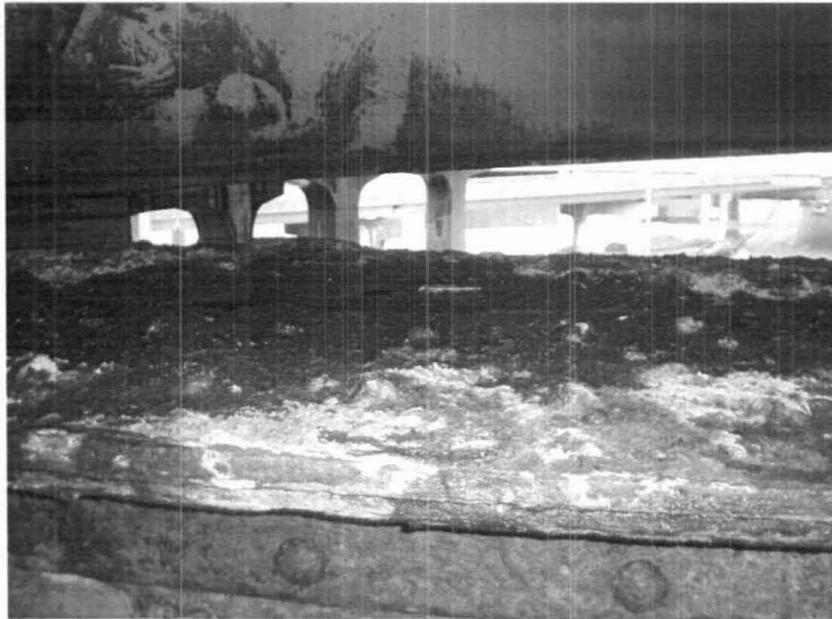
Photo # 31: Heavy laminated rust with section loss in the top flange cover plate of the steel pier cap (pier 1).

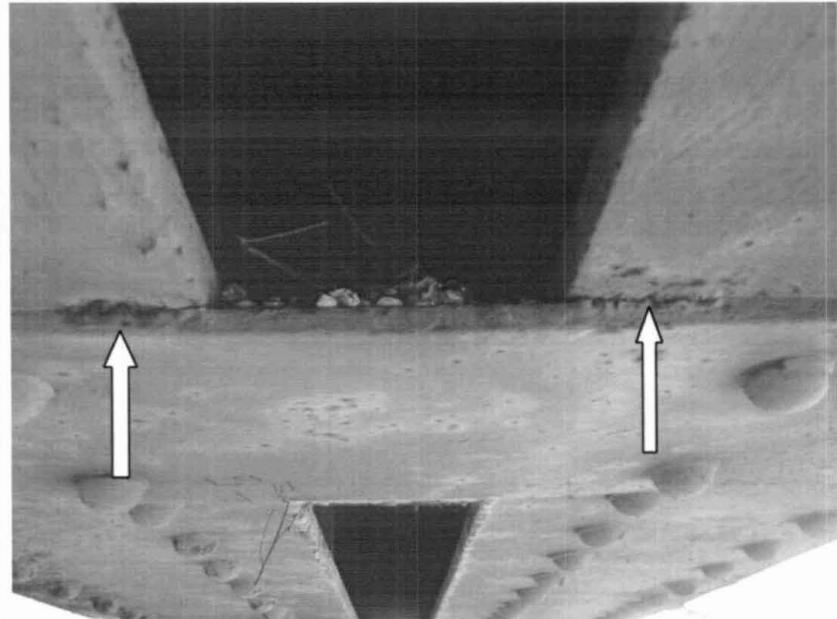
Photo # 32: Typical cracked/broken tack welds between the batten plates and bottom flange cover plate of steel pier cap (pier 1).

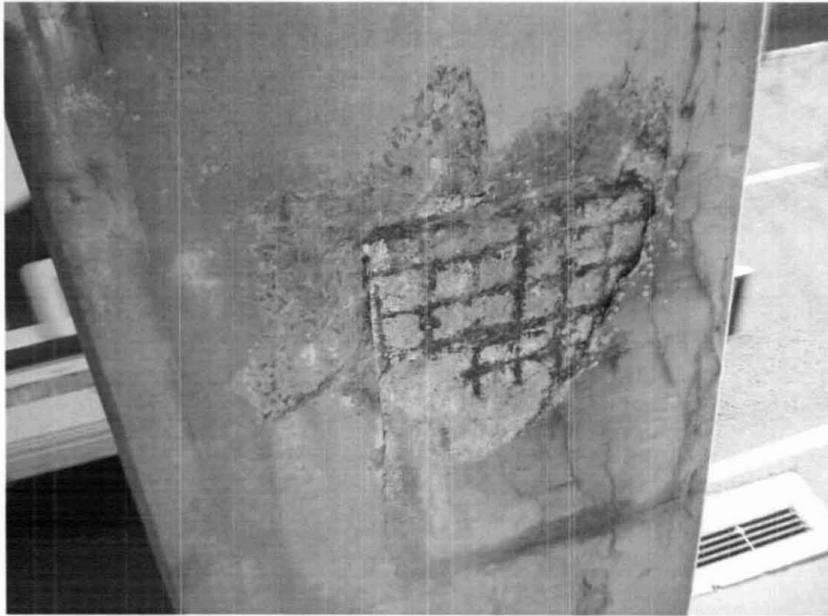
There are also issues with the concrete pier caps (Piers 2,3, & 5). The concrete pier columns have hollow areas, spalls up to 4" deep with exposed rebar <section loss on rebar>, map cracking and cracks open up to 1/16" with rust and efflo.

Photo # 33: Large spall with exposed rebar and section loss on pier 2, column 2 at the west elevation.

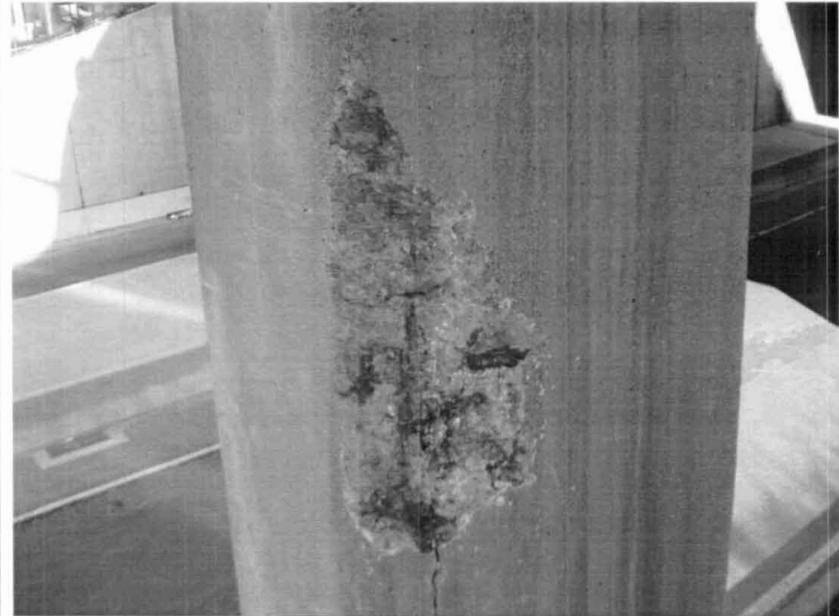
Photo # 34: Pier 2 east elevation, column 1 with a large spall with exposed rebar.
