STRUCTURE NO. 02138

ROUTE 15
over
INLET TO RESERVOIR
GREENWICH

COMBINED UNDERWATER AND ROUTINE INSPECTION

BRIDGE NO. 02138
ROUTE 15 OVER INLET TO RESERVOIR
GREENWICH, CONNECTICUT
MARCH 27, 2008

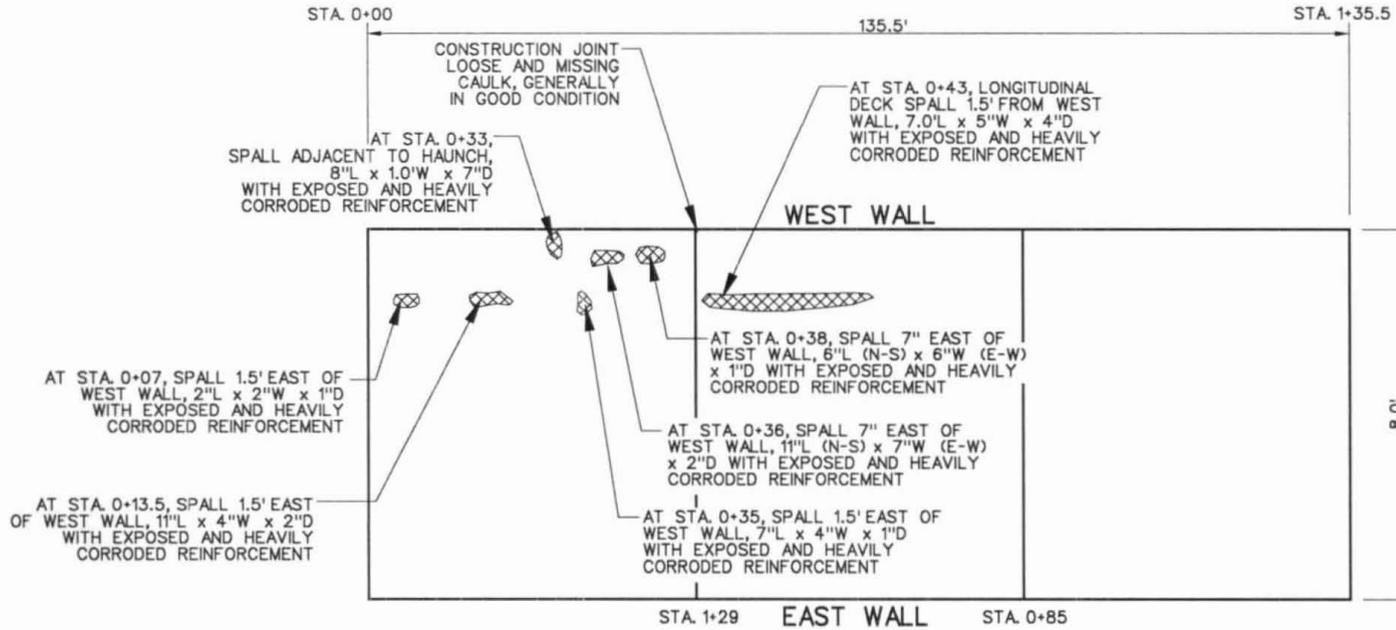
UNDERSIDE DECK

1. ENTIRE DECK EXHIBITS HONEYCOMBING UP TO 1" D.

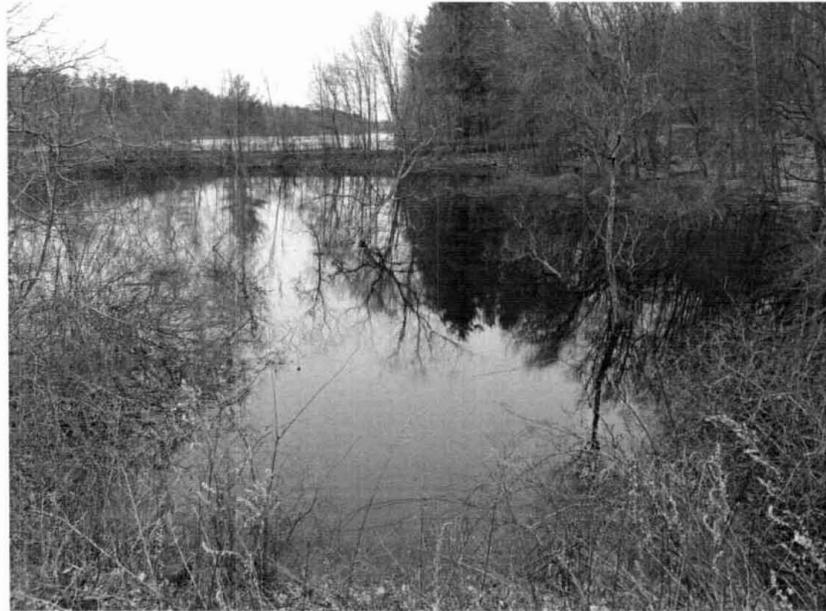
Photo # 16: Downstream (South) channel.

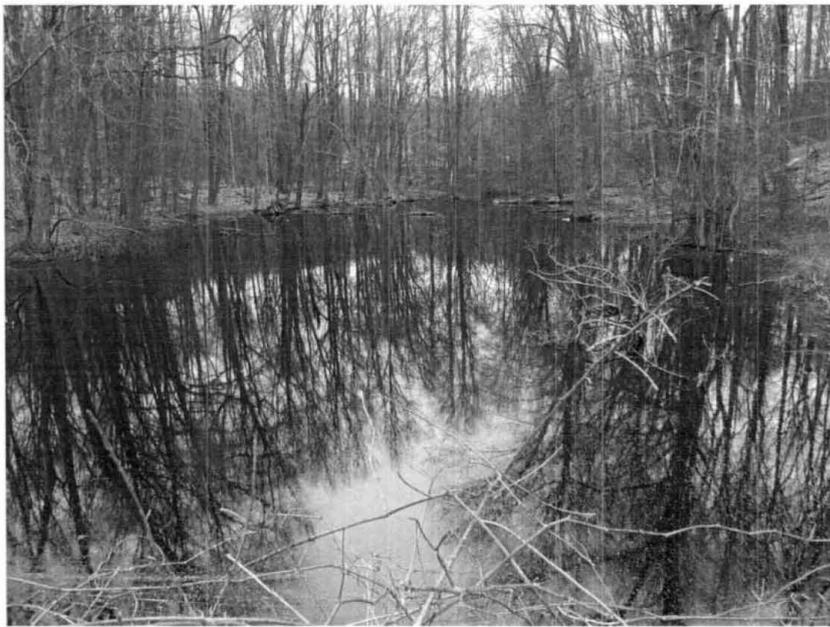
Photo # 17: Upstream (North) channel.

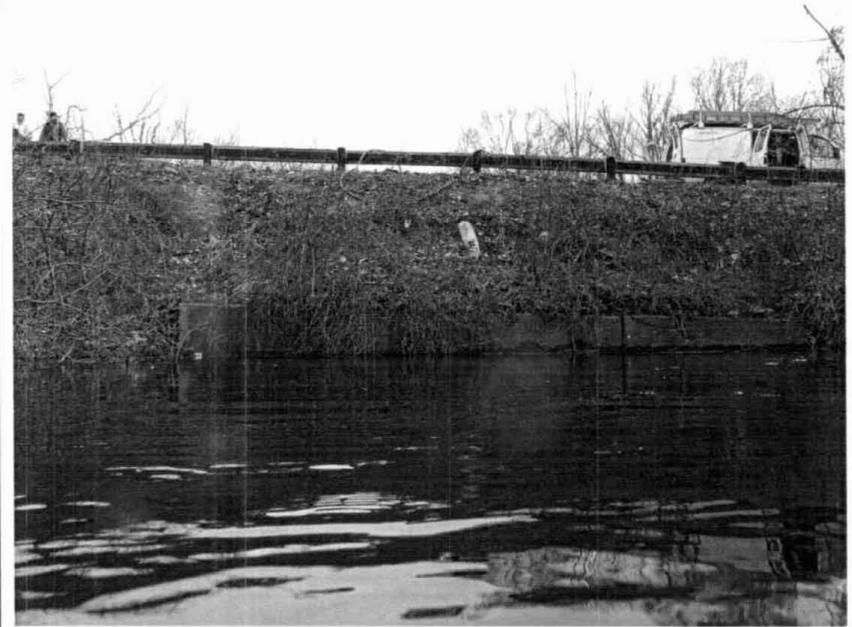
Photo # 18: Downstream (South) Elevation.

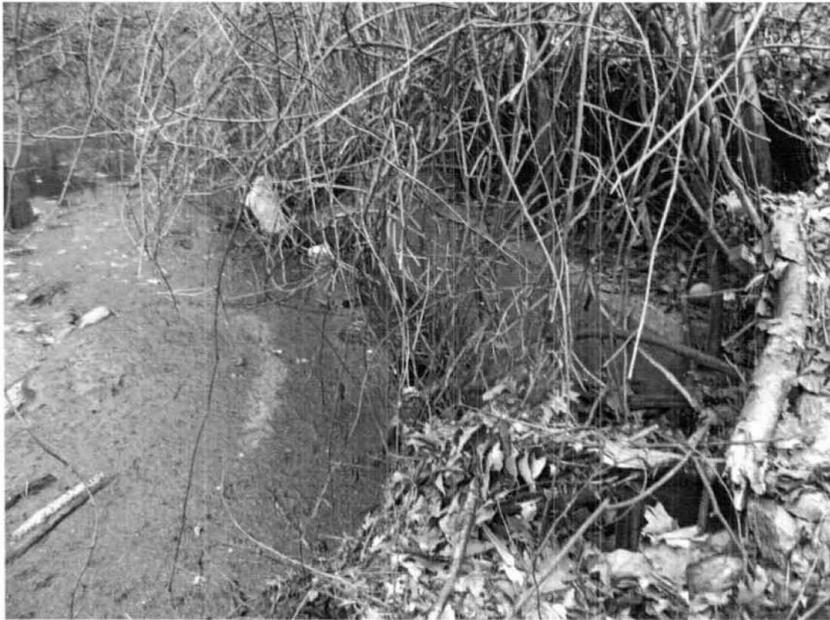
Photo # 19: Upstream (North) Elevation.

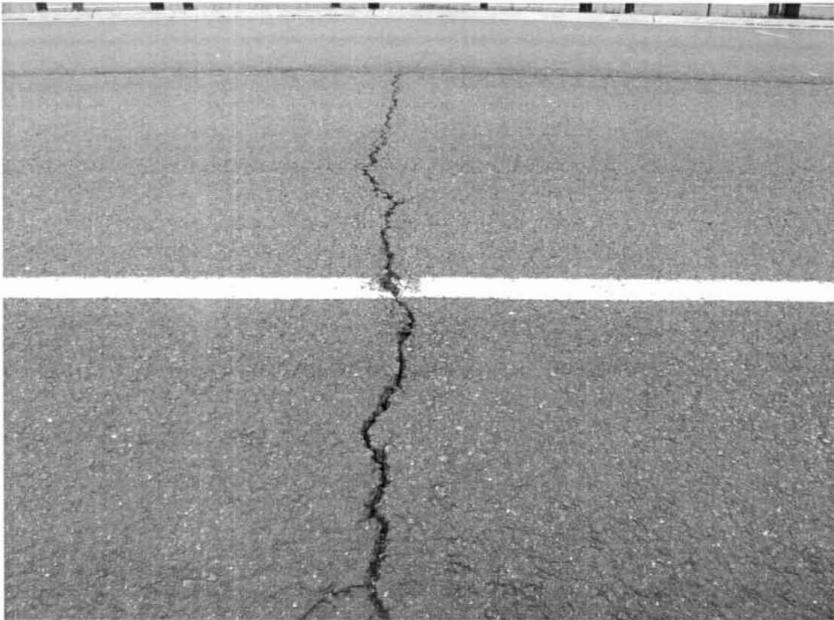
- 1) The bituminous concrete overlay displays several ¼" to ½" wide longitudinal and transverse cracks in both approaches of the northbound and southbound roadway. Seal cracks in overlay (150 LF).

Photo # 20: Typical transverse crack, Northbound.

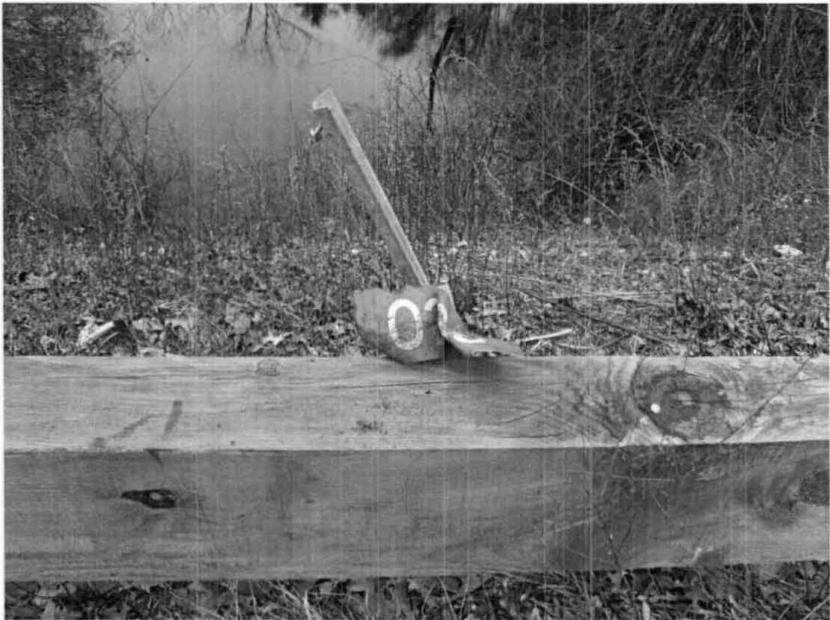
Bridge Identification Number is attached to a post that has been damaged and knocked to the ground along the northbound embankment (Photo 21).

<p>A black and white photograph showing a metal bridge ID marker with the number '021' on it. The marker is bent and lying on a wooden plank. The background shows a wooded area with trees and brush.</p>	<p>This cell left intentionally blank.</p>
<p>Photo # 21: Damaged Bridge ID.</p>

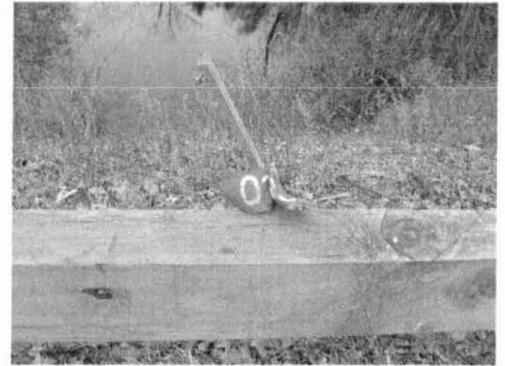
3 – Damaged Bridge ID.

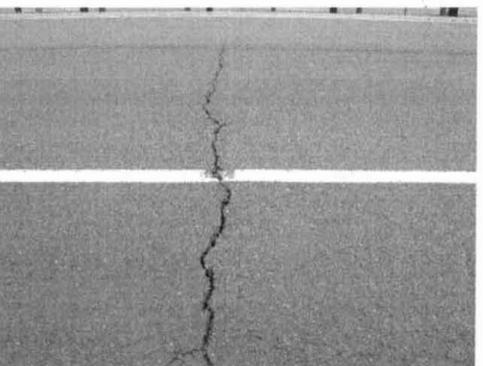
10 – Northbound lanes exhibit transverse crack.

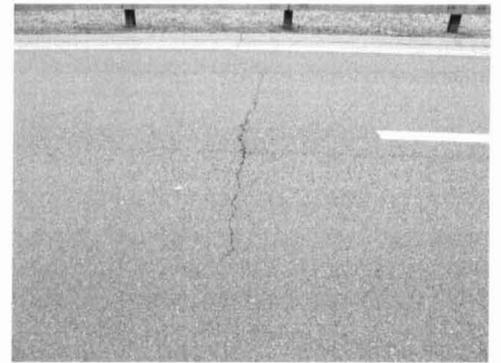
18 – Southbound lanes display 1/4" transverse crack on the east approach.

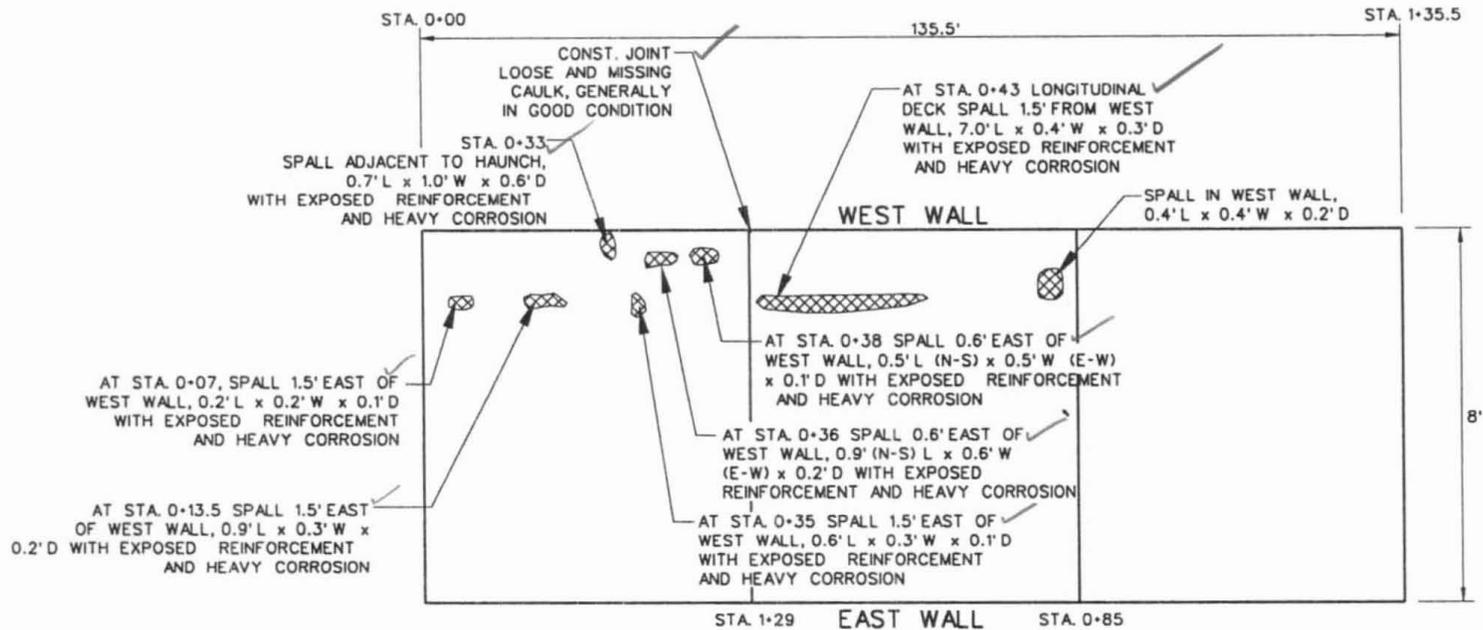
DRAWING NO. 02138F

1. ENTIRE DECK EXHIBITS HONEYCOMBING
UP TO 1" D.
