STRUCTURE NO. 02507

ROUTE 82
over
BROOK
EAST HADDAM

Routine Inspection
on
3/28/2007

Bridge Inspection Report BRI-18

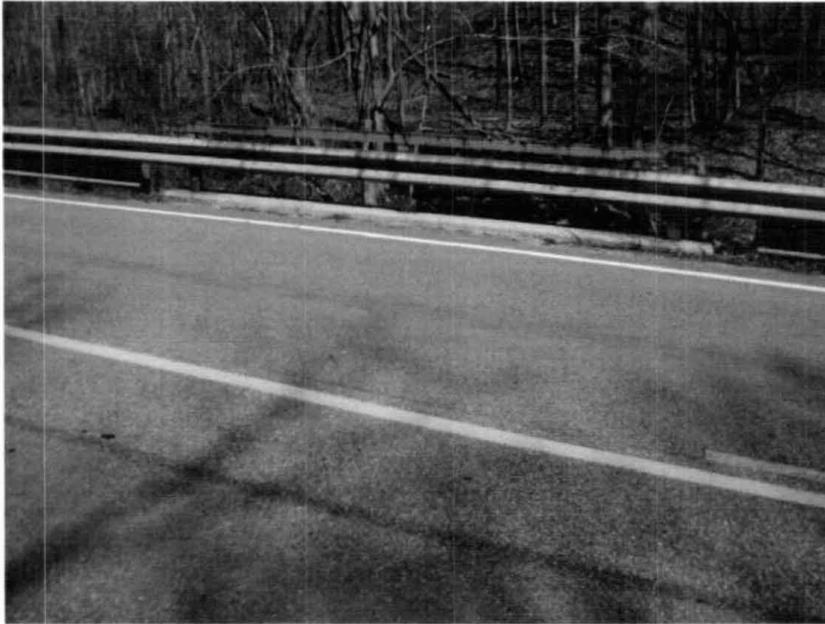
RATING	
OVERLAY	8	Bituminous concrete.
DECK STR. CONDITION	8	Integral deck, rating based only on the condition of the wearing surface. See item 59-3.
CURBS	7	Combination curb and railbase. Light to medium scale and concrete patches.
MEDIAN	N	
SIDEWALKS	N	
PARAPET	N	
RAILING	7	Angle Iron posts and hand rail with flex beam rail integrated with approach guide rail. Railing shows peeling paint and spotty light rust.
PAINT	3	Greater than 50% of railing shows peeling paint and light rust.
FENCE	N	
DRAINS	N	
LIGHTING STANDARD	N	
UTILITIES TYPE/SIZE	N	
CONSTRUCTION JOINTS	N	
EXPANSION JOINTS	N

Photo # 5: WEARING SURFACE AND TYPICAL BRIDGE RAIL.

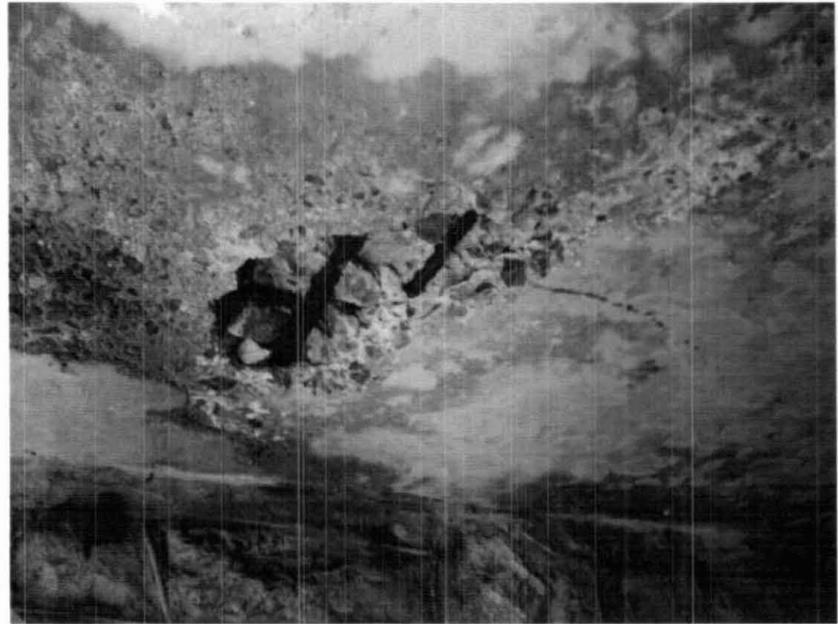
RATING	
BEARING DEVICES	N	
STRINGERS	N	
GIRDERS	4	Curing, map hairline, and longitudinal cracks. 30 sf. ± light to medium scale and concrete patches, some hollow. 10 sf. ± hollow and potential spall areas. Map and longitudinal hairline cracks with heavy efflo. with candles at both edges. Spalls with exposed rebar. 25 % ± deterioration. See Sketch.

SPALL WITH EXP REBAR
30" X 20" X 4" DEEP
WITH 50% SECTION LOSS
ON REBAR.

Photo # 6: SPALL 30 IN. X 20 IN. X 4 IN D. ± WITH EXPOSED REBAR WITH UPTO 50% SECTION LOSS IN UNDERSIDE 6 FT. FROM SOUTH END.

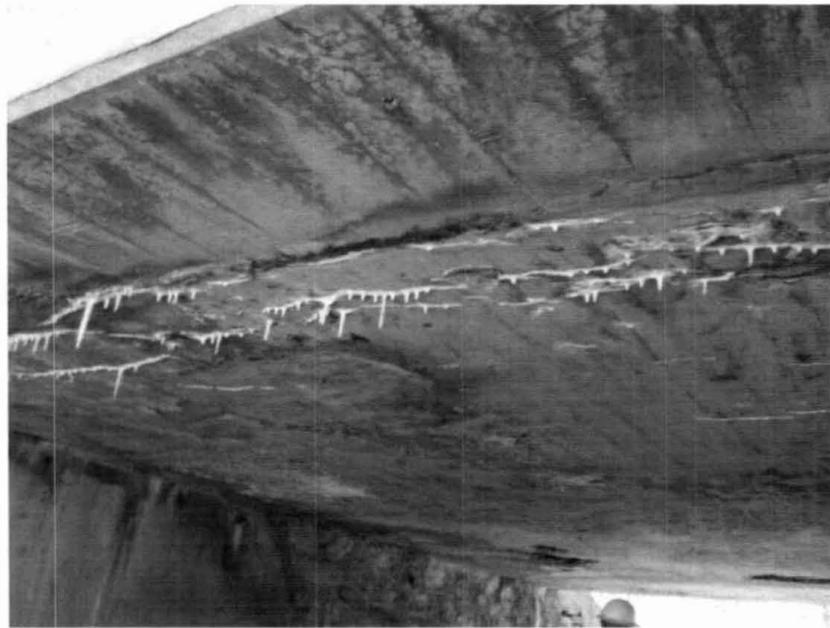
HOLLOW AREA
WITH HVY EFFLO
AND CANDLES
2' WIDE X 8' LONG

Photo # 7: NORTH END OF UNDERSIDE WITH CRACKS, HEAVY EFFLO., HOLLOW AREAS AND CANDLES.

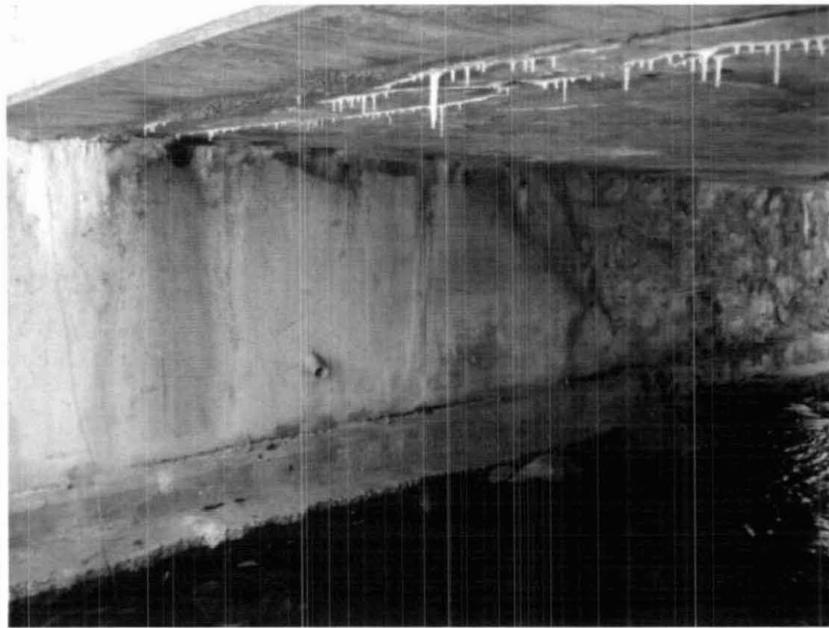
PIERS/BENTS-SETTLEMENT	<input type="text" value="N"/>	<input type="text"/>
EROSION-SCOUR	<input type="text" value="7"/>	Stream bed erosion along abutment # 2.
CONCRETE CRACK-SPALL	<input type="text" value="7"/>	See above items.
STEEL CORROSION	<input type="text" value="N"/>	<input type="text"/>
PAINT	<input type="text" value="N"/>	<input type="text"/>
TIMBER DECAY	<input type="text" value="N"/>	<input type="text"/>
COLLISION DAMAGE	<input type="text" value="8"/>	<input type="text"/>
DEBRIS	<input type="text" value="N"/>	<input type="text"/>

CHANNEL SCOUR	<input type="text" value="7"/>	Minor scour along abutment # 2. Sand bags at face of scour wall have been scoured away. No undermining at this inspection.
EMBANKMENT EROSION	<input type="text" value="7"/>	Minor areas of erosion.
DEBRIS	<input type="text" value="8"/>	<input type="text"/>
VEGETATION	<input type="text" value="8"/>	<input type="text"/>
CHANNEL CHANGE	<input type="text" value="7"/>	Channel alignment directed towards abutment # 2.
FENDER SYSTEM	<input type="text" value="N"/>	<input type="text"/>
SPUR DIKES & JETTIES	<input type="text" value="N"/>	<input type="text"/>
RIP RAP	<input type="text" value="n"/>	Bagged concrete along Abutment # 2 has apparently washed away.

Photo # 8: ABUTMENT # 2 WITH SAND BAGS AT FACE OF SCOUR WALL SCOURED AWAY. NO UNDERMINING AT THIS INSPECTION.

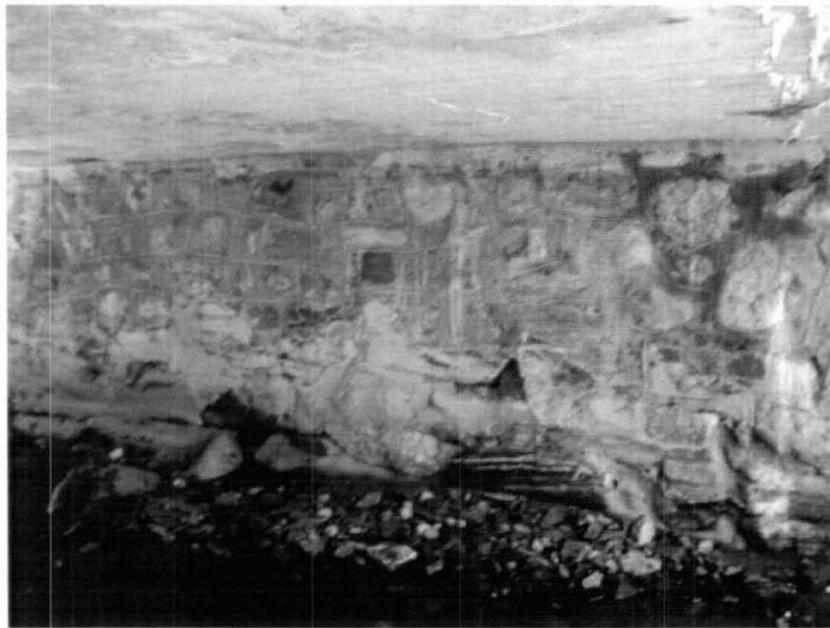
Photo # 9: ABUTMENT # 1.

60. SUBSTRUCTURE		OVERALL RATING 7
	RATING	
ABUTMENTS-STEM	7	Masonry with concrete caps. Some cracked mortar and stones. Abutment # 1 - Void at bottom 36 in. x 5 in. x 5 in. ± deep. Abutment # 2 - Large concrete repaired section at upstream end with map and vertical cracks.
ABUTMENTS-BACKWALL	N	
ABUTMENTS-FOOTINGS	N	Not visible.
ABUT.-SETTLEMENT	8	
ABUTMENTS-WINGWALLS	7	3 stone masonry wings and concrete wing at up stream corner of abutment 2. Masonry generally shows cracked mortar and stones and gunite.
PIERS/BENTS-CAPS	N	
PIERS/BENTS-PILE BENT	N	
PIERS/BENTS-COLUMN	N	
PIERS/BENTS-FOOTINGS	N

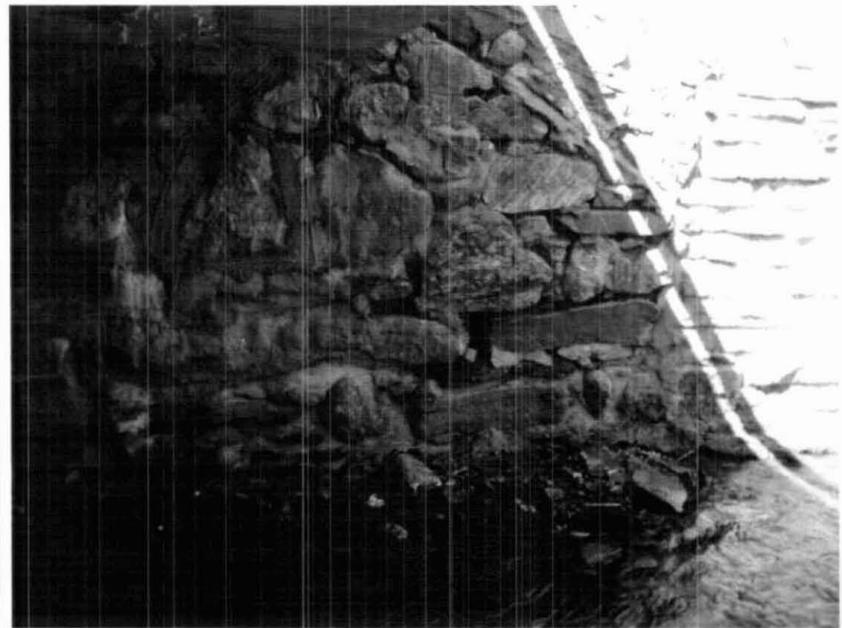
Photo # 10: NORTH END OF ABUTMENT # 1 WITH STONE VOIDS.

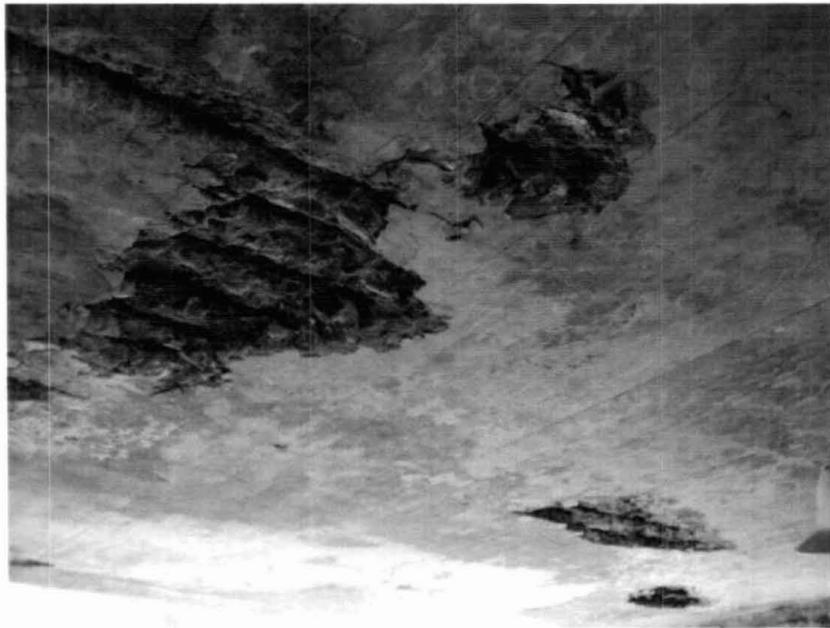
SPALL WITH EXP REBAR
60" X 24" X 2" DEEP
LAM RUST ON REBAR
HOLLOW AROUND EDGES -
SPALL WITH EXP REBAR
27" X 12" X 2" DEEP

Photo # 11: SOUTH END OF UNDERSIDE WITH MULTIPLE SHALLOW SPALLS WITH EXPOSED REBAR.

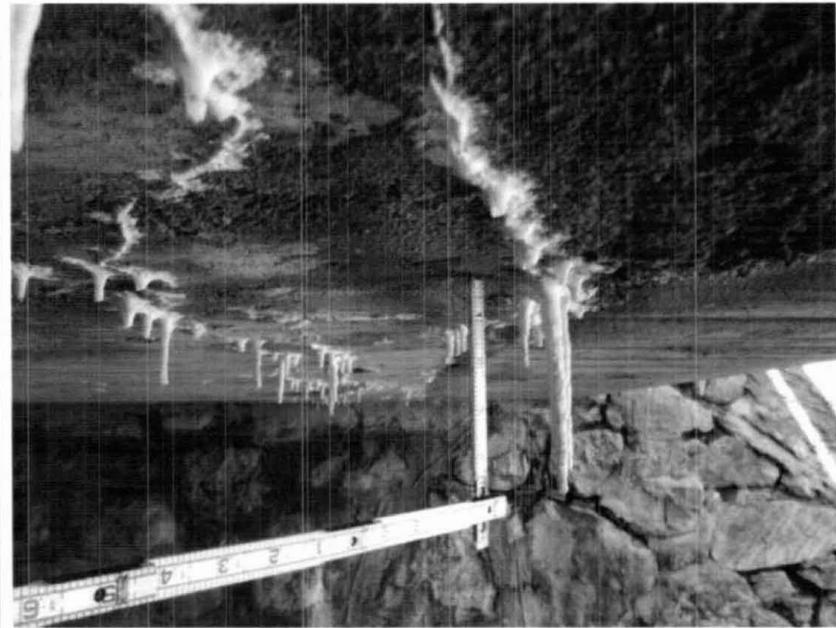
Photo # 12: NORTH END OF UNDERSIDE SHOWING HEAVY EFFLO. AND 6 IN. ± CANDLES.
