Structure No. 03290

Route 9 North Bound

Nedobity Road

Routine Inspection

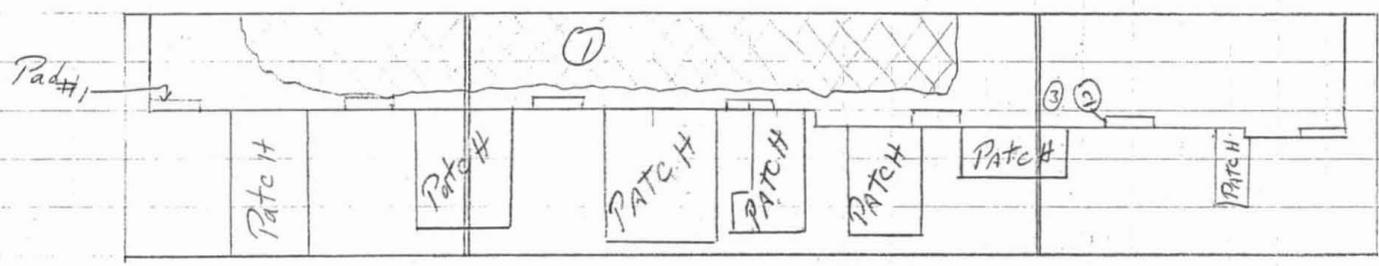
Abut. 2

- ① Potential spall ± 26' Long by 2 1/2' wide x 18" dia. w. spalling along edges ①
- ② minor corner spall @ edge of Patch ① west face 13" L x 5 1/2" x 1 1/2" dia w. exp. CORAL.
- ③ minor efflo stains.

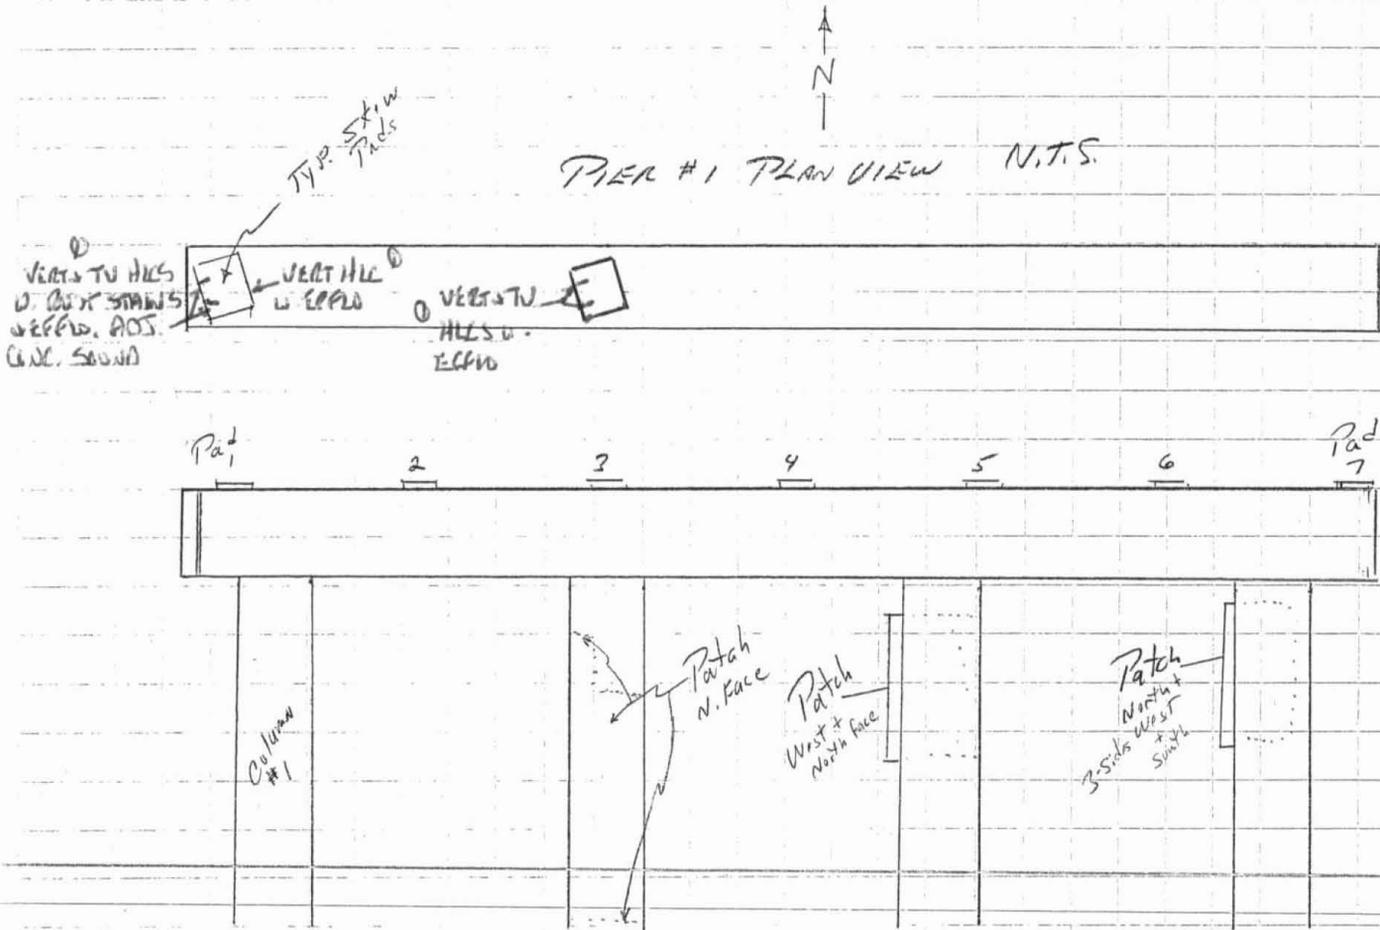
Pier #1 South ELEV.

General note. Some shallow wire construction debris embedded in Column, 10ft off sketch for sketch clarity

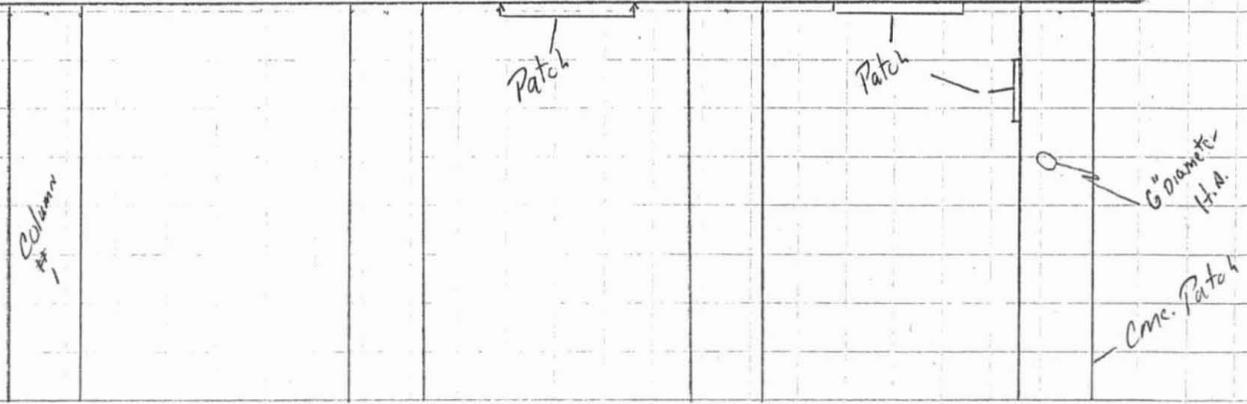
South Face N.T.S.

± 3' H.C. (Horiz)  
below top chord

General note: Column show some minor shallow form wire debris embedded, left off sketch for sketch clarity

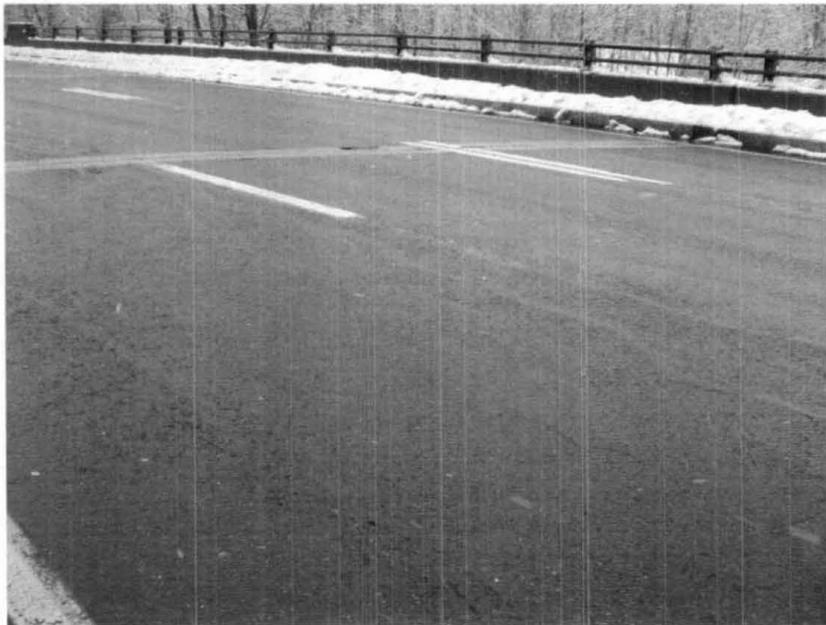
RATING	
OVERLAY	<span style="border: 1px solid black; padding: 2px;">6</span>	BITUMINOUS CONCRETE OVER MEMBRANE - RANDOM, TRANSVERSE AND LANE JOINT CRACKS. - RAVELING.
DECK STR. CONDITION	<span style="border: 1px solid black; padding: 2px;">7</span>	UNDERSIDE - CURING TYPE CRACKS. - TRANSVERSE HAIRLINE CRACKS.  JOINT UNDERSIDES - LARGE SURFACE SPALLS, 4 SQUARE FEET TOTAL.
CURBS	<span style="border: 1px solid black; padding: 2px;">7</span>	SAFETYWALKS WITH GRANITE CURBS - SNOW COVER AT THIS TIME, COMMENTS FROM PREVIOUS REPORT. - MINOR AREAS OF LIGHT SCALE. - TRANSVERSE AND VERTICAL HAIRLINE CRACKS.
MEDIAN	<span style="border: 1px solid black; padding: 2px;">N</span>	
SIDEWALKS	<span style="border: 1px solid black; padding: 2px;">N</span>	
PARAPET	<span style="border: 1px solid black; padding: 2px;">7</span>	- TRANSVERSE AND VERTICAL HAIRLINE CRACKS. - AREAS OF LIGHT SCALE.
RAILING	<span style="border: 1px solid black; padding: 2px;">7</span>	STANDARD (2) PIPE (GALVANIZED) - AREAS OF GALVANIZE WORN OFF WITH LIGHT RUST.  WEST RAIL - SPAN #1, (1) RAIL CLIP HAS HEAVY LAMINAR RUST WITH HEAVY SECTION LOSS.

**PHOTO # 3 GENERAL CONDITION OF BITUMINOUS OVERLAY.**

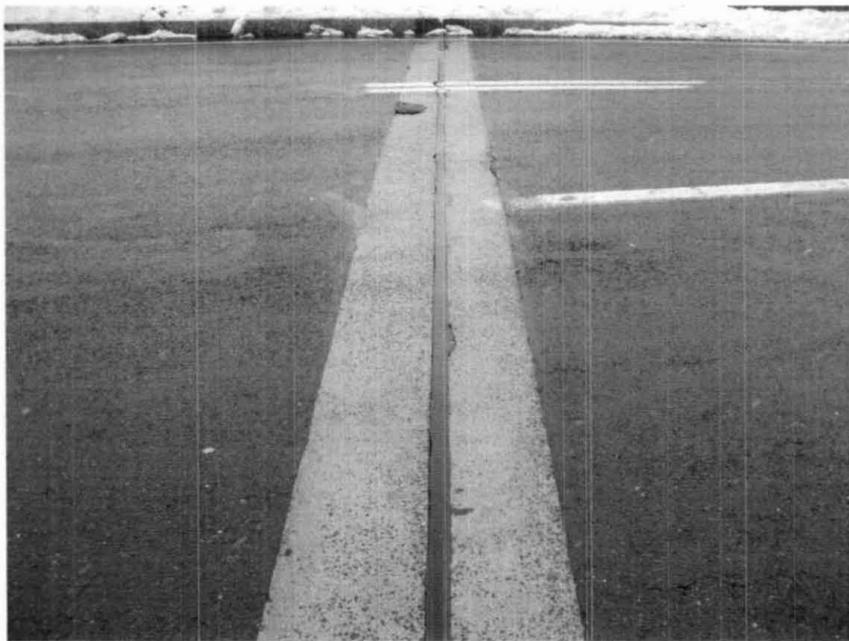
PIER #1 - CLIMBING LANE, SEVERE SCALE 5 FT. LONG X 4 IN. WIDE X 1 1/2 IN. DEEP.  
- SLOW LANE, LARGE SURFACE SPALL 24 IN. X 10 IN. X 1 1/2 IN. DEEP (PARTIALLY PATCHED).

**PHOTO # 5 GENERAL CONDITION OF JOINT OVER PIER #1.**

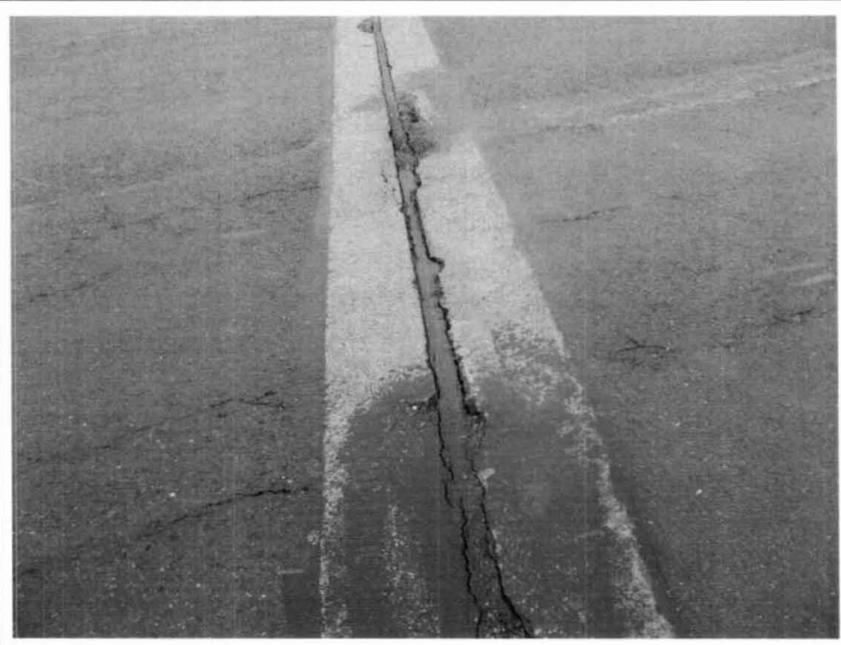
PIER #2 - BITUMINOUS PATCHED AREAS.  
- HOLLOW AREAS WITH POTENTIAL SPALLS, SEVERE SCALE AREAS AND LARGE SURFACE SPALLS 11 FT. LONG TOTAL X UP TO 5 IN. WIDE X UP TO 3 IN. DEEP. SOME SPALLS PARTIALLY BITUMINOUS PATCHED.

**PHOTO # 8 GENERAL CONDITION OF JOINT OVER PIER #2.**

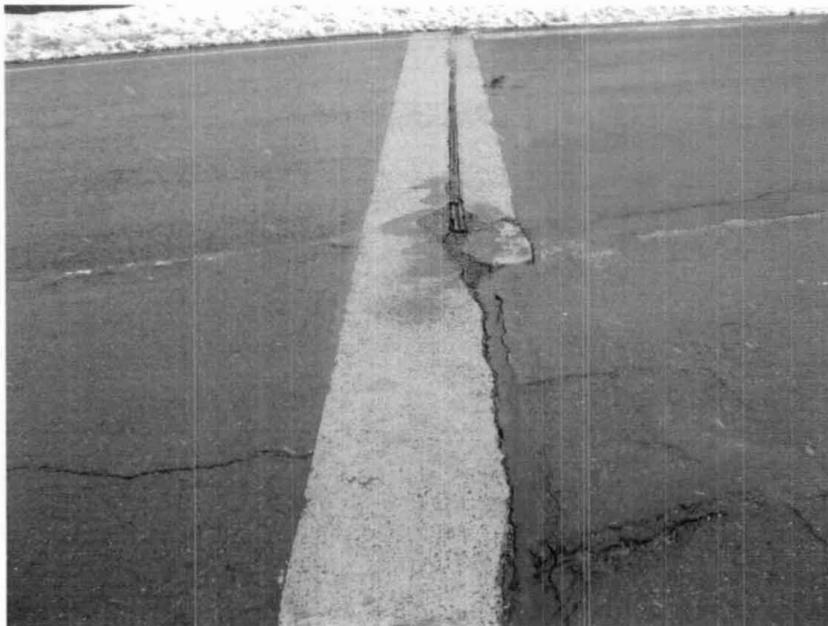
ABUTMENT #2 - POTENTIAL SPALL IN CENTER LANE, 3 SQUARE FEET.  
- SEVERE SCALE IN SLOW LANE 21 IN. X 2 IN. X UP TO 4 IN. DEEP.  
- SEVERE SCALE AREA IN RIGHT SHOULDER 41 IN. LONG X 4 IN. WIDE X 2 IN. DEEP.

**PHOTO # 9 GENERAL CONDITION OF JOINT OVER ABUTMENT #2.**

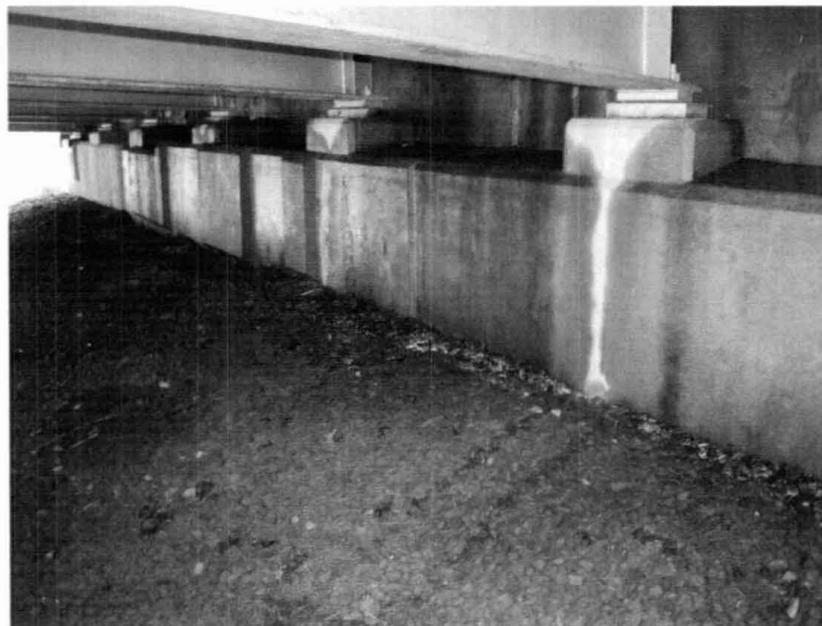
**PHOTO # 10 TYPICAL CONDITION OF ABUTMENTS.**

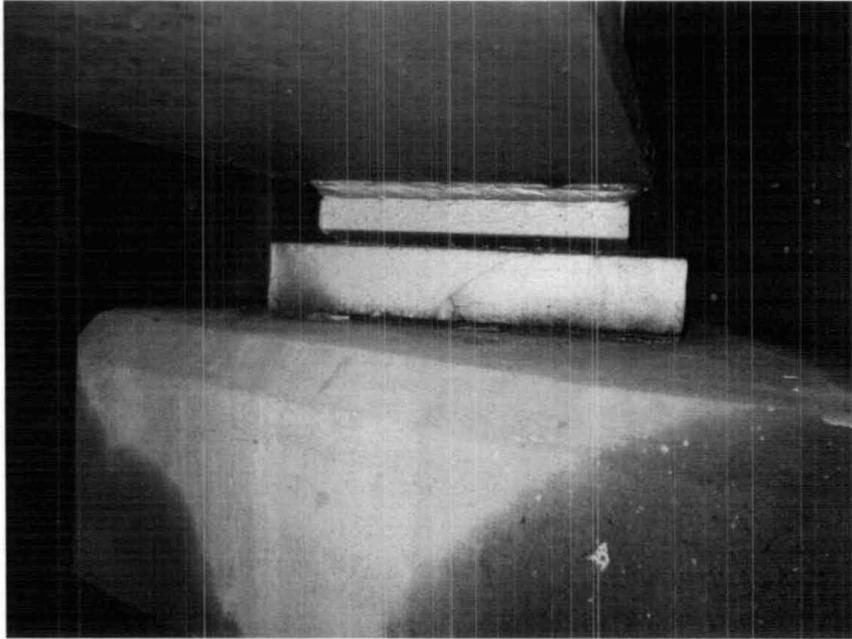
PIER #1 AND BOTH ABUTMENTS - CURVED SOLE PLATE.  
- ABUTMENTS, LIGHT RUST.  
- PIER #1, HEAVY LAMINAR RUST WITH 1/8 IN. IMPACTED RUST.

**PHOTO # 11 GENERAL CONDITION OF BEARINGS OVER ABUTMENTS.**

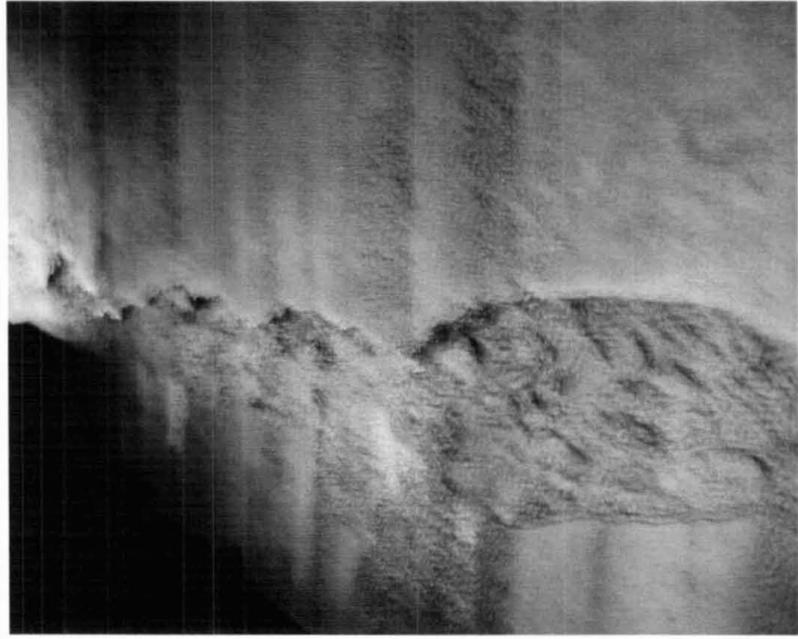
**PHOTO # 12 SPALLING AND HOLLOW AREAS IN BACKWALLS.**

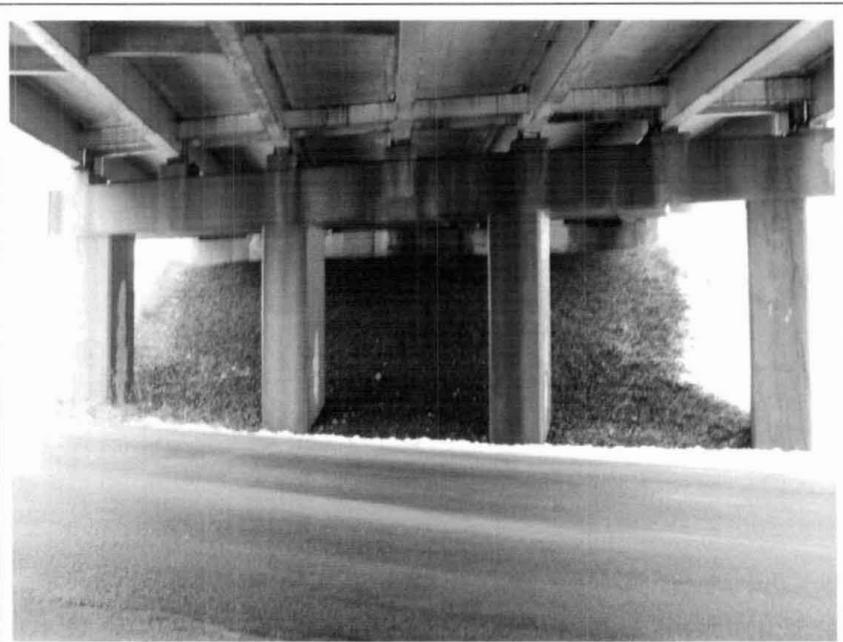
PIERS/BENTS-PILE BENT	<span style="border: 1px solid black; padding: 2px;">N</span>	
PIERS/BENTS-COLUMN	<span style="border: 1px solid black; padding: 2px;">7</span>	- VERTICAL HAIRLINE CRACKS. - LIGHT SCALE. - CONCRETE PATCHED AREAS, SOME WITH CURING TYPE CRACKS. - SEE ATTACHED SKETCHES.
PIERS/BENTS-FOOTINGS	<span style="border: 1px solid black; padding: 2px;">N</span>	NOT VISIBLE.
PIERS/BENTS-SETTLEMENT	<span style="border: 1px solid black; padding: 2px;">8</span>	
EROSION-SCOUR	<span style="border: 1px solid black; padding: 2px;">8</span>	
CONCRETE CRACK-SPALL	<span style="border: 1px solid black; padding: 2px;">4</span>	SEE BACKWALLS.
STEEL CORROSION	<span style="border: 1px solid black; padding: 2px;">6</span>	
PAINT	<span style="border: 1px solid black; padding: 2px;">N</span>	
TIMBER DECAY	<span style="border: 1px solid black; padding: 2px;">N</span>	
COLLISION DAMAGE	<span style="border: 1px solid black; padding: 2px;">8</span>

**PHOTO # 14 TYPICAL CONDITION OF PIERS.**

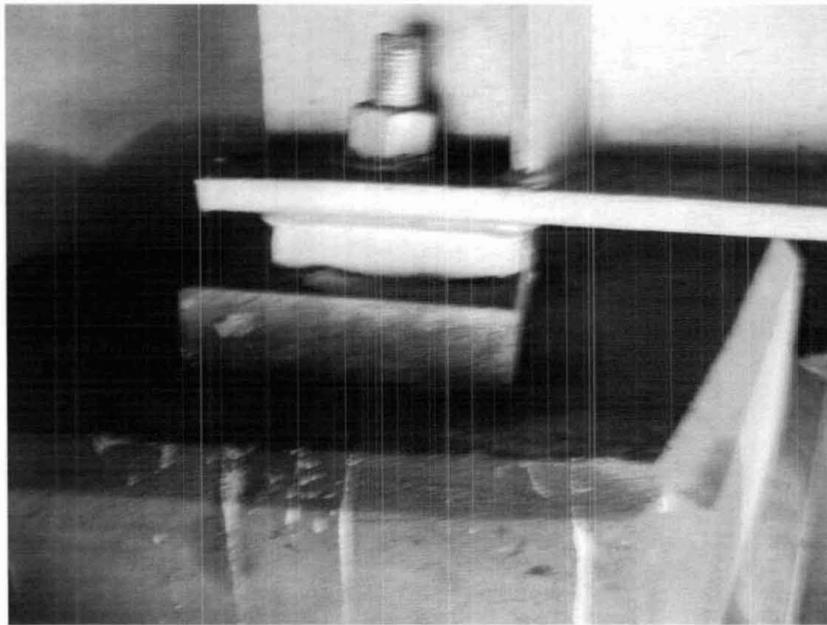
ABUTMENT #2 - ANCHOR BOLTS TIPPED TO THE SOUTH.  
- BEARING #2, MASONRY PLATE TIPPED TO THE SOUTH LEAVING A 3/8 IN. GAP AT BACK OF BEARING. GAP IS FILLED WITH IMPACTED RUST WHICH COULD HAVE BEEN A PLATE ADDED UNDER BEARING IN THE PAST.

**PHOTO # 17 BEARING #2 OVER ABUTMENT #2 –  
TIPPED TO THE SOUTH,**

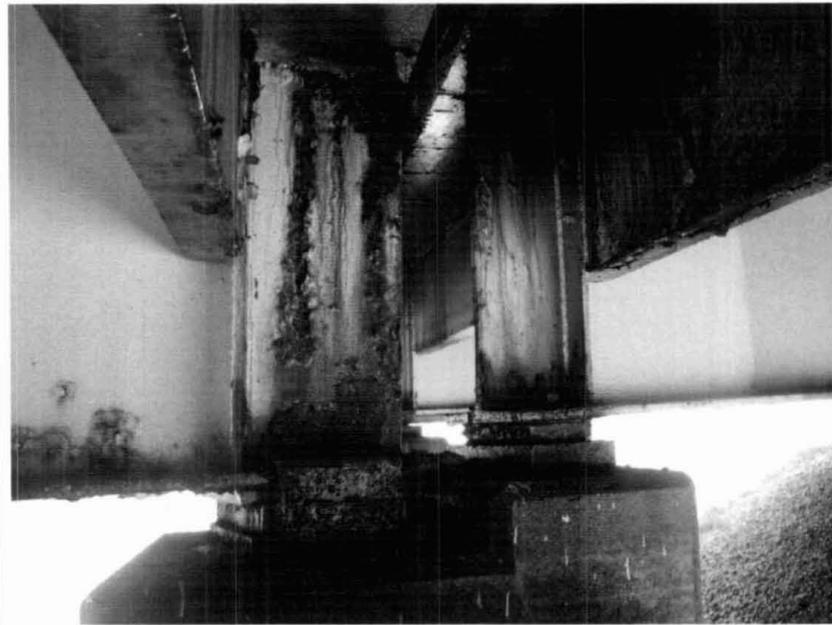
PIER #2 - SPAN #2, BRONZE SLIDING PLATES.  
- HEAVY LAMINAR AND IMPACTED RUST (1/8 IN.).  
- KEEPER PLATES ON BEARINGS.

ROLLED BEAMS - HEAVY LAMINAR RUST IN RANDOM BEAM ENDS OVER PIERS.

PIERS - ALL BEAM ENDS HAVE APPROXIMATELY 3/16 IN. PITTING TYPE SECTION LOSS IN BOTTOM FLANGES, TOP AND BOTTOM OF WEBS AND BASE OF STIFFENERS.

**PHOTO # 18 TYPICAL CONDITION OF BEAM ENDS  
AND BEARINGS OVER PIERS.**
