# STRUCTURE NO. 06656

ROUTE 202  
over  
BROOK  
LITCHFIELD

Routine Inspection  
on  
8/24/2006

Special Inspection  
on  
9/19/2007

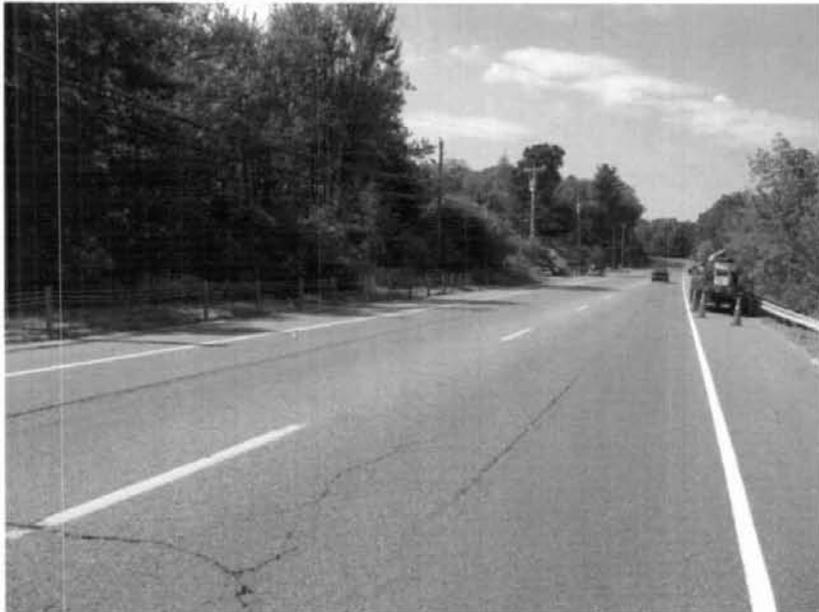
**Photo # 1**  
**Looking South from the North approach. {Bucket truck parked at structure.**

- RATING**
- APPROACH SLAB **N**
- RELIEF JOINTS **N**
- APPROACH GUIDE RAIL **7** (MBR) at west.  
Weak posts at east, some posts slightly tipped north.
- APPROACH PAVEMENT **6** Bituminous concrete shows transverse & longitudinal cracks open up to 1/2 inch +/-.  
See photo 1.
- APPROACH EMBANKMENT **7** Paved runoff at the southeast and some roadway runoff erosion.

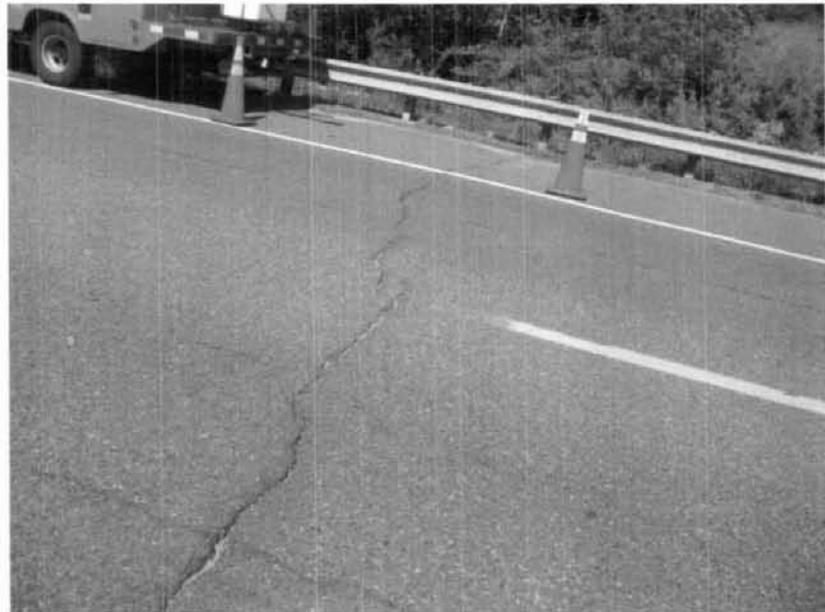
**Photo # 2**  
**Wearing surface.**

RATING	
OVERLAY	<b>6</b>	Overlay shows some transverse & longitudinal cracks open up to 1/2 inch. Also, (1) full width transverse crack open up to 2 inches +/-. See photo 2.
DECK STR. CONDITION	<b>N</b>	
CURBS	<b>N</b>	
MEDIAN	<b>N</b>	
SIDEWALKS	<b>N</b>	
PARAPET	<b>N</b>	
RAILING	<b>N</b>	
PAINT	<b>N</b>	
FENCE	<b>N</b>	
DRAINS	<b>N</b>	
LIGHTING STANDARD	<b>N</b>	
UTILITIES TYPE/SIZE	<b>N</b>	
CONSTRUCTION JOINTS	<b>N</b>	
EXPANSION JOINTS	<b>N</b>

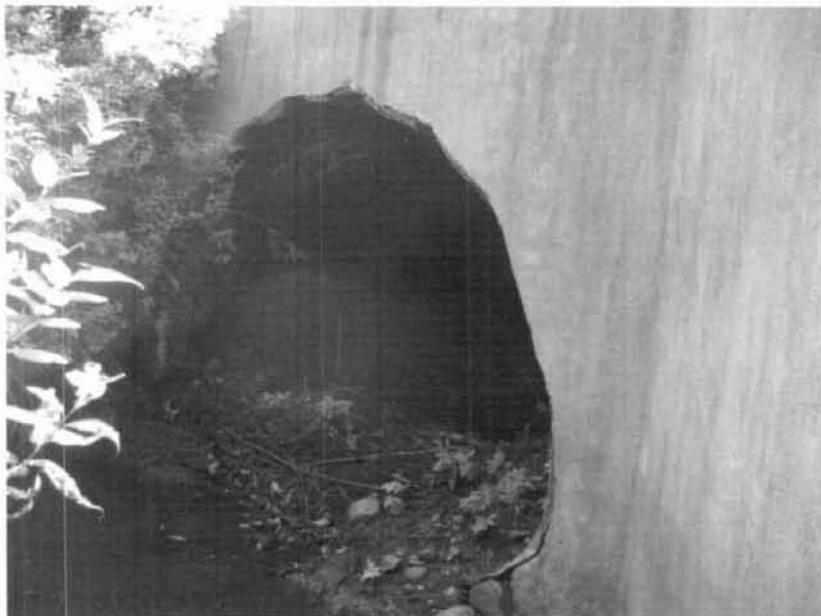
**Photo # 3**  
**Inlet. {West}**

- DEBRIS **5** Moderate accumulation of silt & brush up to 1.5 feet +/- at inlet end extending for 6 feet +/- into pipe.  
See photos 3, 9 & 10.
- RETAINING WALL STEM **6** Southeast wingwall with a 15 inch diameter (accmp) shows light scale & vegetation growth on top.  
Northeast wingwall shows hairline cracks with light to moderate efflorescence.  
Southwest wingwall shows (1) isolated vertical hairline crack.  
Northwest wingwall covered with heavy vegetation growth.  
See photos 11 thru 14.

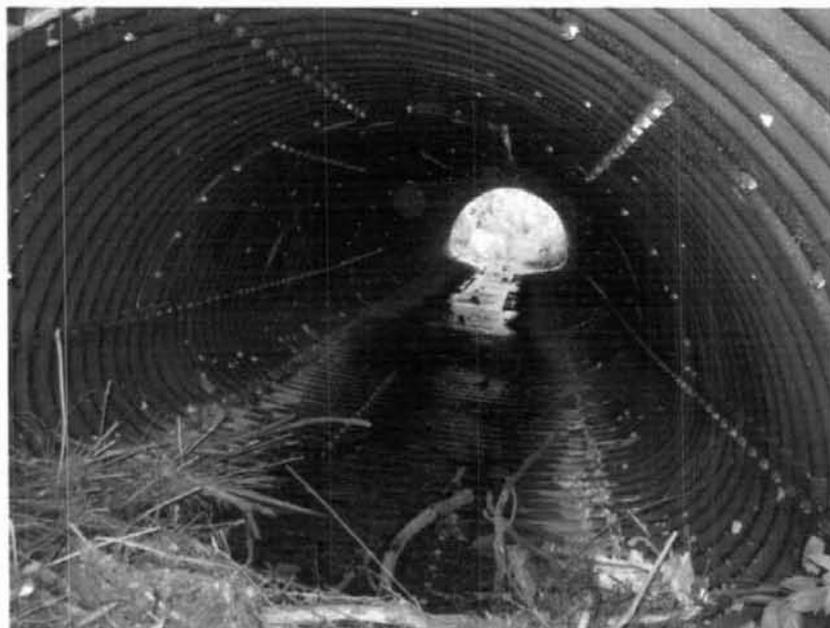
**Photo # 5**  
**Looking in from the inlet.**

- RATING**
- BARREL **N**
- CONCRETE **N**
- STEEL **4** (ACCOMP)  
7 Plates. 6 inch by 1-3/4 by 3/16 inch corrugations.  
Areas of protective coat peeling, isolated areas of staining & small chips in paint.  
Invert shows moderate pitting with moderate to heavy rust.  
First 11 feet +/- at inlet shows perforation holes up to 9 inches long by 2 inches wide along north side.  
Mid point of culvert shows random perforation holes up to 1/2 inch +/- in diameter along south side.  
Last 8 feet at outlet shows isolated perforation holes up to 6 inches long up to 2-3/8 inches wide along north side.  
See photos 5 thru 8.

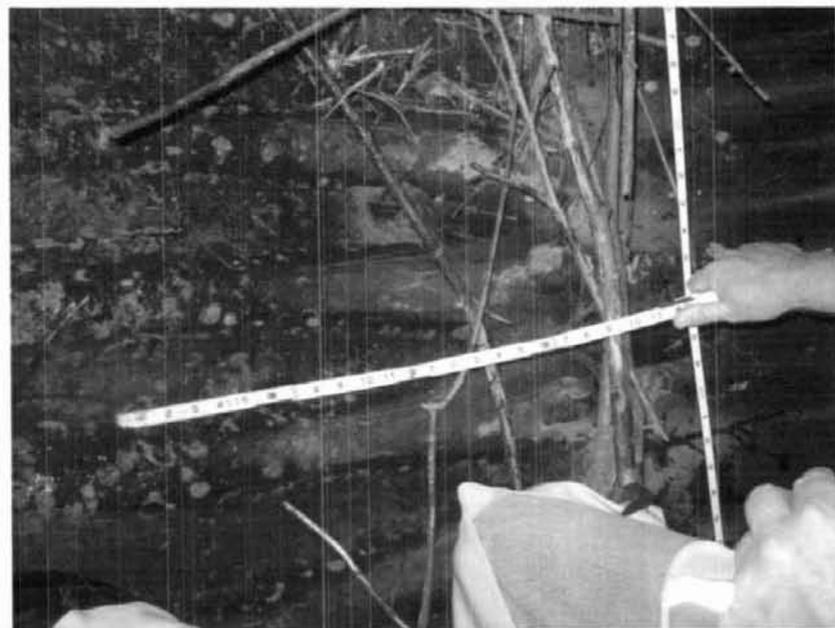
Is the bottom deteriorated? Yes x \_\_\_\_\_ No \_\_\_\_\_ if yes, comment below  
**Perforation holes up to at inlet, center & outlet up to 9 inches long up to 2 inches wide.**

**Photo # 6**  
**Holes in the invert near the inlet.**

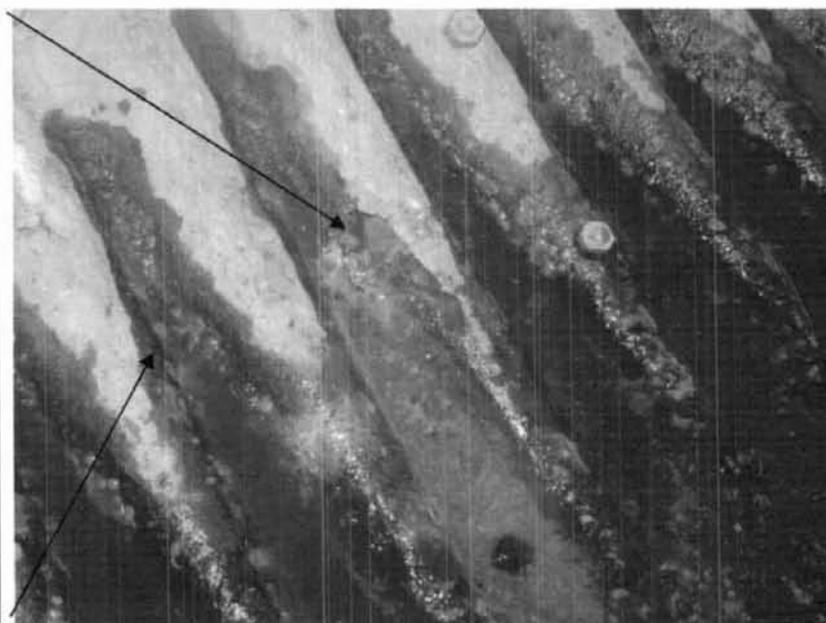
**Photo # 8**  
Holes in the invert near the outlet.

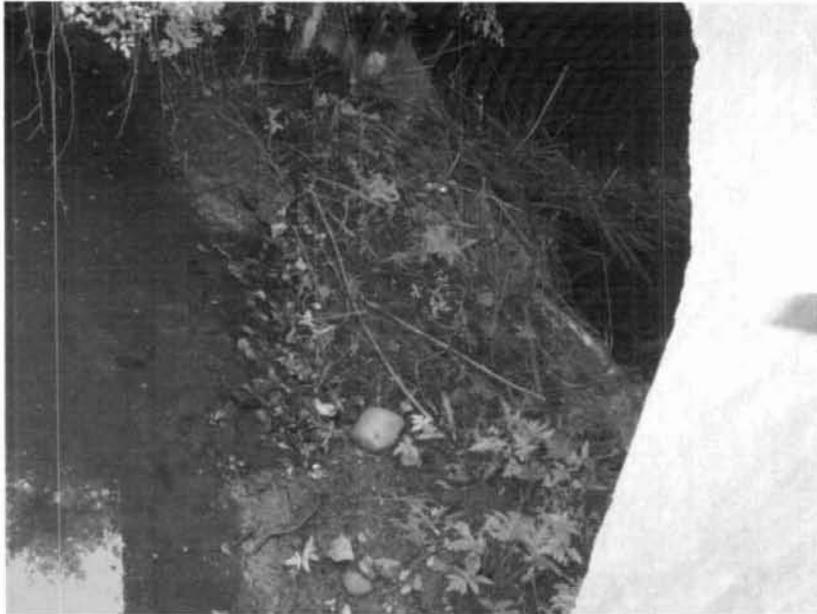
**Photo # 9**  
**Debris built-up at the inlet.**

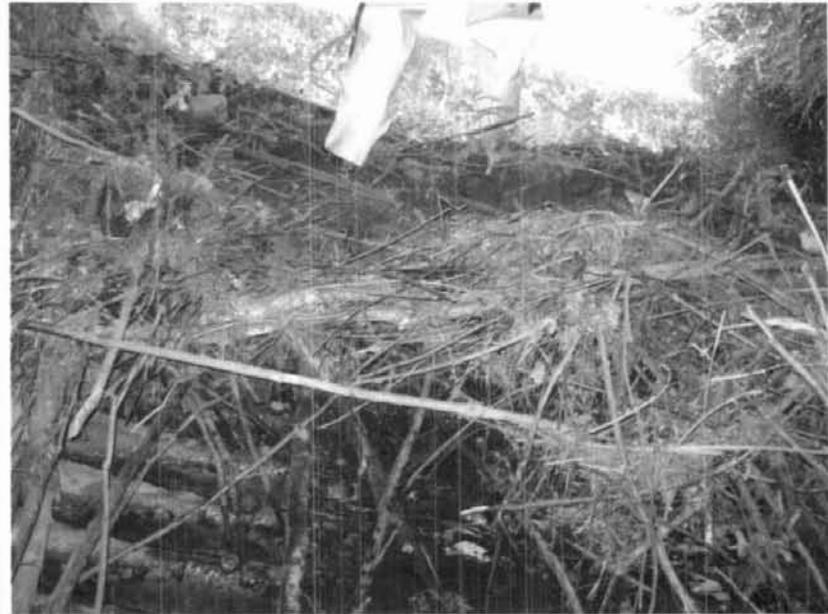
**Photo # 10**  
**Looking at the debris built-up at the inlet from inside the pipe.**

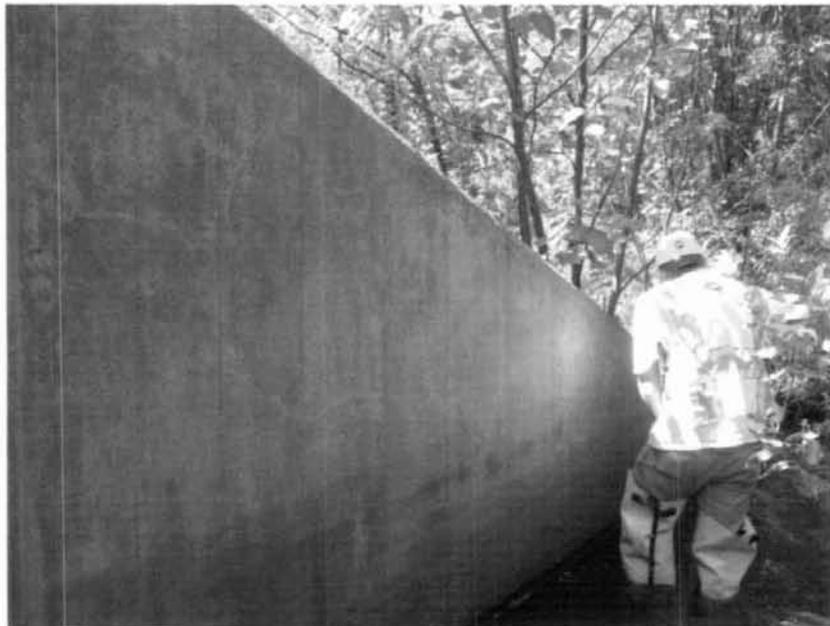
**Photo # 11**  
**The Southwest wingwall.**

RATING	
CHANNEL SCOUR	<b>7</b>	Local scour up to 2.5 feet exposing backside free end of the southwest wingwall, caused from alignment of channel. Also, local scour at outlet end from 15 inch diameter (accmp) in the southeast wingwall.
EMBANKMENT EROSION	<b>5</b>	Embankment erosion along the southwest wingwall. See above item.
DEBRIS	<b>5</b>	Encroachment limits channel flow.
VEGETATION	<b>5</b>	Heavy vegetation growth. See photos 15 & 16.
