CONNECTICUT LOCAL BRIDGE PROGRAM

PRELIMINARY APPLICATION

FIRETOWN ROAD over

ConnDOT Bridge No. 04549

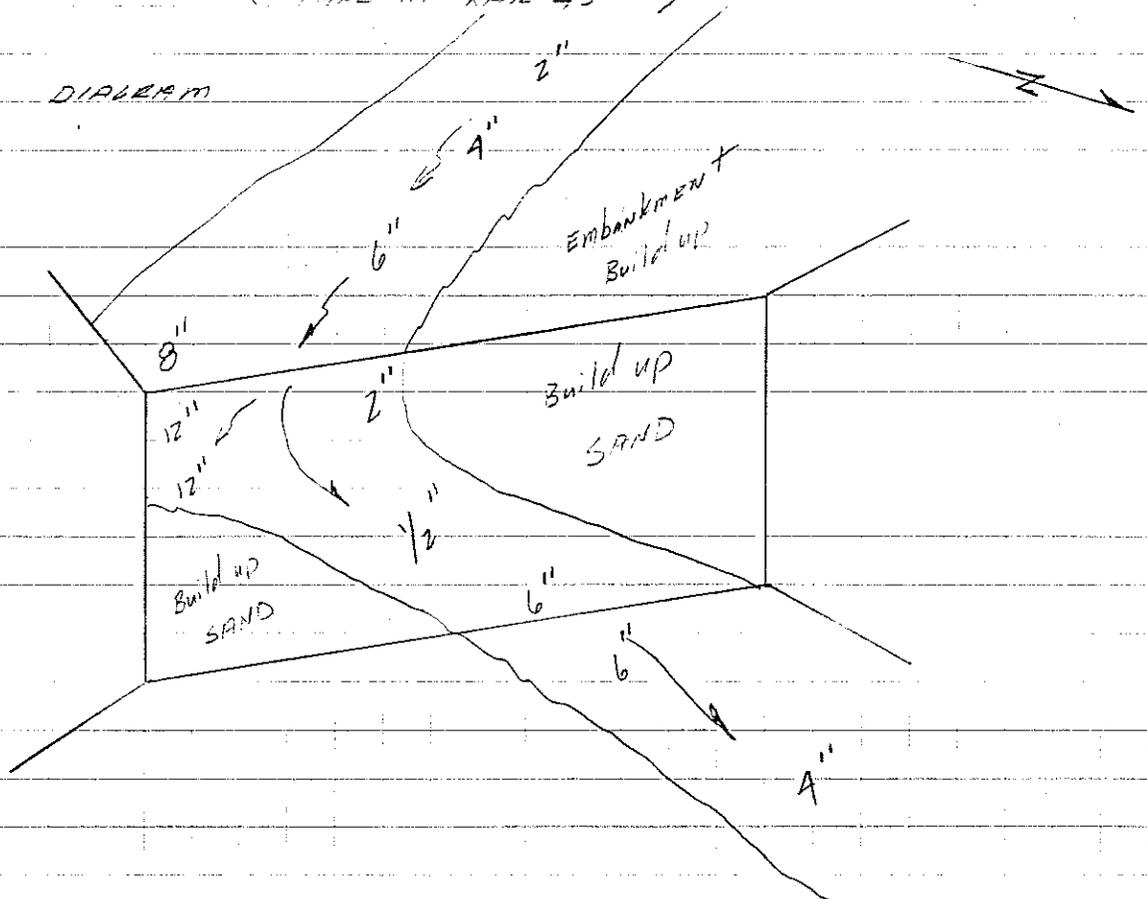
WATER DEPTH DIAGRAM

LOOKING DOWNSTREAM
(THREE INSIDE MEASUREMENTS)
TAKE AT PILE 4'S

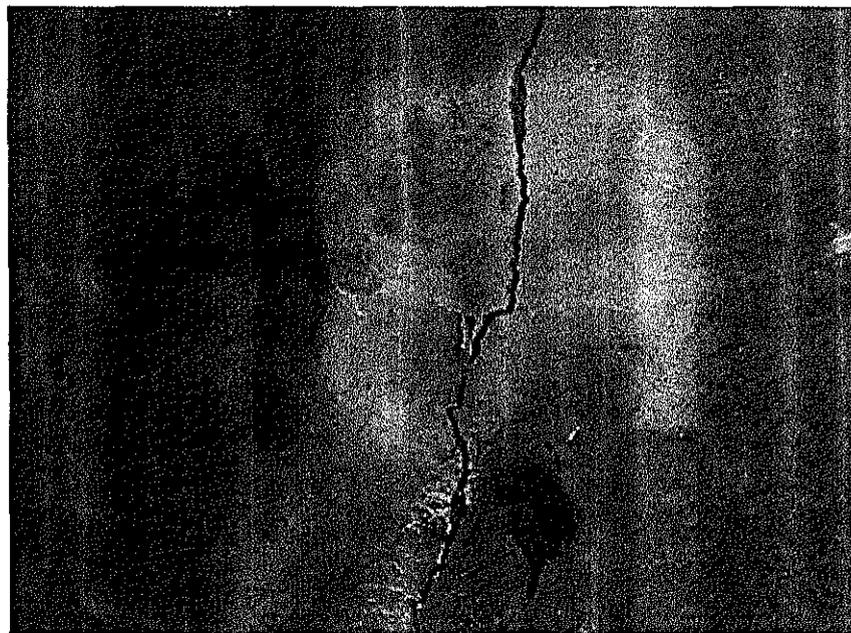
According to the ConnDot bridge inspection report, dated 9/7/99, the substructure is in satisfactory condition (rating=6). There is a full height vertical crack at abutment #2 and small surface spalls. The northeast wingwall shows a large diagonal crack from the bridge seat elevation to the base of the wingwall caused by the deck shifting. There is spalling and exposed rebar along this crack.

60. SUBSTRUCTURE	Rating	Overall Rating --> 6
1.ABUTMENTS STEM	6	BOTH ABUTMENTS SHOW LIGHT SCALE AT THE WATERLINE. ABUTMENT #2 SHOWS A FULL HEIGHT VERTICAL CRACK OPEN 1/8" AND SMALL SURFACE SPALLS, N/C.
BACKWALL	N	
FOOTING	7	FOUR FEET OF ABUTMENT #1 AND SOUTHWEST

Description: VERTICAL CRACK OPEN 1/8" @ ABUTMENT #2

- 1) Remove the existing deck and superstructure.
- 2) Repair the abutment crack and replacing the damaged portions of the wingwalls.
- 3) Install prestressed concrete deck units and elastomeric bearing pads on rebuilt bridge seats to create a 28' travelway.
- 4) Cast new sidewalks and parapets.
- 5) Install a new bridge rail system
- 6) Pave the structure with 2 ½ inches of bituminous concrete over membrane waterproofing.
- 7) Install new guide railing and approaches.

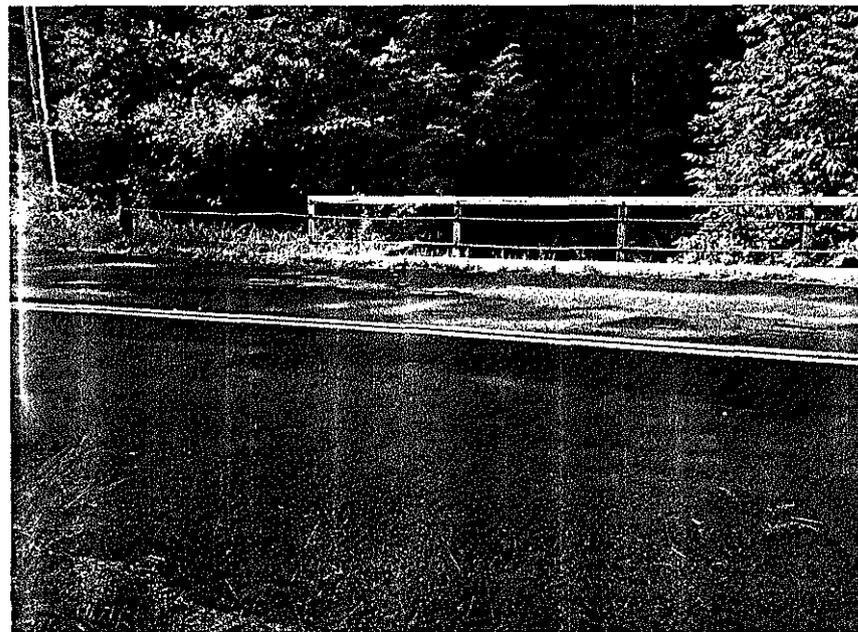
58. DECK	Rating	Overall Rating --> 7
1.OVERLAY	7	MACADAM, SHORT TRANSVERSE AND LONGITUDINAL CRACKS.
2.DECK- STR. CONDITION	7	NO KNOWN MEMBRANE.SEE 59-2.
3.CURBS	N	
4.MEDIAN	N	
5.SIDEWALKS	N	
6.PARAPET	7	RAILBASE---LIGHT SCALE AND ONE SMALL SURFACE SPALL ON THE EAST RAILBASE.
7.RAILING	7	ANGLE IRON POSTS AND CAPS SHOW LIGHT TO MODERATE RUST WITH EXPOSED PRIMER.
8.PAINT	N	
9.DRAINS	N	
10.LIGHTING STANDARD	N	
11.UTILITIES TYPE/SIZE	N	
12.CONSTRUCTION JOINTS	N	
13.EXPANSION JOINT	N

Description: OVERLAY

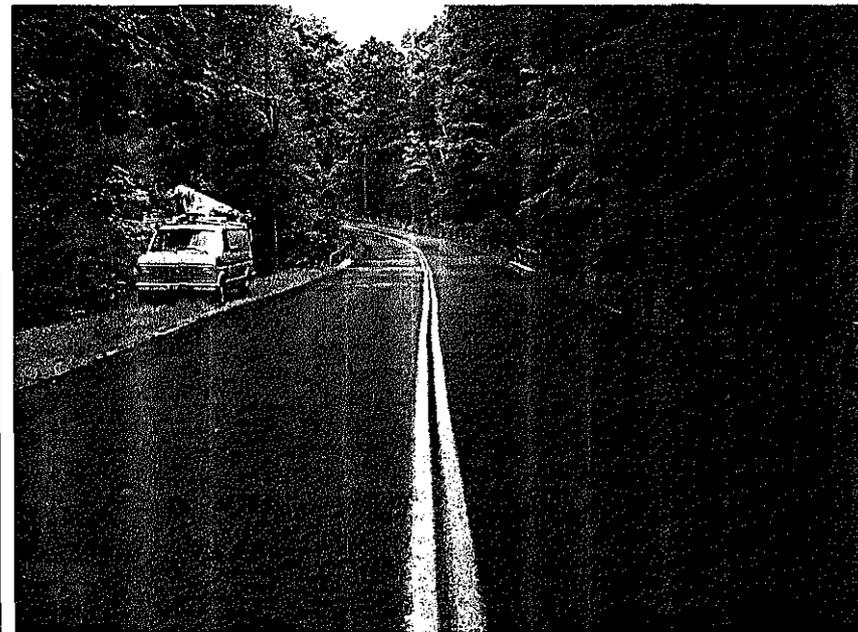
APPROACH GUIDE RAIL 8 DOUBLE WIRE ROPE RAIL ON WOOD POSTS.
PAVEMENT 7 TRANSVERSE AND LONGITUDINAL CRACKS.
EMBANKMENT 6 NORTHWEST HAS ERODED FROM ROADWAY
RUNOFF.

Description: SOUTH APPROACH LOOKING NORTH
