PRELIMINARY APPLICATION FOR THE LOCAL BRIDGE PROGRAM

Bridge Location: Sterling Hill Road over Ekonk Brook

Bridge Number: 04751 Length of Span: 23 feet

Replacement of Sterling Hill Road Bridge over Ekonk Brook, Bridge No. 04751 Plainfield, CT

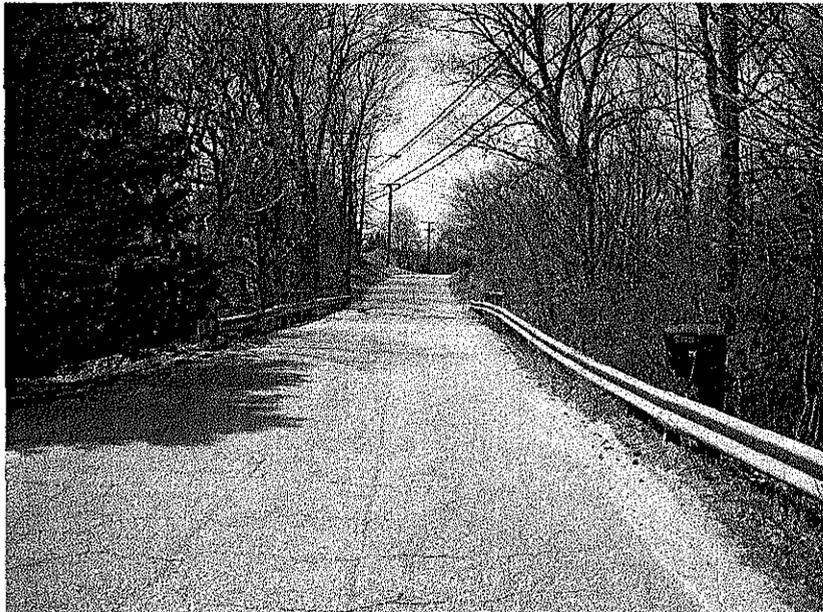
Photo # 1: Bridge and west approach

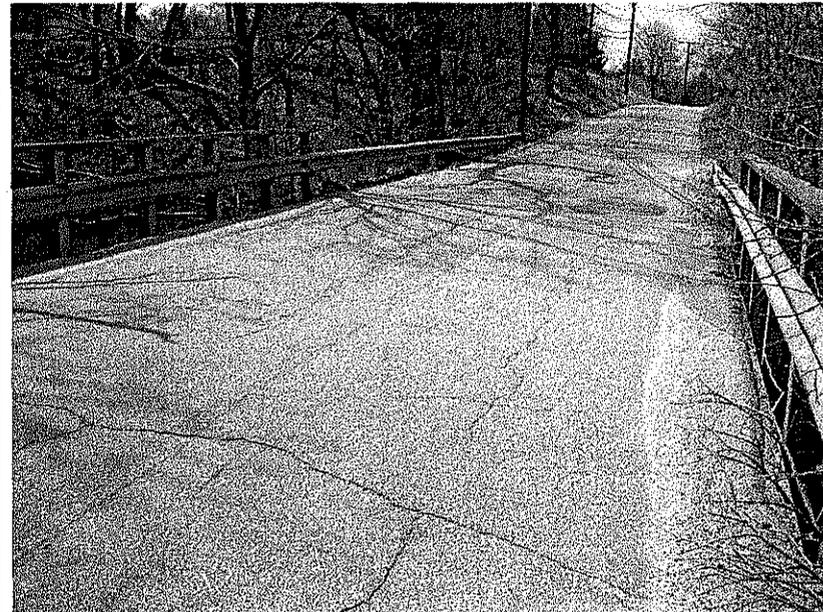
Photo # 2: Typical top of deck

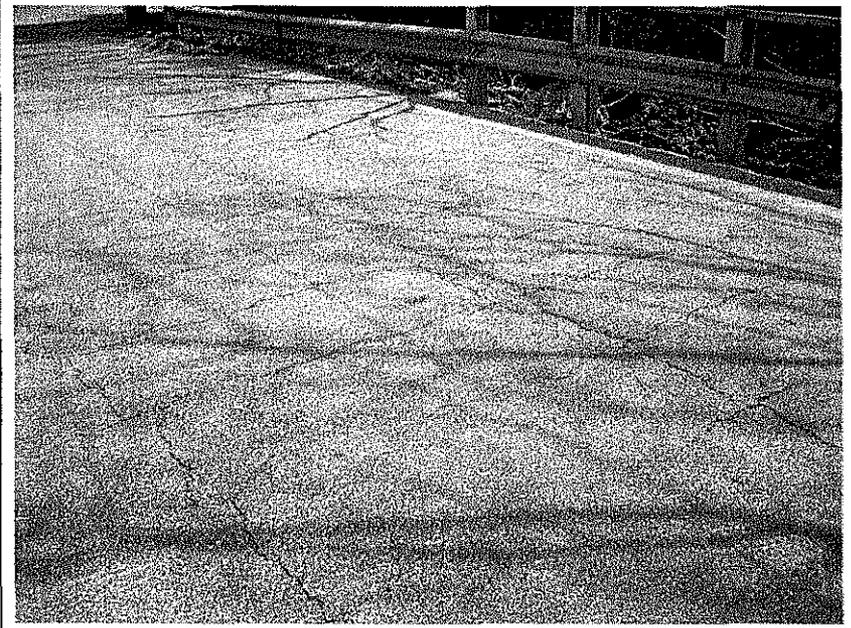
Photo # 3: Typical condition of the overlay. Note up to 1/2" cracking of bituminous

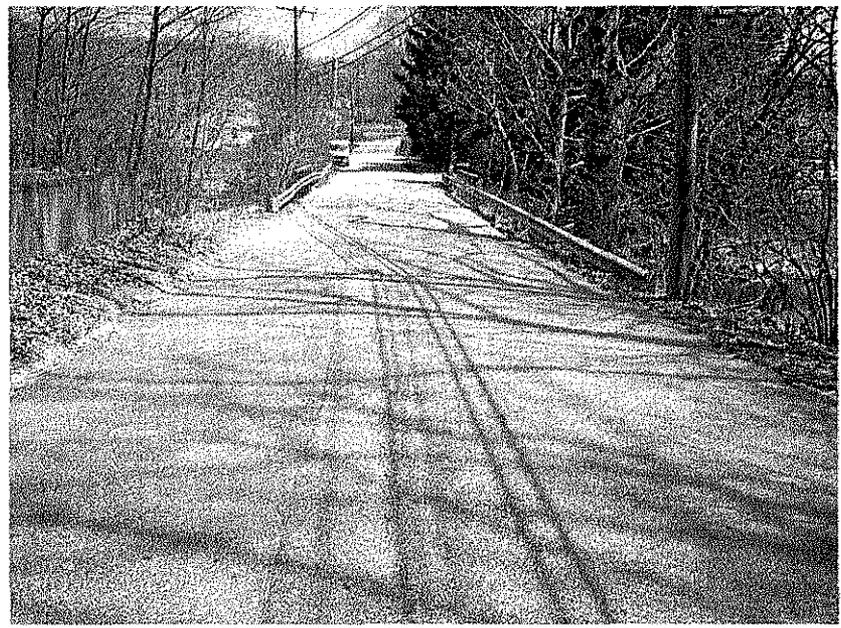
Photo # 4: Bridge and east approach

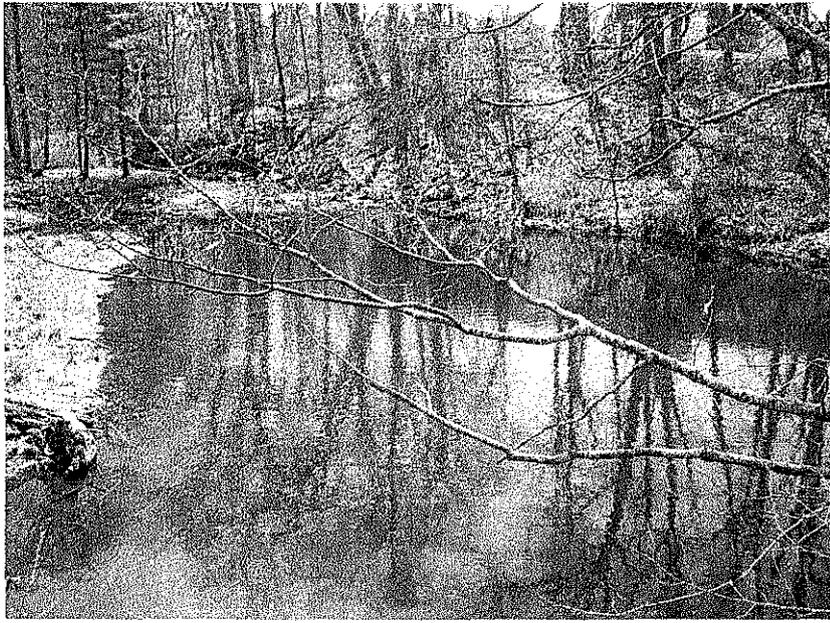
Photo # 5: Channel upstream

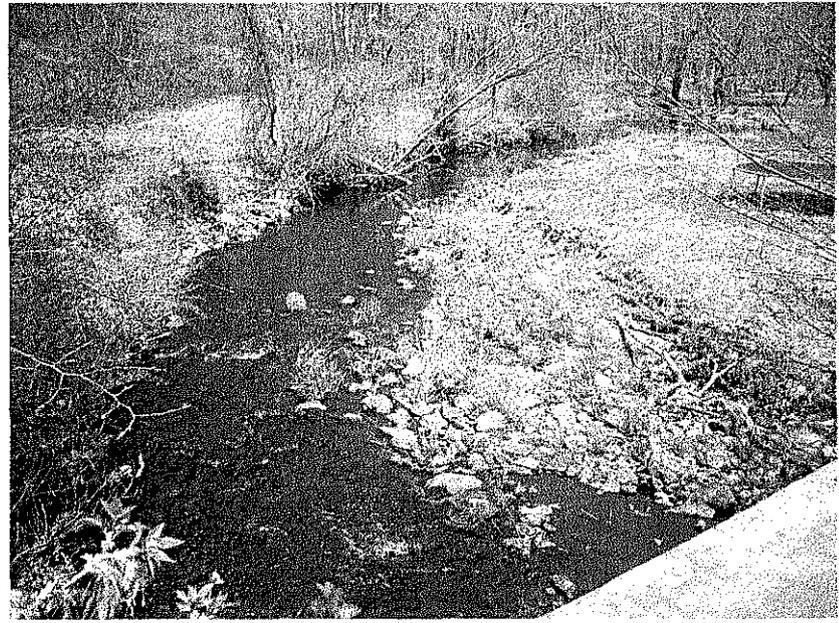
Photo # 6: Channel downstream

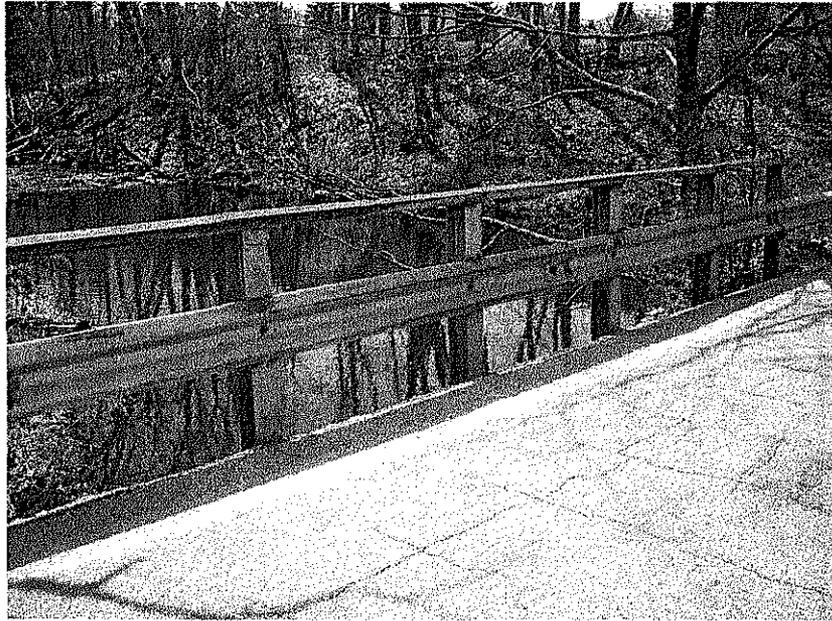
Photo # 7: Typical railing configuration

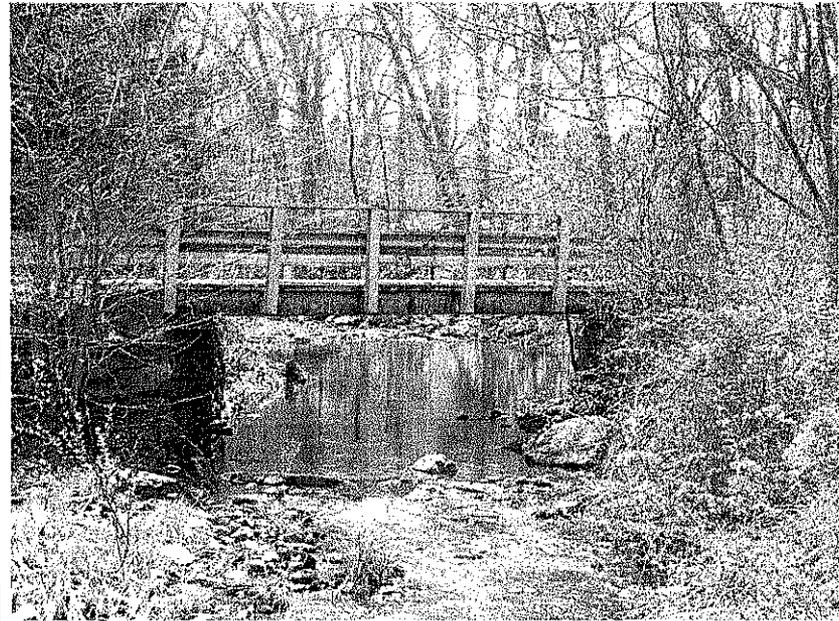
Photo # 8: North elevation

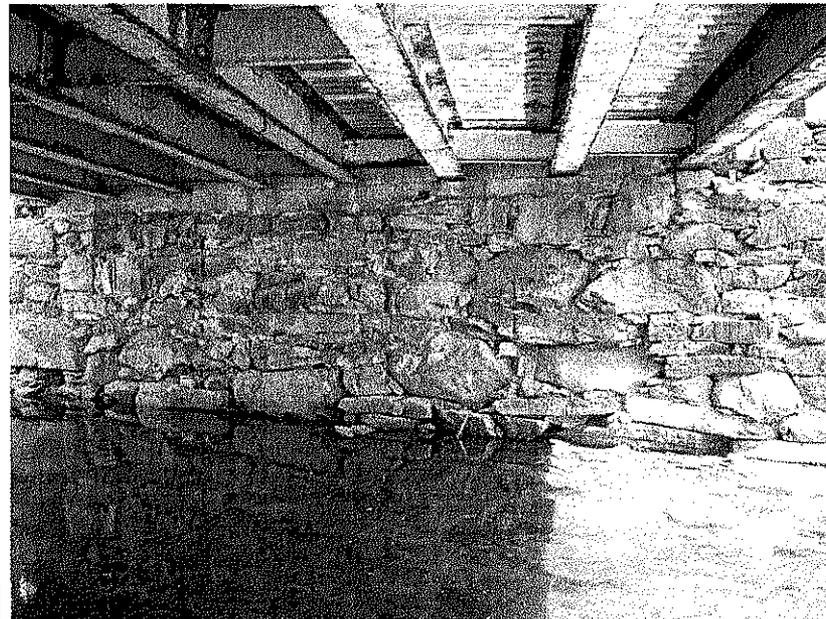
Photo # 10: West abutment

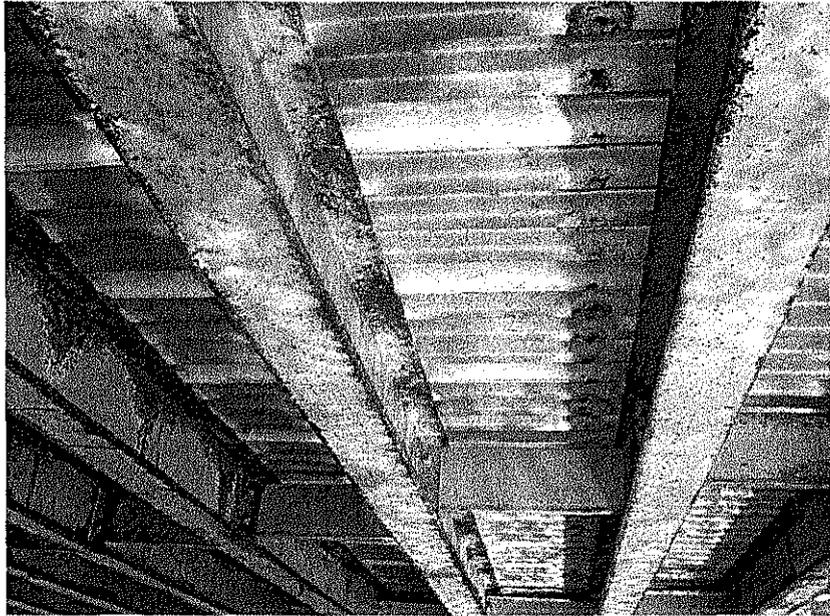
Photo # 11: Typical underside of deck

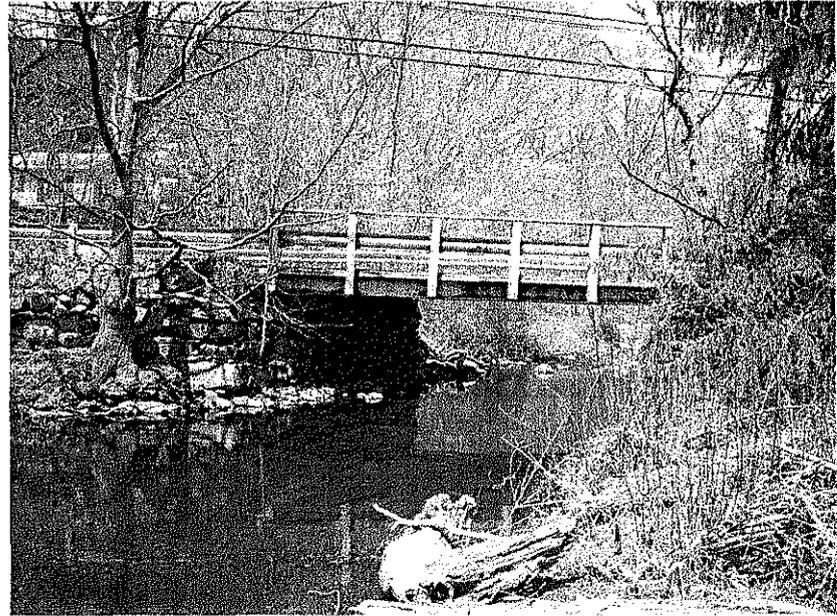
Photo # 12: South elevation
