STRUCTURE NO. 05140

SANDY BROOK ROAD
over
SANDY BROOK
COLEBROOK

Routine Inspection
on
1/19/2007

Structure No.	05140	Town	COLEBROOK
Inspection Date	1/19/2007	Inspectors	TEAM 01

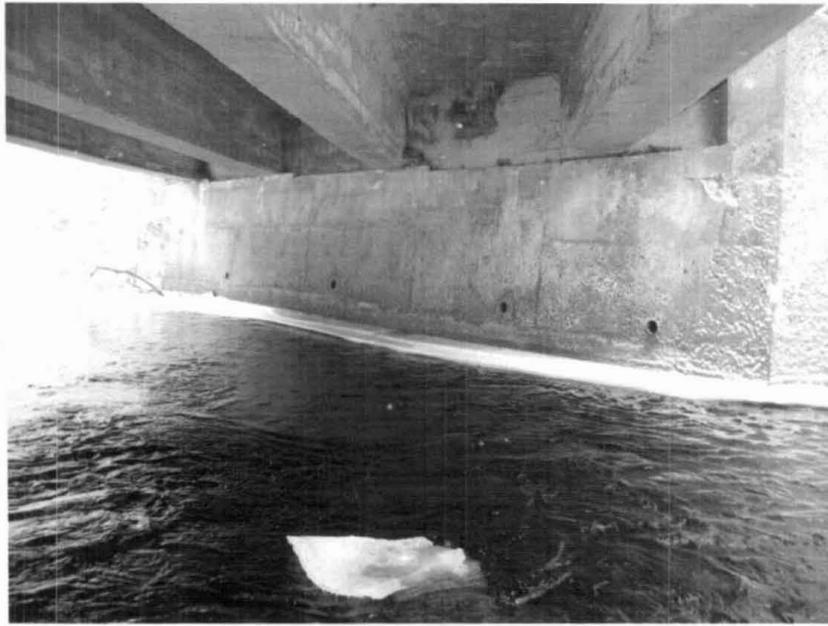
Photo # 3:
General view of abutment # 2

RATING	
ABUTMENTS-STEM	6	<p>Abutment #1 - Vertical hairline cracks and horizontal hairline cracks some with light efflorescence.</p> <p>Abutment #2 - Vertical hairline cracks.</p> <p>Open vertical crack under bay #2 at the center of the stem open 1/4" with small spalls and a very slight shift of 1/4" of south half to the west.</p>

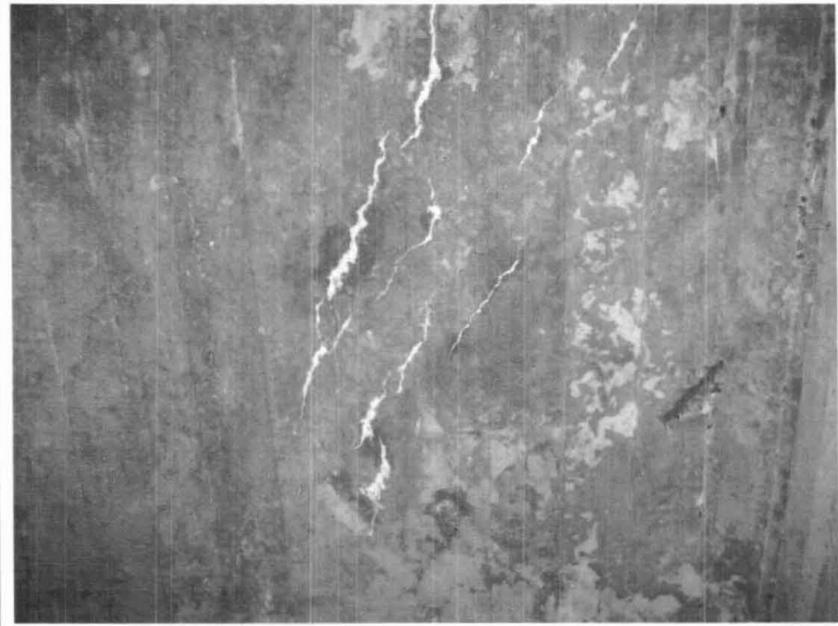
BEARING DEVICES	N	
STRINGERS	6	An area of short longitudinal cracking with efflorescence in bay #3 span #1 and #2. Scattered areas of efflorescence stains and light map cracks in both spans. Moss growth span #1 and #2 Beam #1 outside face.

Photo # 4:
Short random cracks with efflo and shallow rebar in bay # 3, span # 2

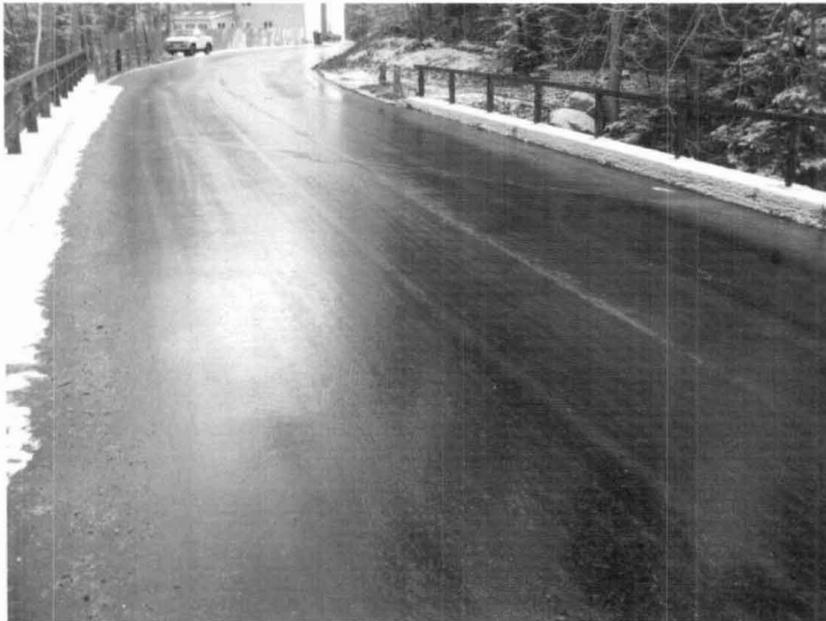
Photo # 7:
Overlay

OVERLAY	7	Bituminous overlay. Random longitudinal and transverse cracks.
DECK STR. CONDITION	N	
CURBS	N	
MEDIAN	N	
SIDEWALKS	N	
PARAPET	7	RAILBASE - Vertical hairline cracks and light to medium scale on both. Partial snow covered this inspection.
RAILING	6	Angle iron posts and cap - Extensive loss of paint on both rails. Light rust on exposed steel. Remaining paint faded. Minor collision damage at the westend of the south rail.
PAIN	N	
FENCE	N	
DRAINS	N	
LIGHTING STANDARD	N	
UTILITIES TYPE/SIZE	N	
CONSTRUCTION JOINTS	N	
EXPANSION JOINTS	N
