An Open Letter to Metro-North Railroad Customers

*A Review of the Actions Taken by Metro-North
Railroad in Response to
Multiple Heat-Related Incidents on the
New Haven Line
July 22, 2011*

I. Current Condition of the New Haven Line

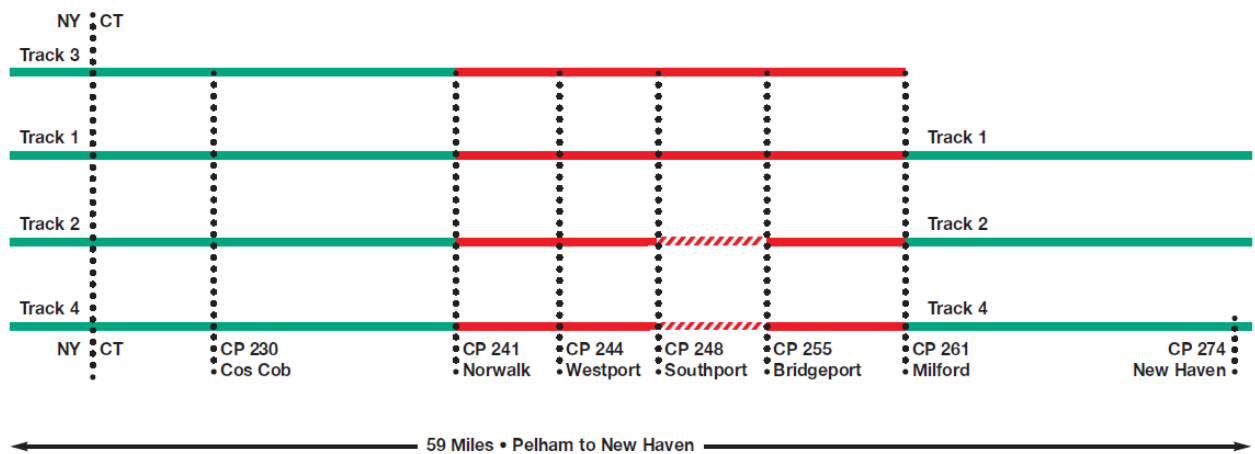
Current Status of New Haven Line Catenary System

CDOT commenced its catenary replacement in 1996. Completion is planned for 2015. Today, of the 172 miles of catenary on the New Haven Line in the State of Connecticut, 60% is the new constant tension system and 40% is either the original antiquated system or out of service for repair. MNR's operation is particularly vulnerable in the 7-mile stretch between Southport and Bridgeport. Of the four tracks in that area, 2 tracks are out of service for catenary replacement and bridge work; all trains, therefore, must operate on the other two tracks under old catenary. This system is decades past its useful life and the fragile condition of the system leads to regular failures, significantly impacting service reliability.

- █ New Catenary
- ▨ Replacement Underway (tracks out-of-service for trains)
- █ Old Catenary Circa 1914

Status as of 8/11

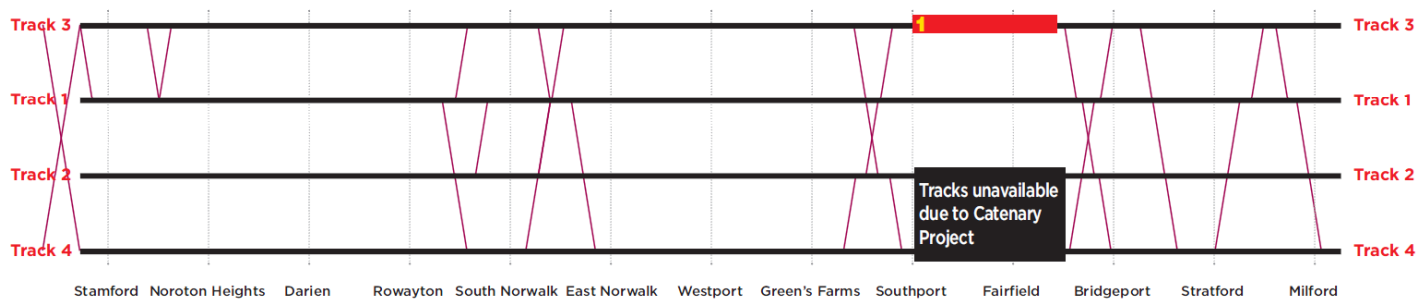
New Haven Line East of Stamford July 22, 2011 Before 1:30 PM

1 CMV Inspection/Sagging Wire 12:59 PM - 2:45 PM

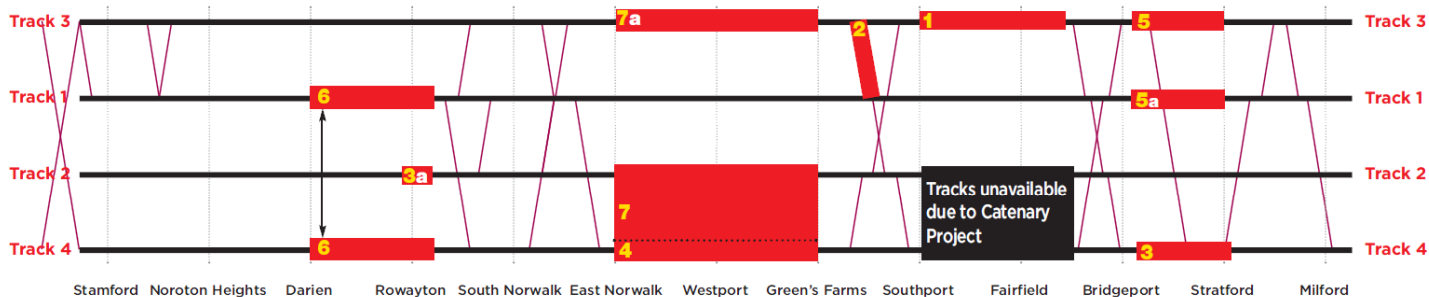
New Haven Line East of Stamford July 22, 2011 After 1:30 PM

1	CMV Inspection/Sagging Wire	12:59 PM - 2:45 PM
2	13 at CP 248 Switch Failure	1:34 PM - 11:00 PM
3	Train 1526 Pantograph Damage	1:34 PM - 3:14 PM
3a	10 mph Track Kink	1:42 PM - 11:59 PM
4	Train 1532 Sagging Wire	2:51 PM - 9:15 PM
5	Train 1573 Pantograph Damage	4:24 PM - 8:04 PM
5a	Train 1169 Rescue of Train 1573	4:25 PM - 5:37 PM
6	Transformer Fault at South Norwalk	4:32 PM - 6:25 PM
7	Train 1536 Disabled at CP 241	4:31 PM - 6:25 PM
7a	Train 1538 Rescue of Train 1536	4:40 PM - 4:59 PM
