# STRUCTURE NO. 00712

ROUTE 124  
over  
ROUTE 15  
NEW CANAAN

Routine Inspection  
on  
3/22/2011

Inspected by Team 6  
for Area 6

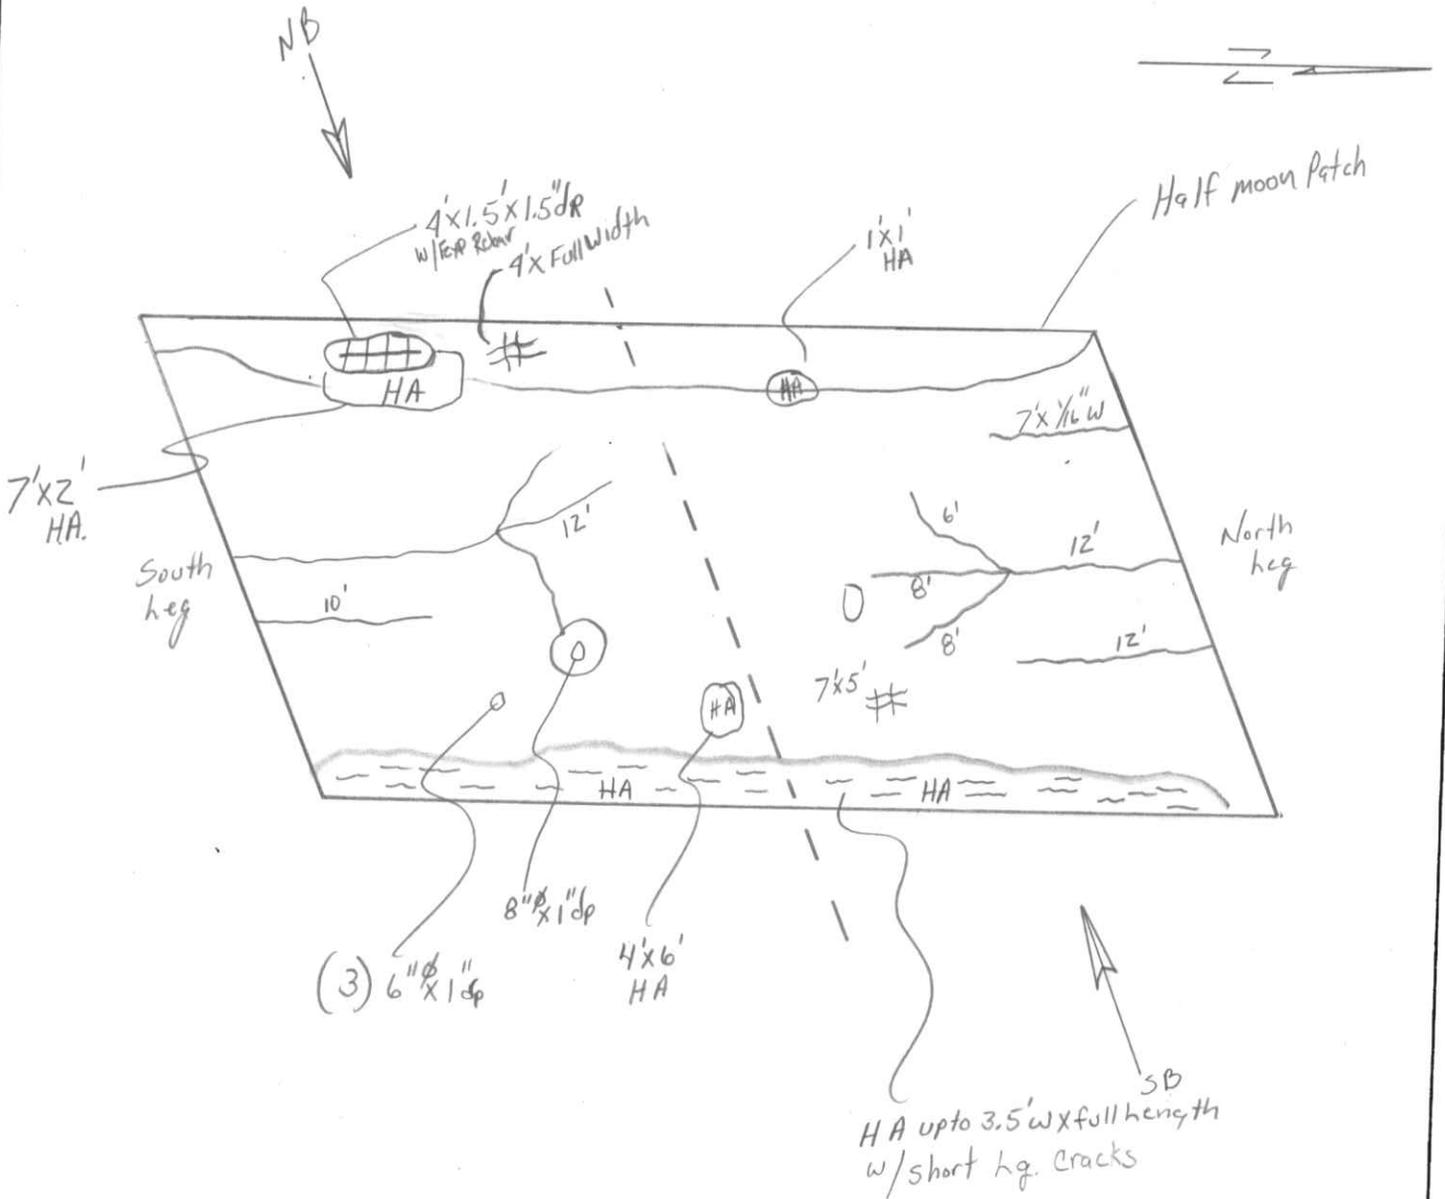
DESCRIPTION: *Uside OF DECK*

BEARING DEVICES:	N	-
STRINGERS:	N	-
GIRDERS:	4	Reinforced Concrete Rigid Frame: Soffit: The soffit exhibits longitudinal and transverse cracks up to 18' long x 1/16" wide with and without efflorescence, areas of map cracking with and without efflorescence, isolated hollow areas up to 3' x 5' spalls up to 5' x 3' x 2" deep with and without exposed rebar. Some spalls have been previously repaired/coated. The heaviest concentration of deterioration is adjacent to the fascias.  Fascias: Both fascias exhibit horizontal and vertical hairline cracks up to 15' long with and without efflorescence. There are areas of map cracking up to 14' x 3' with light efflorescence.  The east underdiside edge is hollow in both spans approximately 50ft.L x 2ft.w with short longitudinal cracks some with efflo.
FLOOR BEAMS:	N	-
TRUSSES-GENERAL:	N	-
TRUSSES-PORTALS:	N	-
TRUSSES-BRACING:	N	-
PAINT:	N	-
RUST:	N	-
MACHINERY MOV SPAN:	N	-

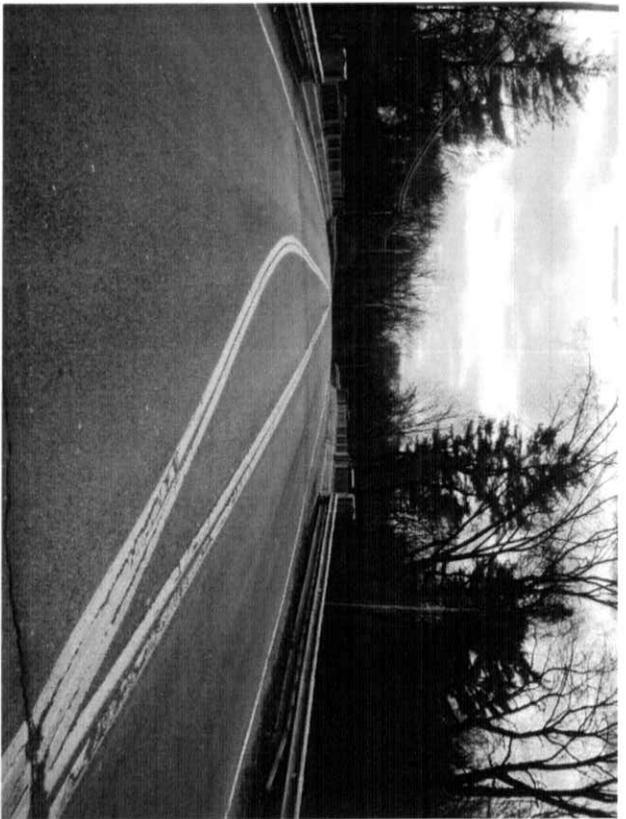
**Photo #1 :**  
**Looking south over structure**

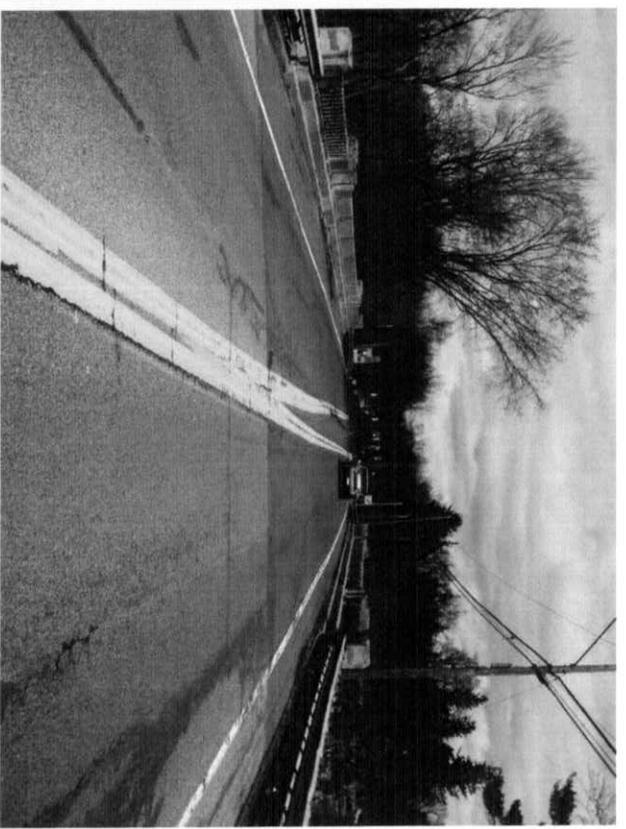
**Photo #2 :**  
**Looking north over structure**

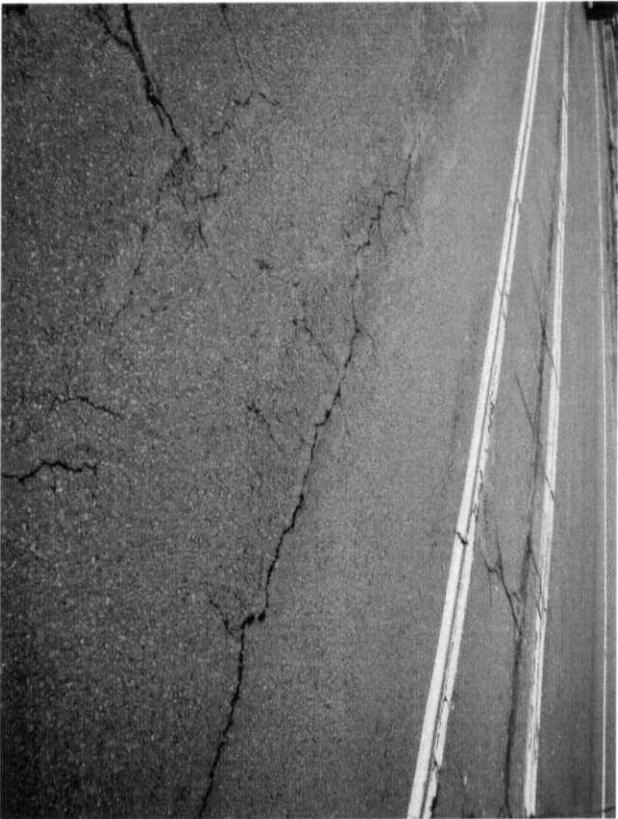
<b>OVERLAY:</b>	6	The bituminous concrete overlay exhibits random longitudinal and transverse cracks with some open up to 1/2" wide. Also there are some previously sealed cracks that have reopened.  Along the west shoulder there is a half moon sawcut shape bituminous patch. This area may have been from past concrete work done on the underside. (see photo #8)
<b>DECK-STR. CONDITION:</b>	N	-
<b>CURBS:</b>	7	The west and east curb reveal measurements were 3-1/2" and 3" respectively.
<b>MEDIAN:</b>	N	-
<b>SIDEWALKS:</b>	7	The safety walks show some vertical cracks on the face.
<b>PARAPET:</b>	6	Areas of the vertical face display random vertical hairline cracks. Transverse cracks with efflorescence .
<b>RAILING:</b>	N	-
<b>PAINT:</b>	N	-

**Photo #3 :**  
General view wearing

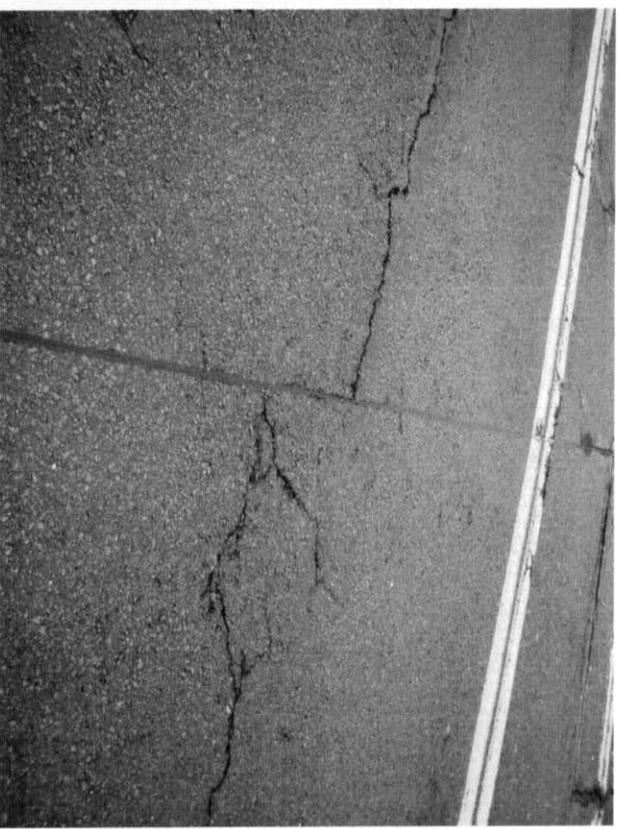
FENCE:	N	-
DRAINS:	N	-
LIGHTING STANDARD:	N	-
UTILITIES TYPE/SIZE:	N	-
CONSTR JOINTS:	N	-
EXPANSION JOINTS:	7	Both expansion joints are sawed and sealed and display sealed cracks.

**Photo #4 :**  
Kerf cut joint over north leg

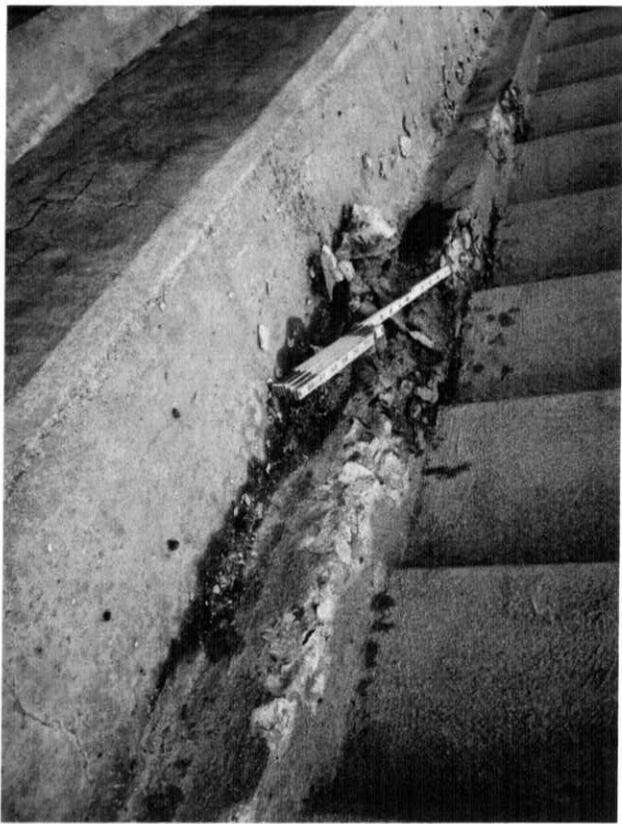
**Photo #5 :**  
2"x10" area of punky concrete east parapet

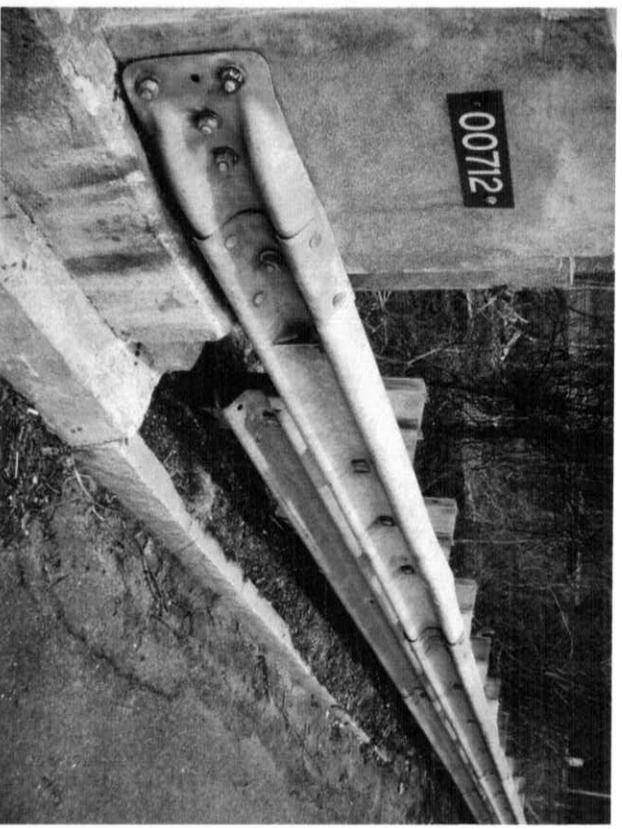
APPROACH SLAB:	N	-
RELIEF JOINTS:	N	-
APPROACH GUIDE RAIL:	7	The metal beam railing along both sides of the approaches displays only minor scrapes and dents. The transition rub rails do not connect to the parapets. The metal beam railing extends past the approach limits.
APPROACH PAVEMENT:	7	The bituminous approach pavement exhibits random cracks up to 1/2" wide. Also there are some sealed cracks.
APPROACH EMBANKMENT:	7	Southeast embankment has(2) trenches from roadway runoff exposing the lower end of the H-posts

**Photo #6 :**  
M.B.R. transition to bridge at northwest approach

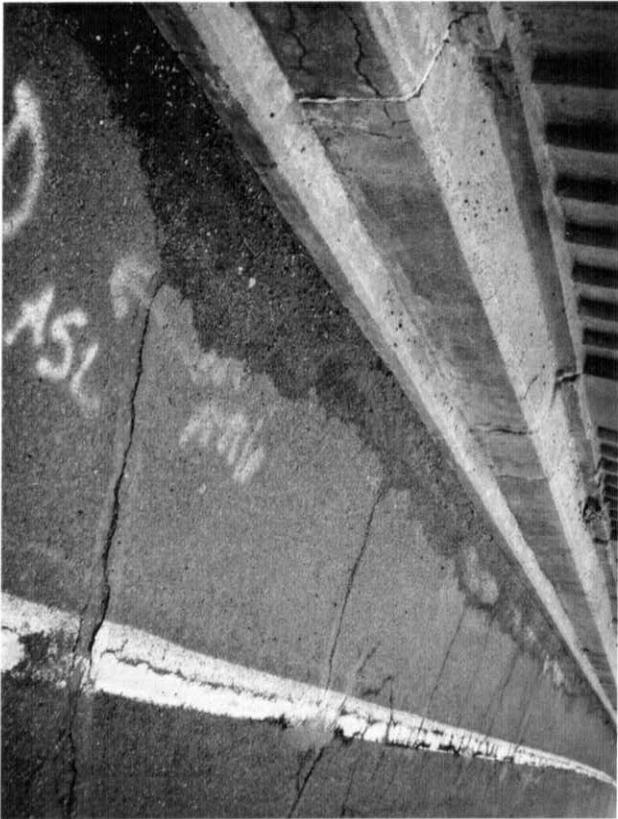
**Photo #7**

Damp area along east curb line

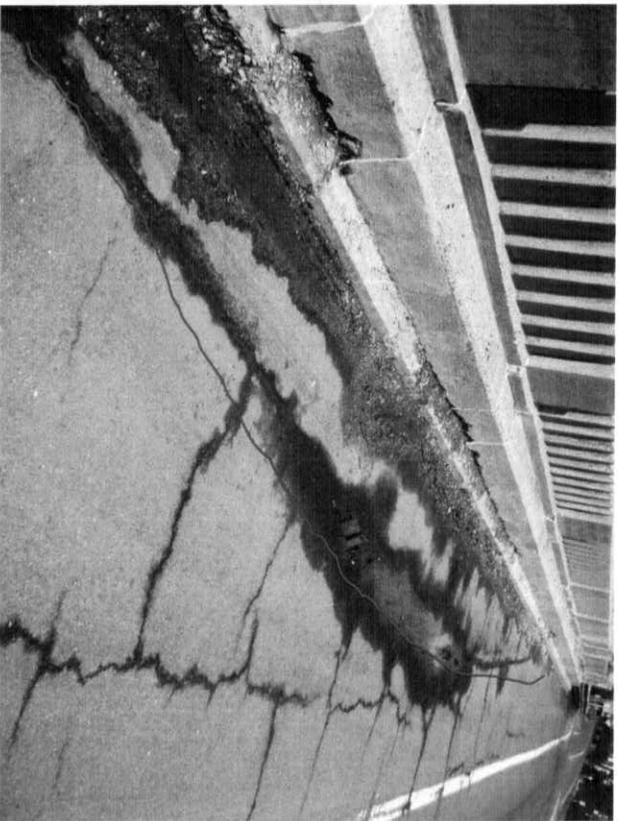
**Photo #8**

Saw cut not sealed mirrors patch underside

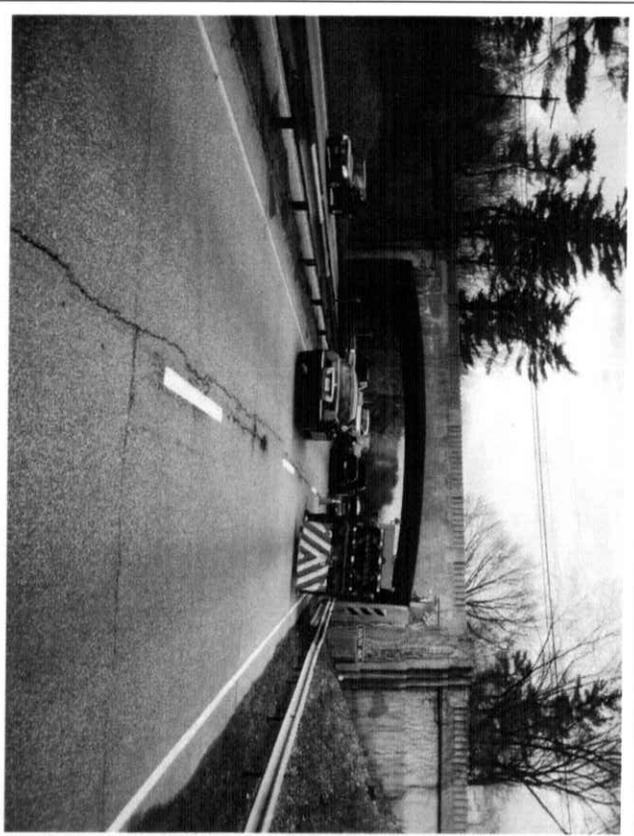
**Photo # 9**  
East elevation

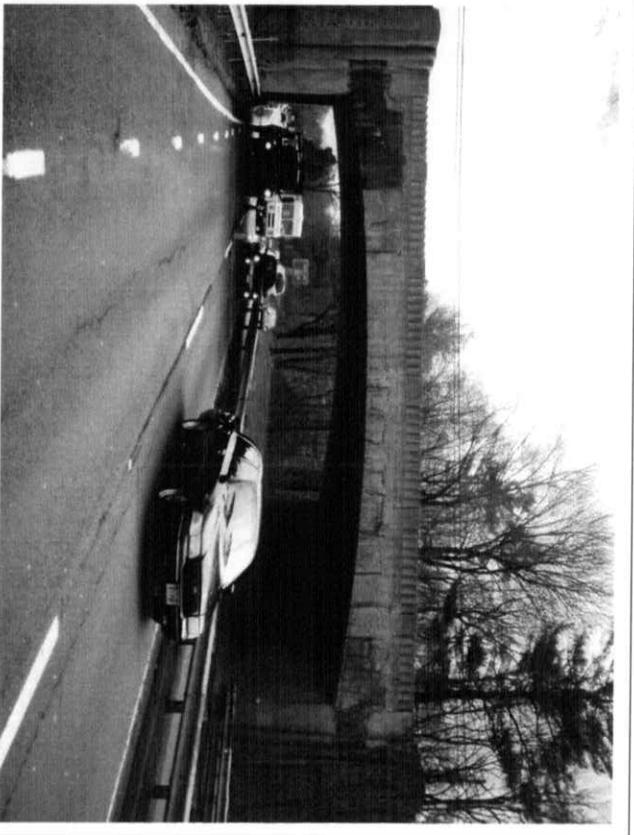
**Photo # 10**  
West elevation

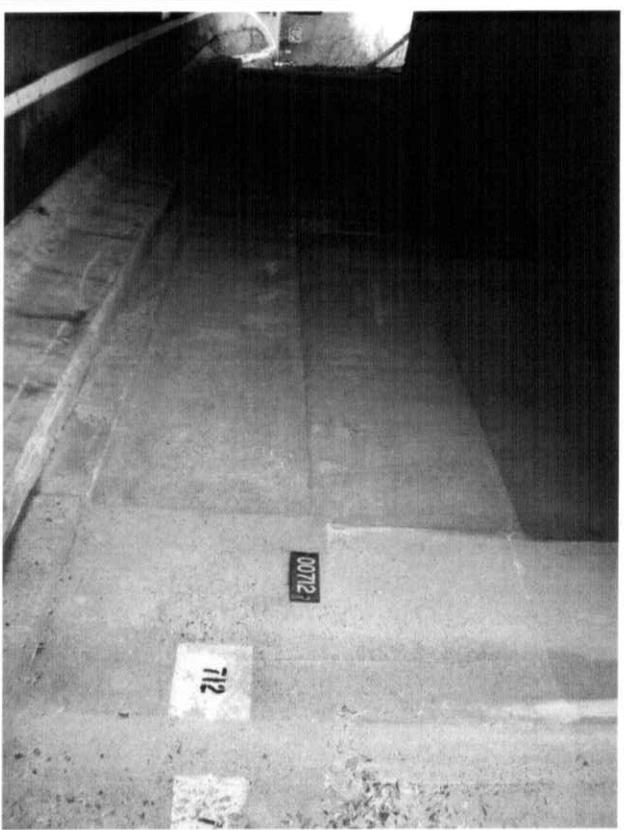
ABUTMENTS-STEM:	6	Borth frame legs exhibit vertical hairline cracks up to 8' long. Also, there are areas of light scale up to 5' x 4' and edge spalls up to 1' x 6" x 1-1/2 " deep.
ABUTMENTS-BACKWALL:	N	-
ABUTMENTS-FOOTINGS:	N	No visible.
ABUTMENTS-SETTLEMENT:	8	-
ABUTMENTS-WINGWALLS:	6	The wingwalls exhibit random horizontal and vertical hairline cracks up to 10' long some with efflorescence, areas of mapcracking and areas of light scale.
PIERS/BENTS-CAPS:	N	-
PIERS/BENTS-PILE BENT:	N	-
PIERS/BENTS-COLUMNS:	N	-
PIERS/BENTS-FOOTING:	N	-
PIERS/BENTS-SETTLMT:	N	-
EROSION-SCOUR:	8	-
CONCRETE CRACK-SPALL:	6	See items "Abutments-Stem" and Abutments-Wingwalls" above.
STEEL CORROSION:	N	-
PAINT:	N	-
TIMBER DECAY:	N	-
COLLISION DAMAGE:	8	-
DEBRIS:	8	-

**Photo #11**  
**General condition of leg #2**

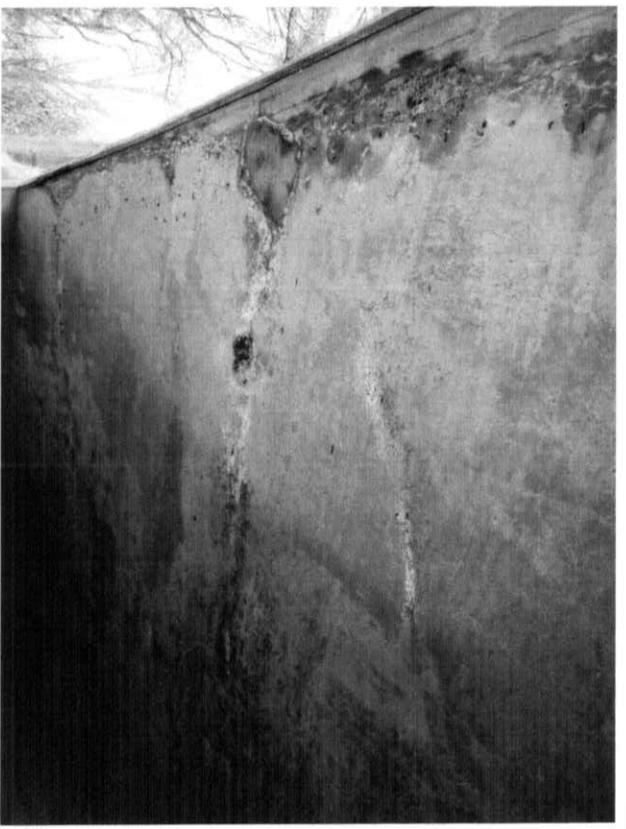
**Photo # 12**  
**General view of underside**

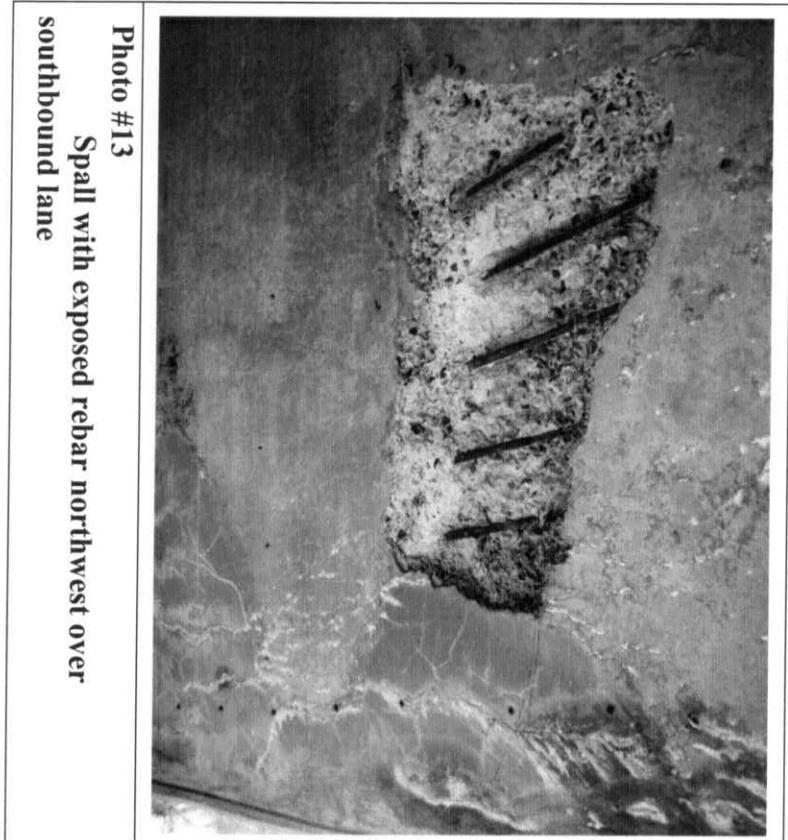
**Photo #13**  
**Spall with exposed rebar northwest over southbound lane**

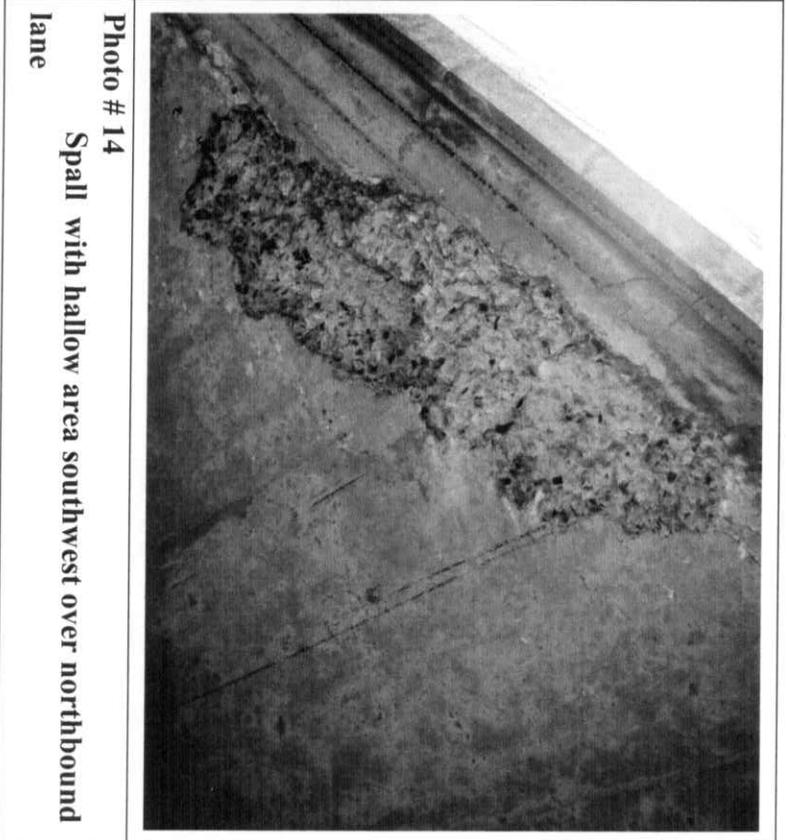
**Photo # 14**  
**Spall with hallow area southwest over northbound lane**

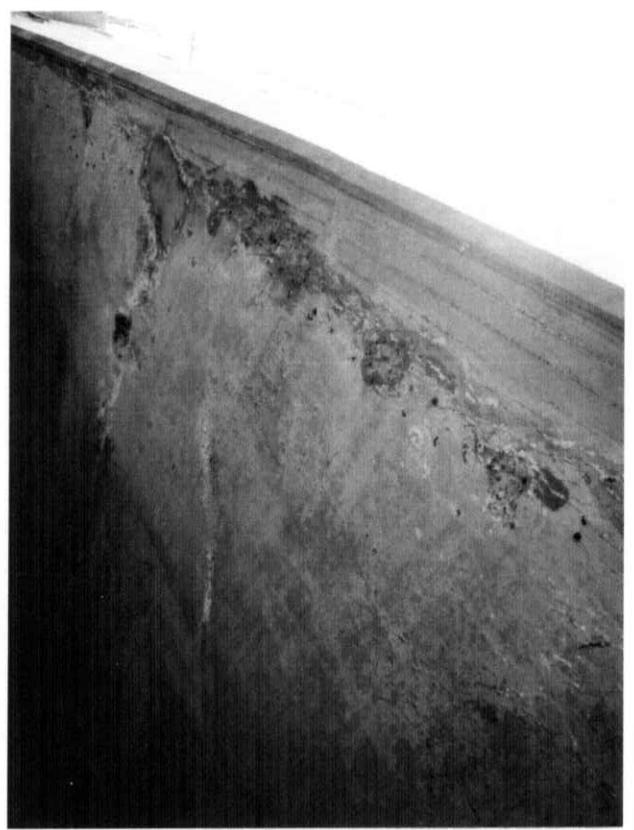
**Photo # 15**  
3' wide hallow area east fascia over southbound lanes

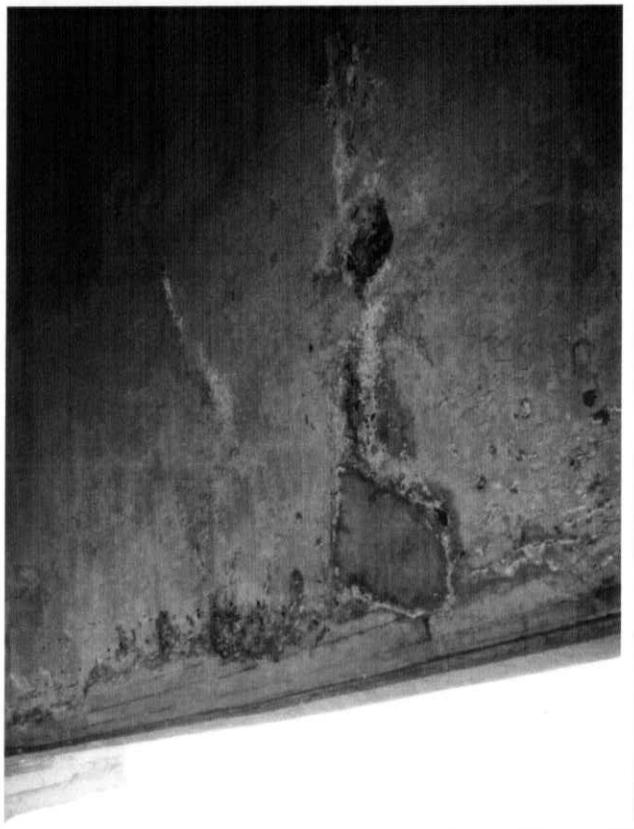
**Photo # 16**  
Transverse cracks some with efflo. and some spalls have been repaired west fascia
