TASK 210: SURFICIAL SITE INVESTIGATION

**IMPROVEMENTS TO ROUTES 82 AND 85
SALEM AND MONTVILLE**

**ConnDOT Assignment No. 95632
ConnDOT Project No. 0120-0079**

Atlantic Project No. 1178-075-210

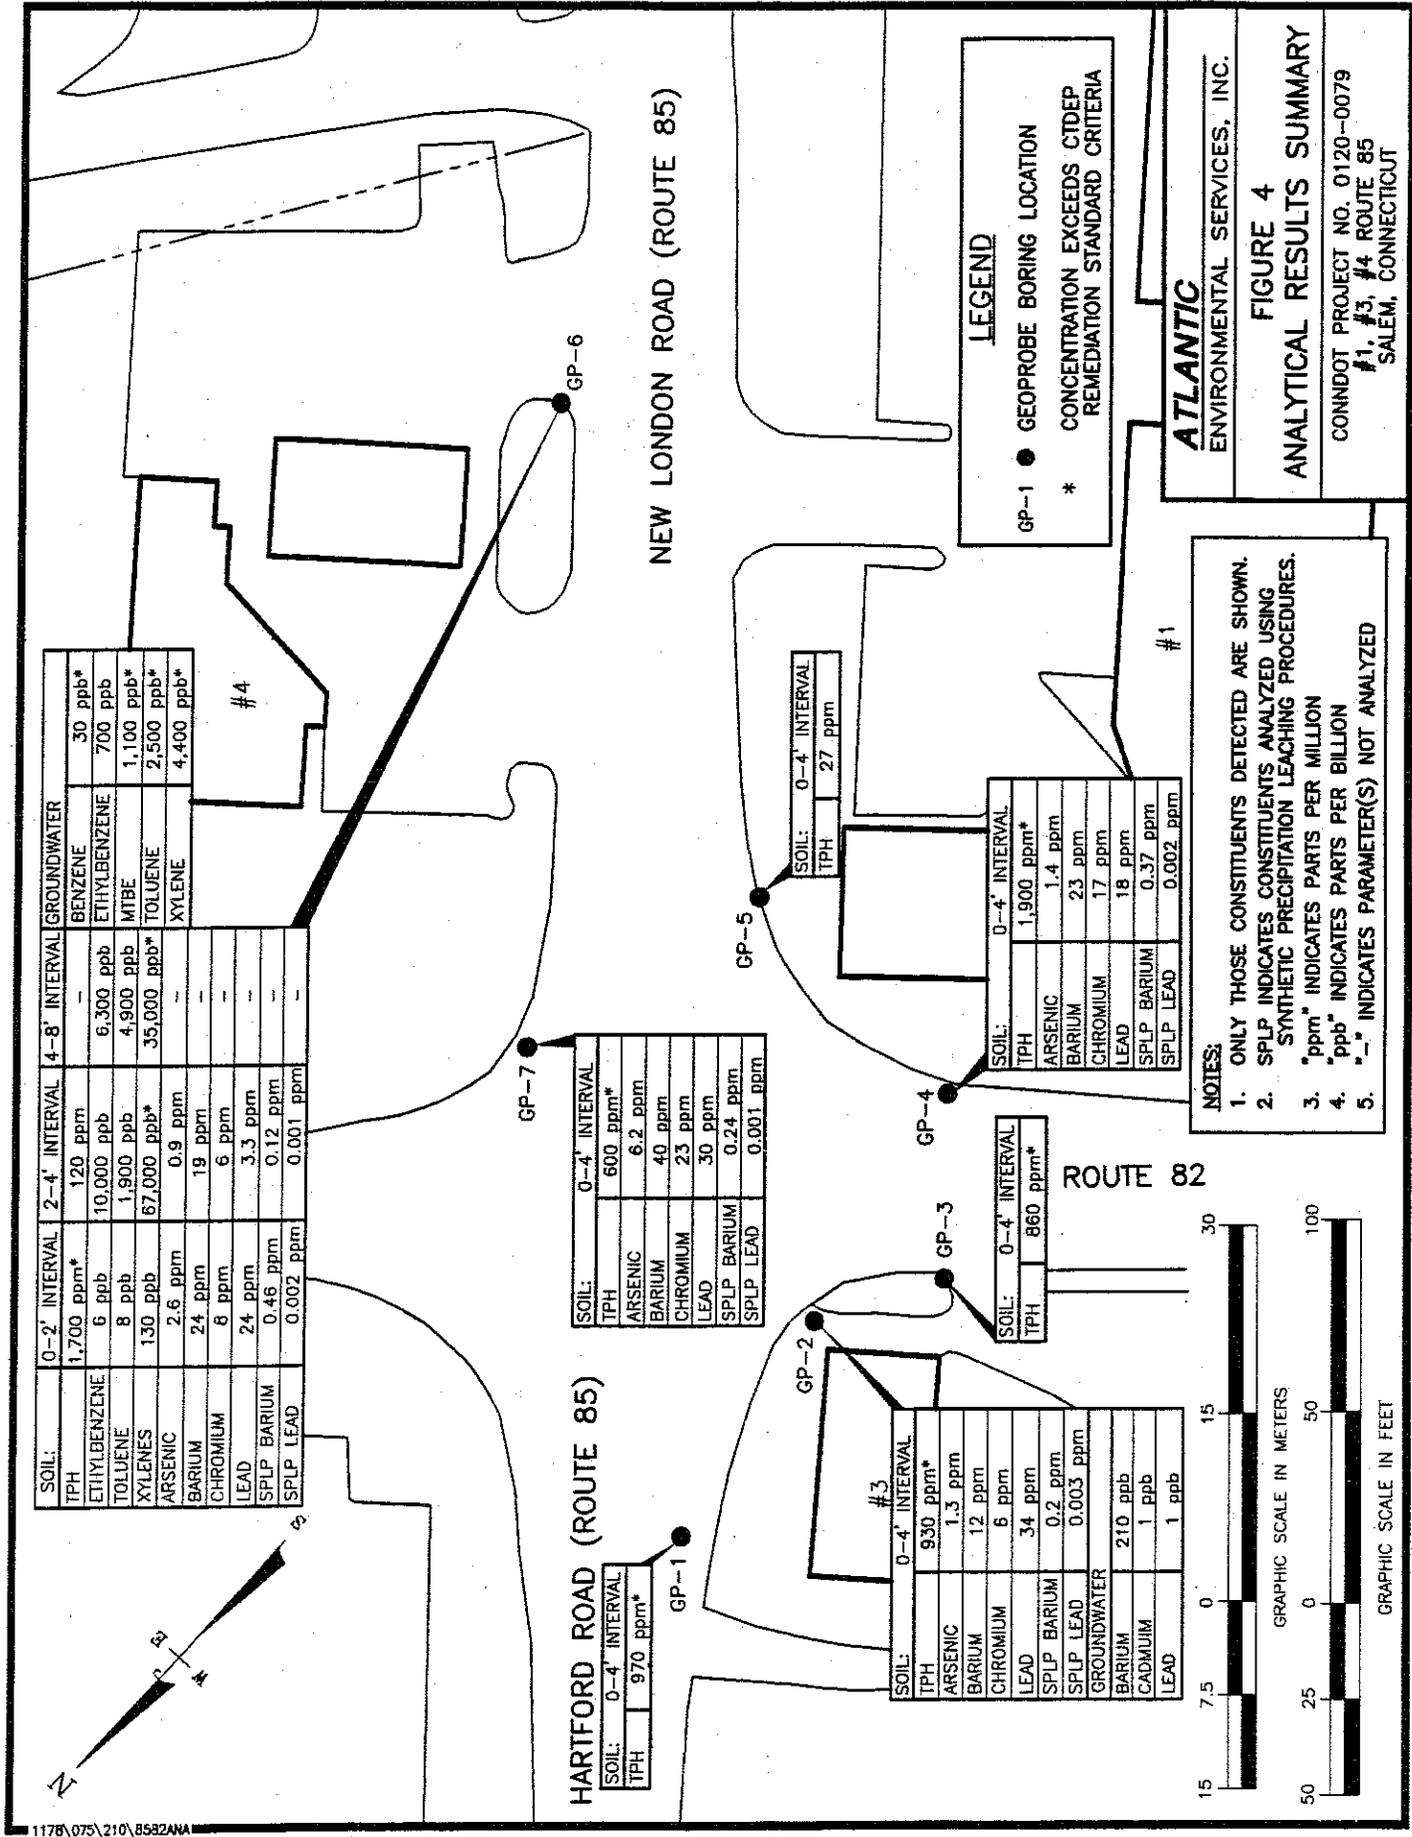
Twelve of the 16 Geoprobe™ samples analyzed for TPH were found to exceed applicable CTDEP remediation standard criteria: GP-1 (970 ppm); GP-2 (930 ppm); GP-3 (860 ppm); GP-4 (1,900 ppm); GP-6, 0 to 2 feet (1,700 ppm); GP-7 (600 ppm); GP-8 (1,200 ppm); GP-9 (660 ppm); GP-10 (2,100 ppm); G-11 (1,400 ppm); GP-13, 0 to 4 feet (1,800 ppm); and GP-14 (2,000 ppm). It has been Atlantic's experience that these levels are not uncommon in soils underlying paved roadways. All of these samples were collected from the ground surface (immediately beneath the paved roadway) to a depth of 2 to 4 feet. It is likely that the source of the TPH present in these samples is associated with the bituminous material and is not indicative of a release of petroleum product.

Arsenic, barium, chromium, and lead were identified in all of the samples analyzed for total metals at this intersection (GP-2, GP-4, GP-6 and GP-7). Only low levels of these constituents were noted; none of them exceeded the DEC. Barium and lead were detected by the SPLP metals analysis in the aforementioned samples; no levels exceeded the PMC.

Elevated levels of VOC parameters were detected in GP-6, exceeding the Groundwater Protection Criteria (GPC) for GA areas. These include benzene (30 ppb), methyl-tertiary-butyl-ether (1,100 ppb), toluene (2,500 ppb), and xylenes (4,400 ppb). This is indicative of a recent gasoline leak/spill. No other VOC parameters were detected in this water sample. No VOC parameters were detected in the groundwater sample obtained from GP-2 (western side of intersection).

Based on available information to date, Atlantic recommends additional site screening within the existing ROW to determine the extent of gasoline-related contamination at the two identified areas of concern. In addition, those sites requiring property takes should also be further evaluated to determine current subsurface conditions.

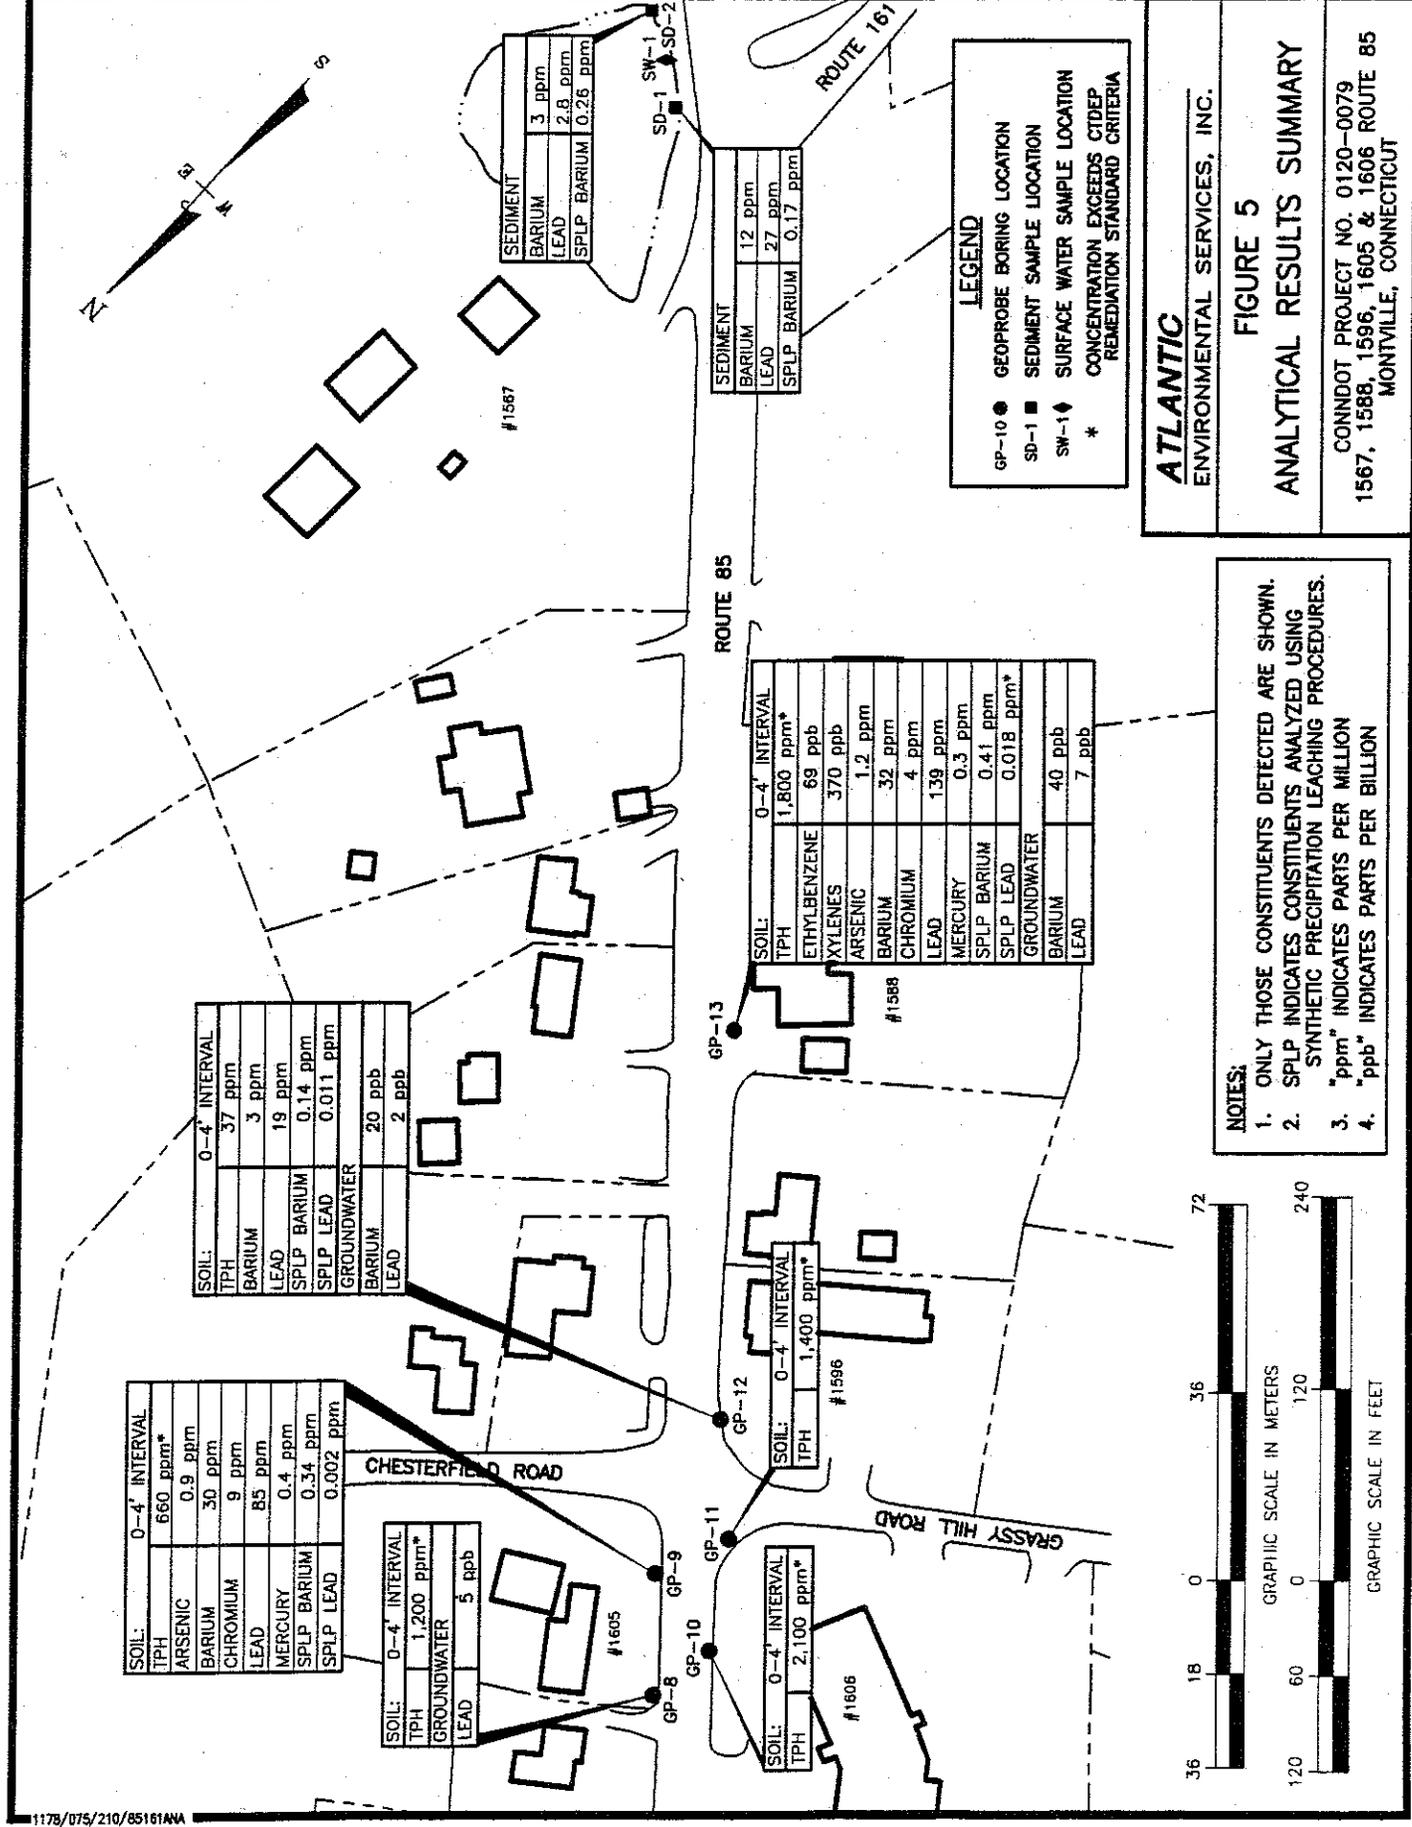
FIGURE 5
ANALYTICAL RESULTS SUMMARY

Barium and lead were identified in all the samples analyzed for total metals taken from this area. Additionally, GP-9 and GP-13 (0 to 4 feet) were noted to contain detectable quantities of arsenic, chromium and mercury. None of the levels observed exceeded the DEC. Barium and lead were detected using the SPLP method in GP-9, GP-12 and GP-13 (0 to 4 feet). The lead value for GP-13 (0 to 4 feet [0.018 ppm]) was noted to exceed the PMC; the remainder of the SPLP metal results were below the PMC for this area.

TPH was present in site soil samples collected from this intersection; five samples were above applicable criteria. TPH was noted in GP-12; however, the level was below the PMC and the DEC.

Due to the presence of some VOCs in GP-13 (0 to 4 feet) it would appear that a minor petroleum release has occurred. The lead value was notably higher than other samples taken from the project area. This might suggest that the released petroleum product was of historic nature (i.e., leaded gasoline). The absence of VOCs in the lower sample interval (GP-13 [4 to 8 feet]) suggests that the release may have occurred as a result of a surface spill rather than a leak from a UST, or the release has not migrated to a significant depth.

No VOCs were detected in the groundwater samples taken from this area (GP-8, GP-12 and GP-13). Low levels of dissolved lead were noted in GP-8. Dissolved barium and lead were identified in samples taken from GP-12 and GP-13. None of the groundwater samples taken from this area exceeded the GA GPC for dissolved metals.
