**SEMI-FINAL INSPECTION OF OVERHEAD TRUSS SIGN SUPPORTS  
GALVANIZATION DEFECTS PER BRIDGE SAFETY AND EVALUATION INSPECTIONS**

**Walsh Construction Submittal No. 1201235-01-013-01 August 9, 2011**

**REVIEW OF MATCO REPORT AND PROPOSED REPAIR**

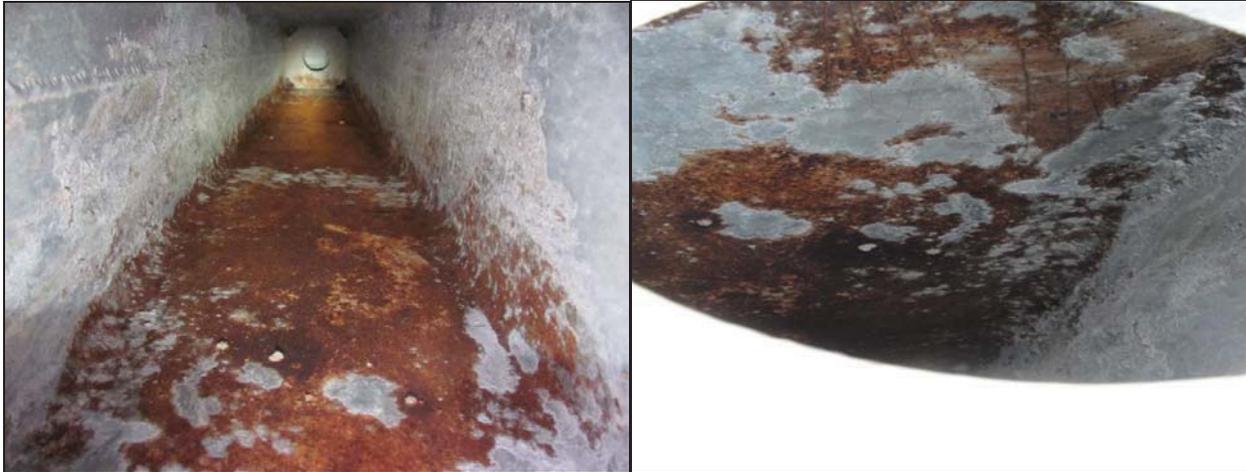
1. Based on the conclusions of the MATCO inspection and report the defects and concerns raised during the field inspections performed by Bridge Safety and Evaluation have been validated. Areas that exhibit rusting and the appearance of having no galvanizing have been confirmed to have no galvanizing. See figure below for representative photograph of areas found to have no galvanizing.

Photograph to the left is a GARG inspection photo. Photograph to the right is the same area taken by MATCO. See MATCO report, Figure No.8 Upper Left Core sample Structure 21960 and Figure No. 18 Representative photograph showing an area identified as “missing galvanizing” and red rust.

2. With regard to the need to address and repair the defects the MATCO report did not specifically address other areas on both sign structures that exhibit similar rusting as shown in the photographs of structure 21960 above. However, it is implied that the representative photographs can provide a visual basis to compare to other areas of the sign structures. On this premise we have prepared a photograph and repair location key for each sign structure that provides correlation of the BS&E Inspection photographs and the MATCO Core sample locations. They are included here as Plate 1 for Structure 21959 and Plate 2 for Structure 21960. The Plates also include highlighted areas of the structures that would be subject to repair of interior surfaces.

3. The repair procedure provided (quote for services from Tech Painting Company) does not provide enough detail of the means and methods to be employed. In addition the quote for services is limited to a specific area on Structure 21960. Other areas on both structures may require repair.

4. The repair procedure should include complete information on specialized equipment, tools and methods for surface preparation considering the geometry of the interior sections of the structures and limited access.

5. The repair procedure should include complete information on the proposed coating material and its application requirements specifically to achieve the required performance.

6. The repair procedure should include the qualifications of surface preparation and coating application personnel as well as inspection or quality control personnel and procedures to be used to provide the required quality control of the work as recommended in the MATCO report.

Please resubmit with the required information and provide a schedule for completion of this corrective work including all other exterior defects noted on the BS&E and MATCO inspection.

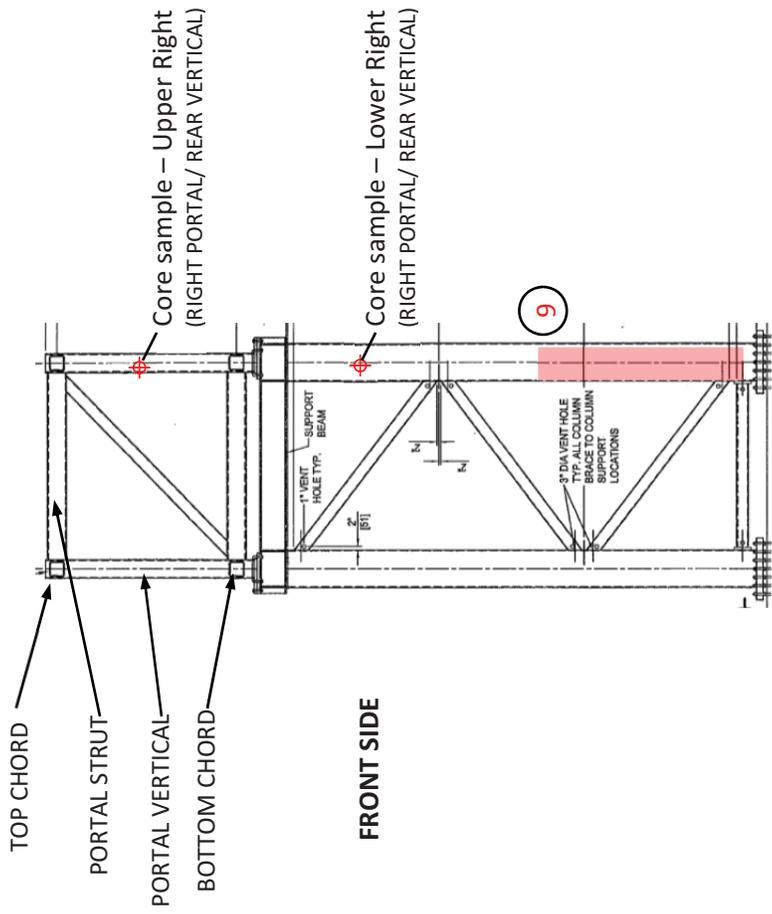
**PLATE 1- STRUCTURE NO. 21959**

Typical area for repair

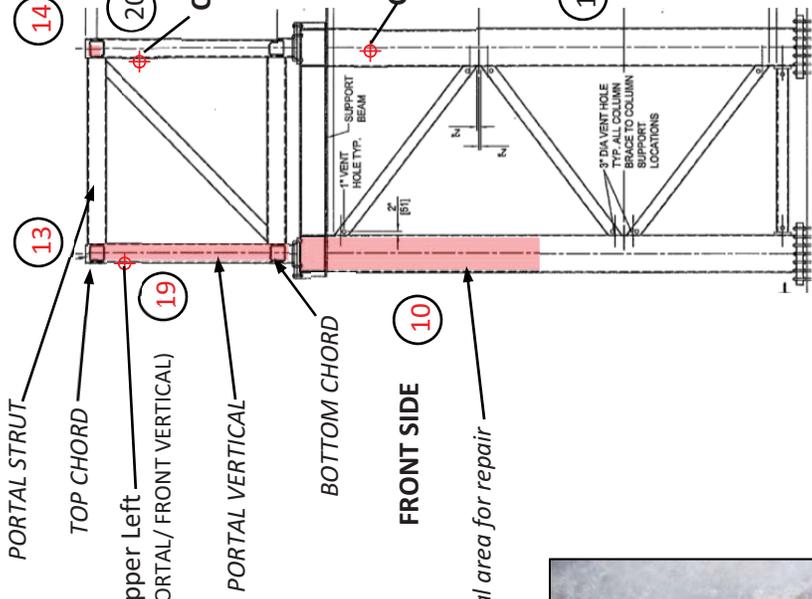
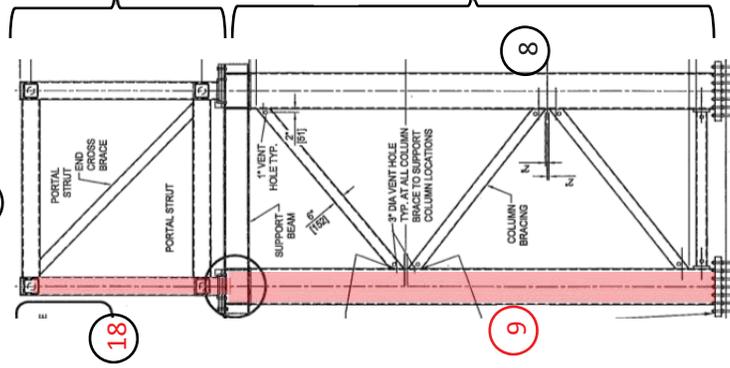
PLATE 2- STRUCTURE NO. 21960

\* Core sample - Upper Left  
(FRONTFACE/RIGHT PORTAL/ FRONT VERTICAL)

Core sample - Upper Right  
(FRONT FACE /RIGHT PORTAL/  
REAR VERTICAL)

Core sample - Lower Right  
(RIGHT FACE/RIGHT TOWER/  
REAR POST)

Typical area for repair

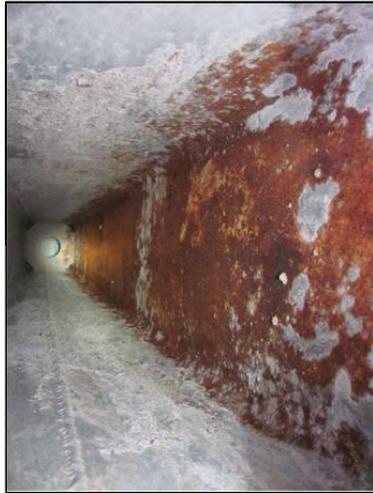
\* PHOTO #19 - GARG INSPECTION  
NO GALVANIZING ON CORE

NOTE: Photo 18 included for excessive  
dross to be removed for inspection of  
surface below.
