Individual Station Report

Wilton

Connecticut Department of Transportation

CONDITION INSPECTION
FOR THE
WILTON STATION

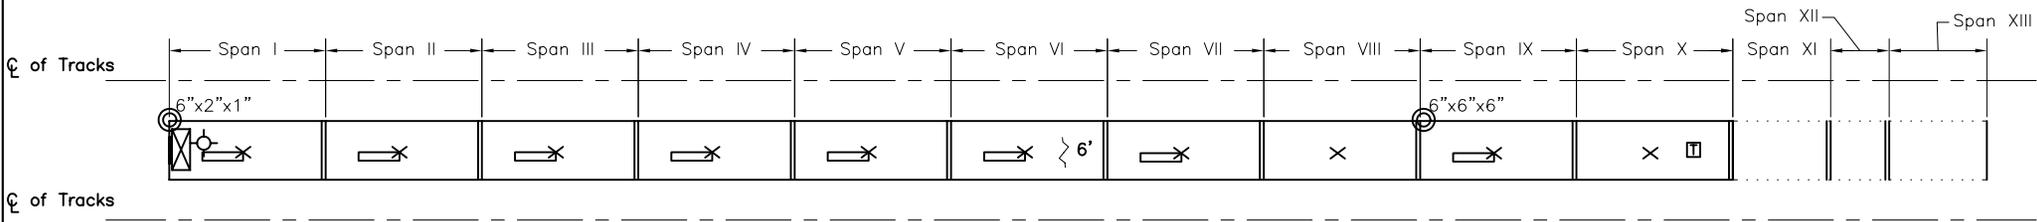
Urbitran Associates, Inc.
Connecticut Dept. of Transportation
Wilton Station Platform Plan
Date: 12-13-01

1. 30% of the concrete base of the columns in Span I, II, III, V, and X is cracked.
2. The top of the footing in Span I is cracked and deteriorated.
3. The base of the light pole is majorly dented.
4. There is rust at the canopy joints; ponding of water was noted below the joints.

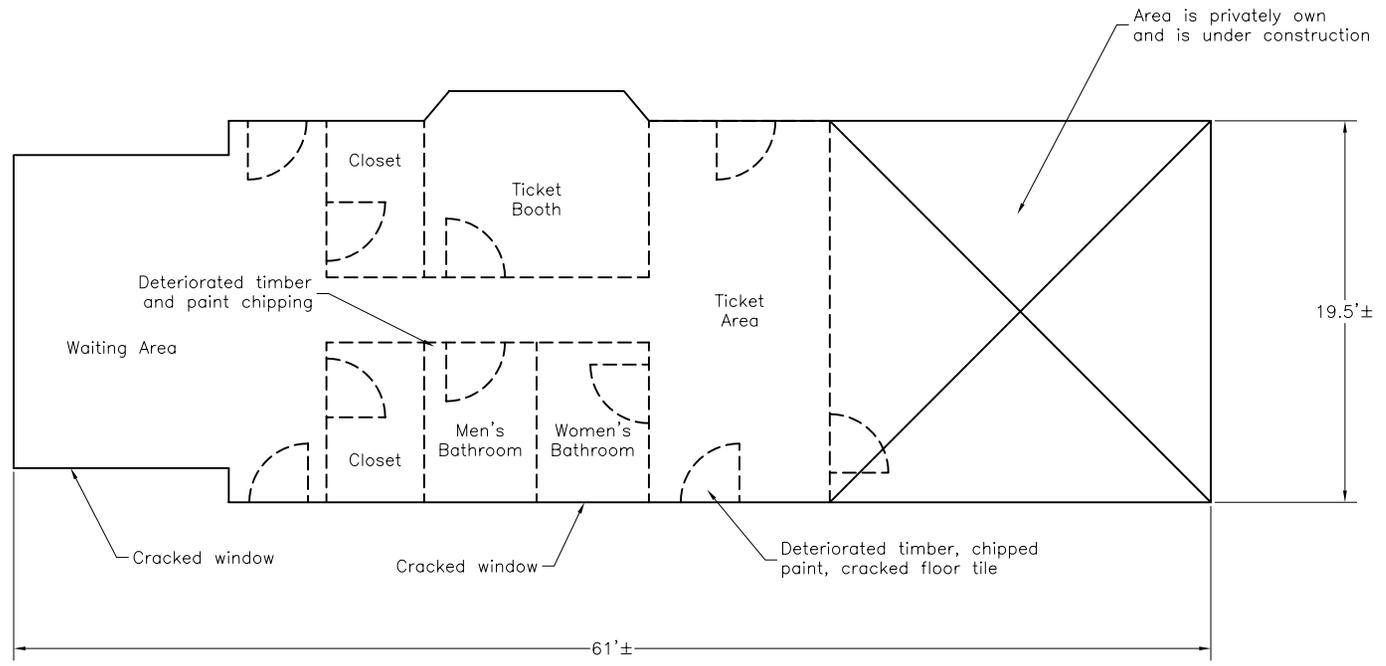
Urbitran Associates, Inc.
Connecticut Dept. of Transportation
Wilton Station Station House Plan
Date: 12-13-01

1. The Northeast coner of the over hang is cracked in two locations.
2. The Northwest corner of the overhang is deteriorated with splintering timber.
3. The roof is damaged in isolated areas.

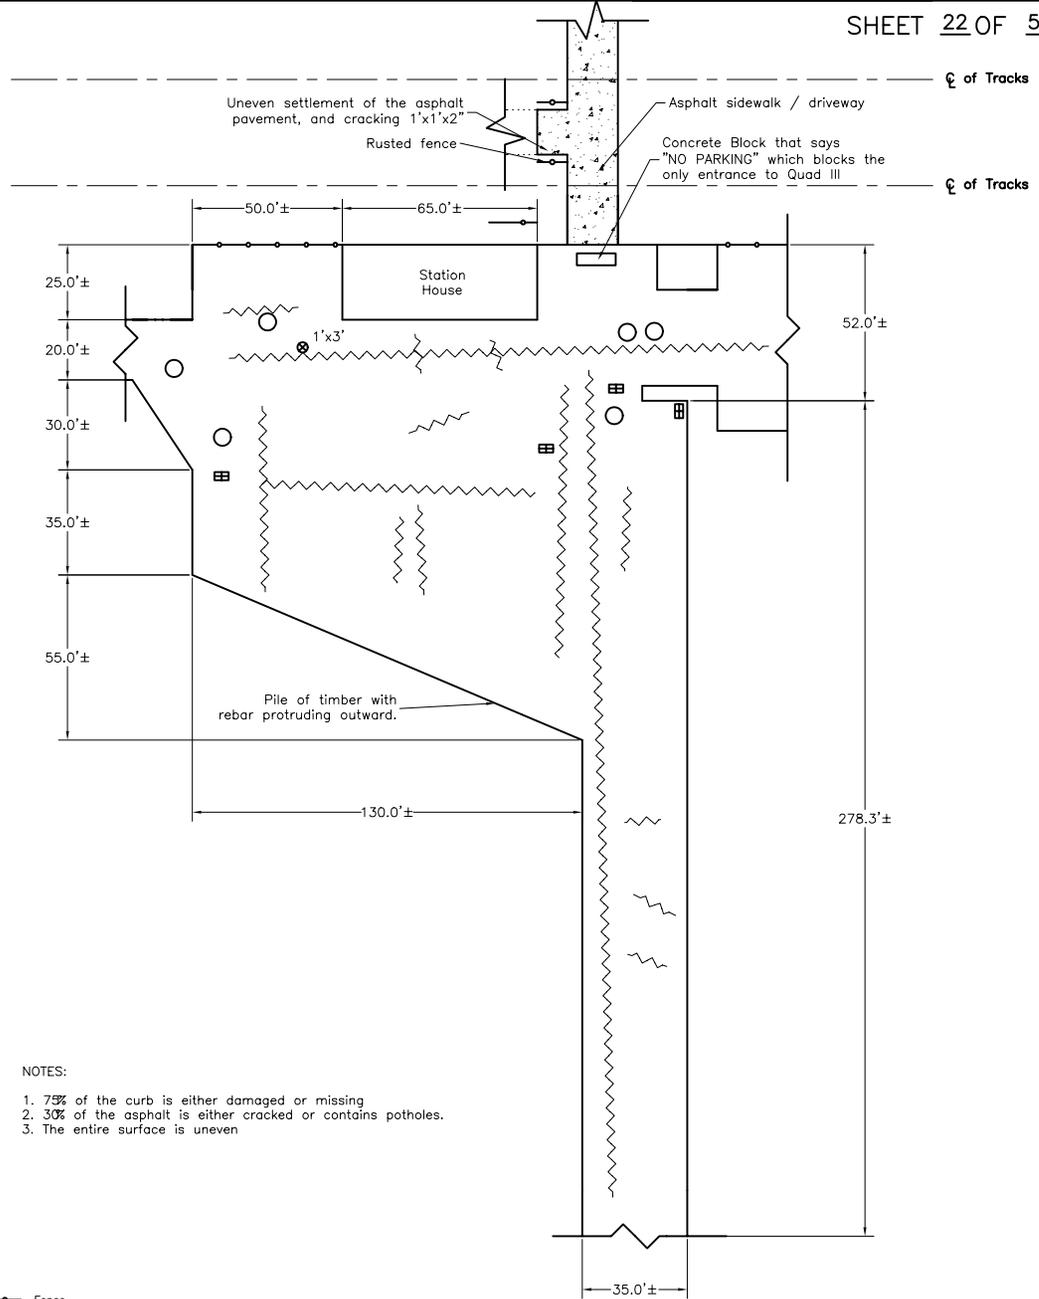
Urbitran Associates, Inc.
 Connecticut Dept. of
 Transportation
 Wilton Station
 Quadrant I Plan
 Date: 12-13-01

- NOTES:
1. 73% of the curb is either damaged or missing
 2. 30% of the asphalt is either cracked or contains potholes.
 3. The entire surface is uneven

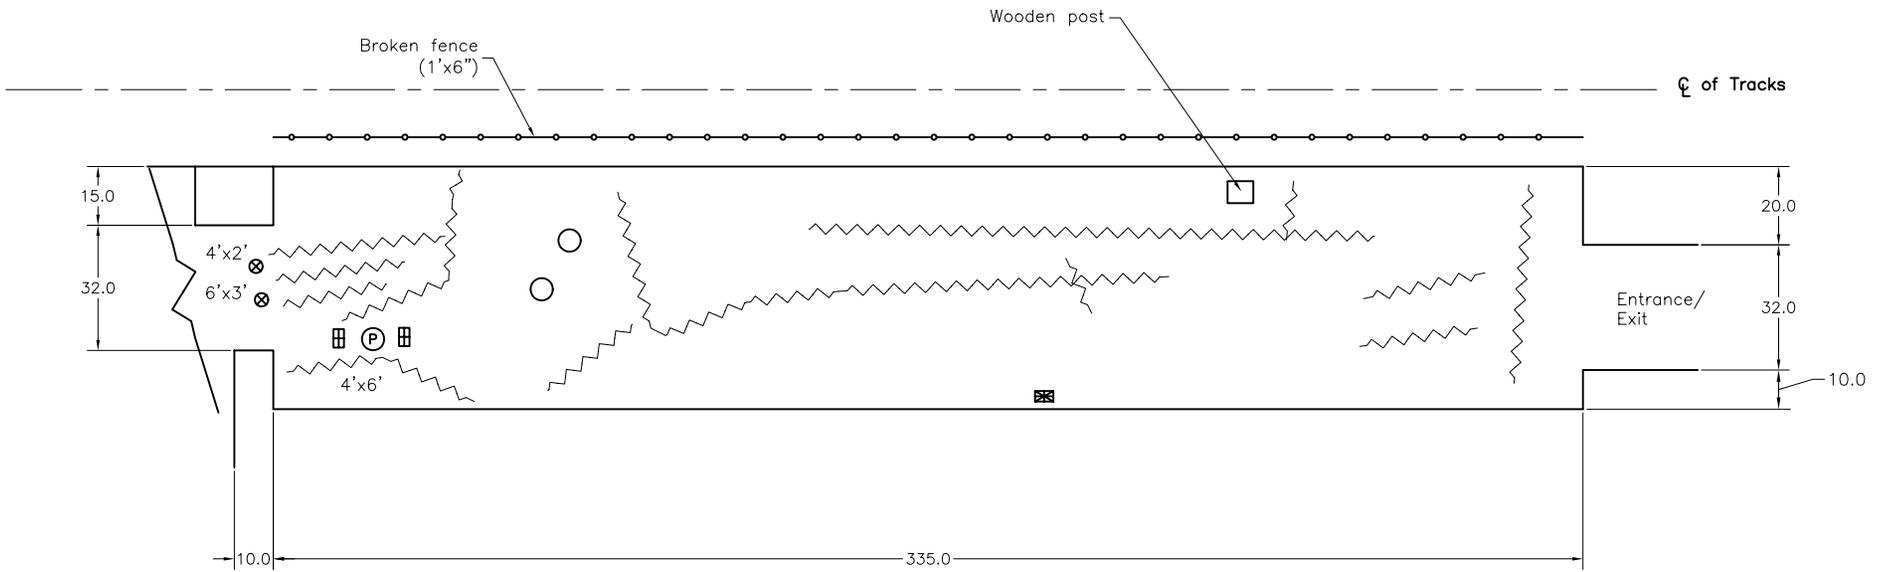
Urbitran Associates, Inc.
Connecticut Dept. of Transportation
Wilton Station Quadrant II Plan
Date: 12-13-01

1. 20% of the asphalt curb is cracked.
2. 8% of the asphalt curb is broken or missing.
3. 10% of the asphalt surface is cracked.

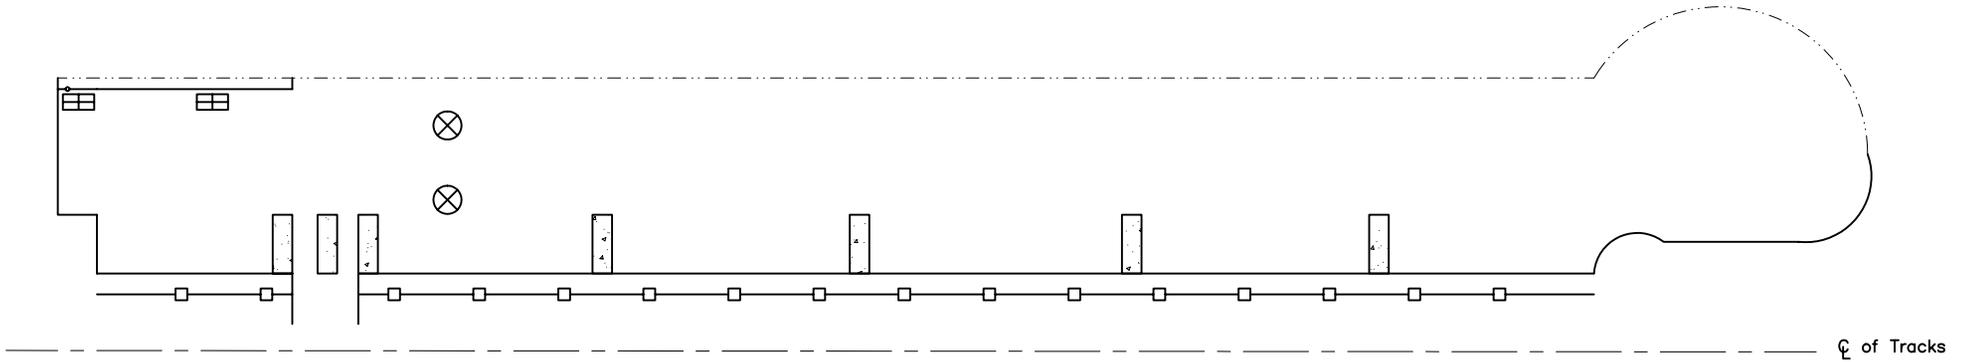
Urbitran Associates, Inc.
Connecticut Dept. of Transportation
Wilton Station Quadrant III Plan
Date: 12-13-01

1. The parking lot appears to be a new lot and the only entrance is blocked by a concrete barrier

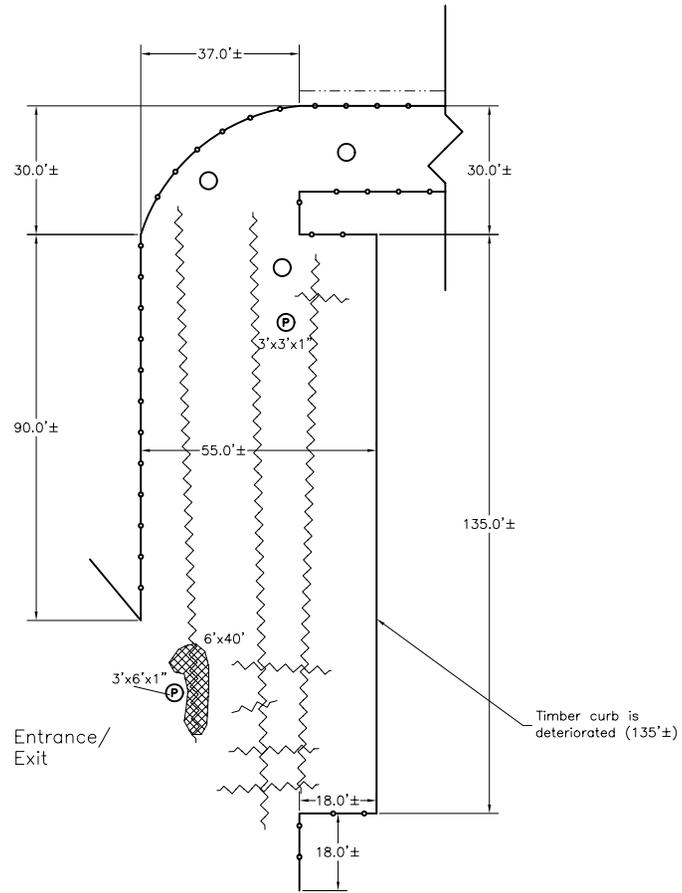
Urbitran Associates, Inc.
Connecticut Dept. of Transportation
Wilton Station Quadrant V Plan
Date: 12-13-01

- NOTES:
1. 50% of the asphalt curb is missing
 2. 30% of the asphalt pavement is cracked.
