Lessons Learned Catenary Work Items

NEW HAVEN MAIN LINE
CATENARY REPLACEMENT BETWEEN STRUCTURES 236 AND 356A
CATENARY SYSTEM INTERIM CONTACT WIRE LOWERING

Metro-North Railroad Bridges in Greenwich, CT
CDOT Project Nos. 56-248, 301-0042/0044

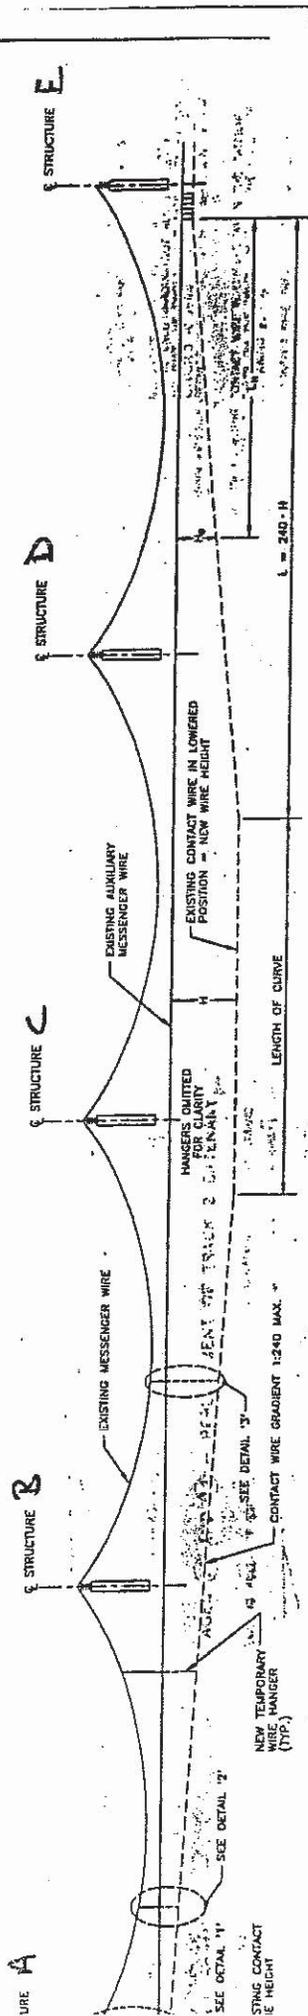
SKETCH #1 (TO UNDERSTAND LINEAL FOOT BUS)

NOTE: HAD THE FIELD CONDITION LOOKED LIKE BELOW WE WOULD HAVE PAID FROM STRUCTURE B TO STRUCTURE D. (ACCORDING TO PAY ITEM LANGUAGE)

BUT, IN REALITY WE WENT PAST STRUCTURES A & E THEREFORE WE HAD TO PAY FROM A TO E IN ACCORDANCE WITH PAY ITEM LANGUAGE.

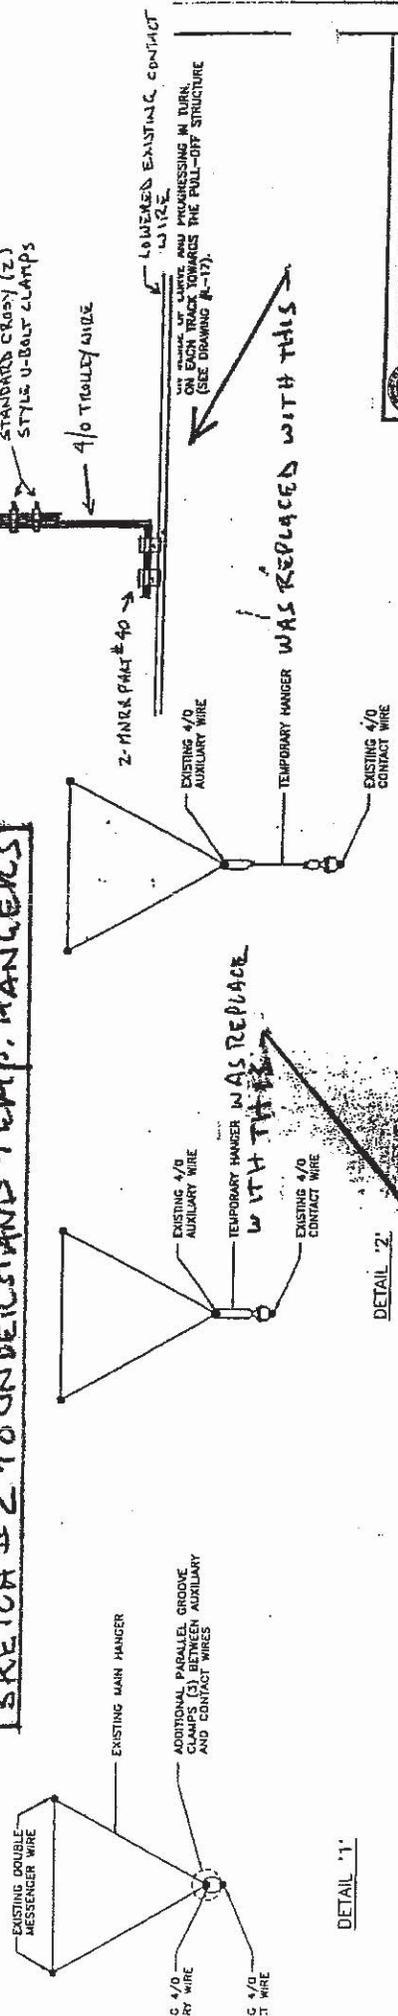
SKETCH #2 TO UNDERSTAND TEMP. HANGERS

- 2.) TEMPORARY CONDITIONS: Lowering of Existing Catenary** – MNRR did not approve the type of temporary hangers that were shown on Drawing L-15 when submitted by the Contractor. Their argument was that since the existing contact wire was fastened in a rigid manner to the messenger wire(s), MNRR desired that the temporary condition be capable of providing that same level of rigidity. As a result, MNRR accepted a proposal by the Contractor to fabricate hangers from two pieces of trolley (contact) wire. Standard MNRR parts were used to attach them to the existing catenary and common Crosby style u-bolts were used to join the two pieces together. This enabled the hanger length to be adjusted in the field (see attachment “A”, sketch #2). This method worked well and pleased the Railroad. However, had the Engineer previously been made aware of the Railroad’s dissatisfaction with the hangers shown on Drawing L-15, the Change Order Item #O6A0002 would have been avoided.

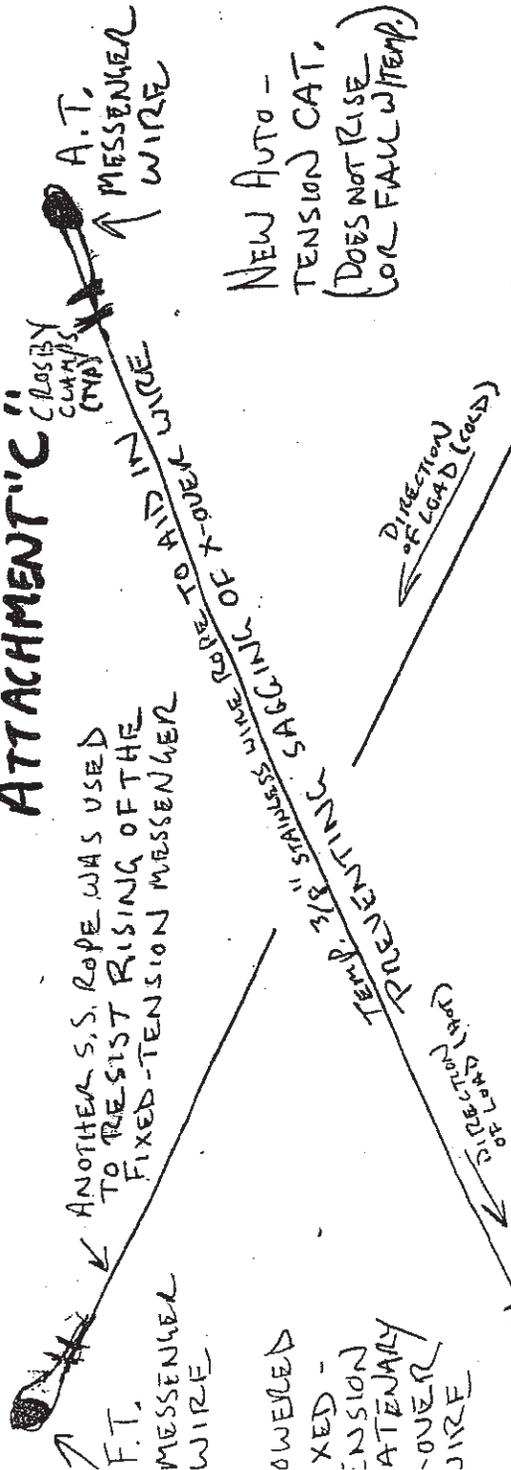
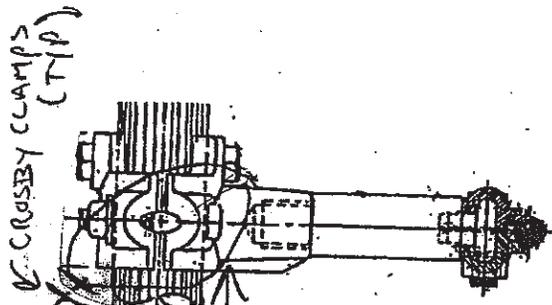
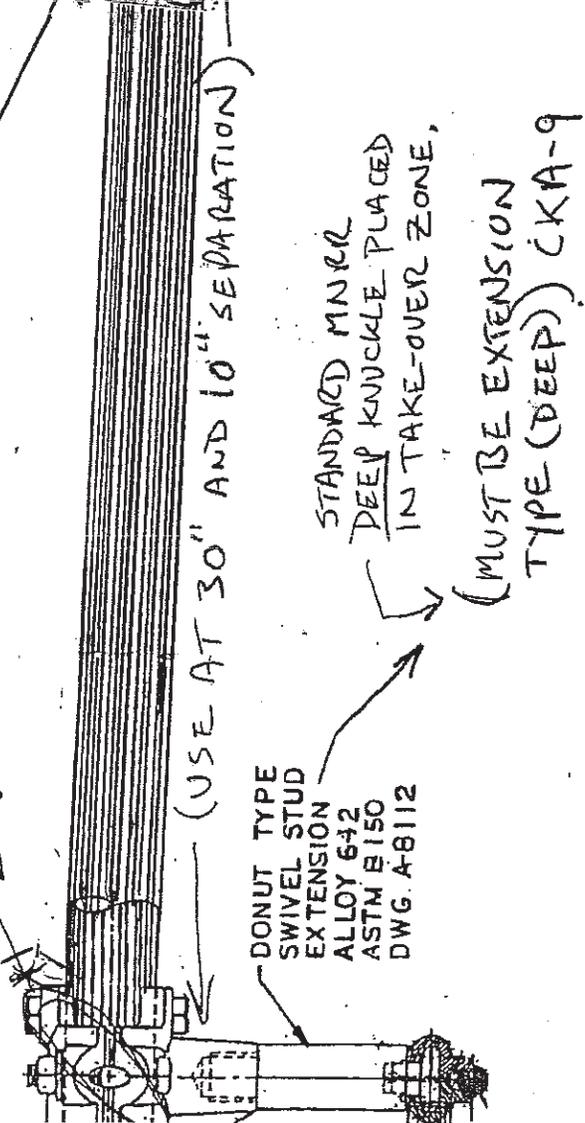
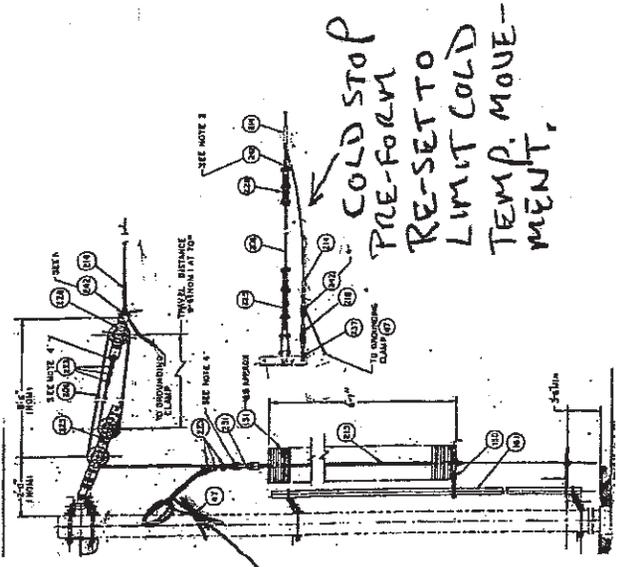
ATTACHMENT "C"

NEW AUTO-TENSION CAT. (DOES NOT RISE (OR FALL W/TEMP.))

SLACK EXTENDED AND FASTENED TO POLE BY LOOPING AROUND LACING TO LIMIT HOT TEMP. MOVEMENT.

NOTE: IF USED FOR MORE THAN ONE SEASON SPRING AND FALL ADJUSTMENTS REQUIRED.

NOTE: CROSS-OVER WIRE ALSO SUPPORTED FROM CLOSEST STRUCTURE, EVEN IF NEW DESIGN DOES NOT CALL FOR THAT (LIMIT-DRAW LENGTH)

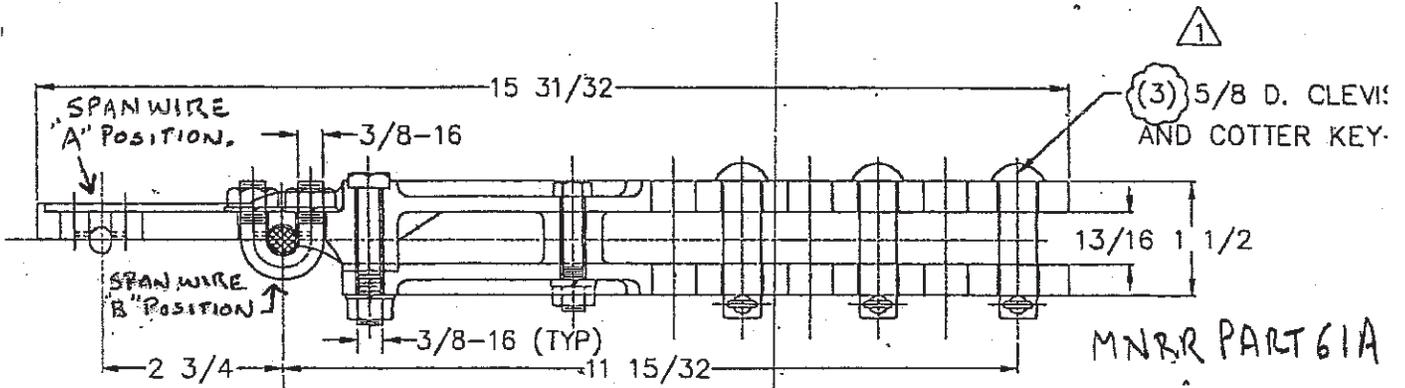
ATTACHMENT "D"

PO-1's & PO-2's as shown on Drawing E-4 can generally accommodate system depths between 18 and 23 inches. This is primarily due to the fact that the PO-6, 9 & 10 shown on Drawing E-7 can accommodate an additional 3 inches of system depth than indicated on the drawing. This just naturally increases the system depth the PO-1 & 2 can handle.

Below are examples of why the pull-off's can be used for larger system depths than the MNRR standards show. Luckily for the Project, many pull-off installation allocations were not in line with the standard, enabling the Project to not have to justify them being installed in a manner that did not conform with the E-4 & 7 drawings.

Note: When span wire is in the "A" position, dimensions add-up to the following when heel distance is included: $(2.75" + 11.5" + 2.5" = 16.75")$.
With the introduction of gravity on the mass of the bracket, the sag in the field (approx. 1.25") enables this PO bracket to accommodate a system depth of 18".

These are examples of Pull-off's whose installation allocations did not conform with the E-4 and E-7 drawings, but were fine in the field. [EXCEPT 246X, TK 4].

The following could guide the possible revision of drawings E-4 & 7
PO-6: (9" to 12")
PO-9: (12" to 18")
PO-10: (9" to 18")
PO-1 & PO-2: (18" to 23")
PO-3, 4 & 12: (24" and greater)

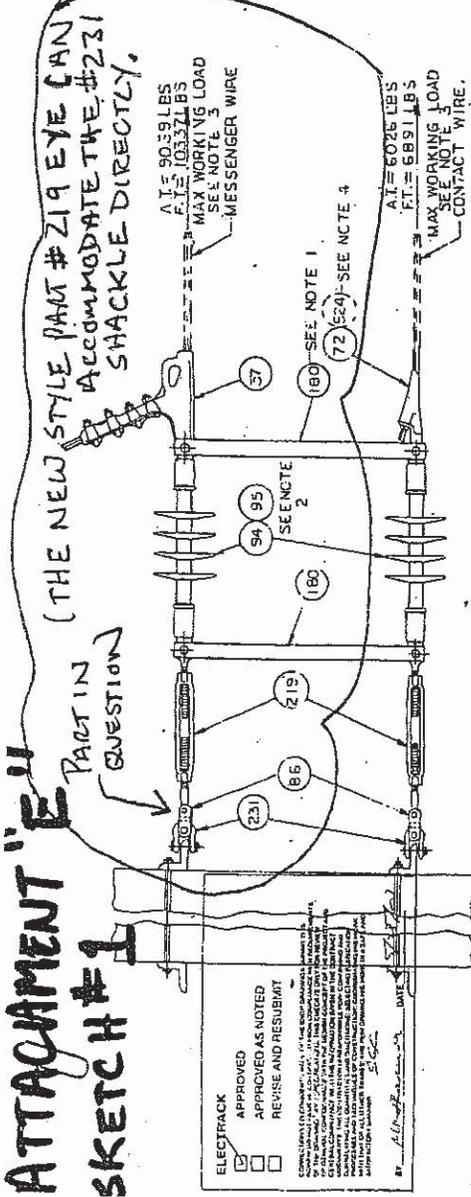
ATTACHMENT 'E' II PART IN QUESTION SKETCH #1

27.) INSTALLATION OF NEW CATENARY WIRE: Assembly Shop Drawing – The CDEA-5 assemblies had an improperly documented change that appeared to be generated by the manufacturer. This caused enough confusion with the MNRR catenary inspectors to note it here. The Project recommends that this drawing conflict be corrected. A different style turnbuckle was introduced by the Dossert Co., and that style appeared to eliminate the need for another component (Part #86) that was allocated to be in the assembly. However, the changed assembly shop drawing was never re-issued to the Project. Attachment "E", sketch #1 is given to better illustrate the recommendation.

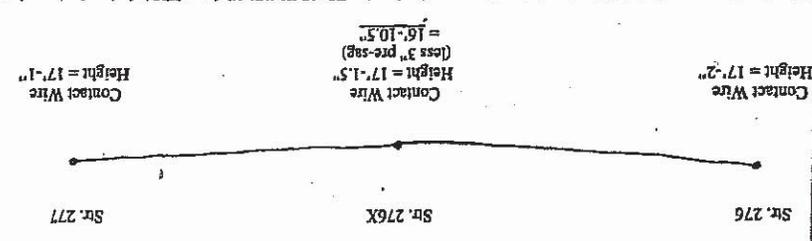
SKETCH #2

EXAMPLE:
Review of Span Bracket Assembly (SBA) design height at structure 276X.

After the Contractor installed the bracket as shown on the drawing ED-276X (17'-9" above HRL) during the lowering process, the Engineer then generated the hanger tabulations once the Contractor worked his way over to track #4. The hanger tabulations called for a hanger here to be 16.25" long. Therefore, the messenger wire will be 16.25" higher than the contact wire at this location. That equals 18'-2.75", this is the height the SBA should have been installed, not at the 17'-9" shown on the drawing. That low bracket had then affected the pull-off on all of the other tracks until the Contractor got back to track three to re-work (raise about 6") the height of the bracket.

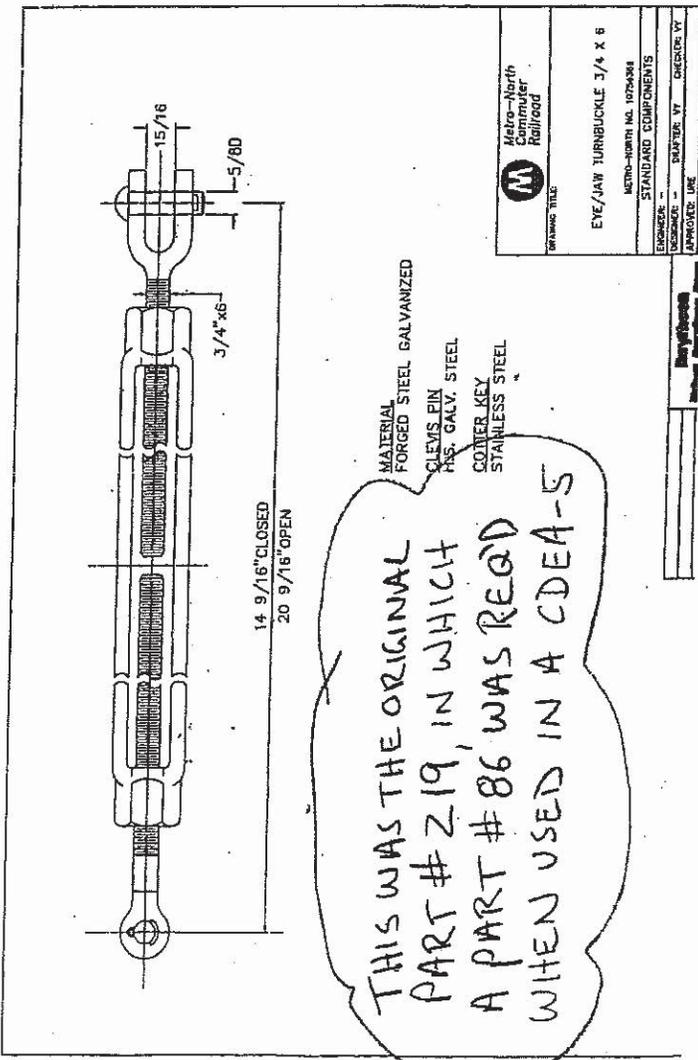
THIS WAS THE ORIGINAL
PART # 219, IN WHICH
A PART # 86 WAS RECD
WHEN USED IN A CDEA-5

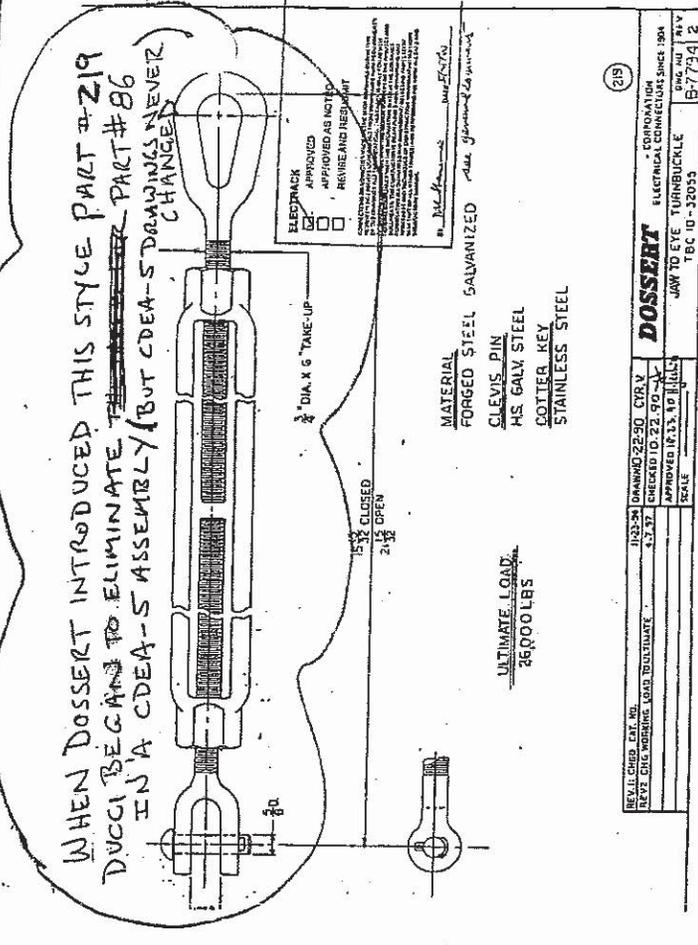
WHEN DOSSERT INTRODUCED THIS STYLE PART # 219
DUCCI BEGINS TO ELIMINATE THE PART # 86
IN A CDEA-5 ASSEMBLY (BUT CDEA-5 DRAWINGS NEVER
CHANGED)
