**Commissioning  
and  
Rebalancing  
of  
Existing System**

**25 Sigourney Street  
Hartford, CT  
Project #BI-2B-033K**

**Prepared by:**  
*LMG Consulting Engineers, Inc.  
78 Beaver Road  
Wethersfield, CT 06109  
November 21, 2007*

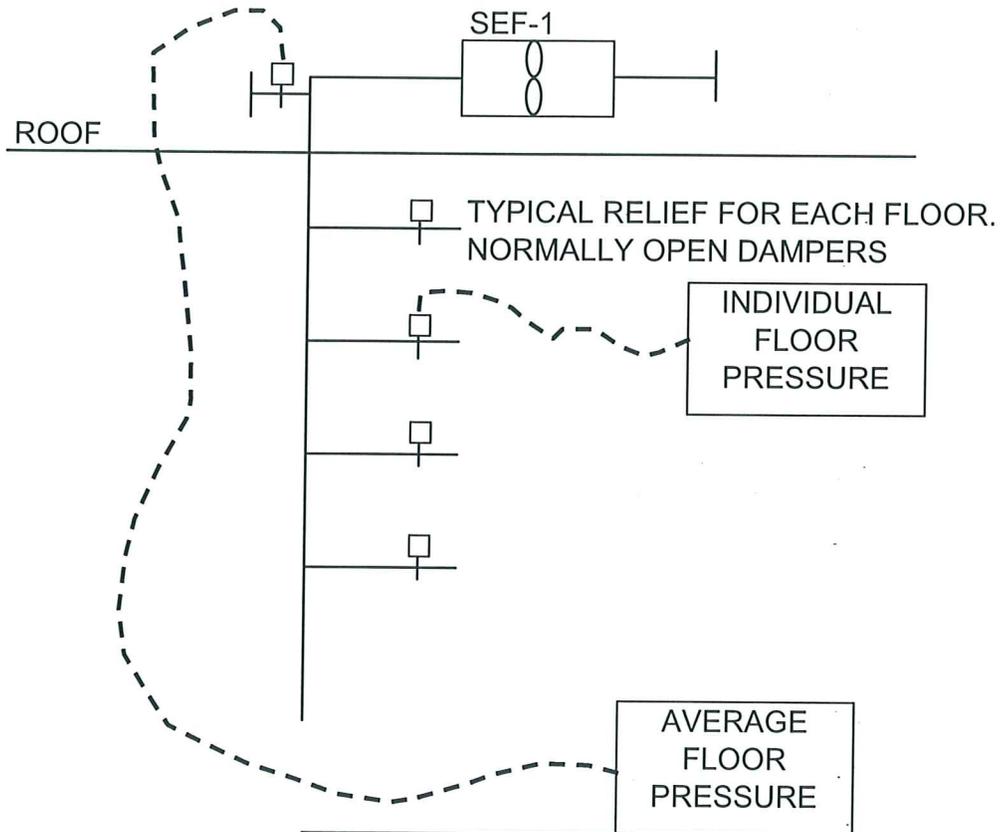
# RELIEF DUCTING

THE BUILDING PRESSURE REDUCES BY .03" WHEN THE ROOF DAMPER OPENS DUE TO FLOOR DAMPERS WHICH DO NOT FULLY CLOSE

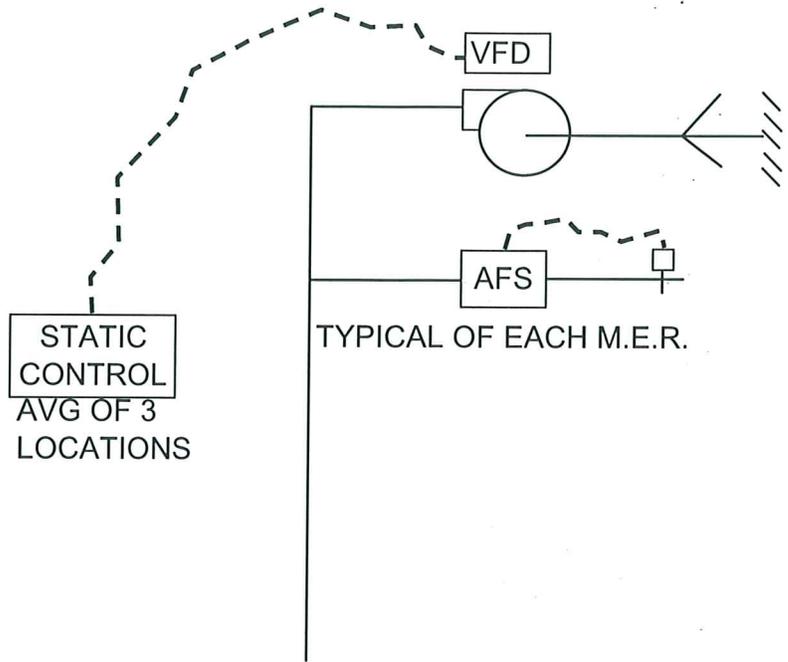
# OUTSIDE AIR DUCTING

THE NORTH SIDE 6TH FLOOR SENSOR IS NOT READING CORRECTLY.

| 10/11/07 | Replaced erratic 6 <sup>th</sup> floor north static pressure sensor and disassembled and repaired 6 <sup>th</sup> floor relief air damper linkage. |

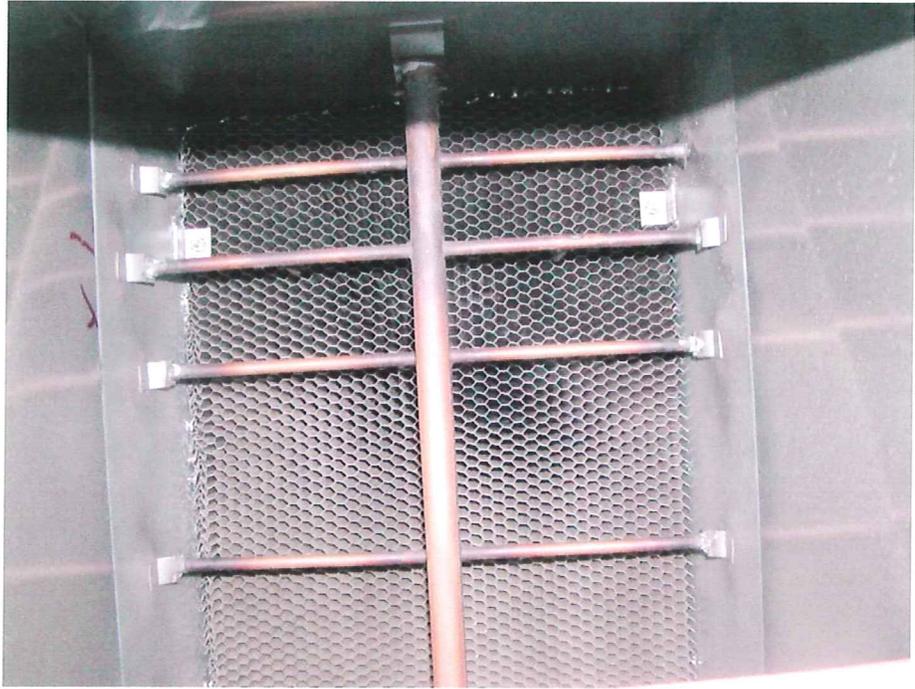
- Some settings had been modified to other than listed values. They have been reset to their design.
- The 9<sup>th</sup> floor damper was side open while handling less than design CFM. An inspection discovered fibrous material plugging the honeycomb air straightener for the Air Flow Station. (See Photo)
- Some flow didn't change when commanded due to defective damper actuators. They are listed on the Outside Air Intake Sheet.

Air Flow Station looking upstream at the honeycomb air straightener.

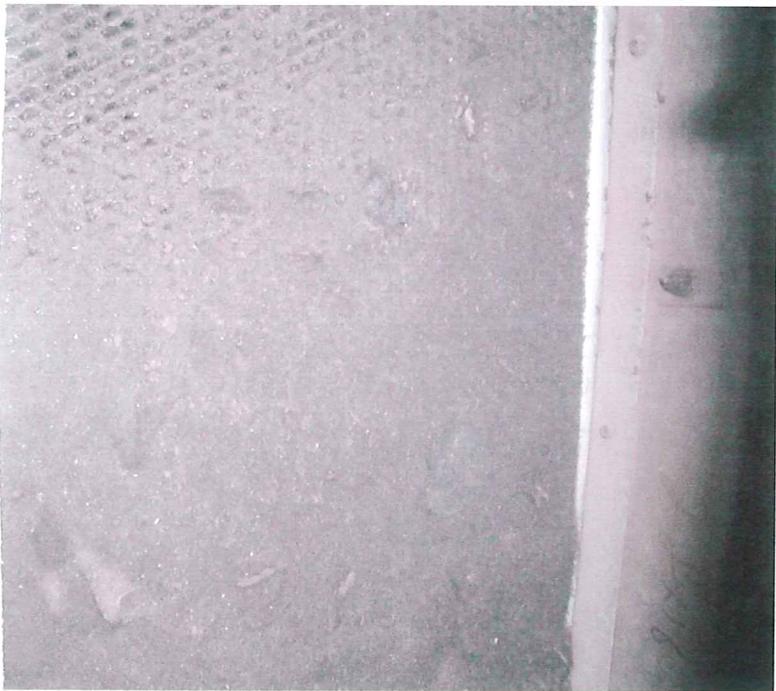
Looking downstream at a plugged honeycomb air straightener.

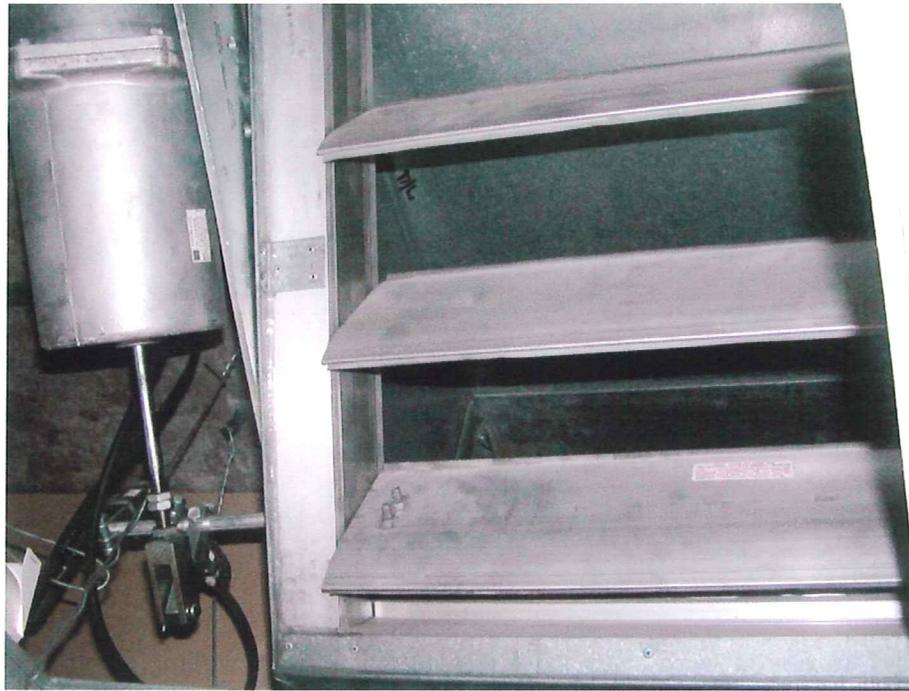
- The 6<sup>th</sup> floor damper is 80% open when commanded for 0% open due to a linkage connection problem. Also, the light fixture is placed in a position that will not allow closure of the damper. (See Photo)
- 4 dampers are not tight and leak air which are on the 8<sup>th</sup>, 10<sup>th</sup>, 15<sup>th</sup>, & 16<sup>th</sup> floors.
- The 9<sup>th</sup> floor relief damper is located in a computer room which is sealed off from the other floor space. No floor pressure will be relieved through this damper.

(1) DPR LINKAGE BROKEN AND LIGHT FIXTURE BLOCKING CLOSURE. SEE PHOTO  
 (2) DPR LINKAGE SLOPPY. NEEDS SERVICE.  
 (3) THIS COMPUTER RM IS VERY TIGHT AND WILL NOT RELIEVE SPACE PRESSURE.

The normally open actuator is stroked. The damper is still open due to a broken linkage. 6<sup>th</sup> Fl

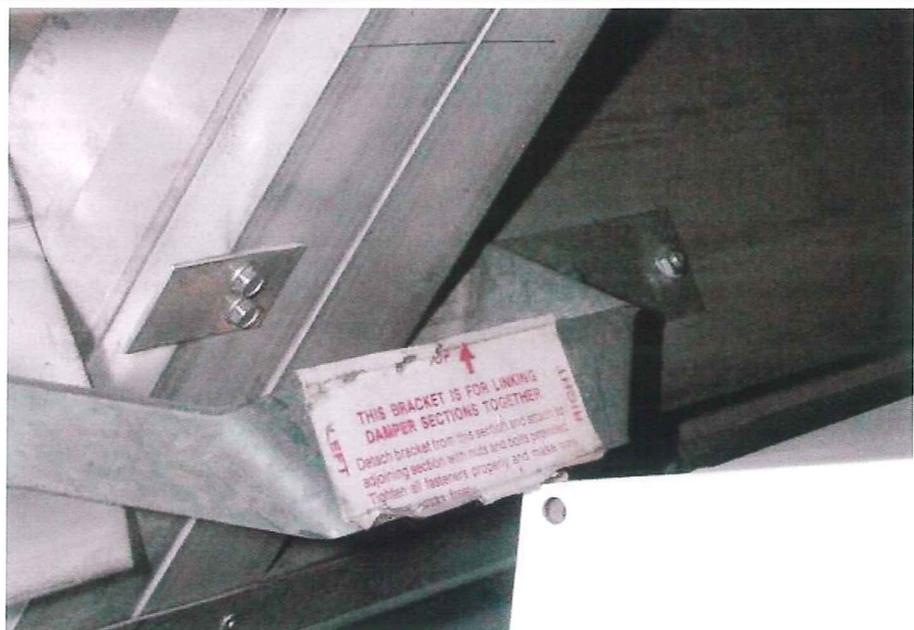
The light fixture is in the way of the damper linkage and can not close. 6<sup>th</sup> Fl
