TO: WARD PONTICELLI
FROM: JACKIE BROWN *JB*
SUBJECT: CORRECTION OF THE "STACK EFFECT" AND IMPROVEMENTS TO BUILDING PRESSURE CONTROLS AT 25 SIGOURNEY
DATE: 08/06/01
CC: MANUEL BECERRA, DONNA BAISLEY

**AIR FLOW STUDY
FOR
25 SIGOURNEY STREET
HARTFORD, CT.**

*Luchini, Milfort, Goodell & Associates, Inc.
Wethersfield, CT.
29 May 2001*

Re: 25 Sigourney Street
6th Floor HVAC Testing

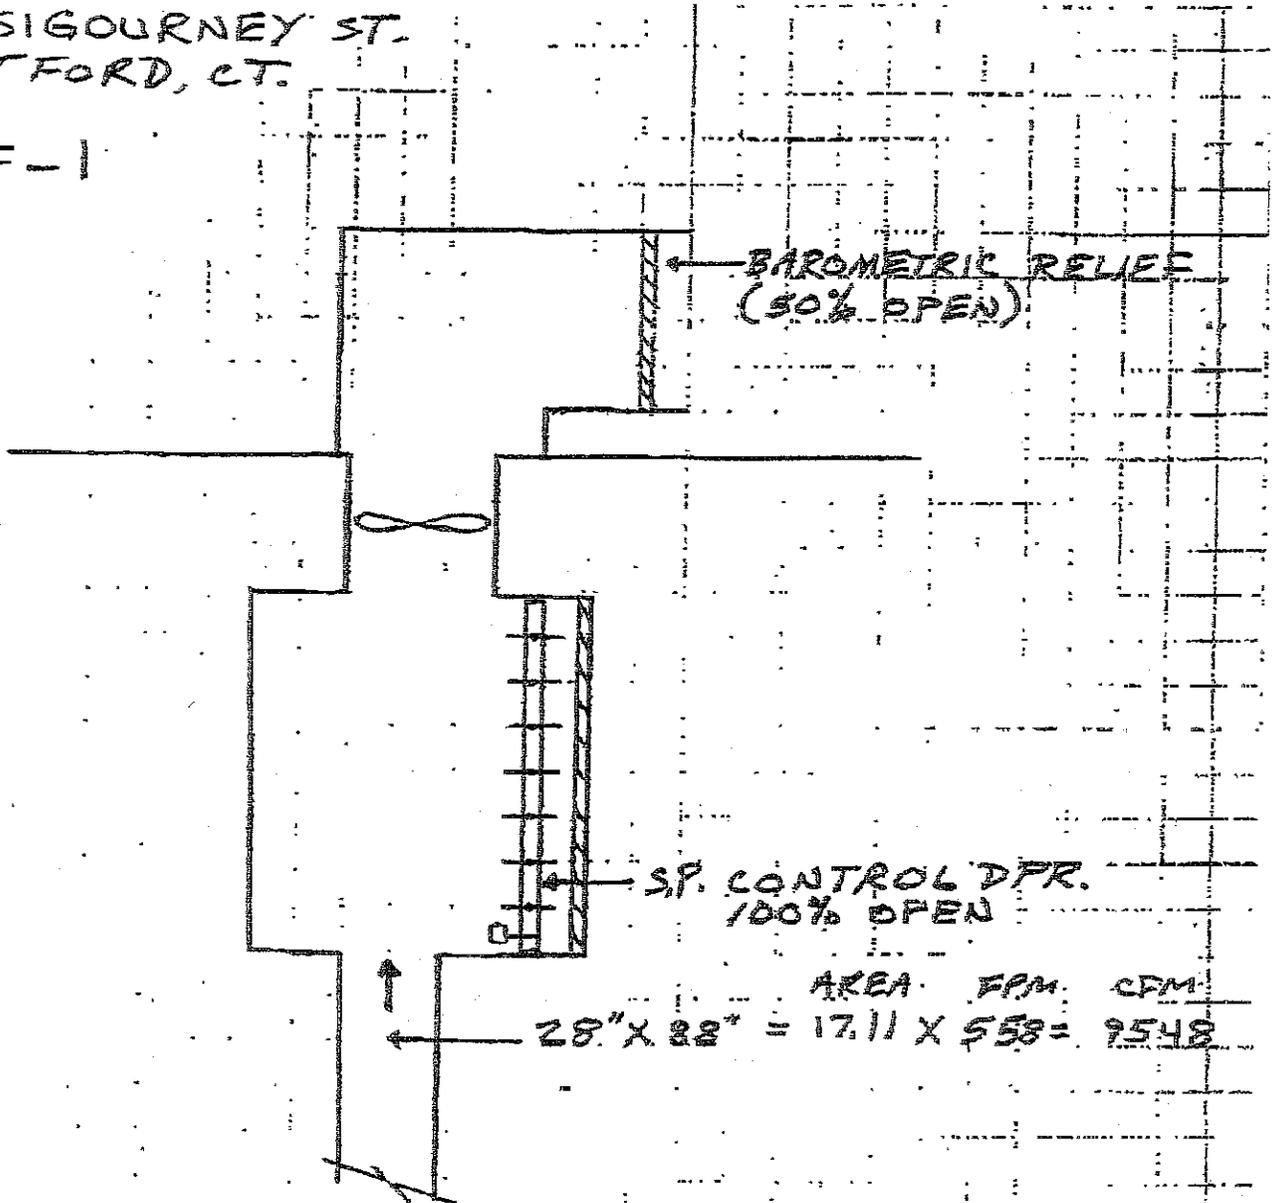
SK-1

Description	Exiting CFM
* SEF-1 (Smoke Exhaust Fan) has a barometric relief back draft damper which is spilling air and the automatic damper is wide open (see sk-1)	9,548
* Elevator machine room roof has a 5'x5' opening to a louvered relief vent	14,675
* Kitchen exhaust fans that are not running, have fan discharge wire mesh screens that are relieving 350 FPM: 44" dia = $138" \times 10" = 9.59 \times 350 = 3358$ 35" dia = $110" \times 9" = 6.87 \times 350 = 2404$	5,762

SEF-1

AREA	FPM	CFM
28" X 28"	17.11	558
		= 9548

- * Contract a HVAC engineering firm to review our report and findings, in addition to addressing code issues, etc. (Note: BVH Engineers, Inc. has first hand information on the base building design.)
- * Eliminate air leakage
 - isolate the SEF-1 relief damper (sk-1)
 - close the static pressure control damper (sk-1)
 - close the elevator shaft ventilation relief
 - tighten the sliding door tracks
 - seal the mullions at the fixed pane windows
- * Adjust the make up air fan systems to provide adequate ventilation for occupants and building pressurization

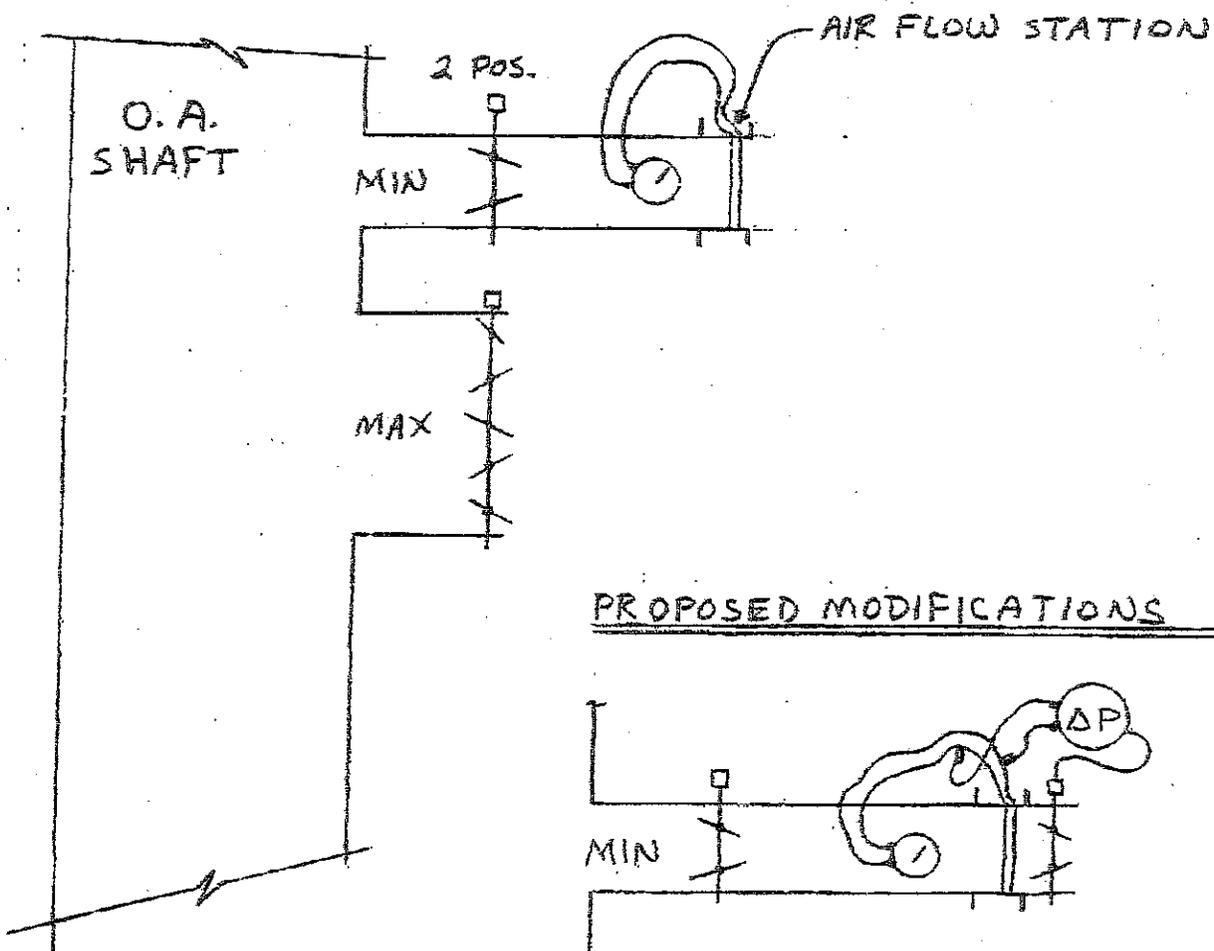
SK-1

THEY ARE LOCATED ON THE 8TH FL. NORTH MER. AND EACH OF THE ΔP CONTROLLERS HAVE THE HI SIDE IN THE DUCT, & THE LOW SIDE OPEN TO THE M.E.R. THIS SITUATION CAN CHANGE THE FLOW POTENTIAL BASED ON THE SUCTION PRESSURE OF THE 8TH FL. NORTH FAN SYSTEM!

EXISTING - TYPICAL FLOOR

- * UPGRADE THE CONTROLS TO PROVIDE AUTOMATIC RELIABLE CONDITIONS. (WHEN THE ΔP SENSOR LO SIDE WAS CONNECTED TO ATMOSPHERE, NO CHANGE TO SYSTEM SPEED OCCURRED.)
- * ADD A DUCT EXTENSION TO THE MIN. SECTION WITH A VOLUME DAMPER TO CONTROL FROM THE EXISTING AIR FLOW STATIONS. (SEE SK-1)

THE NEW DAMPER TO BE CONTROLLED BY A ΔP SENSOR TIED INTO THE AFS.
