**RE: 25 Sigourney Street - HVAC Hygiene Survey**

**State of Connecticut  
Office Building  
25 Sigourney Street  
Hartford, CT**

**HVAC Hygiene Survey**

**Project # 8473**

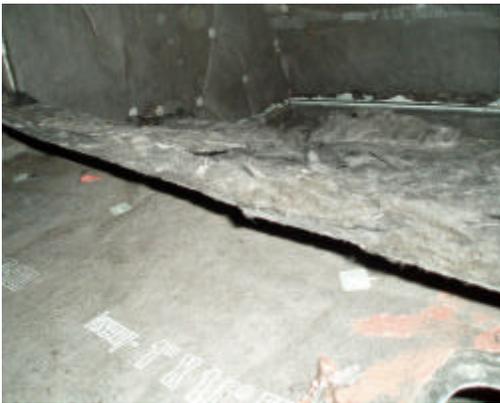
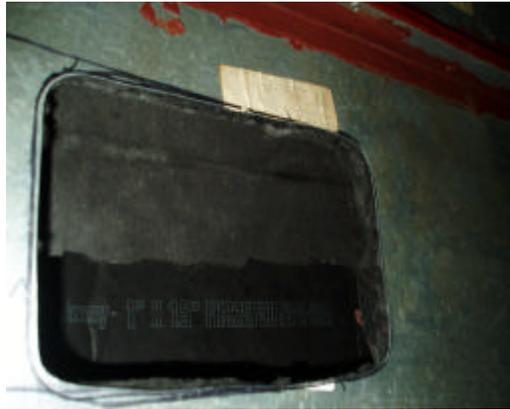
Typically, the fibrous glass insulation located in the supply discharge plenums have minor to moderate damage in the form of exposed edges of fibrous glass that have not been sealed. This can lead to fibers being introduced into the air stream. Location #06 (12<sup>th</sup> Floor North) and Photos #09 and #10 show where the duct insulation has been separated and now is blown back on itself, exposing a large area of damaged fibrous glass.

Particulate: Moderate particulate with signs of moisture  
Rust: None observed  
Water Damage: None observed  
Structural Integrity: Good  
Fibrous Glass: Large pieces of insulation are loose on one end and has been flipped over by the air flow.  
Reheat Coil: N/A  
Additional Observations:

Picture #9  
12<sup>th</sup> Floor North Mech. Room  
Supply Duct, Torn Insulation

Picture #10  
12<sup>th</sup> Floor North Mech. Room  
Supply Duct, Torn Insulation

CVI recommends the condition of the internal fibrous glass insulation be evaluated for structural stability and fiber shed. If it is determined that the fiberglass is shedding the State of Connecticut may wish to consider replacing the insulation or, as a short term measure, coating the interior surface to reduce fiber shedding.

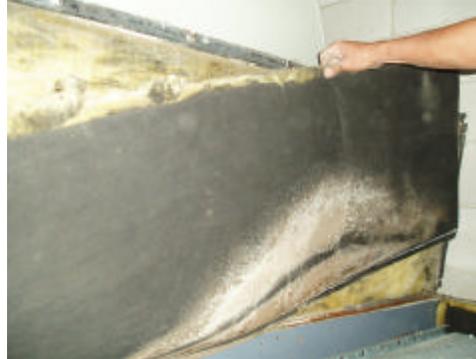
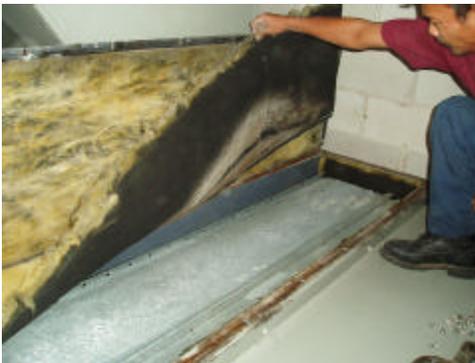
Photos #16 and #17 (17<sup>th</sup> Floor North) are of suspected microbial growth located on the fibrous glass insulation located on the top panel of the air handler unit, above the coil compartment (reference bulk sample #14).

Picture #16  
17<sup>th</sup> Floor North Mech. Room  
Top of Coil

Picture #17  
17<sup>th</sup> Floor North Mech. Room  
Top of Coil
