BOROSCOPIC INSPECTION REPORT

**25 SIGOURNEY STREET
HARTFORD, CT**

**PREPARED FOR
STATE OF CONNECTICUT
DEPARTMENT OF PUBLIC WORKS
FACILITIES MANAGEMENT
165 CAPITOL AVENUE
HARTFORD, CT 06106**

SEPTEMBER 15, 2002

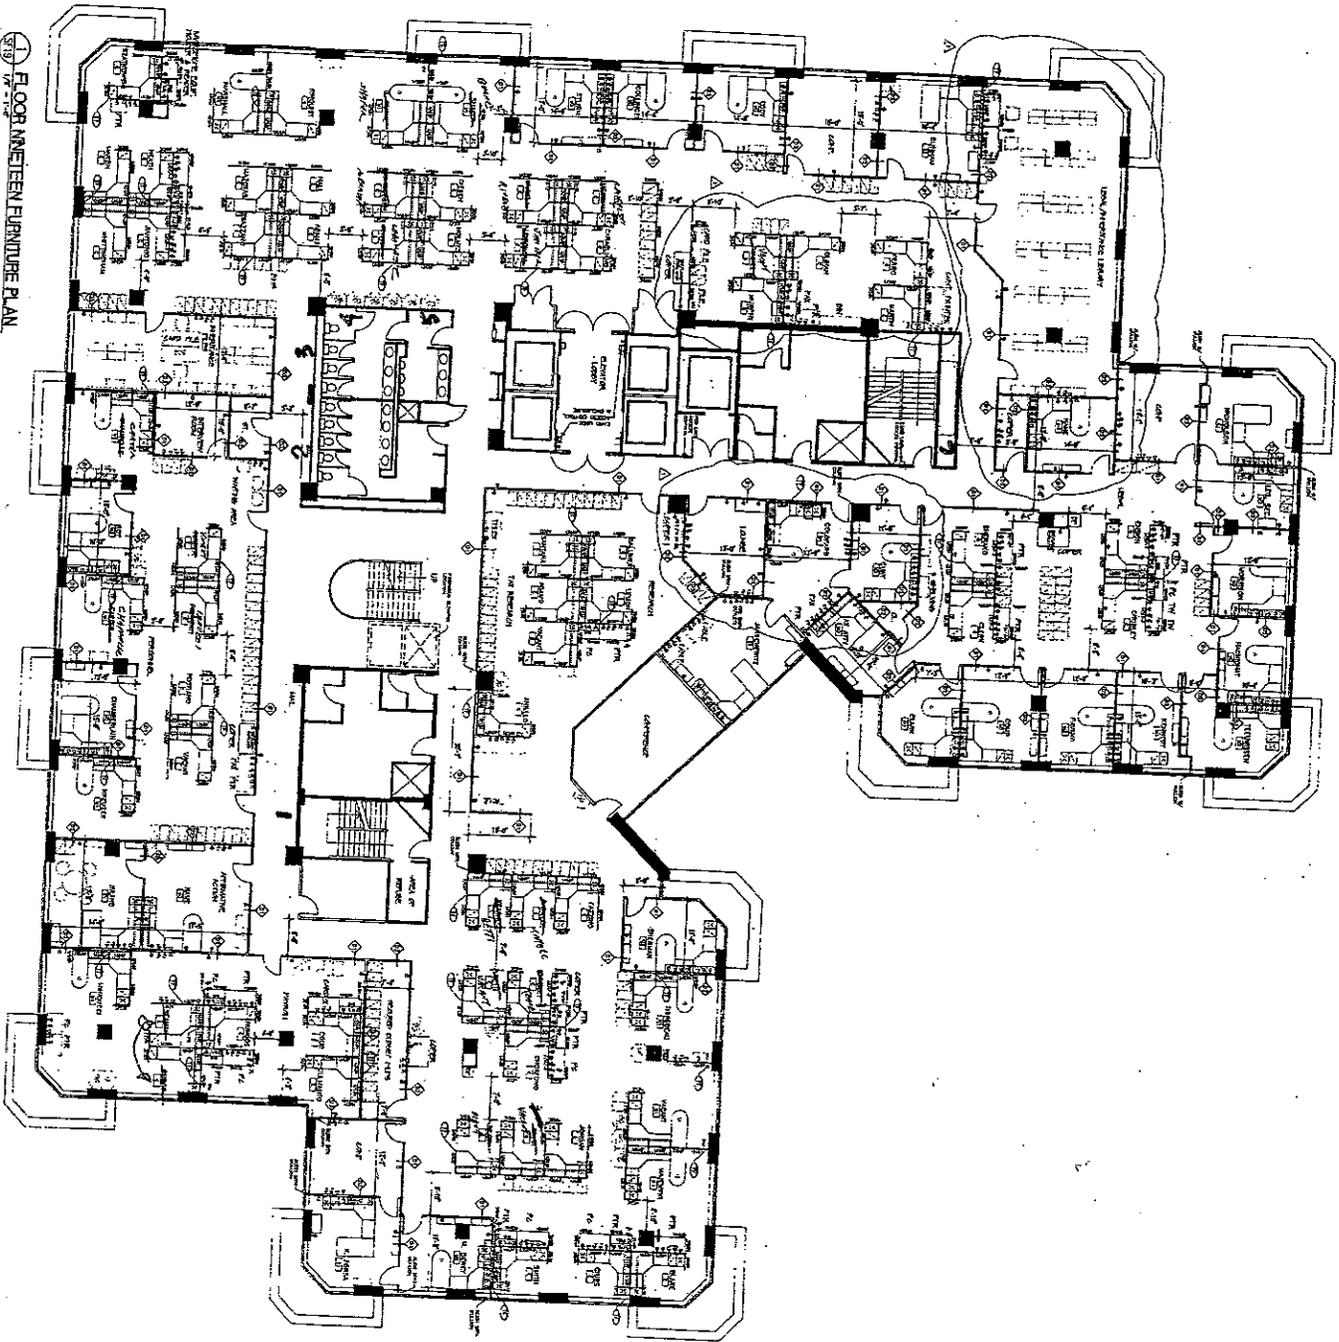
SF19

LOCATION #1: This is back of stairway. It has a concrete wall beyond the gypsum board with a 1" air space between. No staining, rust or contamination was seen.

LOCATION #2: This is back pipe chase of women's toilets. Pipe insulation was clean. There was rust found at bottom of pipe supports but this is from condensation and not from a pipe leak. No contamination was seen.

LOCATION #3: This is back pipe chase of men's toilets. Pipe insulation was clean. There was rust found at bottom of pipe supports but this is from condensation and not from a pipe leak. No contamination was seen.

LOCATION #4: This is side wall of one men's toilet. Studs were clean. Gypsum board was clean. Track was clean.

LOCATION #5: This is side wall of men's toilets investigated because it is under exterior wall above. Insulation was clean. Studs were clean. Gypsum board was clean. Channel had small amount of rust on bottom. This didn't appear to be from a chronic situation.

LOCATION #6: This is inside a duct chase near the north stair investigated because it is by an exterior sign of water staining. Studs were clean. Gypsum board was clean. Track was clean. Water staining is from exterior only.
