# **BOROSCOPIC INSPECTION REPORT**

**PHASE 2**

**25 SIGOURNEY STREET  
HARTFORD, CT**

**SEPTEMBER 25, 2002**

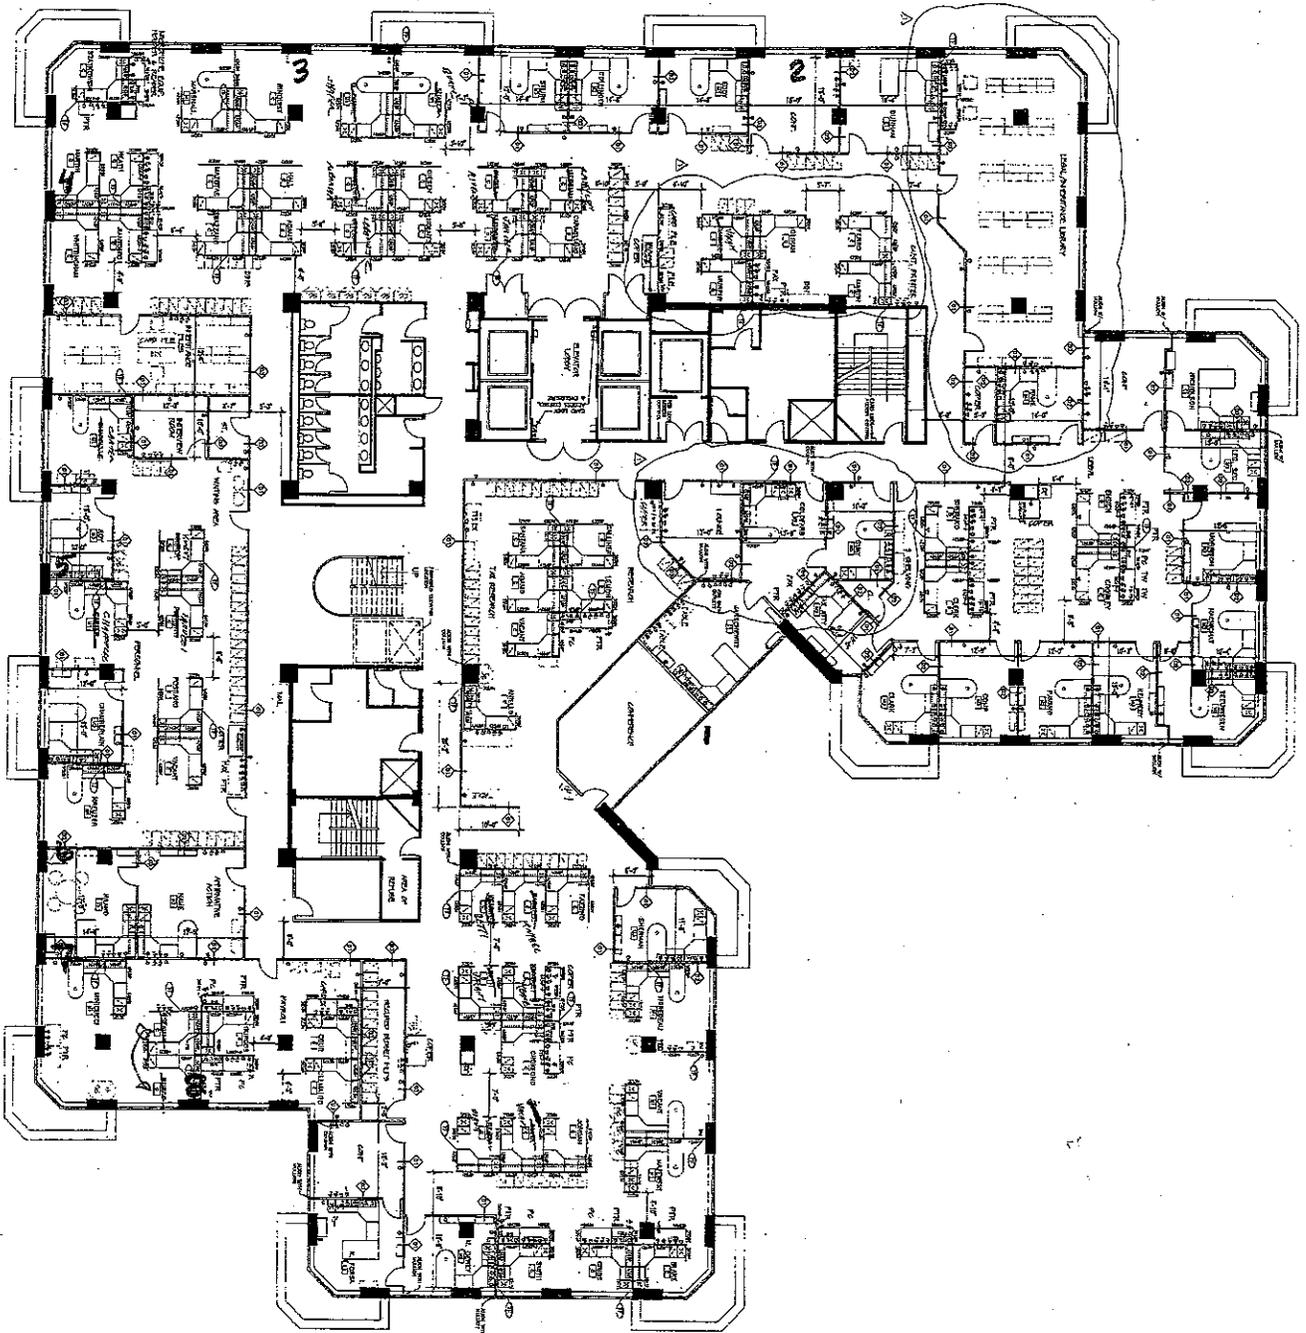
FLOOR NINETEEN FURNITURE PLAN

LOCATION #1B: This is window wall at the conference room. 2 holes were made but there was not enough space to video. Concrete too close.

LOCATION #2B: Room 1922, below desk. No contamination was seen.

LOCATION #3B: This is taken at the bottom of the file cabinets. No contamination was seen.

LOCATION #4B: This is taken through exposed wall next to balcony. No contamination was seen.

LOCATION #5B: This is taken in room 1930 in column by window. Debris found but no contamination was seen.

LOCATION #6B: This is taken in room 1933 through exposed wall. No contamination was seen.

LOCATION #7B: This is taken in room 1933 through other exposed wall. Minor water stain on concrete block. Gypsum board was clean.

LOCATION #8B: This is taken in room 1934 through exposed wall. No contamination was seen.

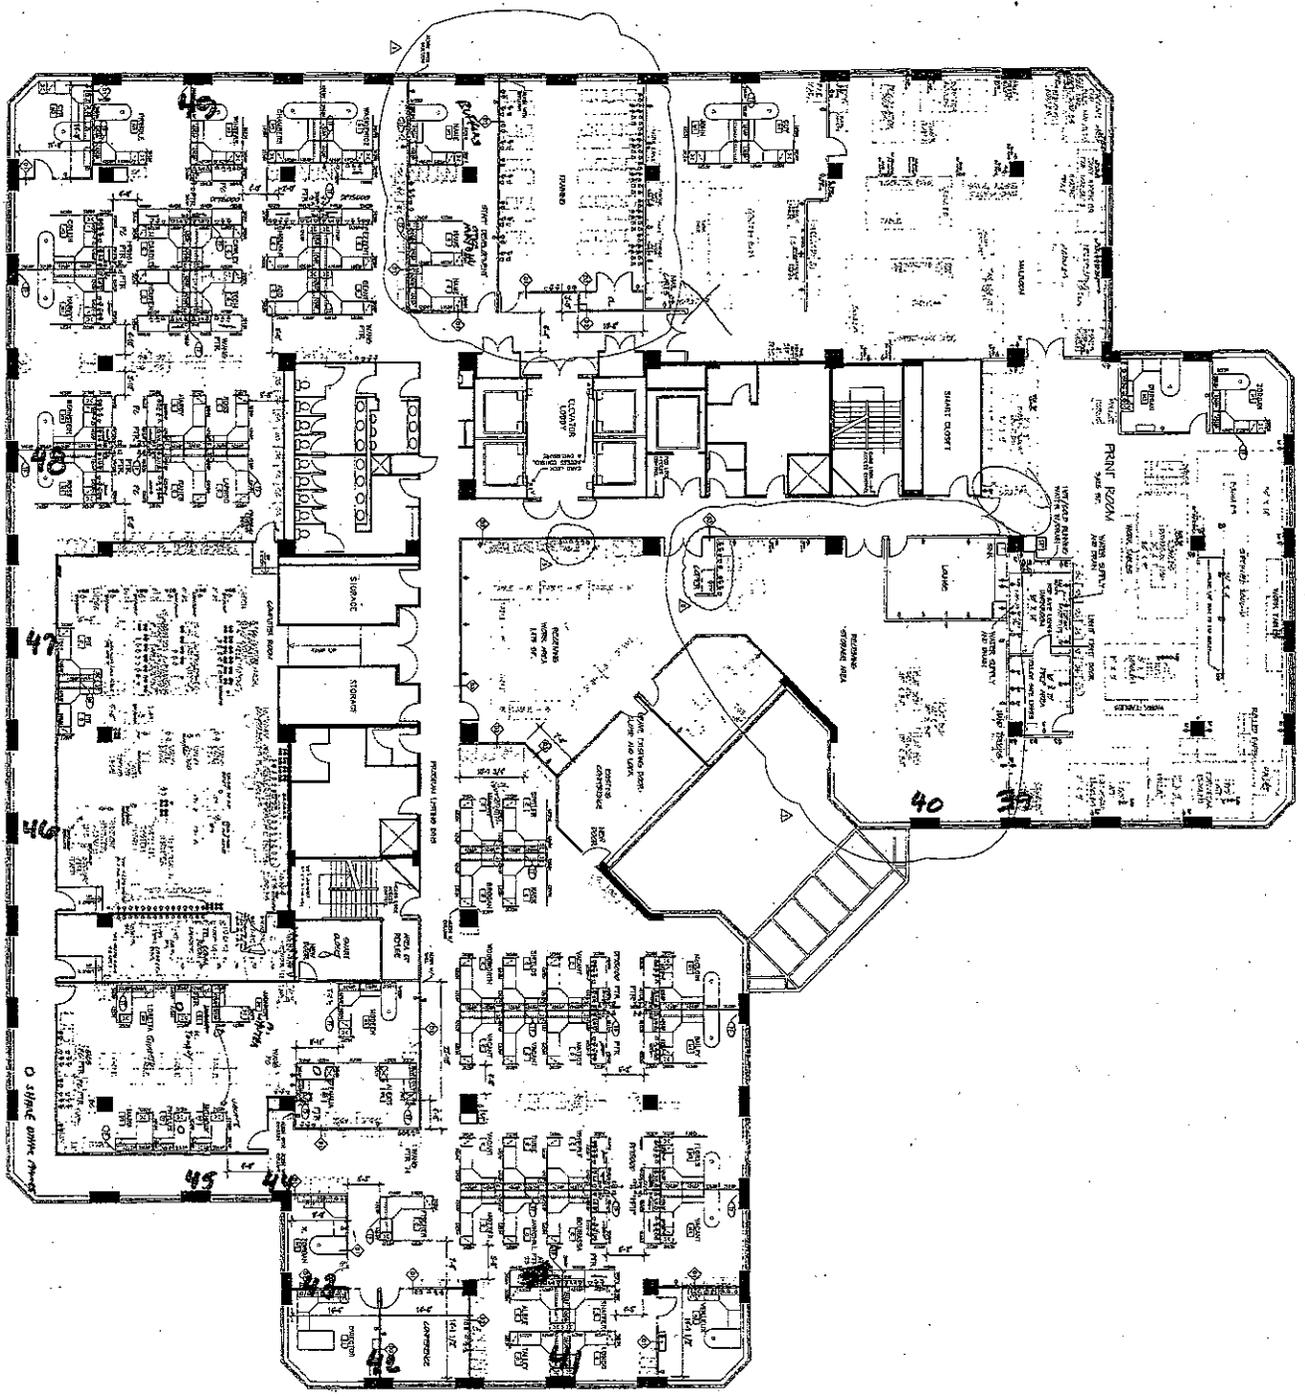
FLOOR SIXTEEN FURNITURE PLAN

LOCATION #39B: This is taken at the left column of the new training room. No contamination was found.

LOCATION #40B: This is taken at the center column of the new training room. Suspicious black spots seen.

LOCATION #41B: This is taken at V. Ohri's work station. Suspicious black spots seen.

LOCATION #42B: This is taken at the left column of room 1618. Suspicious black spots seen all the way up gypsum board.

LOCATION #43B: This is taken at the left column of room 1617. Lots of debris seen and suspicious black spots seen on stud and gypsum board.

LOCATION #44B: This is taken at the right column of room 1617. No contamination was found.

LOCATION #45B: This is taken at the East hallway by the copier. No contamination was found.

LOCATION #46B: This is taken at the South hallway at 4<sup>th</sup> column. Water staining was found.

LOCATION #47B: This is taken at the South hallway at 6<sup>th</sup> column. Discoloration that looks like mold seen along studs.

LOCATION #48B: This is taken at the column behind D. Raheb.. Water staining was found. Suspicious black marks found.

LOCATION #49B: This is taken at the left column behind R. Santana. No contamination was found.

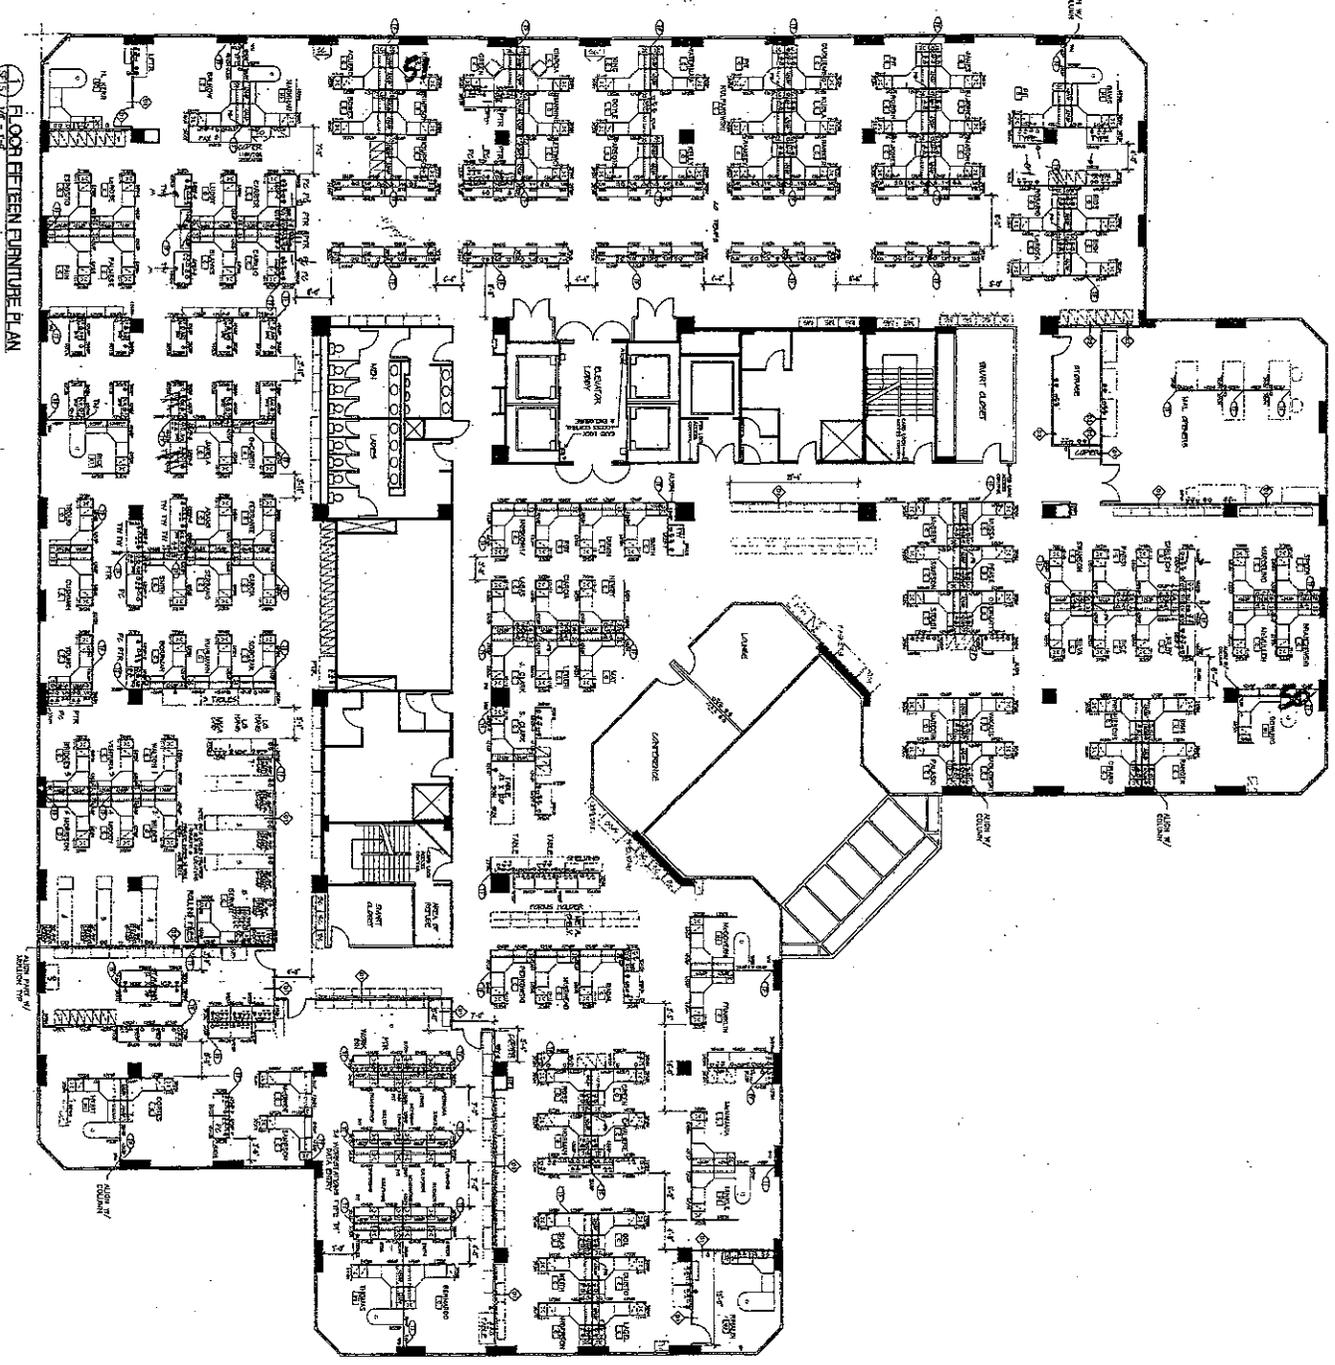
FLOOR FIFTEEN FURNITURE PLAN

LOCATION #50B: This is taken at the left column behind G. Dawling. Couldn't see because of concrete.

LOCATION #50-B-1: This is taken at the same place near the corner. Debris found but no contamination.

LOCATION 51B: This is taken at the column behind L. Agüero. Water staining found.

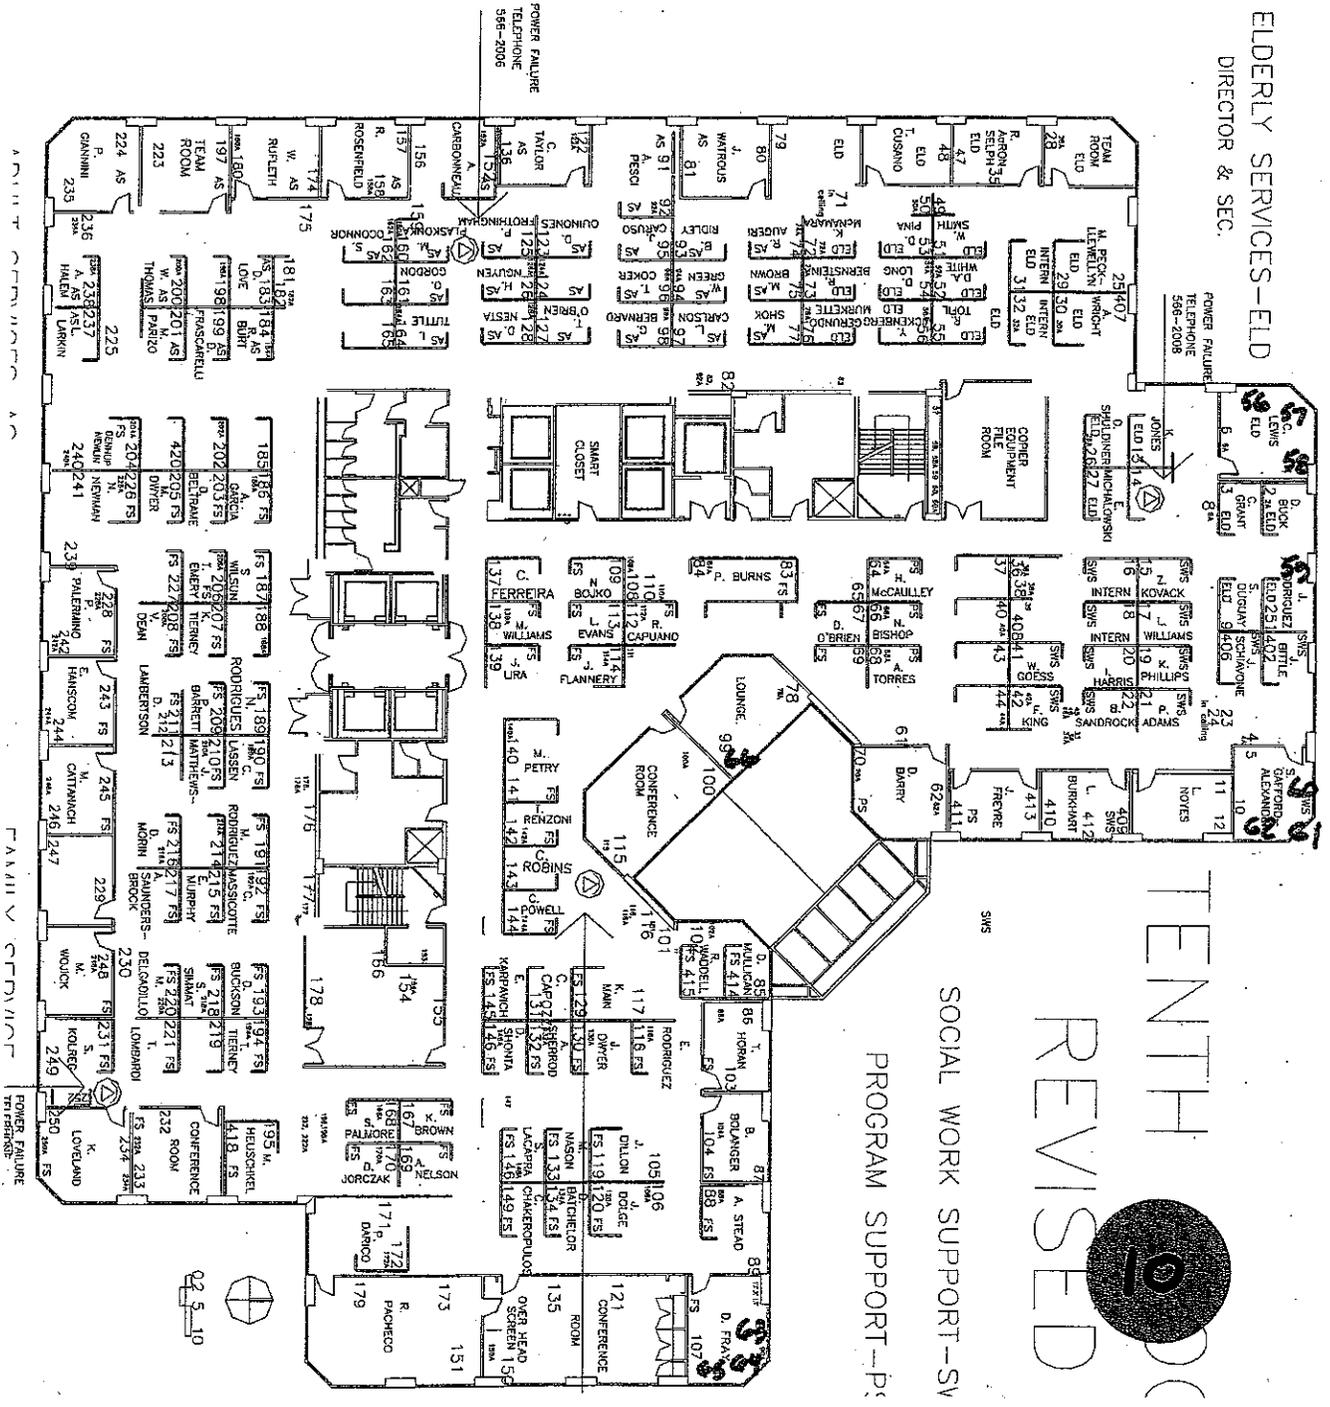
TENTH FLOOR  
REVISSED

LOCATION 56B: This is taken at the column outside of room 1005. No contamination was found.

LOCATION 56B-1: This is taken at the left column outside of room 1005. No contamination was found.

LOCATION 57B: This is taken at the center window of room 1005. No contamination was found.

LOCATION 58B: This is taken at the right column behind desk of room 1005. No contamination was found.

LOCATION 59B: This is taken at the column by clock behind J. Rodriguez. No contamination was found.

LOCATION #60B: This is taken at the left column of room 1004. Water staining found. Broken gypsum board found at track.

LOCATION #61B: This view was taken at the center of the window wall of room 1004. No contamination found.

LOCATION #62B: This view was taken at the right column of room 1004. No contamination found.

LOCATION #63B: This view was taken at the left of the window wall of room 1026. No contamination found.

LOCATION #64B: This view was taken at the center of the window wall of room 1026. No contamination found.

LOCATION #65B: This view was taken at the left of the window wall of room 1026. No contamination found.

LOCATION #66B: This view was taken at the lounge wall, room 1002. No contamination found.

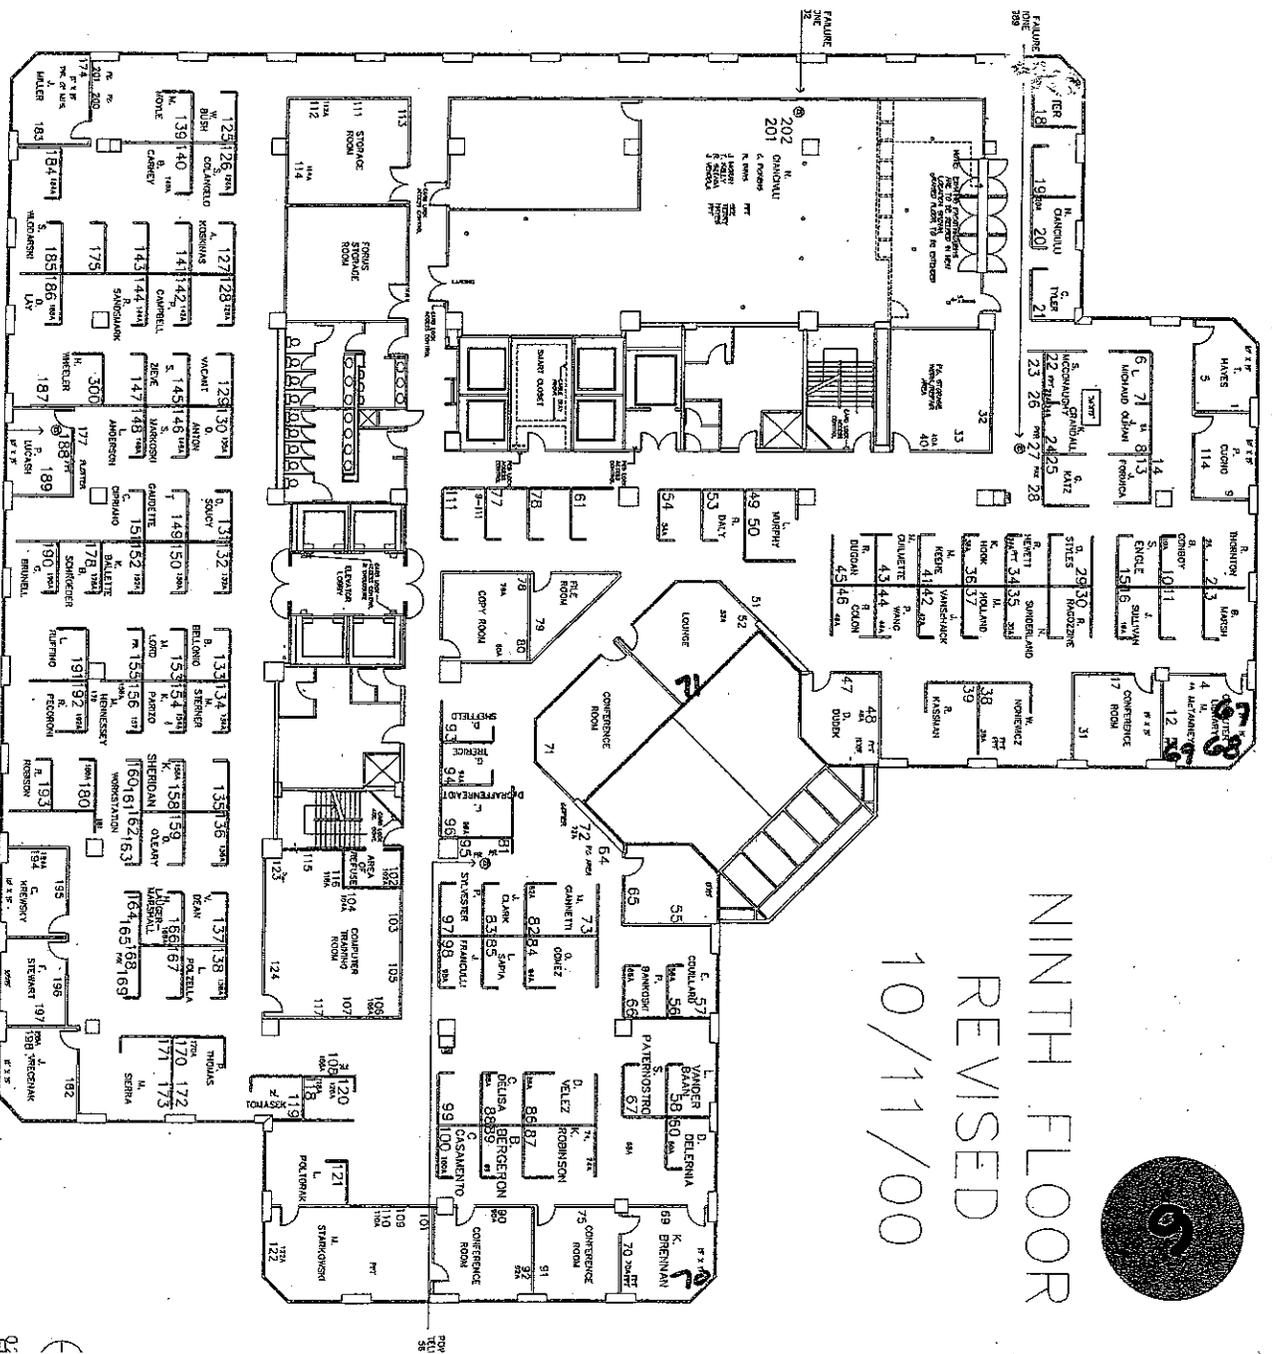
# NINTH FLOOR REVISED 10/11/00

LOCATION 67B: This is taken at the left column by room 905. Light water staining found.

LOCATION 68B: This is taken at the center window wall of room 905. No contamination was found.

LOCATION 69B: This is taken at the right column of room 905. No contamination was found.

LOCATION 70B: This is taken at the center window wall of room 922 (Brennan). No contamination was found.

LOCATION 71B: This is taken at the conference room 901. No contamination was found.

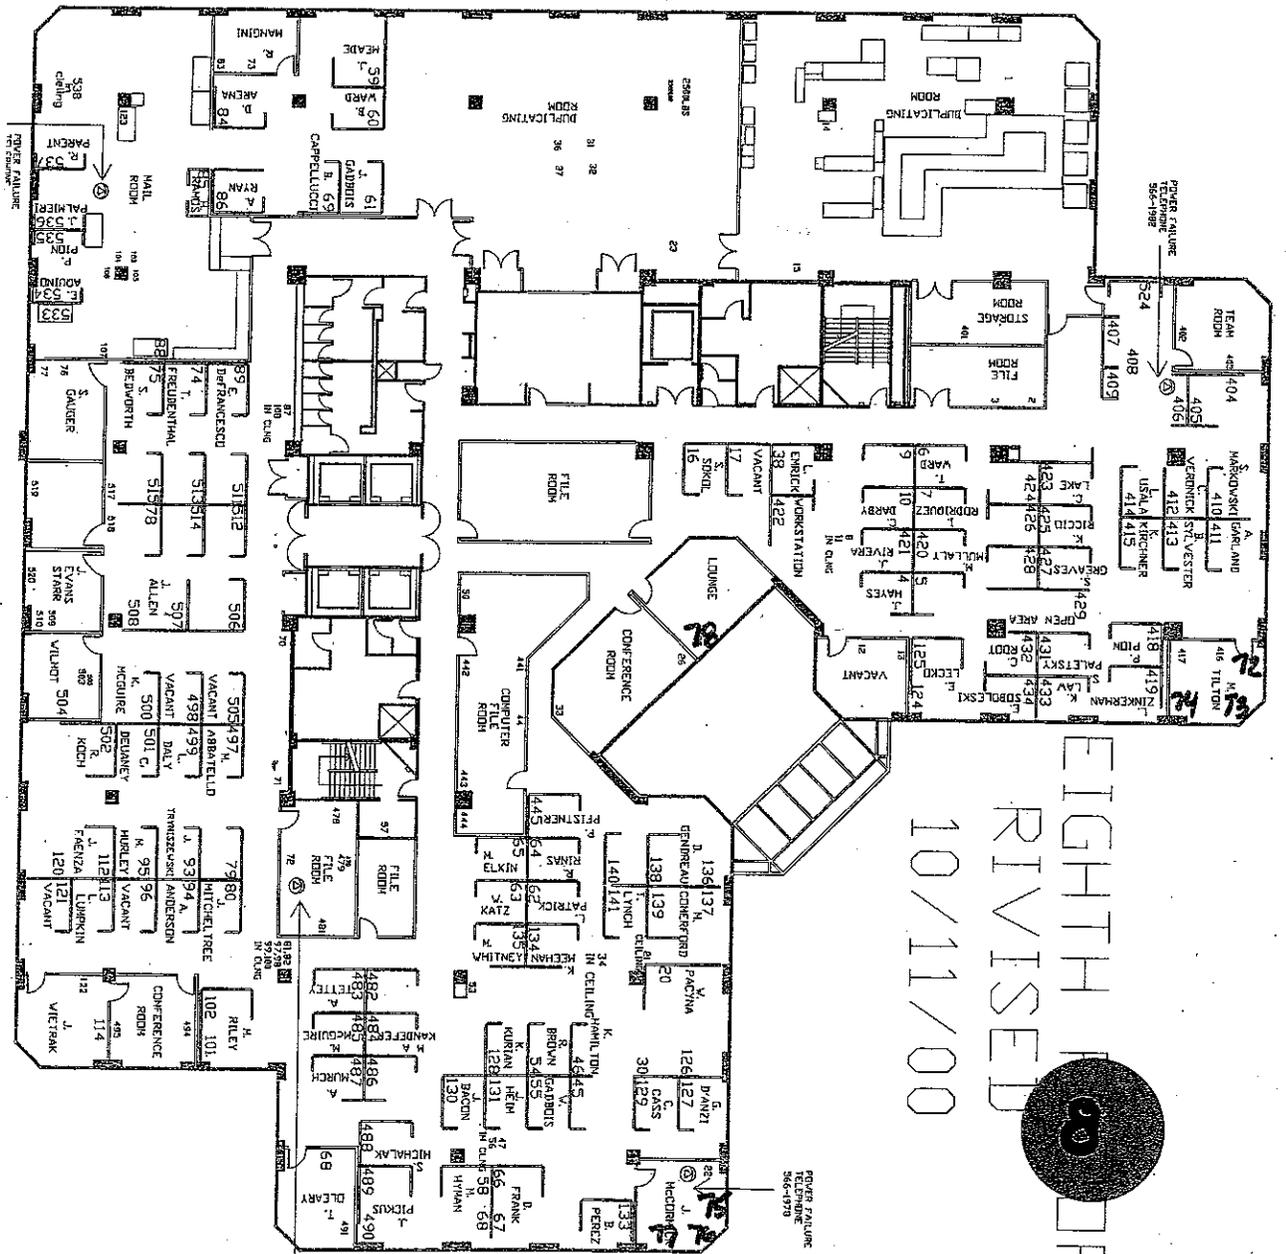
EIGHTH FLOOR

LOCATION 72B: This is taken at the left window wall by room 804. Light water staining found on cardboard.

LOCATION 73B: This is taken at the center window wall of room 804. Debris found but no contamination was found.

LOCATION 74B: This is taken at the right window wall of room 804. No contamination was found.

LOCATION 75B: This is taken at the left window wall of room 818 (S. McCormick). Water staining found.

LOCATION 76B: This is taken at the center window wall of room 818. No contamination was found.

LOCATION 77B: This is taken at the right window wall of room 818. No contamination was found.

LOCATION 78B: This is taken at the right window wall of room 802 (Lounge). No contamination was found.

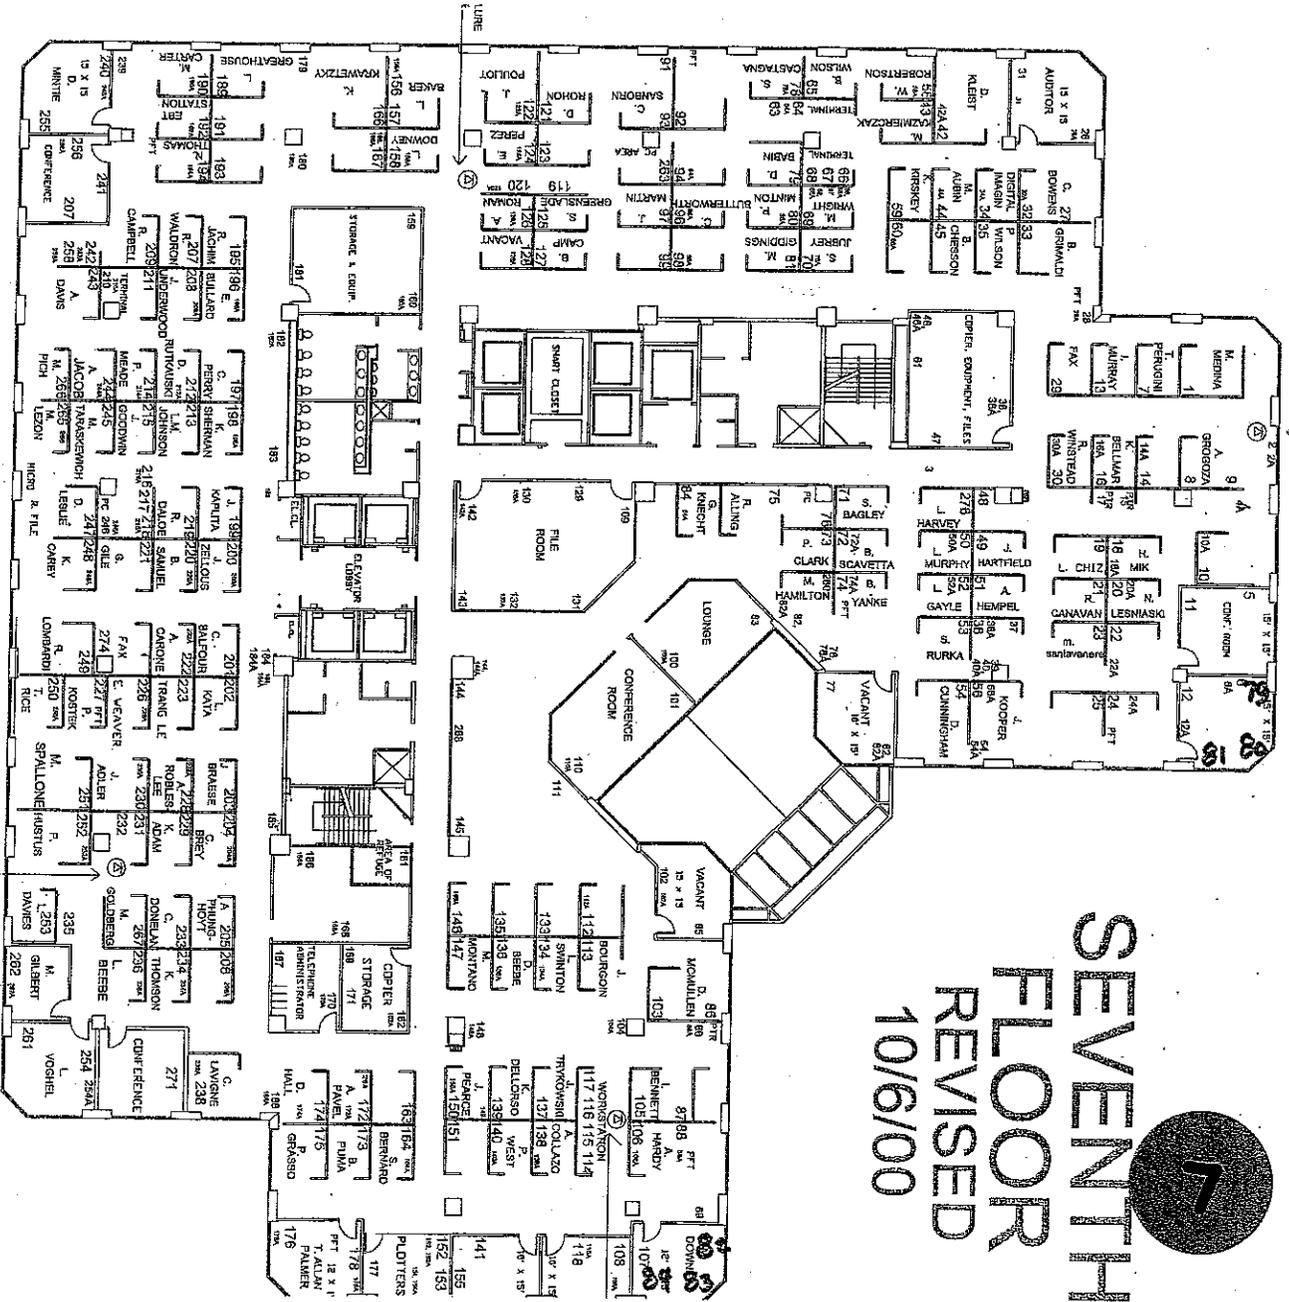
# SEVENTH FLOOR

LOCATION 79B: This is taken at the left window wall by room 704. No contamination found.

LOCATION 80B: This is taken at the center window wall of room 704. No contamination was found.

LOCATION 81B: This is taken at the right window wall of room 704. No contamination was found.

LOCATION 82B: This is taken at the left window wall by room 720. No contamination found.

LOCATION 83B: This is taken at the center window wall of room 720. No contamination was found.

LOCATION 84B: This is taken at the right window wall of room 720. No contamination was found.
