**NATIONAL INSTITUTE FOR  
OCCUPATIONAL SAFETY AND HEALTH**

**ENVIRONMENTAL AND MECHANICAL  
SYSTEM ASSESSMENTS**

**25 SIGOURNEY STREET, HARTFORD, CT**

**EH&E Report #11767**  
**May 5, 2004**

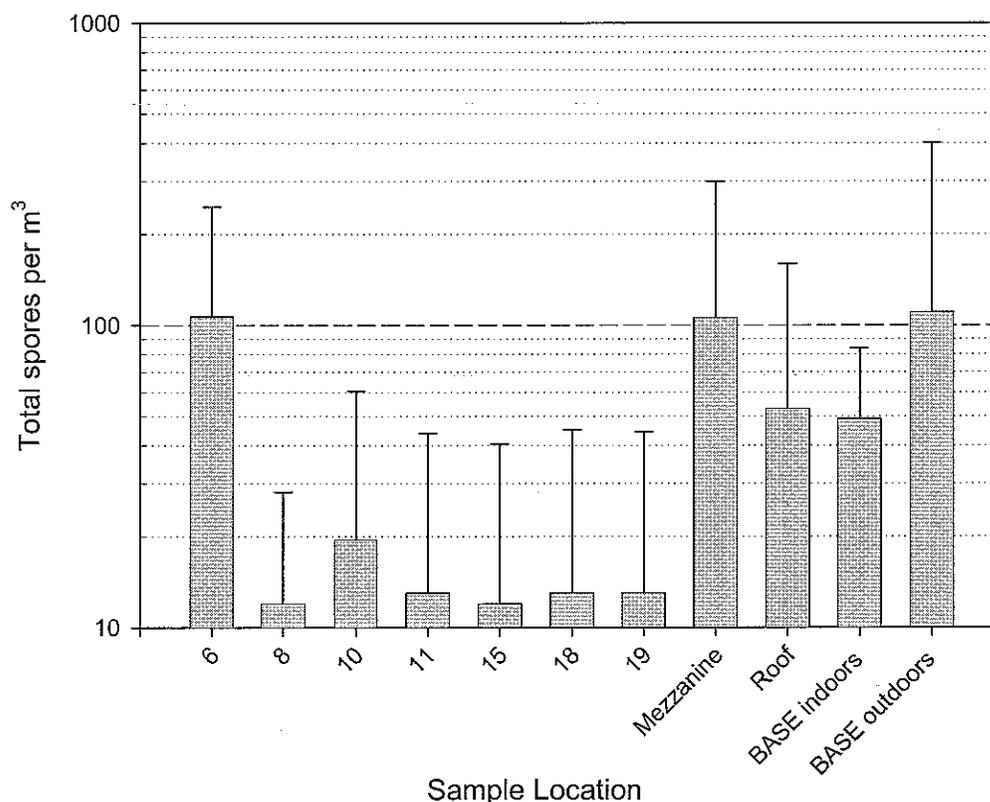
**Figure 3.1** Median Total Spore Concentrations by Floor—March 2003

The results indicated that, overall, the indoor spore concentrations on all floors of the building were low and in the range observed in non-complaint buildings. Indoor concentrations were less than 20% of the values for corresponding outdoor concentrations, except on the sixth floor. Possible reasons for the elevated level on the

sixth floor have not yet been determined. The types of spores identified in the indoor samples were the same as those identified in the outdoor samples, which indicated that no unusual sources of fungal growth were present in the indoor environment. The identified spore types primarily included *Penicillium/Aspergillus*, *Cladosporium*, basidiospores, and other small brown types of spores. All of these spore types are commonly found in air samples collected from indoor and outdoor environments. As shown in Figure 3.1, the measured indoor total spore concentrations were similar to levels measured by EH&E for the EPA in its BASE study of buildings located throughout the United States.

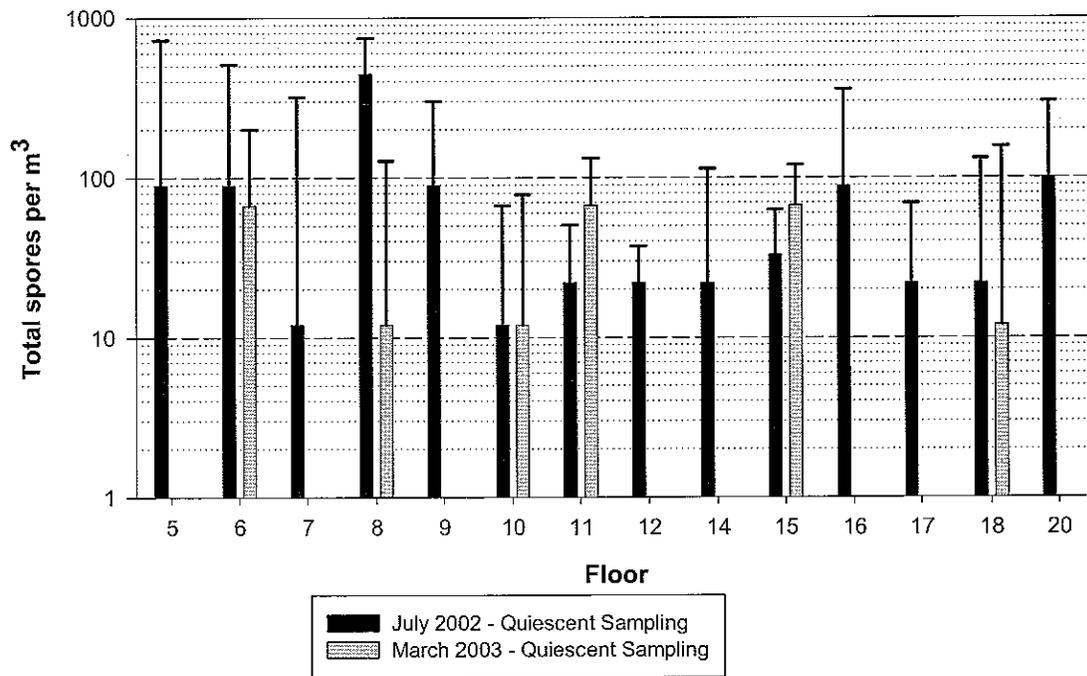
**Figure 3.3** Wall Cavity Sampling—July 2002 and March 2003

One objective for comparison of these data was to determine whether conditions had changed in the wall cavities between the July 2002 and March 2003 sampling periods. The results indicated no statistically significant differences in the results between the two sampling periods. This suggests that conditions in the wall cavities related to possible reservoirs of fungal growth had not changed substantially between the two time periods.

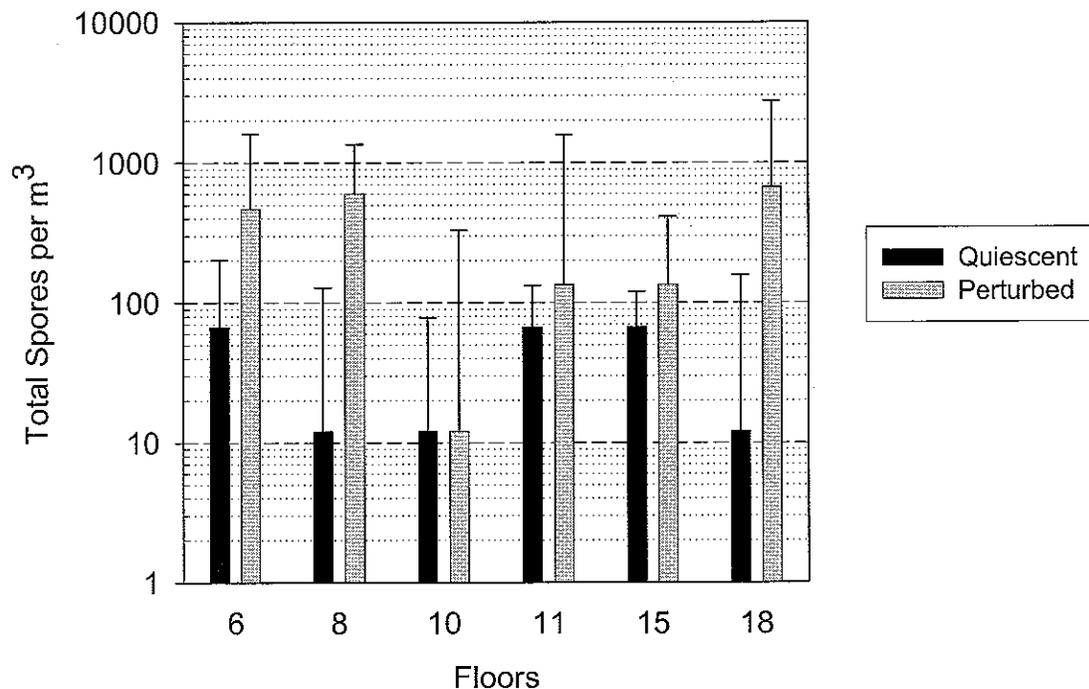
**Figure 3.4** Wall Cavity Sampling—March 2003 Perturbed and Quiescent

Qualitatively, sampling of the wall cavities following perturbation yielded higher total spore concentrations than quiescent sampling. EH&E is in the process of conducting a careful quantitative analysis of the data to support interpretation of these results.

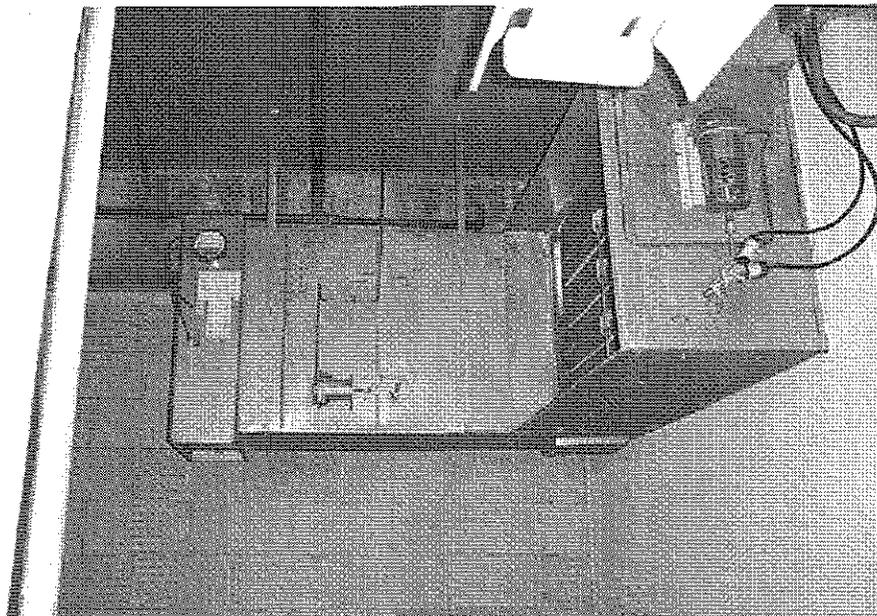
The air handling units were inspected inside and observed to have clean coils, clean linings, etc. According to building management, the systems had been recently cleaned. The units had been fitted with filters that fit in their racks in a manner that minimized the amount of air bypass that normally occurs in normal HVAC equipment.

**Figure 4.2** Photo of Outdoor Air Flow Measurement and Control Station Installed in a Typical Mechanical Room (DCP\_0115.JPG)

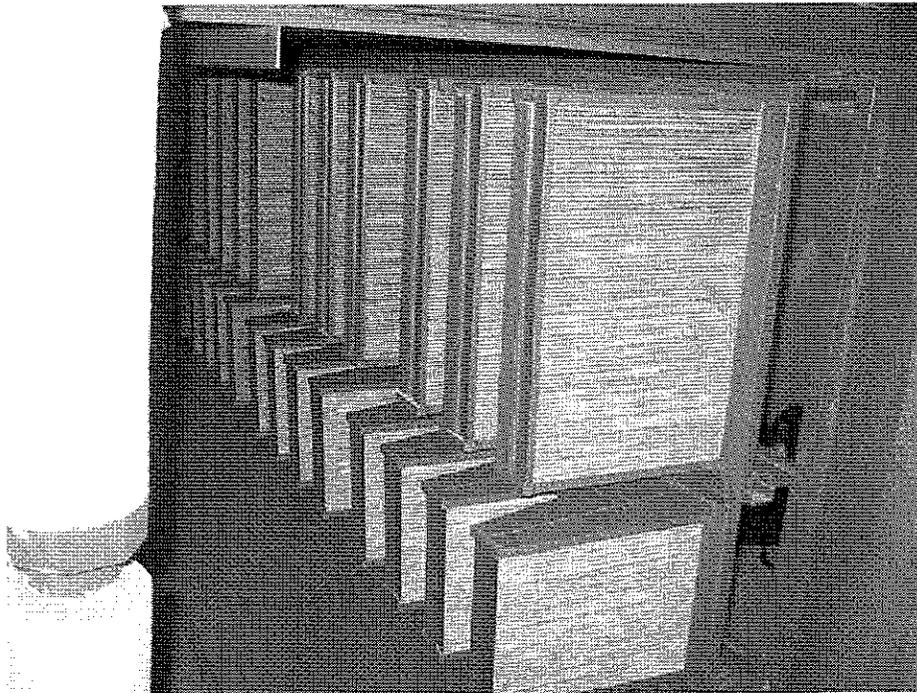
**Figure 4.3** Photo of Typical Filter Installation in an Air Handling Unit (0109-0939\_IMG.JPG)

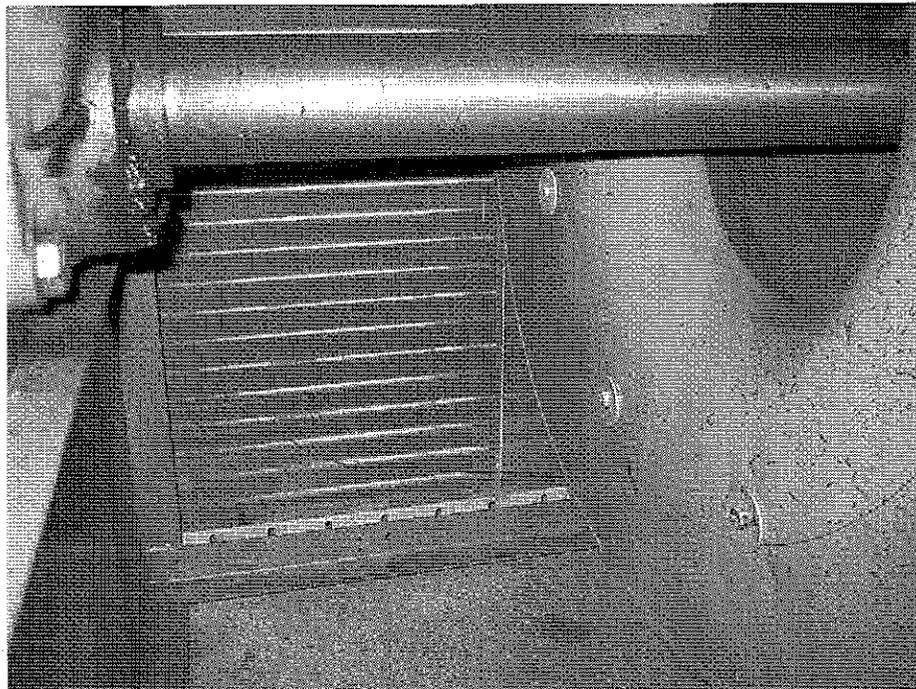
**Figure 4.4** Photo Inside a Typical Air Handling Unit, Showing the Cleanliness of the Coils, Fan, and Bottom of the Drain Pan (109-0936\_IMG.JPG)

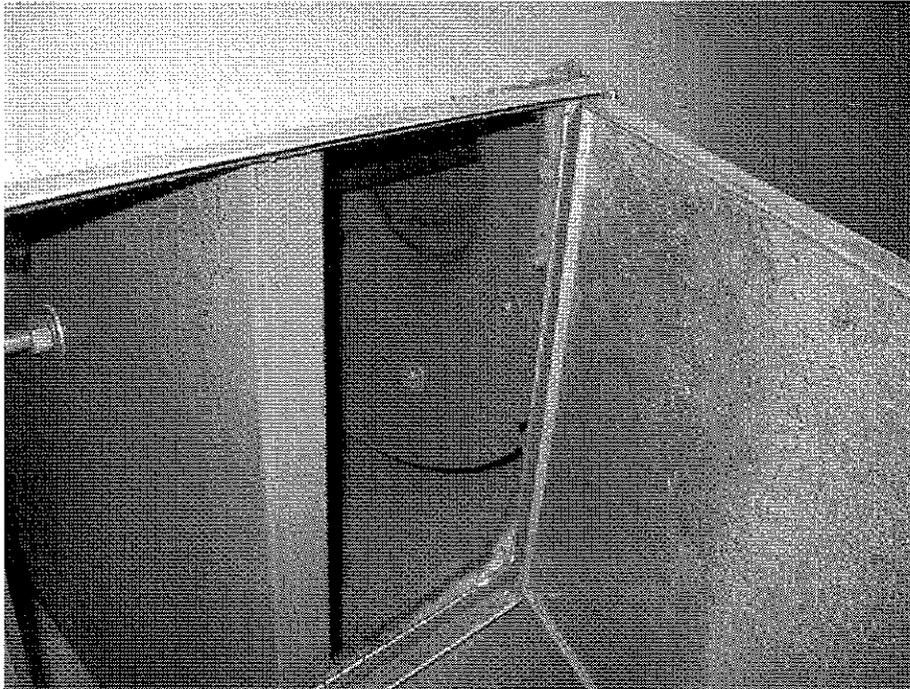
**Figure 4.5** Photo of Cleaning and Inspection Access Panel in Typical Air Handling Unit (109-0948\_IMG.JPG)

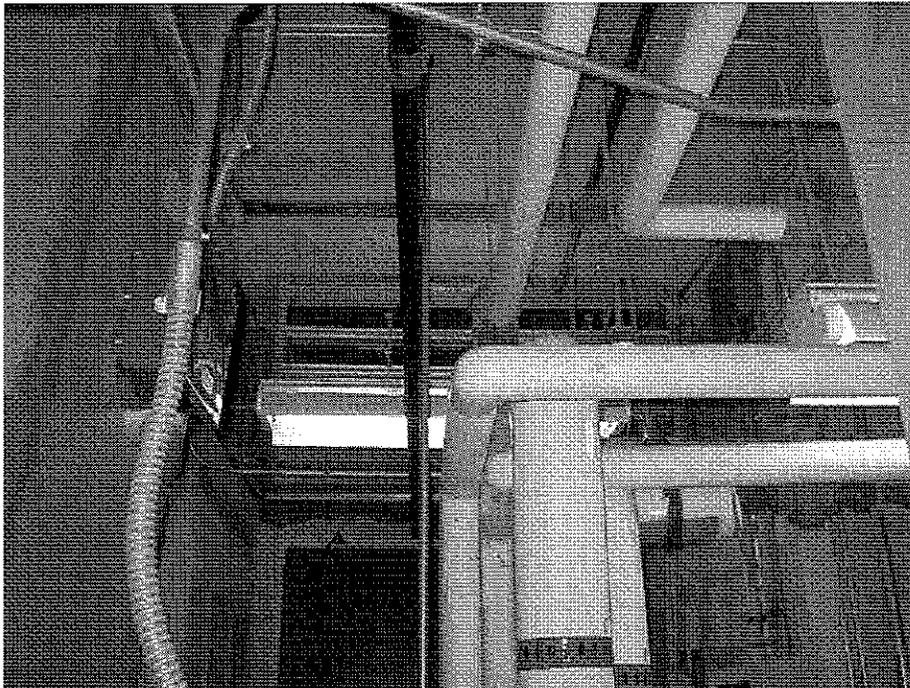
**Figure 4.6** Photo of Return Air Inlet into a Typical Mechanical Room (109-0940\_IMG.JPG)
