# IAQ EVALUATION

**Initial Wall Cavity Evaluation  
17<sup>th</sup>, 18<sup>th</sup>, & 19<sup>th</sup> Floors  
Tunxis Management Company  
25 Sigourney Street  
Hartford, Connecticut**

APRIL 25, 2000

**SUBJECT: Report on Initial IAQ Evaluation  
Tunxis Management Company  
Hartford, Connecticut  
TBS # 2335-01, 2335-02, & 2335-03**

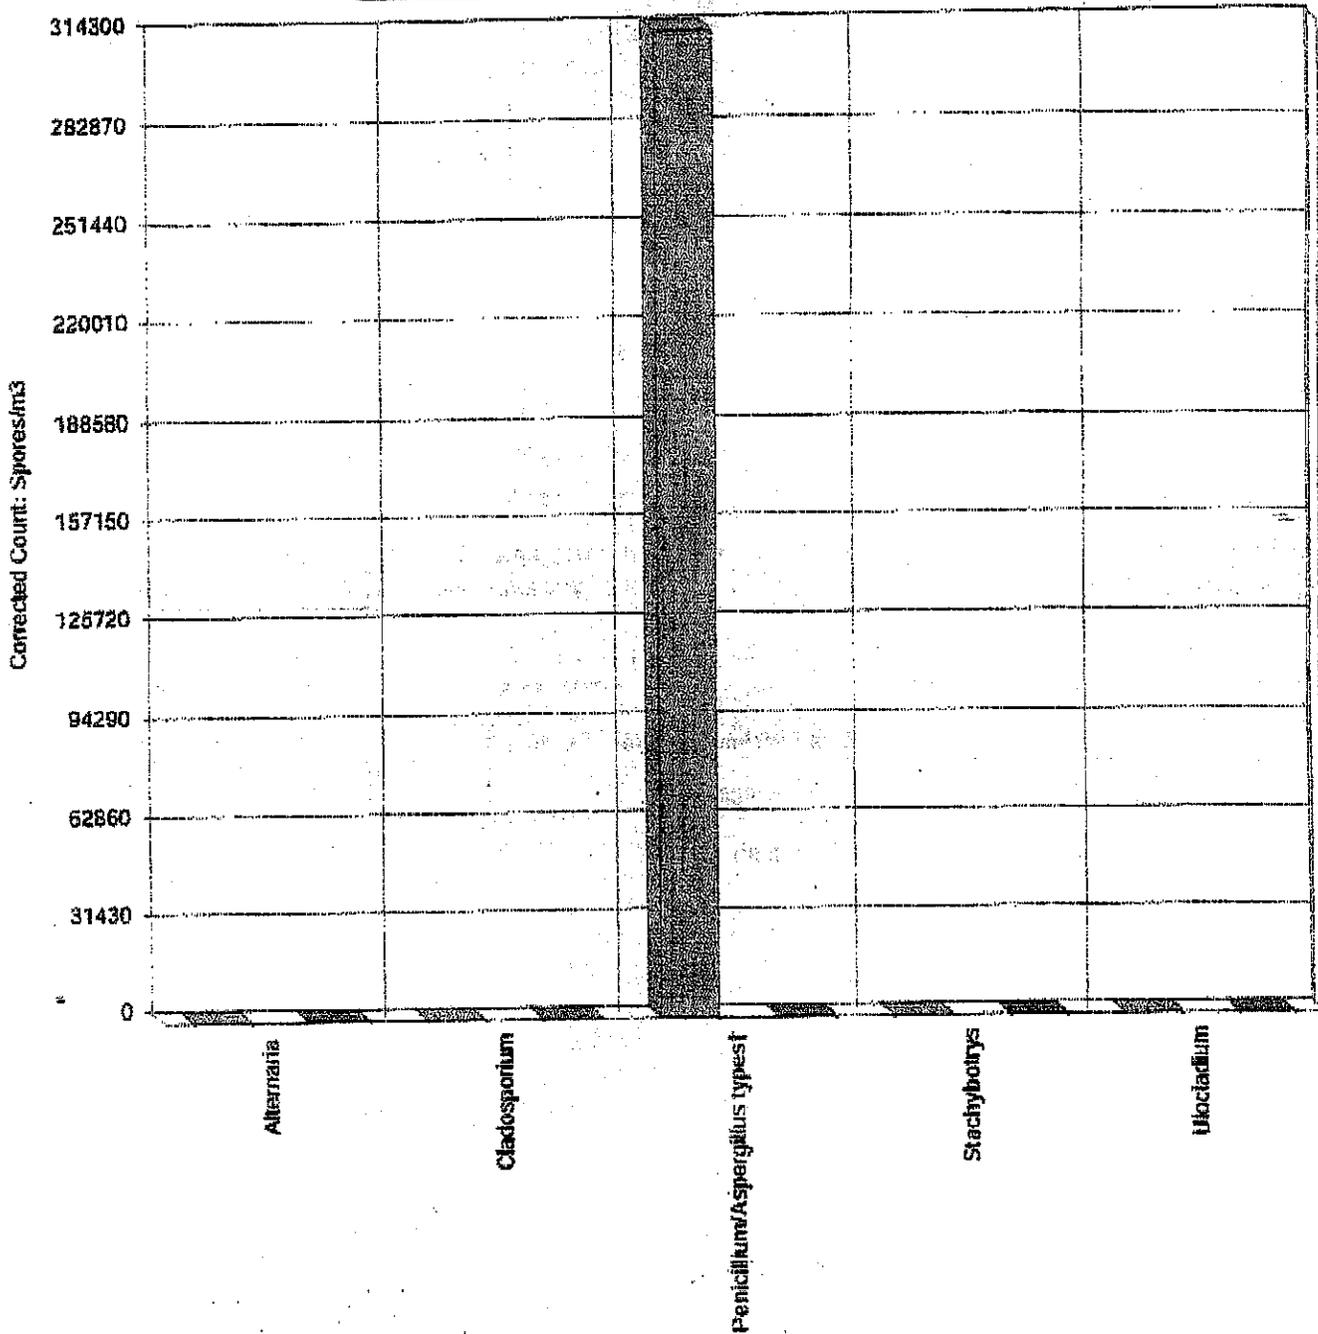
■	WS-1-2331: 19th floor, room 1937, base
□	WS-2-2331: 19th floor, room 1937, 30" high
■	WS-3-2331: 19th floor, room 1937, 46" high

Location:	WS-1-2331: 19th floor, room 1937, base		WS-2-2331: 19th floor, room 1937, 30" high		WS-3-2331: 19th floor, room 1937, 46" high	
	None		None		None	
Comments (see below)	raw ct.	spores/m3	raw ct.	spores/m3	raw ct.	spores/m3
Alternaria					1	22
Arthrinium						
Ascomspores*						
Aureobasidium pullulans						
Basidiospores*						
Botrytis						
Chaetomium			6	133		
Cladosporium						
Curvularia						
Drechslera/Bipolaris group						
Epicoccum						
Fusarium						
Myrothecium						
Nigrospora						
Other colorless						
Penicillium/Aspergillus types†	14,140	314,222			8	178
Pithomyces						
Rusts*						
Smuts*, Periconia, Myxomycetes*						
Stachybotrys	6	133	3	67	1	22
Stemphylium						
Torula herbarum						
Ulocladium	2	44				
Unknown						
Zygomycetes (possible)						
Background debris (1-4+)††	>> 4+		4+		4+	
Sample volume (liters)	45		45		45	
<b>TOTAL SPORES/M3</b>		<b>314,399</b>		<b>200</b>		<b>222</b>

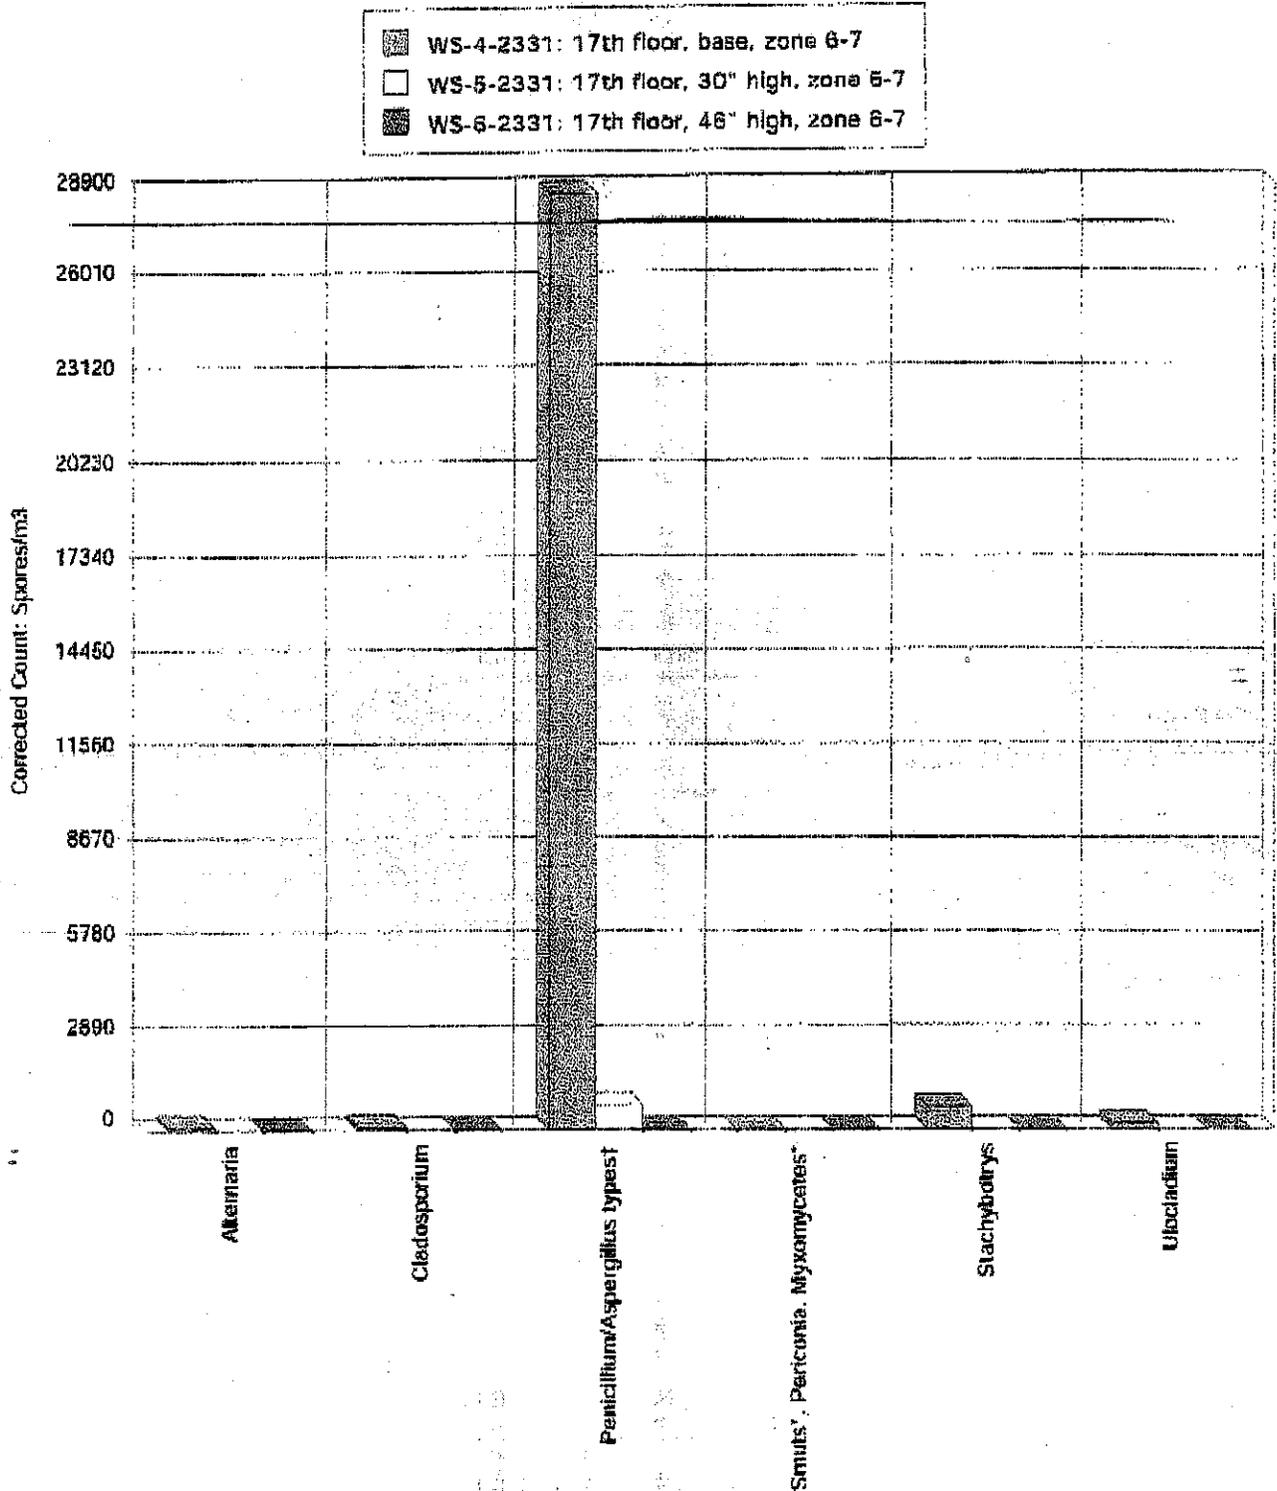
Location:	WS-4-2331:		WS-5-2331:		WS-6-2331:	
	17th floor, base, zone 6-7		17th floor, 30" high, zone 6-7		17th floor, 46" high, zone 6-7	
Comments (see below)	None		None		None	
	raw ct.	spores/m <sup>3</sup>	raw ct.	spores/m <sup>3</sup>	raw ct.	spores/m <sup>3</sup>
Alternaria	4	89				
Arthrinium						
Ascospores*						
Aureobasidium pullulans						
Basidiospores*						
Botrytis						
Chaetomium						
Cladosporium	4	89	1	22		
Curvularia						
Drechslera/Bipolaris group						
Epicoccum						
Fusarium						
Myrothecium						
Nigrospora						
Other colorless						
Penicillium/Aspergillus types†	1,296	28,800	36	800		
Pithomyces						
Rusts*						
Smuts*, Periconia, Myxomycetes*	2	44				
Stachybotrys	31	689				
Stemphylium						
Torula herbarum						
Ulocladium	10	222				
Unknown						
Zygomycetes (possible)						
Background debris (1-4+)††	> 4+		> 4+		> 4+	
Sample volume (liters)	45		45		45	
<b>TOTAL SPORES/M<sup>3</sup></b>		<b>29,933</b>		<b>822</b>		<b>&lt; 22</b>

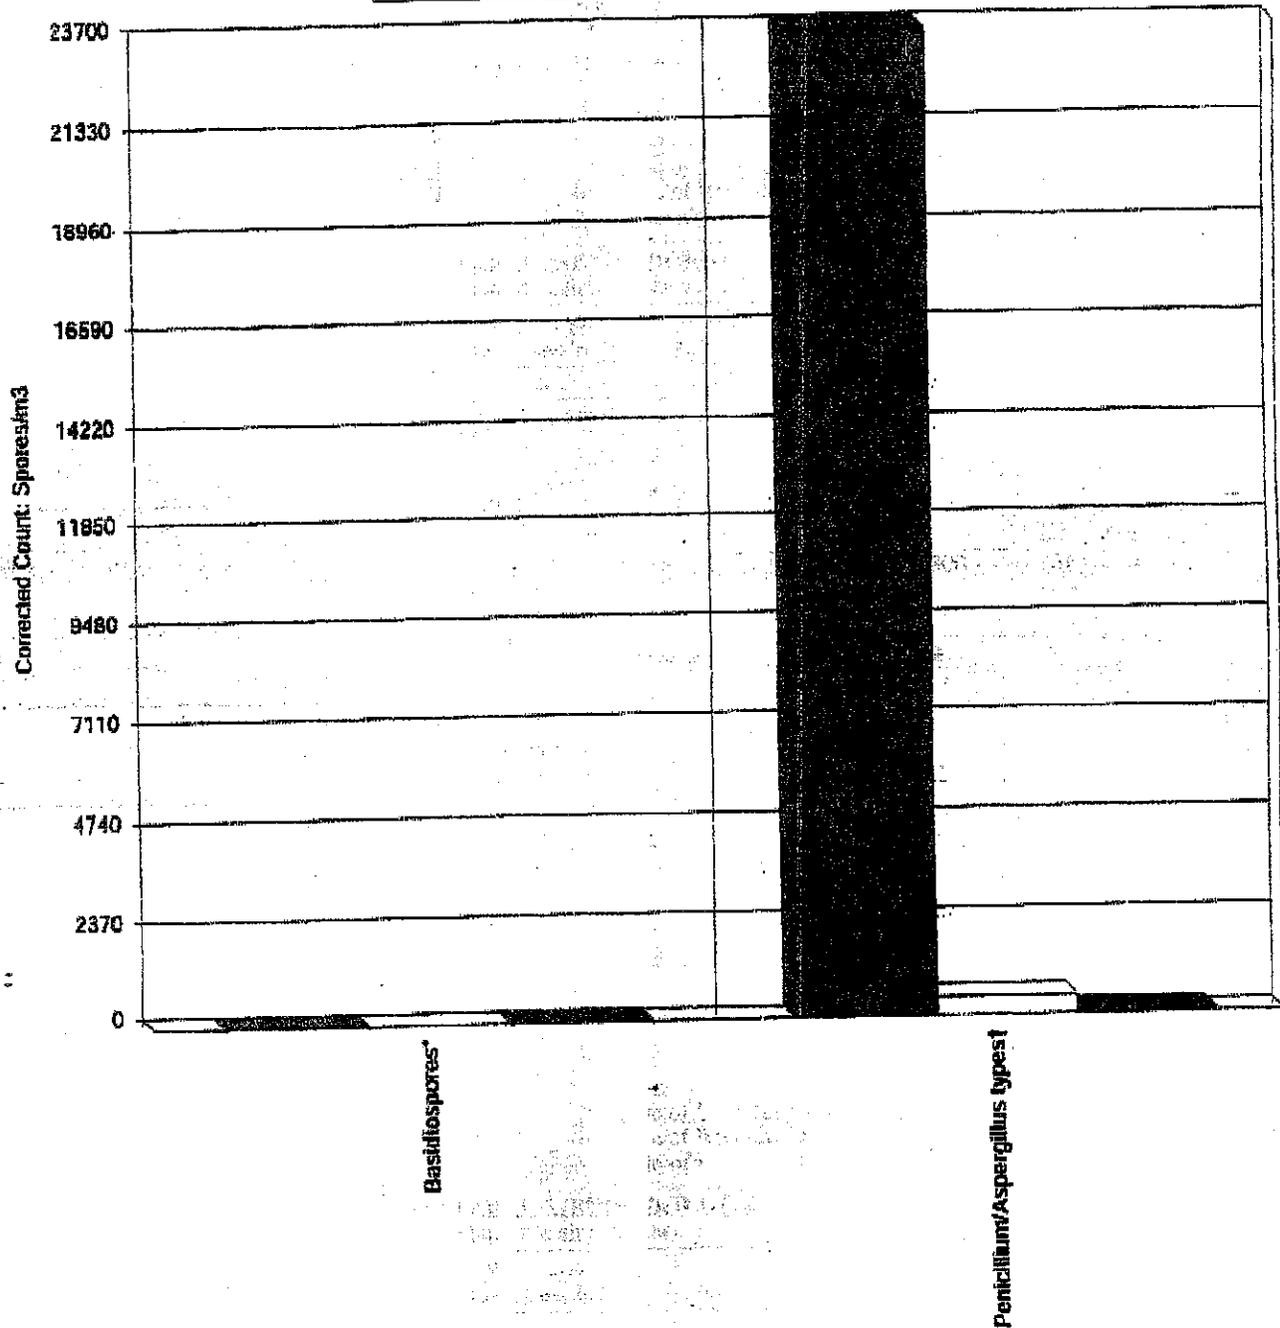
- WS-7-2331: 17th floor, zone 4, base
- WS-8-2331: 17th floor, zone 4, 30" high
- WS-9-2331: 17th floor, zone 4, 48" high

Location:	WS-7-2331: 17th floor, zone 4, base		WS-8-2331: 17th floor, zone 4, 30" high		WS-9-2331: 17th floor, zone 4, 48" high	
	None		None		None	
Comments (see below)	raw ct.	spores/m <sup>3</sup>	raw ct.	spores/m <sup>3</sup>	raw ct.	spores/m <sup>3</sup>
Alternaria						
Arthrinium						
Ascospores*						
Aureobasidium pullulans						
Basidiospores*					1	22
Botrytis						
Chaetomium						
Cladosporium						
Curvularia						
Drechslera/Bipolaris group						
Epicoccum						
Fusarium						
Myrothecium						
Nigrospora						
Other colorless						
Penicillium/Aspergillus types†	1,064	23,644	20	444	4	89
Pithomyces						
Rusts*						
Smuts*, Periconia, Myxomycetes*						
Stachybotrys						
Stemphylium						
Torula herbarum						
Ulocladium						
Unknown						
Zygomycetes (possible)						
Background debris (1-4+)††	> 4+		> 4+		> 4+	
Sample volume (liters)	45		45		45	
<b>TOTAL SPORES/M<sup>3</sup></b>		<b>23,644</b>		<b>444</b>		<b>111</b>

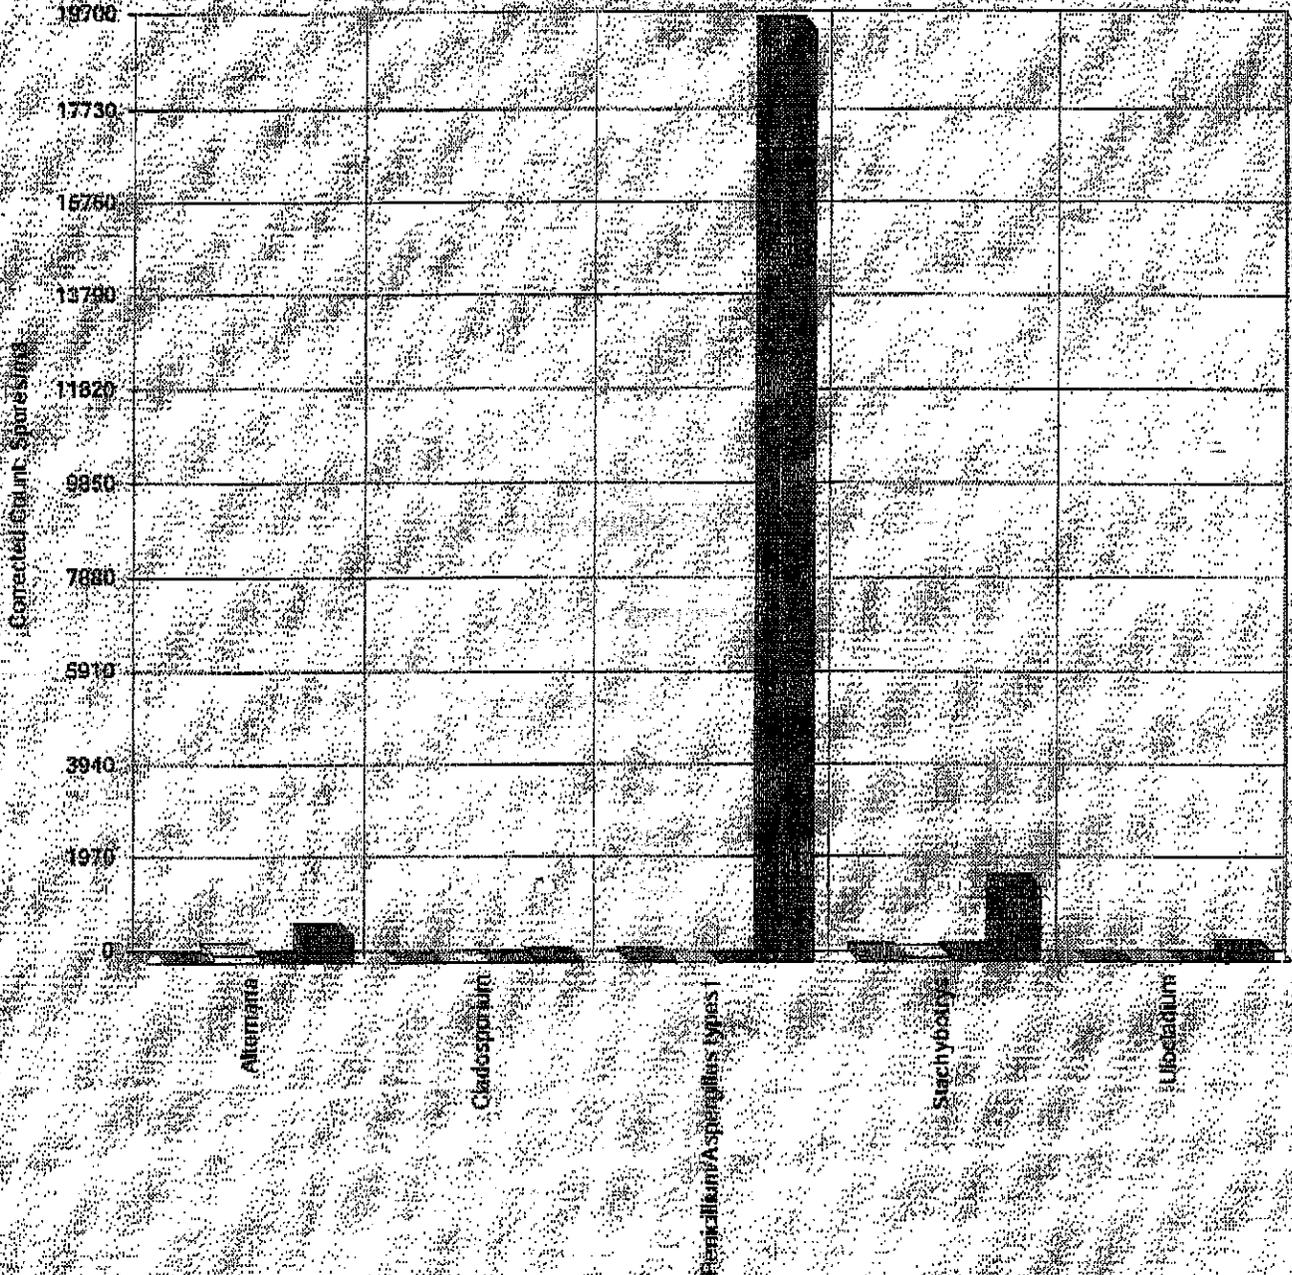
- WS-10-2331: 19th floor, zone 1, room 1914, base
- WS-11-2331: 19th floor, zone 1, room 1914, 30" high
- WS-12-2331: 19th floor, zone 1, room 1914, 60" high
- WS-13-2331: 19th floor, zone 1, room 1914, 72" high

Location:	WS-10-2331: 19th floor, zone 1, room 1914, base		WS-11-2331: 19th floor, zone 1, room 1914, 30" high		WS-12-2331: 19th floor, zone 1, room 1914, 60" high		WS-13-2331: 19th floor, zone 1, room 1914, 72" high	
	None		None		None		None	
Comments (see below)	raw ct.	spores/m <sup>3</sup>	raw ct.	spores/m <sup>3</sup>	raw ct.	spores/m <sup>3</sup>	raw ct.	spores/m <sup>3</sup>
Alternaria	1	22	8	178	2	44	27	600
Arthrinium								
Ascospores*								
Aureobasidium pullulans								
Basidiospores*								
Botrytis								
Chaetomium								
Cladosporium							4	89
Curvularia								
Drechslera/Bipolaris group								
Epicoccum								
Fusarium								
Myrothecium								
Nigrospora								
Other colorless								
Penicillium/Aspergillus types†	4	89					884	19,644
Pitheomyces								
Rusts*								
Smuts*, Periconia, Myxomycetes**								
Stachybotrys	9	200	6	133	9	200	72	1,600
Stemphylium								
Torula herbarum

Ulocladium	2	44	1	22	1	22	10	222
Unknown								
Zygomycetes (possible)								
Background debris (1-4+)††	> 4+		> 4+		4+		> 4+	
Sample volume (liters)	45		45		45		45	
<b>TOTAL SPORES/M<sup>3</sup></b>		<b>355</b>		<b>333</b>		<b>266</b>		<b>22,155</b>

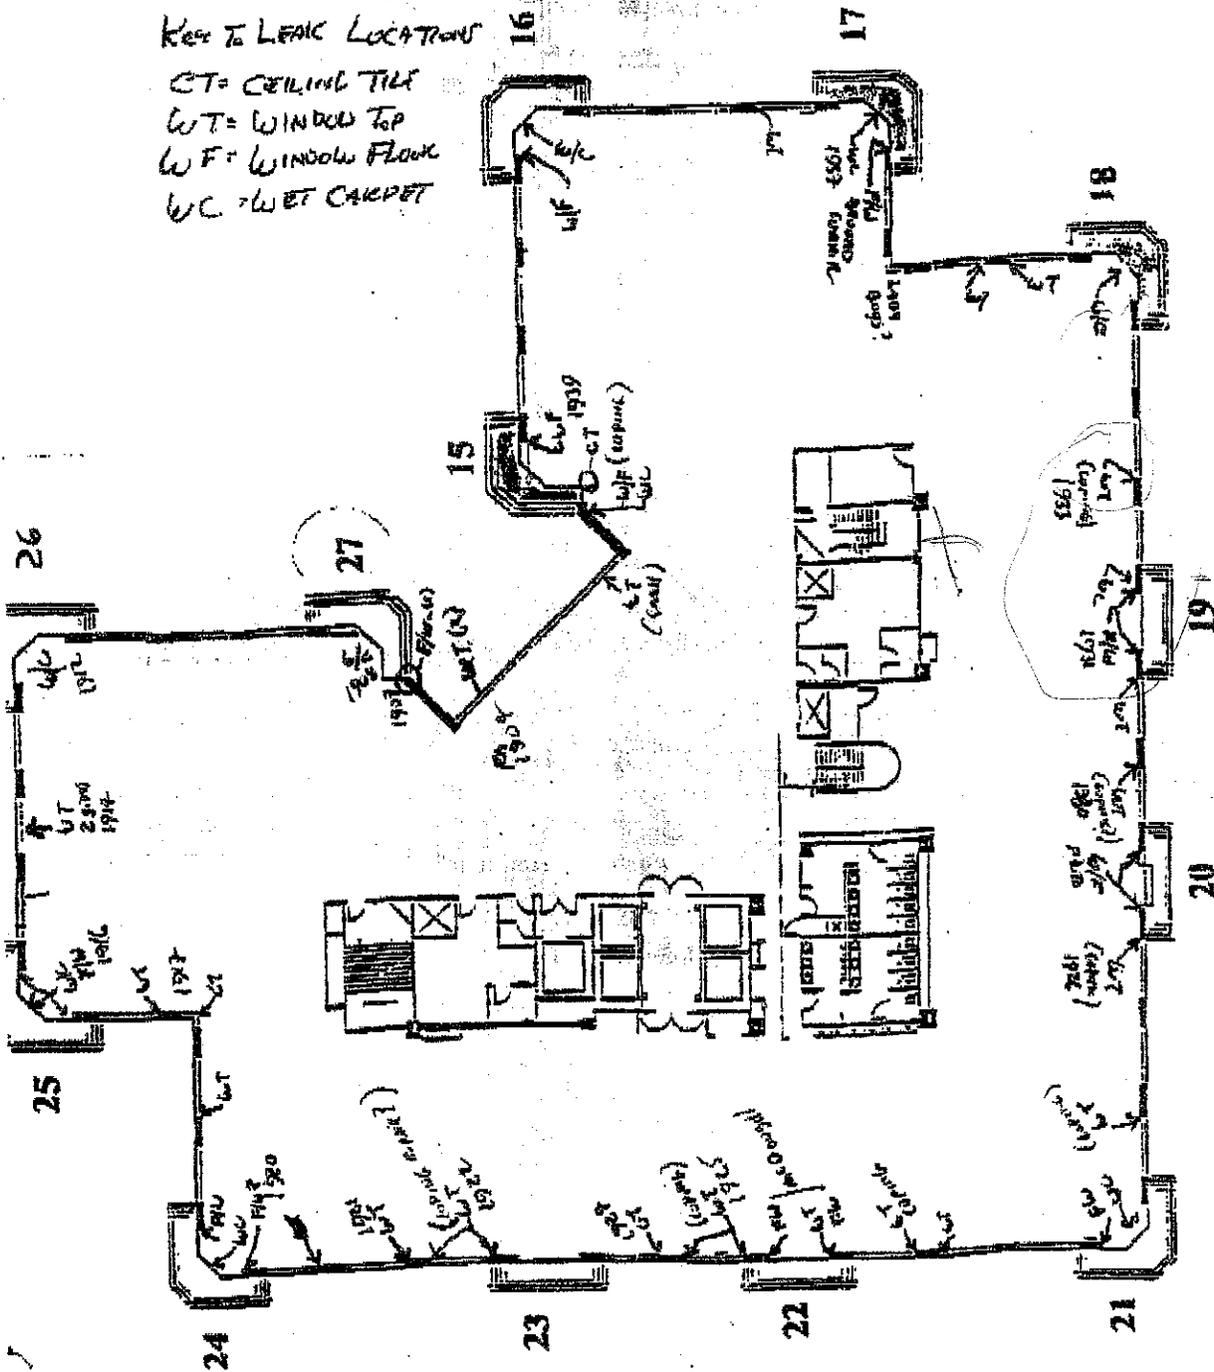
NINETEENTH FLOOR  
OBSERVED 3/29/00

As part of the expanded scope of work, a day was devoted to observations of the complete perimeter of the 17<sup>th</sup>, 18<sup>th</sup>, and 19<sup>th</sup> floors. The building engineer accompanied me and we mapped all known and observed leakage sites. We located areas where we observed signs of past water damage on floor plans (see appendix B).

We recommend that all known water leaks be repaired and made watertight. Mold growth, likely within the wall cavities and possibly present in the carpet at the perimeter, will continue to grow as long as there is a moisture source. We recommend stopping all leaks as soon as possible and before any mitigation efforts of wall cavities are implemented. It is our understanding that other experts are under contract to stop the remaining known leaks. It is our understanding that, in May of 2000, temporary measures will be implemented to address the remaining leak areas and that, in fiscal year 2001, a permanent repair of the known remaining leaks will be implemented.
