Docket No. 272 – Development and Management Plan Inspection

Segment 2a Inspection

Date: October 6, 2008

Location: Segment 2a – Beseck Switching Station to Cheshire/Hamden Town Line

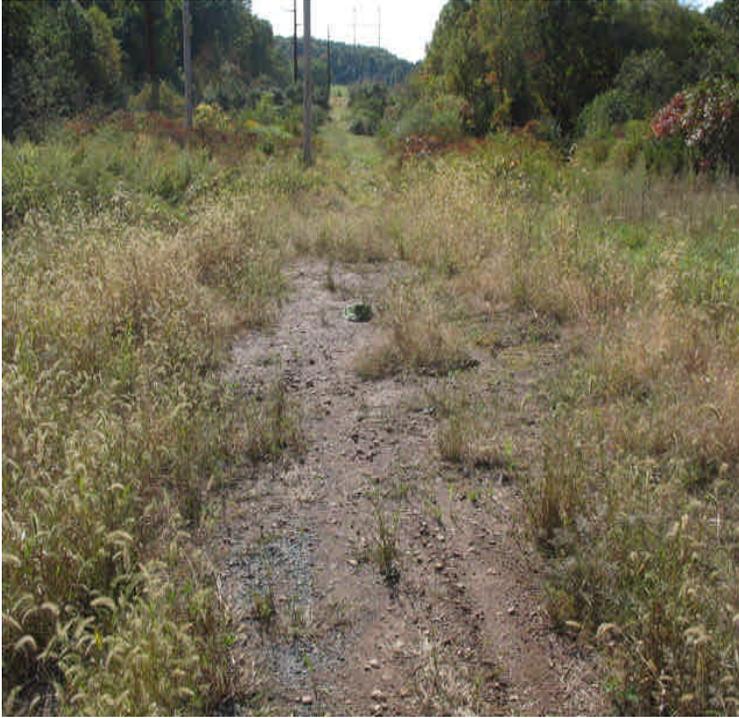
Durham Rd: Small area of upland along the access road remains sparsely vegetated. The wetland and areas immediately adjacent are stable.

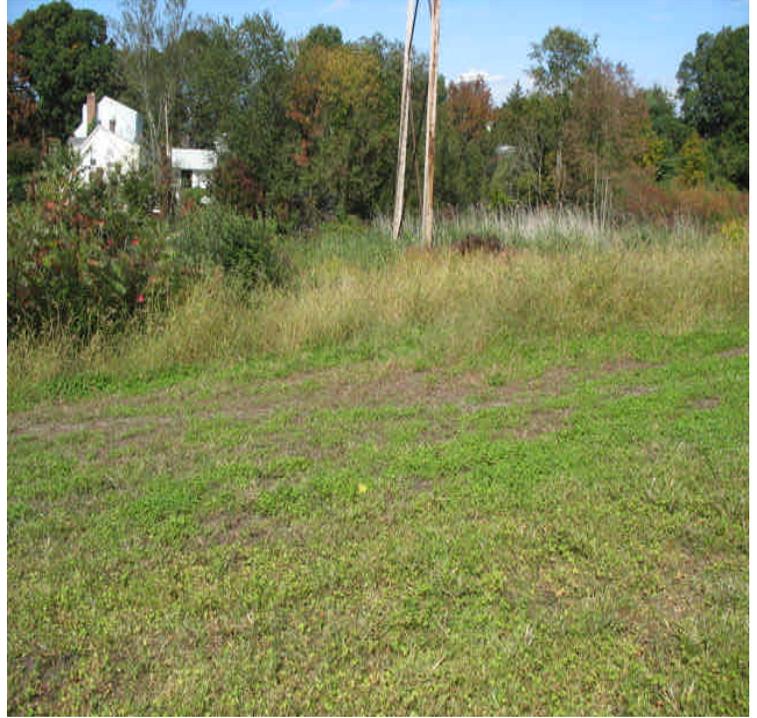
Stony Brook Rd: Small sparse area of vegetation located at the site entrance. It will be evaluated if there is 70% cover overall. It appears to be slowly filling in with grass.

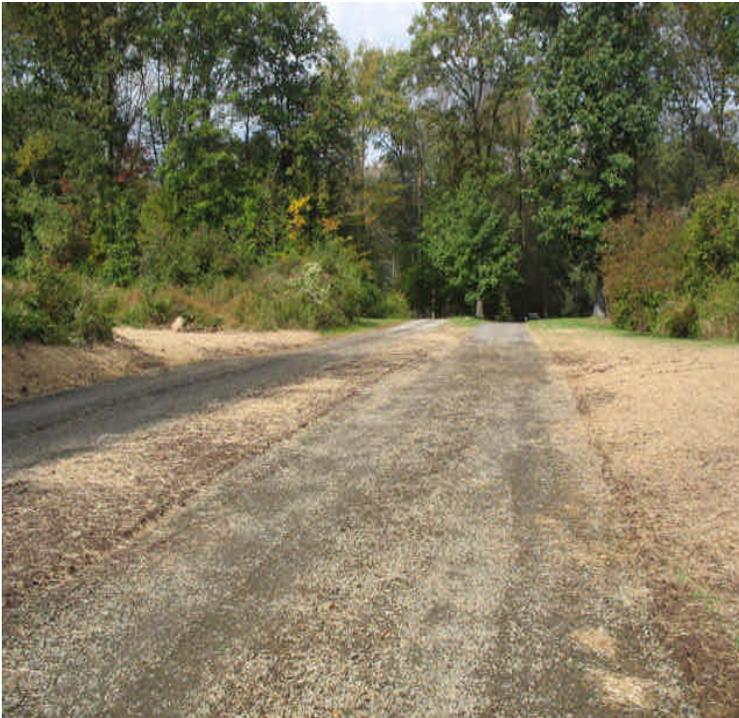
Areas of Inspection	Observation	Recommended Action	Corrected Action
<p>Old Farms Road</p>	<p>Sections of the access road adjacent to driveways and pads were removed, mulched, and seeded. 10/6/08</p> <p>Equipment has damaged the access driveway for overhead work. (Since 1/8) Stone was placed on the access driveway to reduce additional impacts. 10/6/08</p> <p>Following restoration, a new layer of stone dust was placed on the driveway that was originally paved. 10/6/08</p>	<p>Monitor this area until stable. Maintain catch basin controls until upgradient areas are stable. 10/6/08</p> <p>The stone placed on the access driveway should be removed. Evaluate and repair the driveway as needed where damaged. 1/22-10/6/08</p> <p>As indicated since the stone was originally placed, the driveway should be restored to its pre-construction, paved condition. (Unless the homeowner is satisfied with the current status.)</p>	<p>Access road and pad restoration complete. Hay and seed applied.</p> <p>Needs evaluation and attention. Repairs are needed to the access driveway.</p>

Old Farms Rd: Old drainage swale has been removed and seeded during final restoration activities. The previously grass "median" between the two access driveways was also restored. However, the access driveway (on right) was originally a paved driveway. Stone removal is needed and it should be repaved to match pre-construction conditions. (This area has been identified in the report since January)

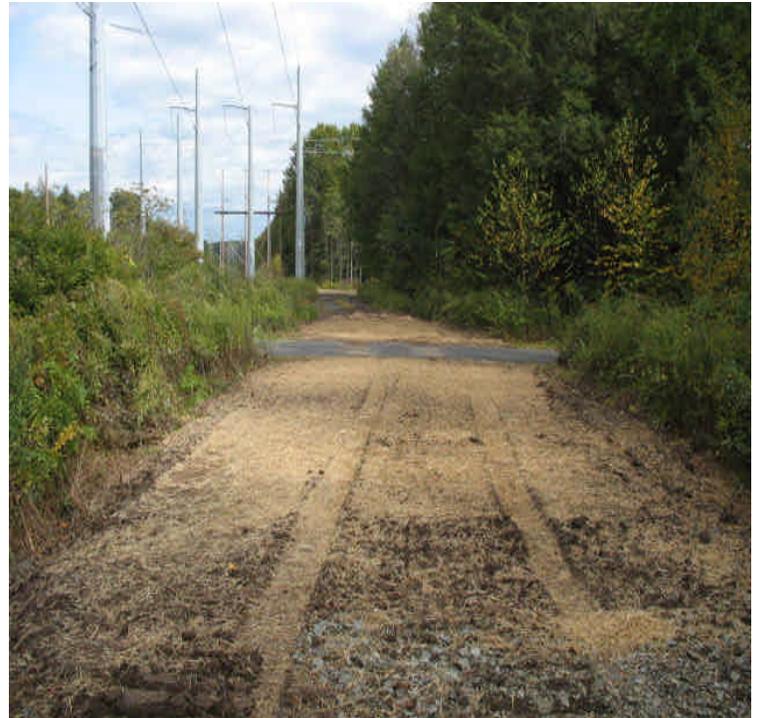
Cook Hill Jct: Final restoration complete. Only the sections of the access road located adjacent to driveway crossings were restored.
