**Docket No. 272 – Development and Management Plan Inspection**

**Beseck Switching Station Inspection**

**Date:** January 2, 2007

**Location:** Beseck Switching Station

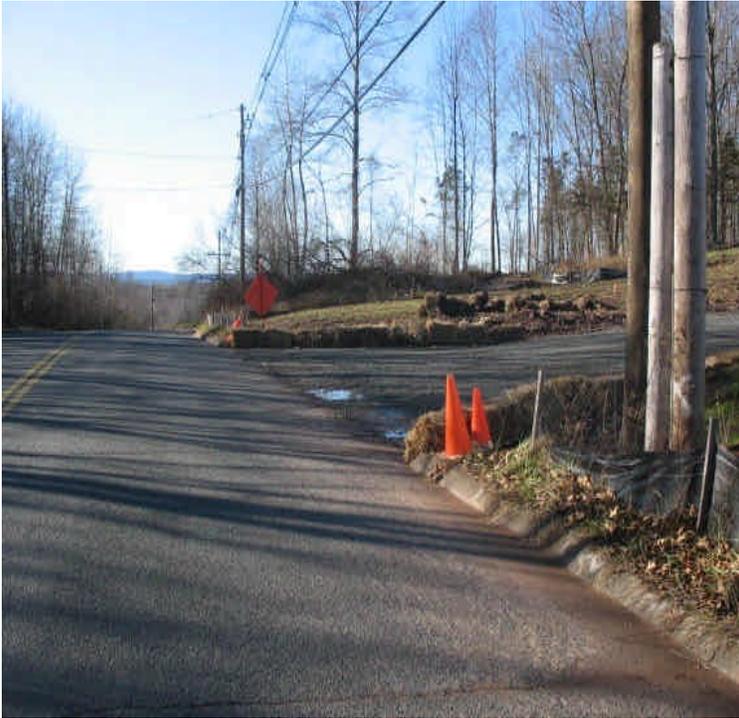
**New entrance off Carpenter Lane is at final grade; erosion controls have been removed. Monitor carefully for run-off.**

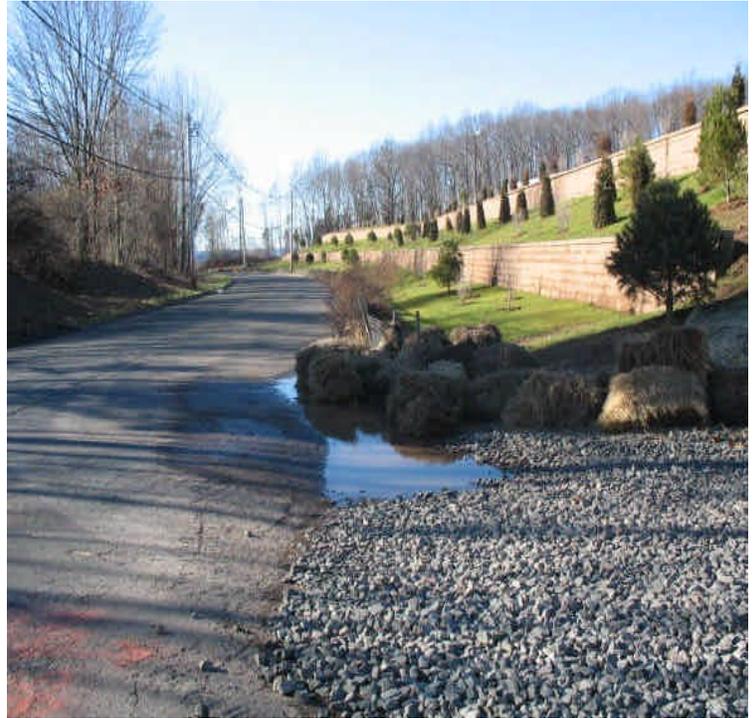
**View of Carpenter Lane and retaining walls. Sediment accumulation was noted in the gutters. Turbid runoff was observed flowing past the controls at the site entrance.**

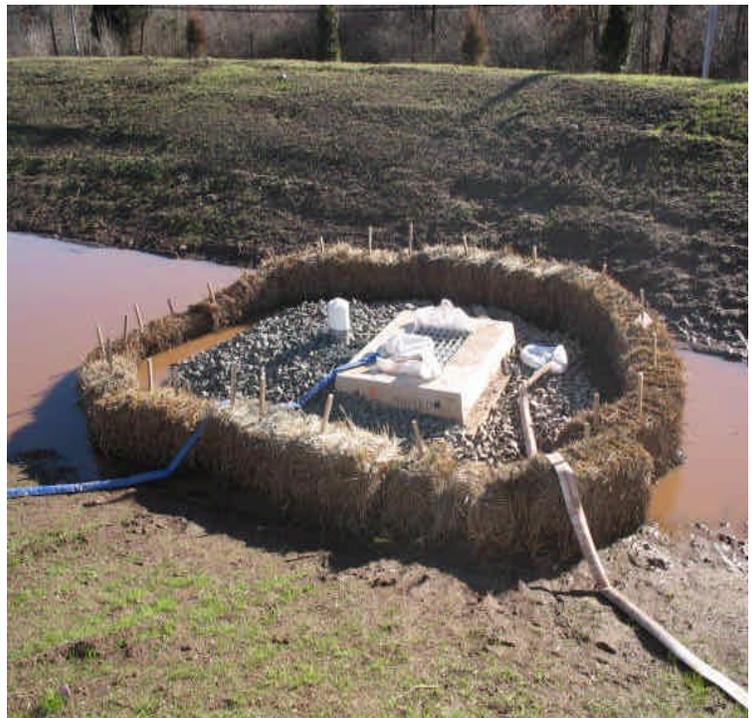
**Additional/alternative controls are still recommended for detention basin inlets. Consider additional filtration/ containment for dewatering discharge. Sandbags were also being used.**

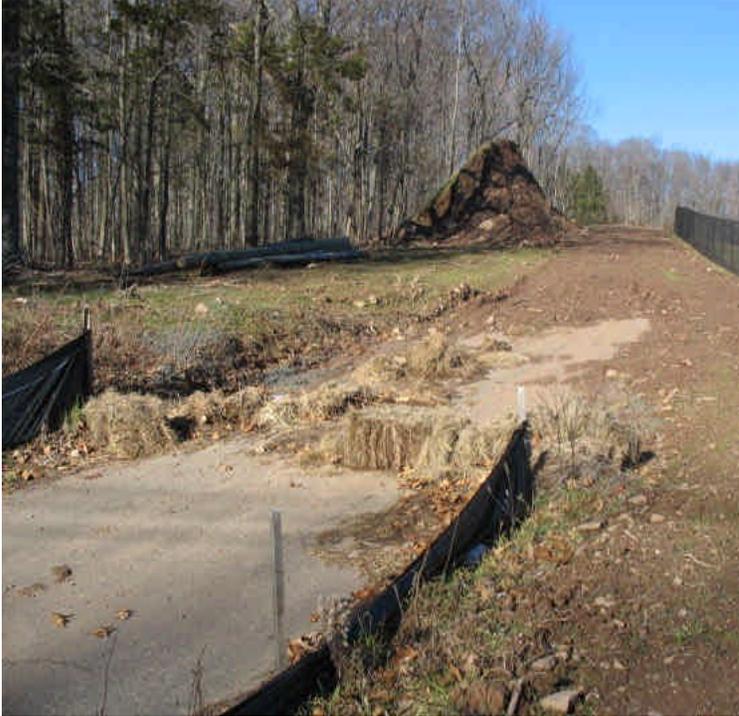
**Replace haybales across the old Zolnik driveway. Adjacent areas have been graded and seeded.**

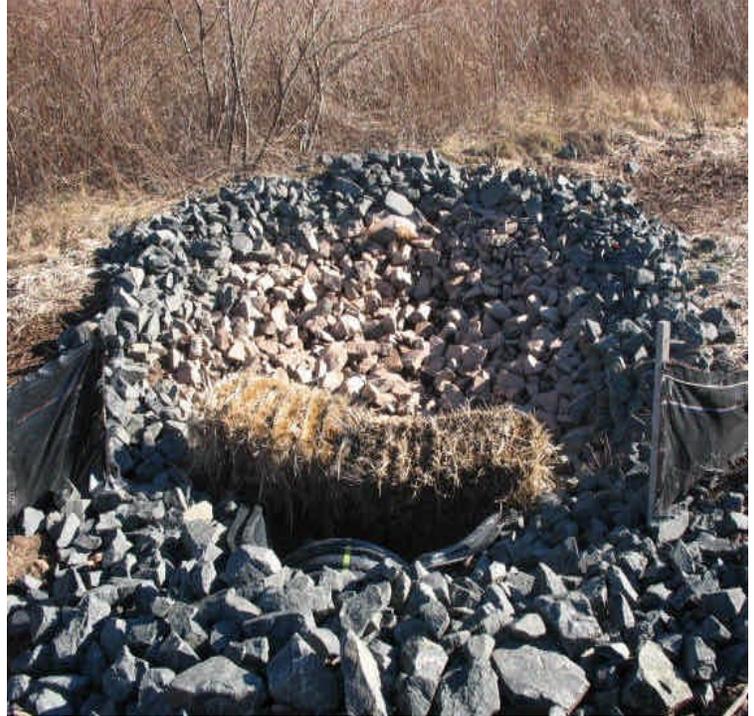
**View of the culvert under the new access road. Minor amount of sediment was noted but appears contained within the trap. Beseck and Seg. 1A contractors are jointly sharing the access road.**

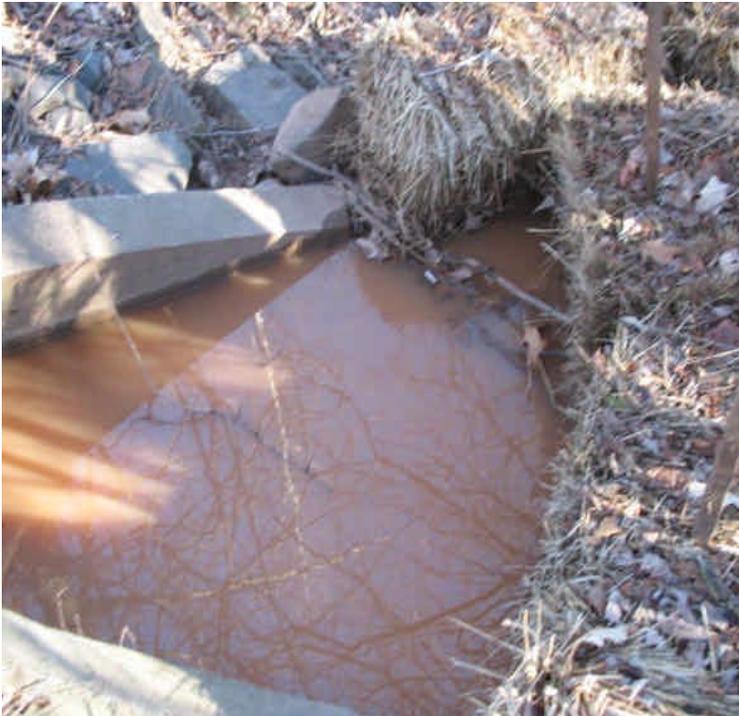
**Storm drain outlet across Carpenter Lane again had turbid water flowing through the outlet pipe and past the degraded haybales into the wetland. New haybales and alternative controls on-site are needed.**

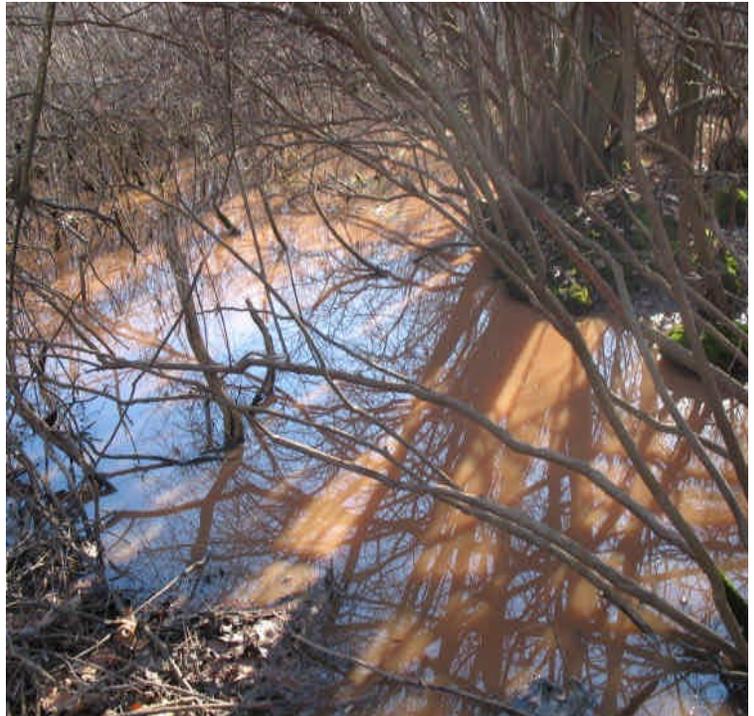
**The wetlands across Carpenter Lane again contain turbid run-off for a second week. Sediment removal may be necessary once the sediment settles out, and the water level subsides.**
