Docket No. 272 – Development and Management Plan Inspection

Beseck Switching Station Inspection

Date: October 23, 2007

Location: Beseck Switching Station

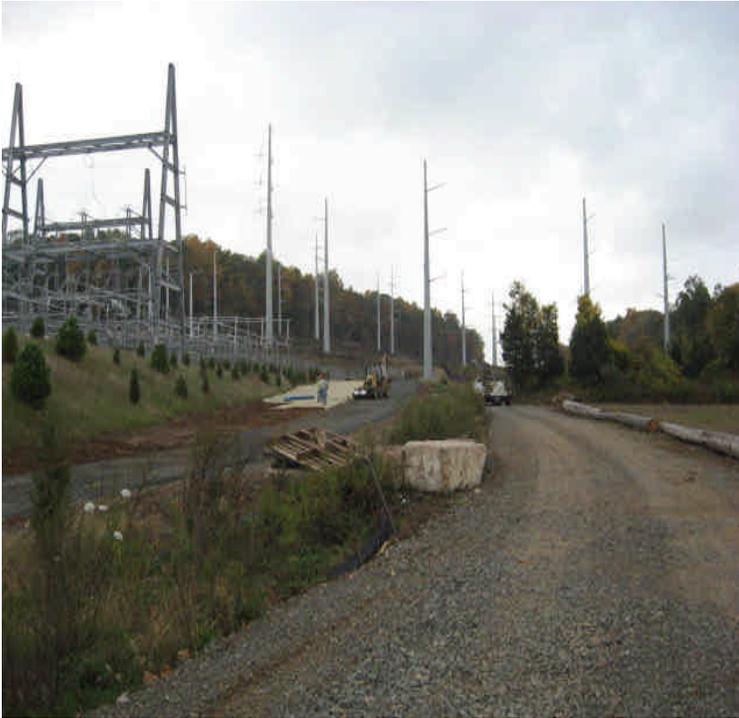
Eastern side of the site, looking from the 1A ROW entrance off Carpenter Ln. Exposed areas are being covered with seed and erosion control mats.

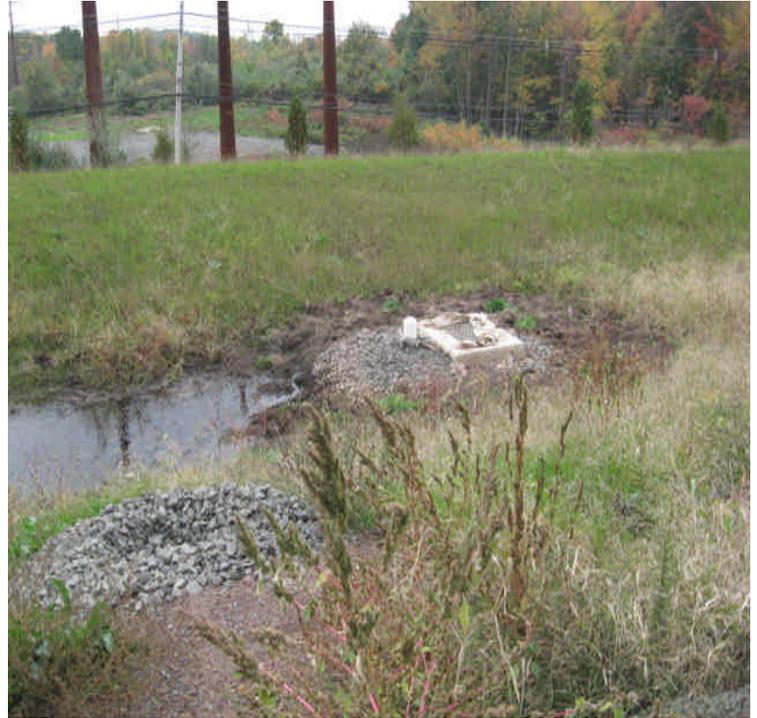
Haybales were removed from around the drain inlets within the detention basins.

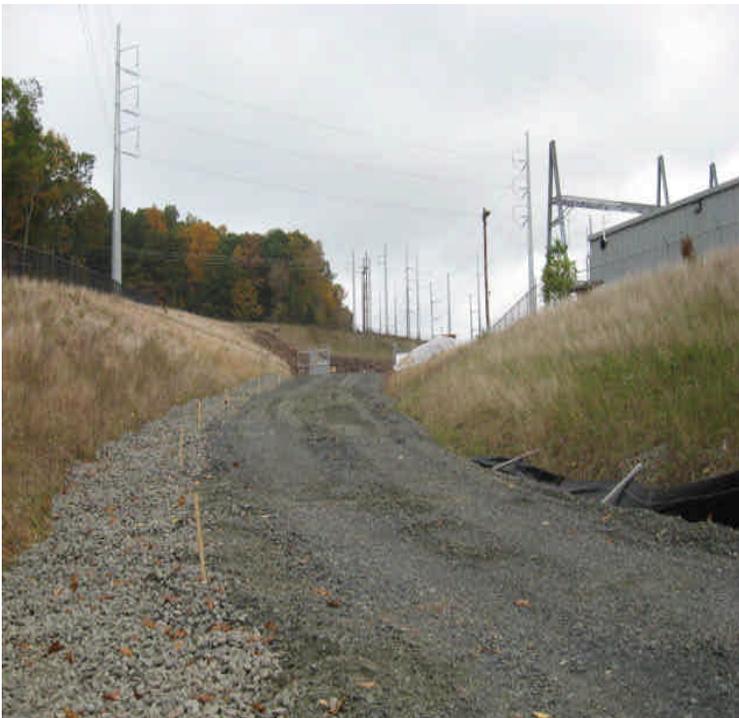
The western site entrance has also been reduced in size and sub-base was added for final paving. A gravel swale was installed along the edge of the	Continue to monitor this entrance during rainstorms and replace controls until paved. 10/23/07	A stone swale was installed.

Road base was installed at final grade and a drainage swale was constructed along the western access road.

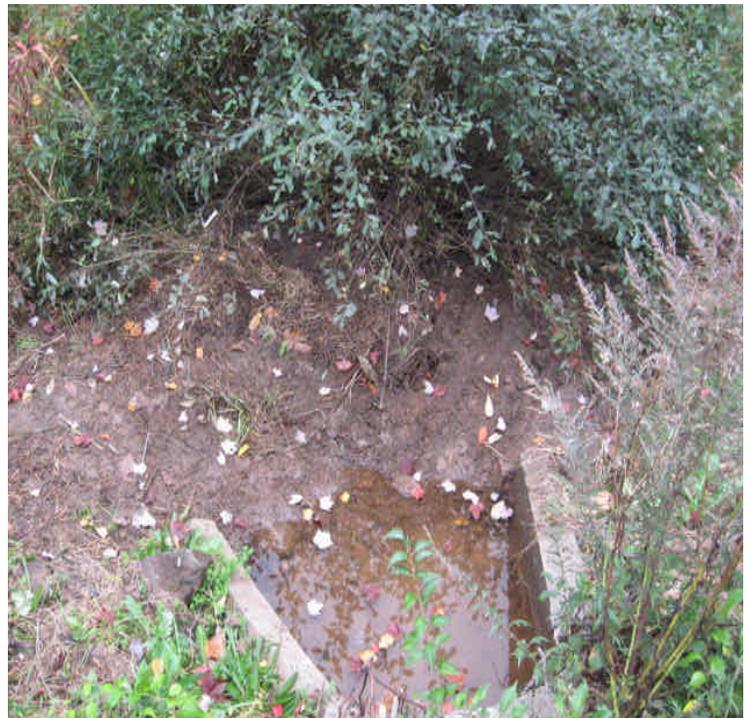
<p>Inland Wetland and Watercourse encroachment and mitigation</p>	<p>Haybales and some sediment have been removed from the outlet the wetlands across Carpenter Lane. Sediment accumulation was noted within and around the outlet where the haybales had been. 10/23/07</p>	<p>Continue to remove all visible sediment from within and around the outlet (and whatever is feasible from within the pipe). Seed the area with a wetland seed mix for final stabilization. Access roads are not fully stabilized/paved, therefore haybales may need to be replaced during heavy rain. 10/23/07</p>	<p>Replace controls as needed. Sediment needs some additional attention.</p>
<p>State species of concern, threatened and endangered species.</p>	<p>According to the D&M plan, state-listed species are not located in this work area. 10/23/07</p> <p>Several different species of frogs, turtles, and salamanders have been</p>	<p>None. 10/23/07</p> <p>Although these species were not state-listed, it indicates good habitat.</p>	<p>NA</p> <p>NA</p>

Haybales were removed from the outlet across Carpenter Lane. Effort should be made to remove all visible sediment at the outlet and within the pipe. Seed the disturbed area with wetland mix.
