# **ENVIRONMENTAL REVIEW REPORT**

**Community Development Block Grant – Disaster Recovery  
Owner Occupied Rehabilitation and Rebuilding Program**

**Applicant # 1072**

**30 Elaine Road  
Milford, Connecticut**

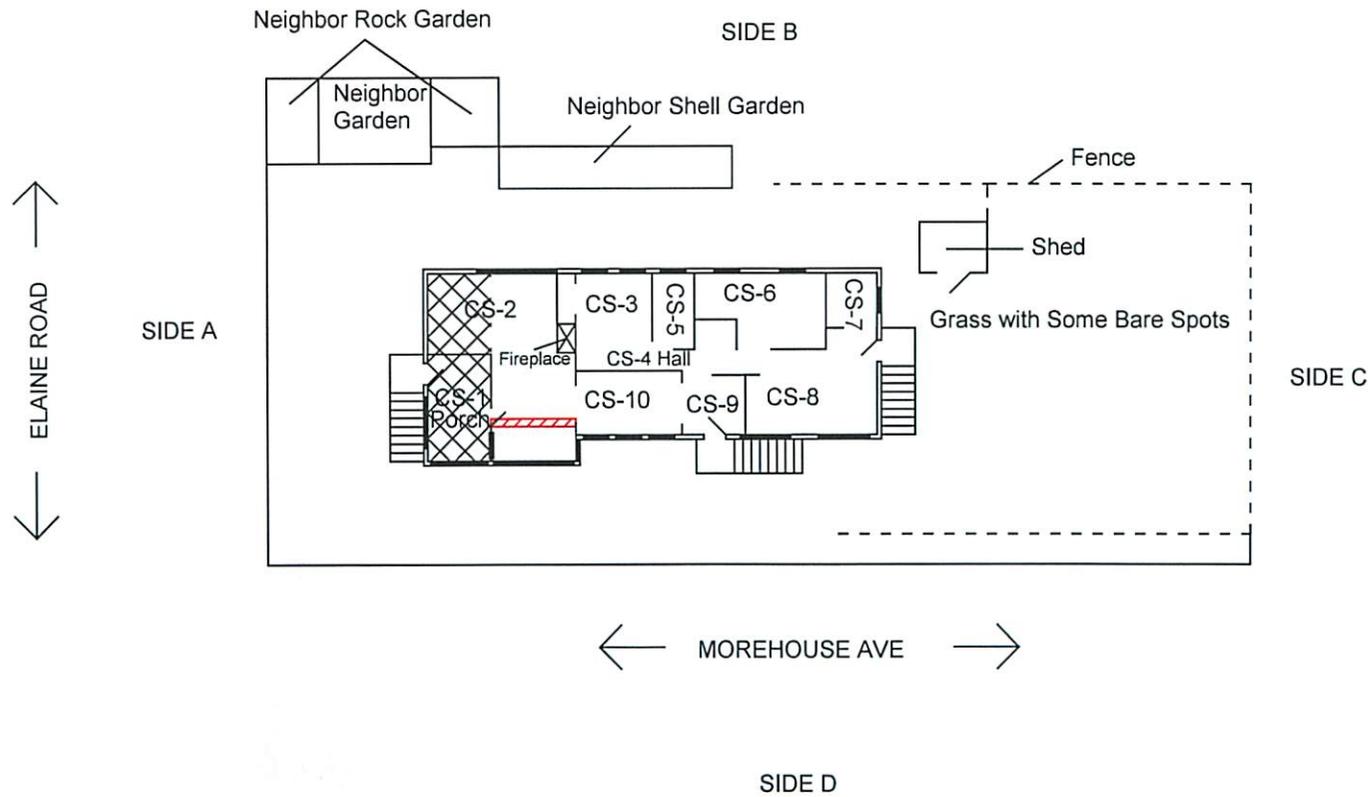
ACM LOCATION DRAWING

\*>1% Asbestos was found in the beige crumbly taping compound only but the combined result of the taping compound and the sheetrock layers is <1% asbestos; consequently, the sheetrock walls and ceilings are OSHA regulated but not EPA-DPH regulated. Materials with <1% asbestos are not defined as asbestos containing materials in State and Federal regulations. However, OSHA regulations require proper procedures be used to prevent exposure to workers performing the related disturbance. This includes training and protection for employees who may be exposed above the OSHA PEL.

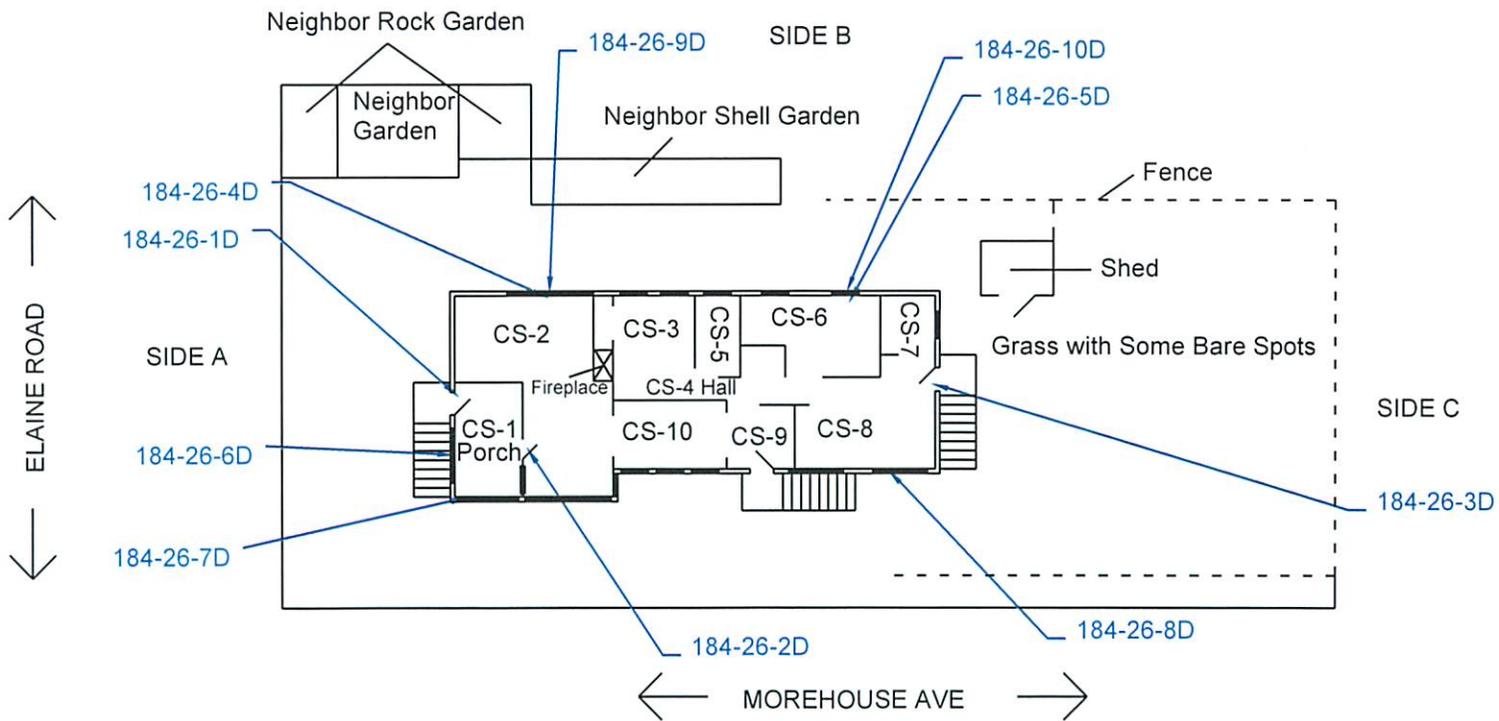
LEAD DUST SAMPLE LOCATION DRAWING

Two of the ten dust samples collected were within acceptable levels. A summary list is given below, see attached analysis reports and drawings for details. **Samples noted in bold on the following page exceeded HUD and CT-DPH standards and represent dust-lead hazards. These samples constitute dust-lead hazards in those rooms.**
