ENVIRONMENTAL REVIEW REPORT

**Community Development Block Grant – Disaster Recovery
Owner Occupied Rehabilitation and Rebuilding Program**

**21 Danbury Avenue
Westport, Connecticut**

March 26, 2015

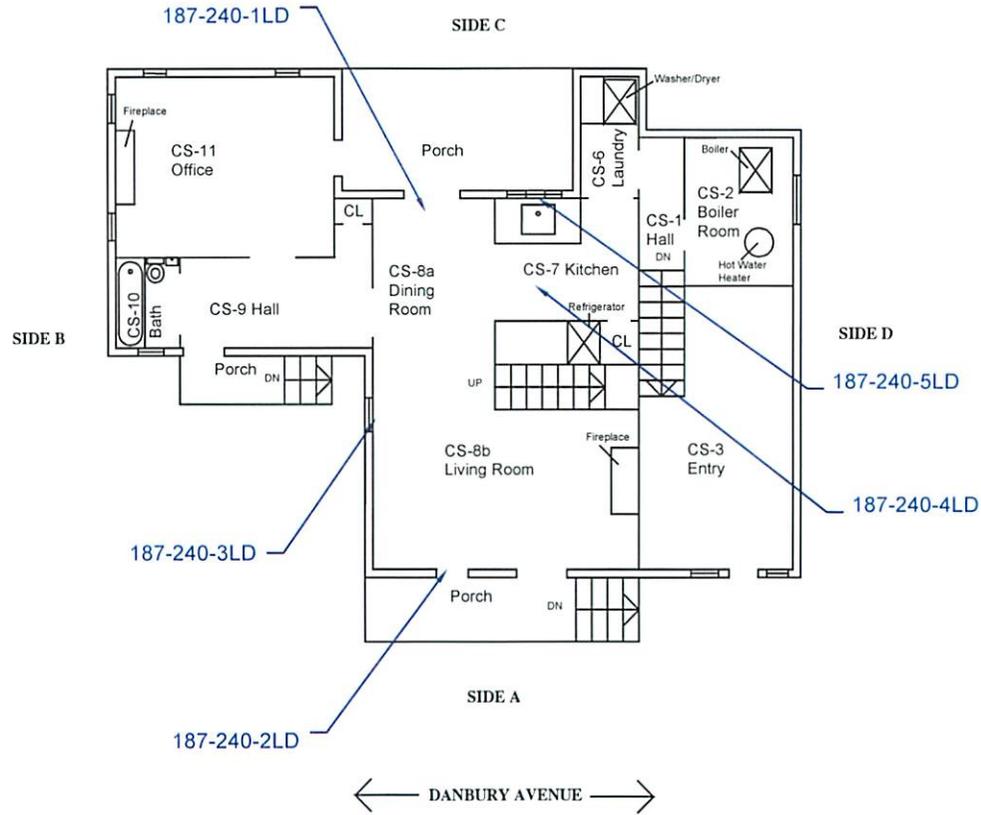
LEAD IN DUST SAMPLE LOCATION DRAWING

Eleven of the twelve dust samples collected were within acceptable levels. A summary list is given below, see attached analysis reports and drawings for details. **Samples noted in bold below exceeded HUD and CT-DPH standards and represent dust-lead hazards. These samples constitute dust-lead hazards in those rooms.**

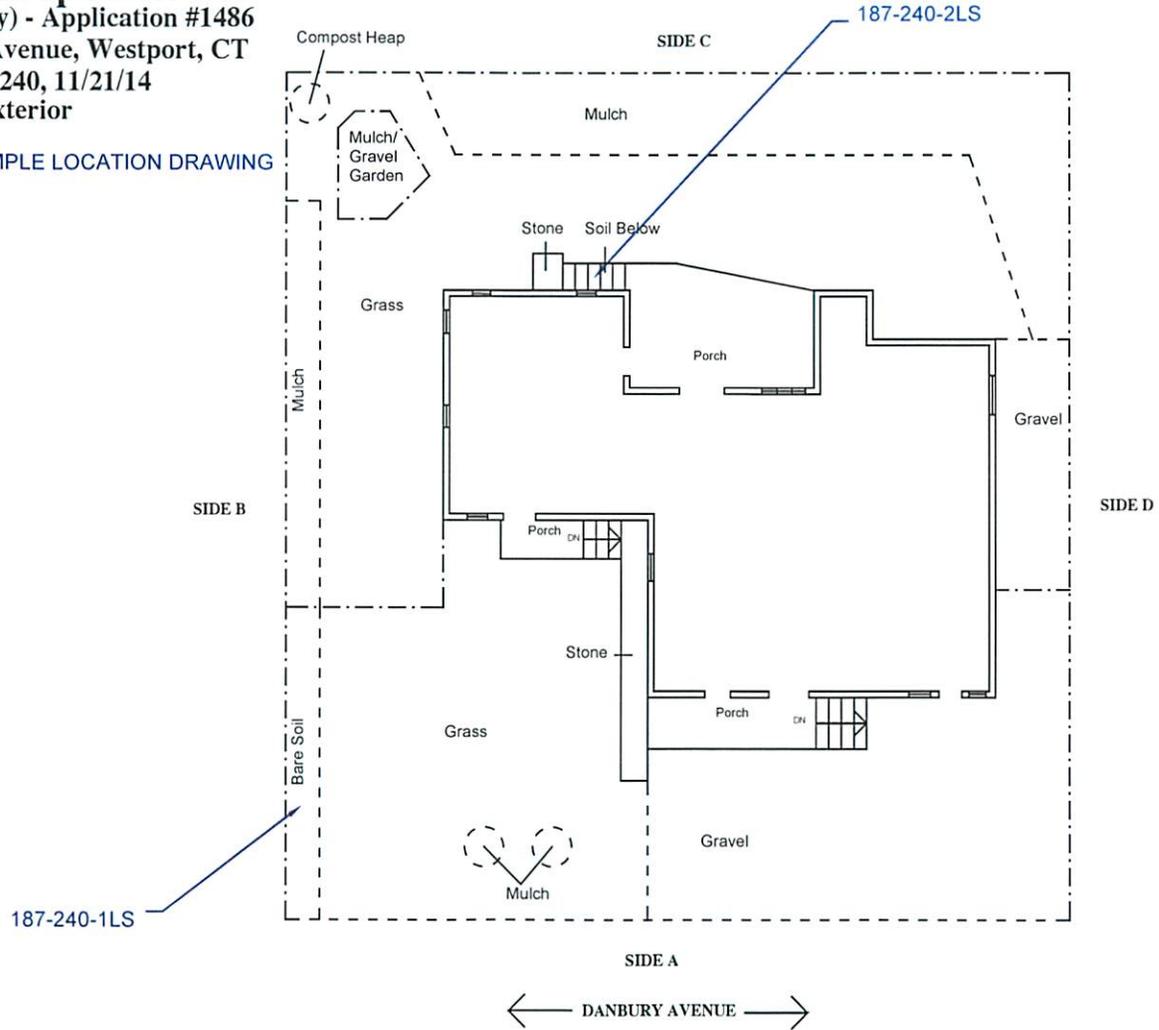
LEAD IN SOIL SAMPLE LOCATION DRAWING

Two (2) composite soil samples were collected at this residence in accordance with the requirements of ASTM Standard E-1727, Standard Practice for Field Collection of Soil Samples for Lead Determination by Atomic Spectrometry Techniques. None of the samples identified lead concentrations above the levels that EPA, HUD or CT-DPH identifies as hazardous. See the following table for a summary of the soil sampling results. Please refer to *Appendix C – Soil Sample Analytical Data* for the detailed analytical reports.
