RE: 116 Seaside Avenue, Guilford, CT

DEPARTMENT OF HOUSING  
 COMMUNITY DEVELOPMENT BLOCK GRANT  
 DISASTER RECOVERY

116 SEASIDE AVENUE  
 GUILFORD, CT

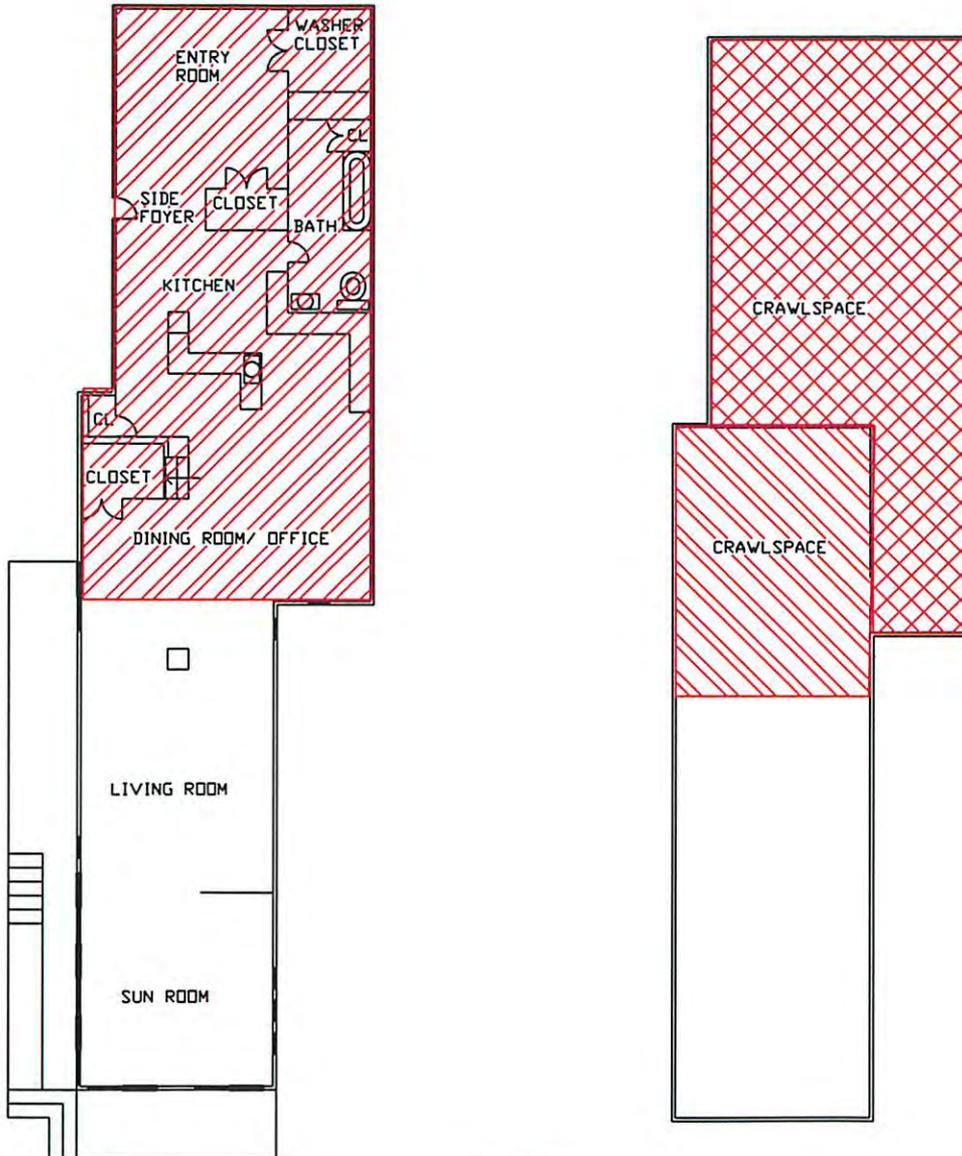
MOLD & MOISTURE LOCATION DRAWING

**Executive Summary:** Mold and moisture issues, as a result of a past water-damage, need to be resolved. There is visible mold in the crawlspace and we understand from the owner when past renovation work has taken place, mold was found inside all of the wall cavities on the first floor.

Table 2 (on page 4) is a summary of our visual observations and moisture readings (mold and moisture issues are shown in ***BOLD Italics***). The crawlspace wood ceiling and beams tested as 20-40% moisture, which is considered damp and would promote mold growth. This is consistent with the visible mold growth in the space.

Location of assumed mold in wall cavities based on prior history
	Location of visible mold on wood ceiling and beams
	Location of pipe insulation with visible mold & moisture damage

In general, correction of water damage requires first eliminating the source of the water. With the house being raised there should be a great increase in the ventilation below the house, which should address the excess humidity in the crawlspace.

5. Remove and replace the wooden subfloor and beams (crawlspace ceiling). Care must be taken to ensure that the house will be structurally sound during the work.
6. Clean other components, which are intact.
7. Replace with new mold-free similar materials.
